**SOILS AND GEOLOGY STUDY  
LOT 1, STERLING RECYCLING FACILITY  
PARCEL NO. 53000-00-743  
COLORADO SPRINGS, COLORADO**

Prepared for:  
**Rhetoric LLC  
20 Boulder Crescent  
Colorado Springs, CO 80903**

August 17, 2023

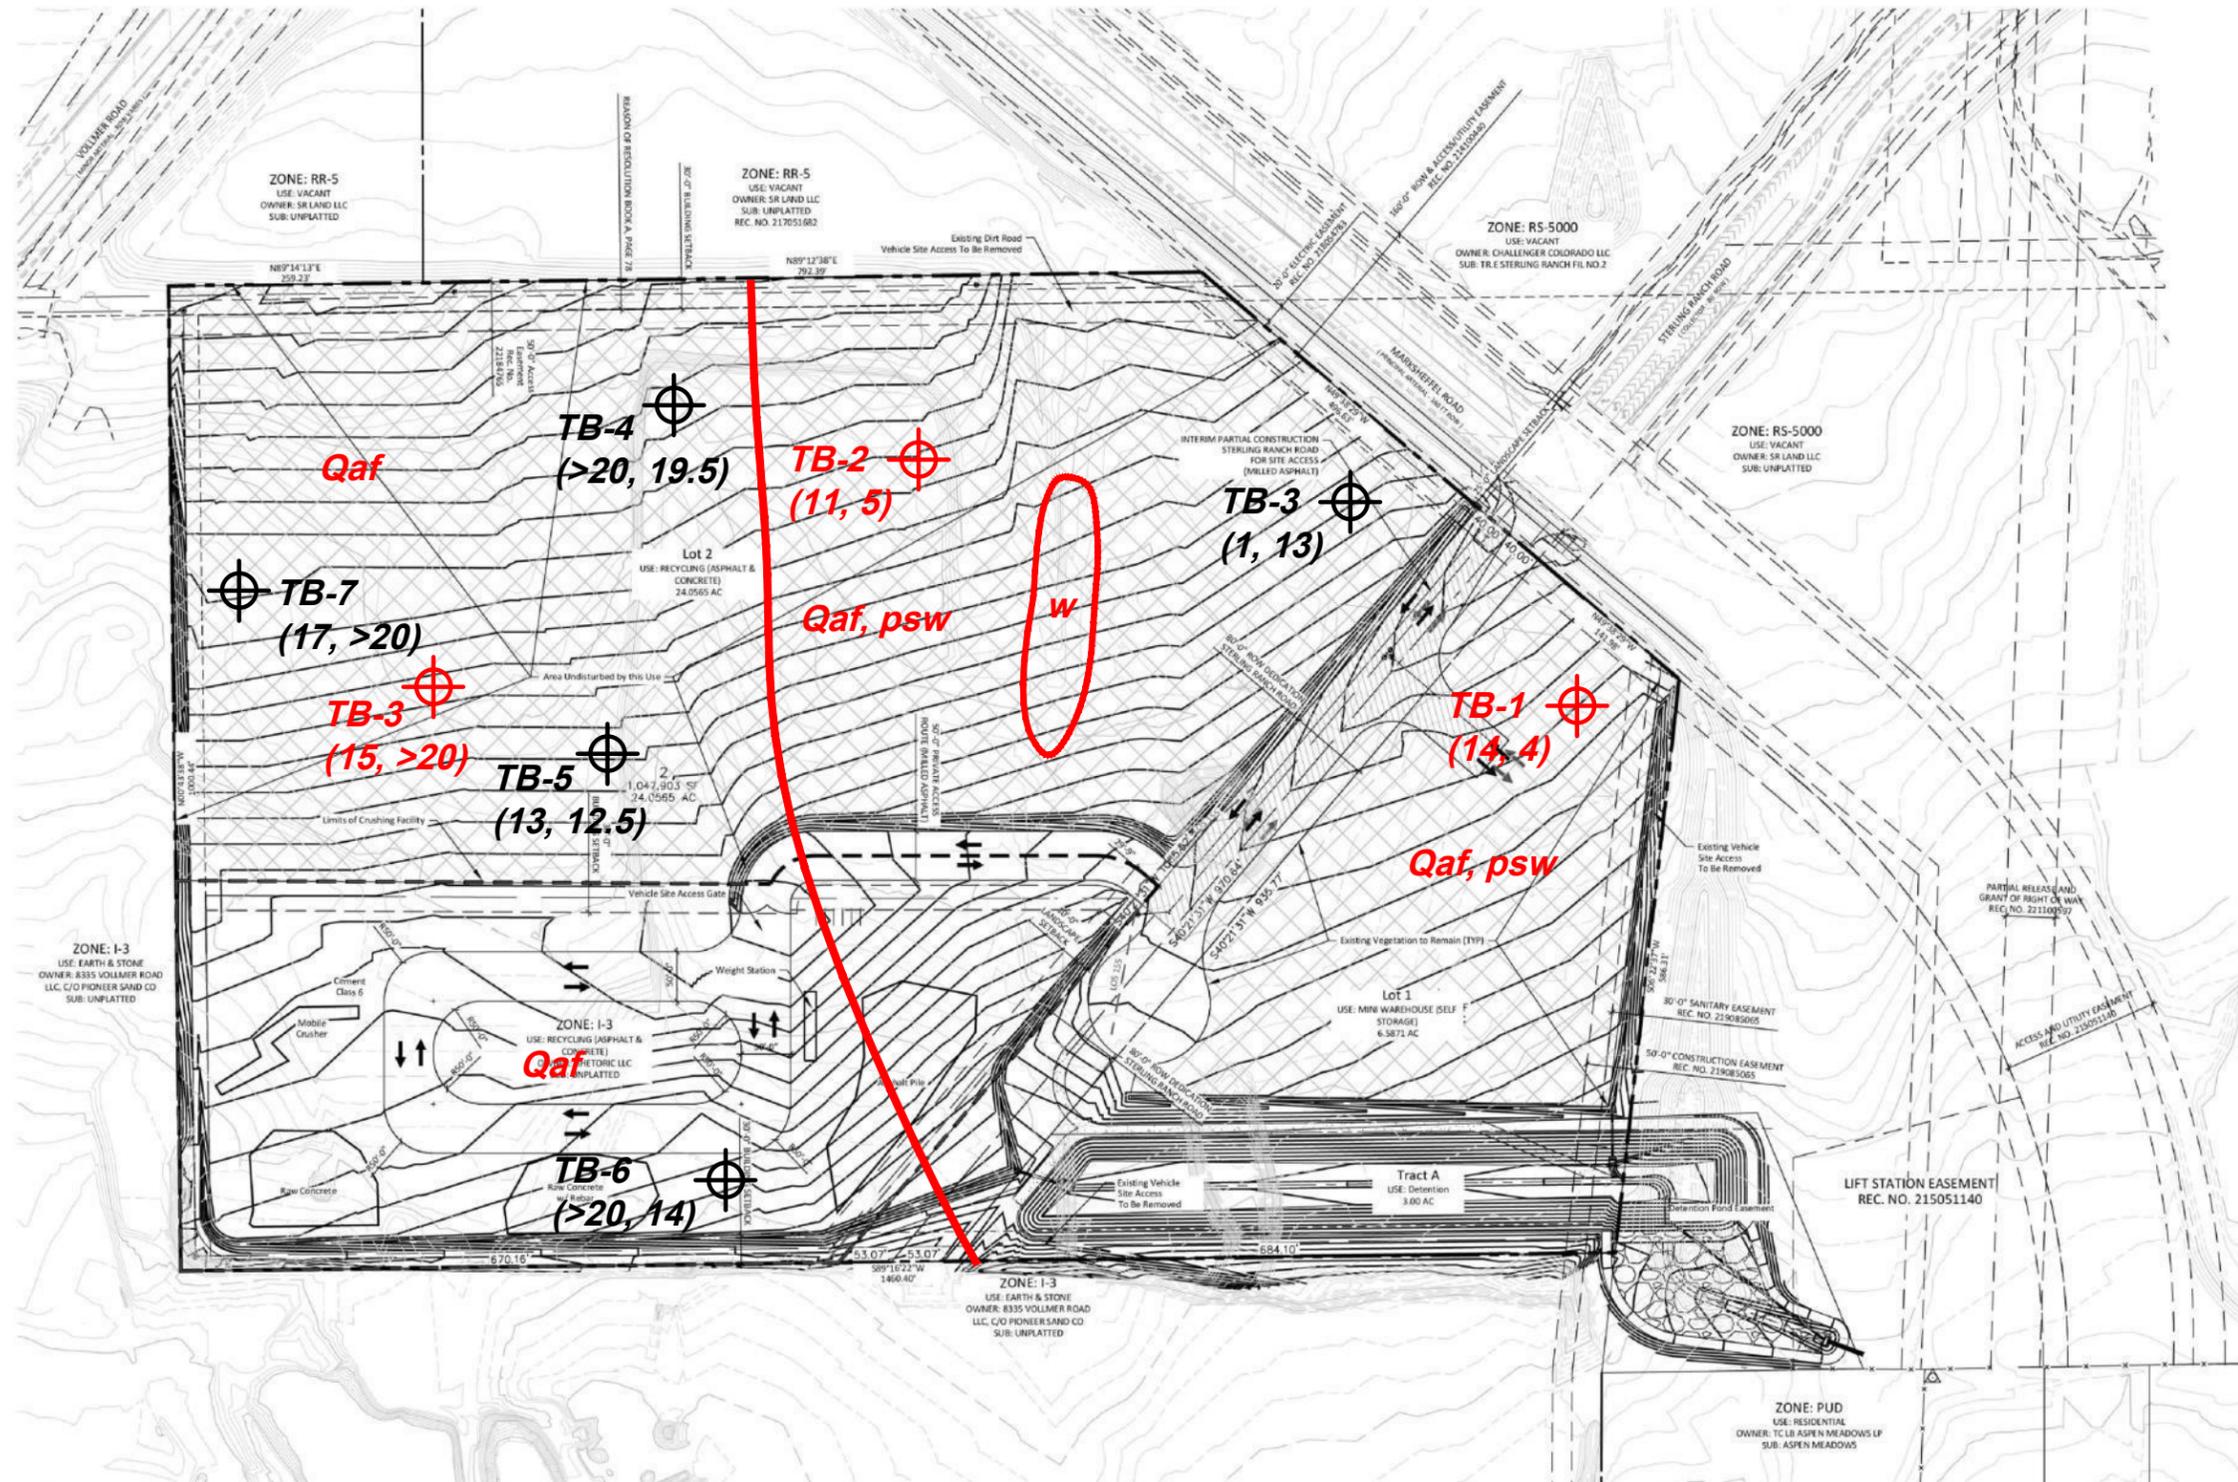
**GEOLOGY/ENGINEERING MAP**  
 LOT 1, STERLING RECYCLING FACILITY  
 EL PASO COUNTY, COLORADO  
 RHETORIC LLC

Geologic mapping has been performed on this site to produce an Engineering Geology Map Figure 7. This map shows the location of various geologic conditions of which the developers should be cognizant during the planning, design and construction stages of the project. These hazards and the recommended mitigation techniques are as follows:

These are areas of man-made fill associated with past quarry operations and fill dumped across the site, in addition to the asphalt, concrete, and soil piles associated with the Sterling Recycling Facility. Fill was encountered in the test borings at depths of 3 to 5 feet. Fill depths are variable across the site and test pits and or additional test borings in the building areas are recommended once development plans are finalized.

In these areas, we would anticipate the potential for periodically high subsurface moisture conditions, frost heave potential and highly organic soils. These areas are primarily located in the eastern half of the site where groundwater was encountered at depths of 4 to 5 feet in the test borings. Preliminary grading plans available at the time of this investigation, indicate that this area is to be filled during site grading. A minimum separation of 3 feet between foundation components and groundwater levels are recommended.

Mitigation: The fill on this site is considered uncontrolled for construction purposes. Any uncontrolled fill encountered beneath foundations will require removal and recompaction at a minimum of 95% of its maximum Modified Proctor Dry Density, ASTM D-1557.

Mitigation: Foundations must have a minimum 30-inch depth for frost protection. In areas where high subsurface moisture conditions are anticipated periodically, subsurface perimeter drains are recommended to help prevent the intrusion of water into areas below grade. Fill added to these areas further raise foundations above groundwater levels. Foundations should be kept as high as possible. Areas may experience higher groundwater levels during period of higher precipitation where water can flow through permeable sands on top of less permeable bedrock materials. Subsurface perimeter drains may be necessary to prevent the intrusion of water into areas below grade. Typical drain details are presented in Figure 8. Where shallow groundwater is encountered, underslab drains or interceptor drains may be necessary. Typical drain details are presented in Figures 9 and 10. It is anticipated that the shallow water areas will be mitigated with site grading and the installation of sewer underdrains. Specific recommendations should be made after additional investigation and site grading has been completed.

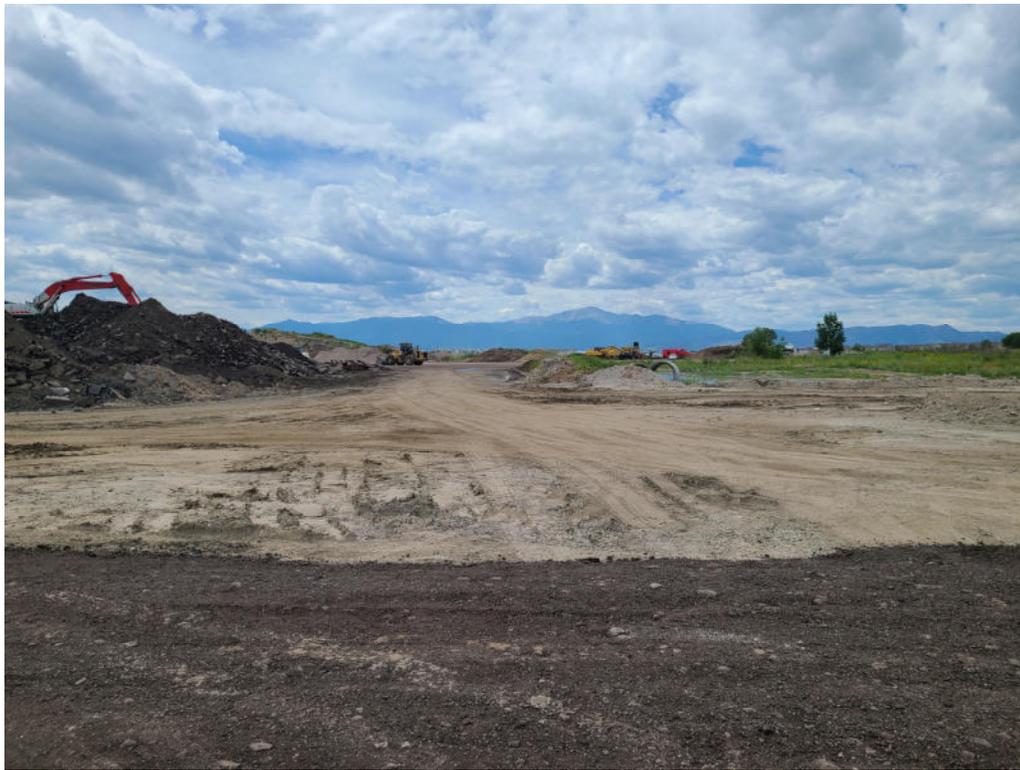
**Looking west from the northeastern portion of the site.**

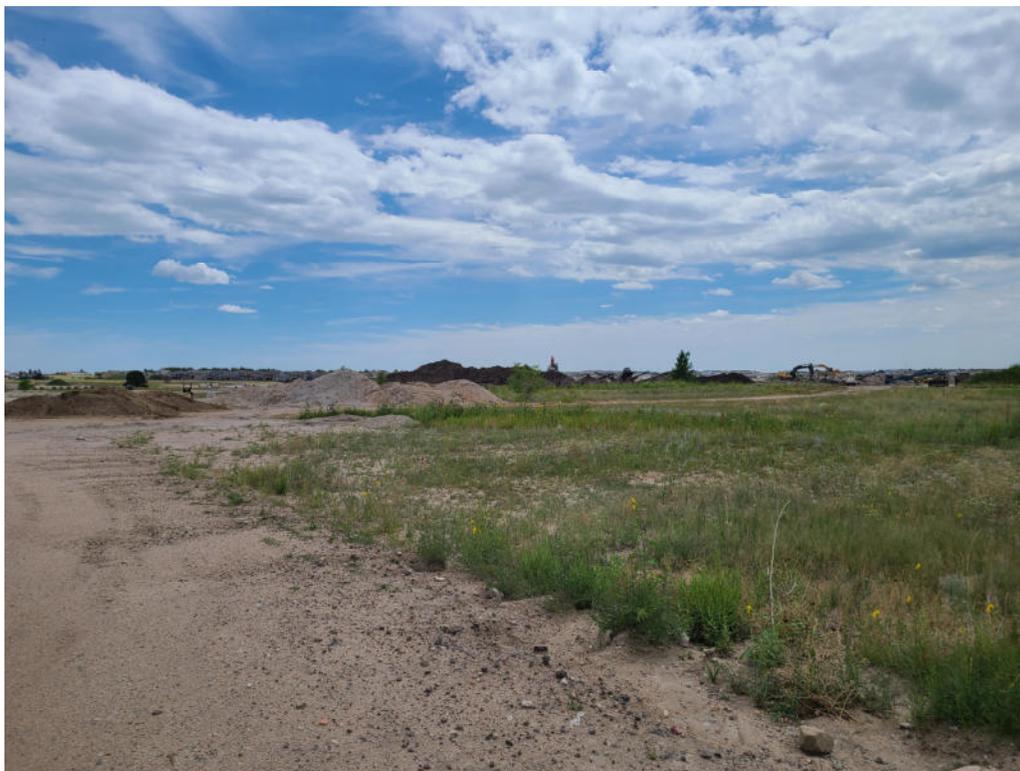
**Looking southeast from the northern portion of the site.**

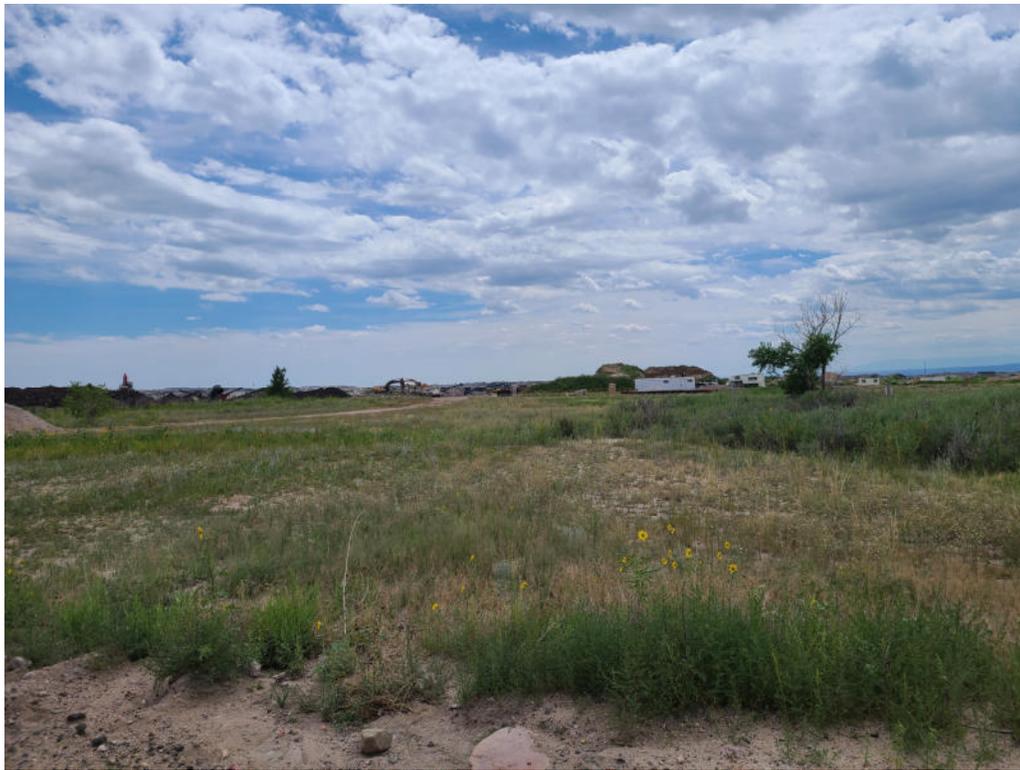
**Looking southwest  
from the northern  
portion of the site.**

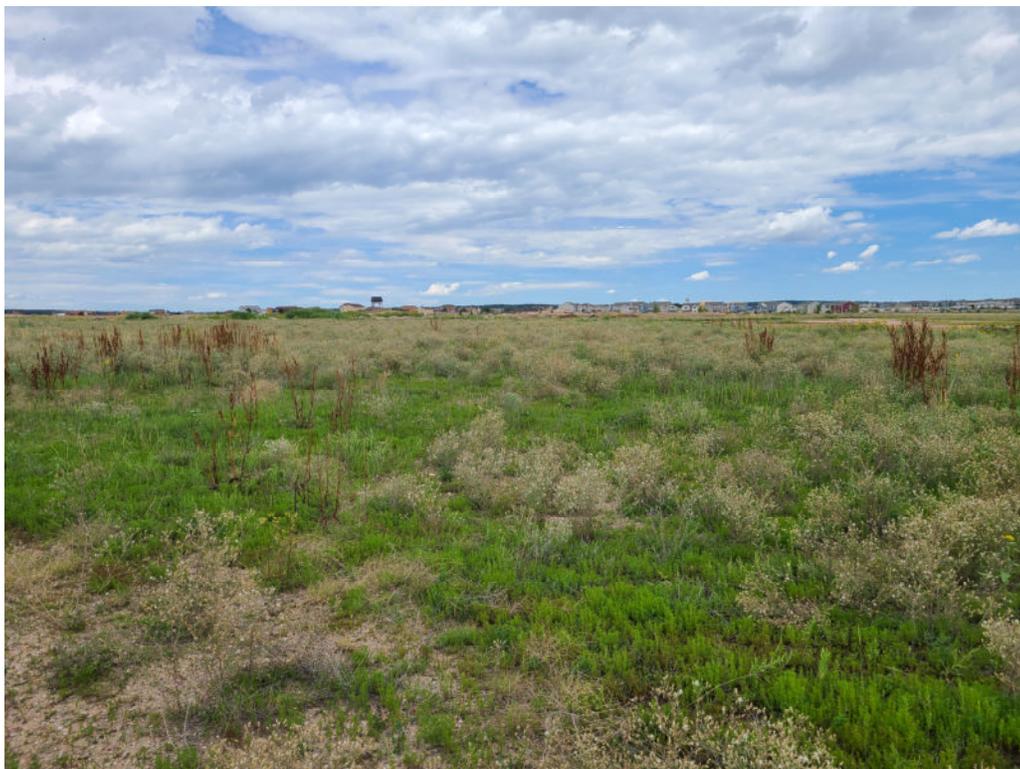
**Looking north from the  
western portion of the  
site.**
