**CONCEPT LEVEL GEOLOGIC HAZARDS EVALUATION
FALCON COMMERCE CENTER
SOUTHWEST OF I-25 AND BAPTIST ROAD
EL PASO COUNTY, COLORADO**

CTL|T Project No. CS19214-100

February 26, 2020

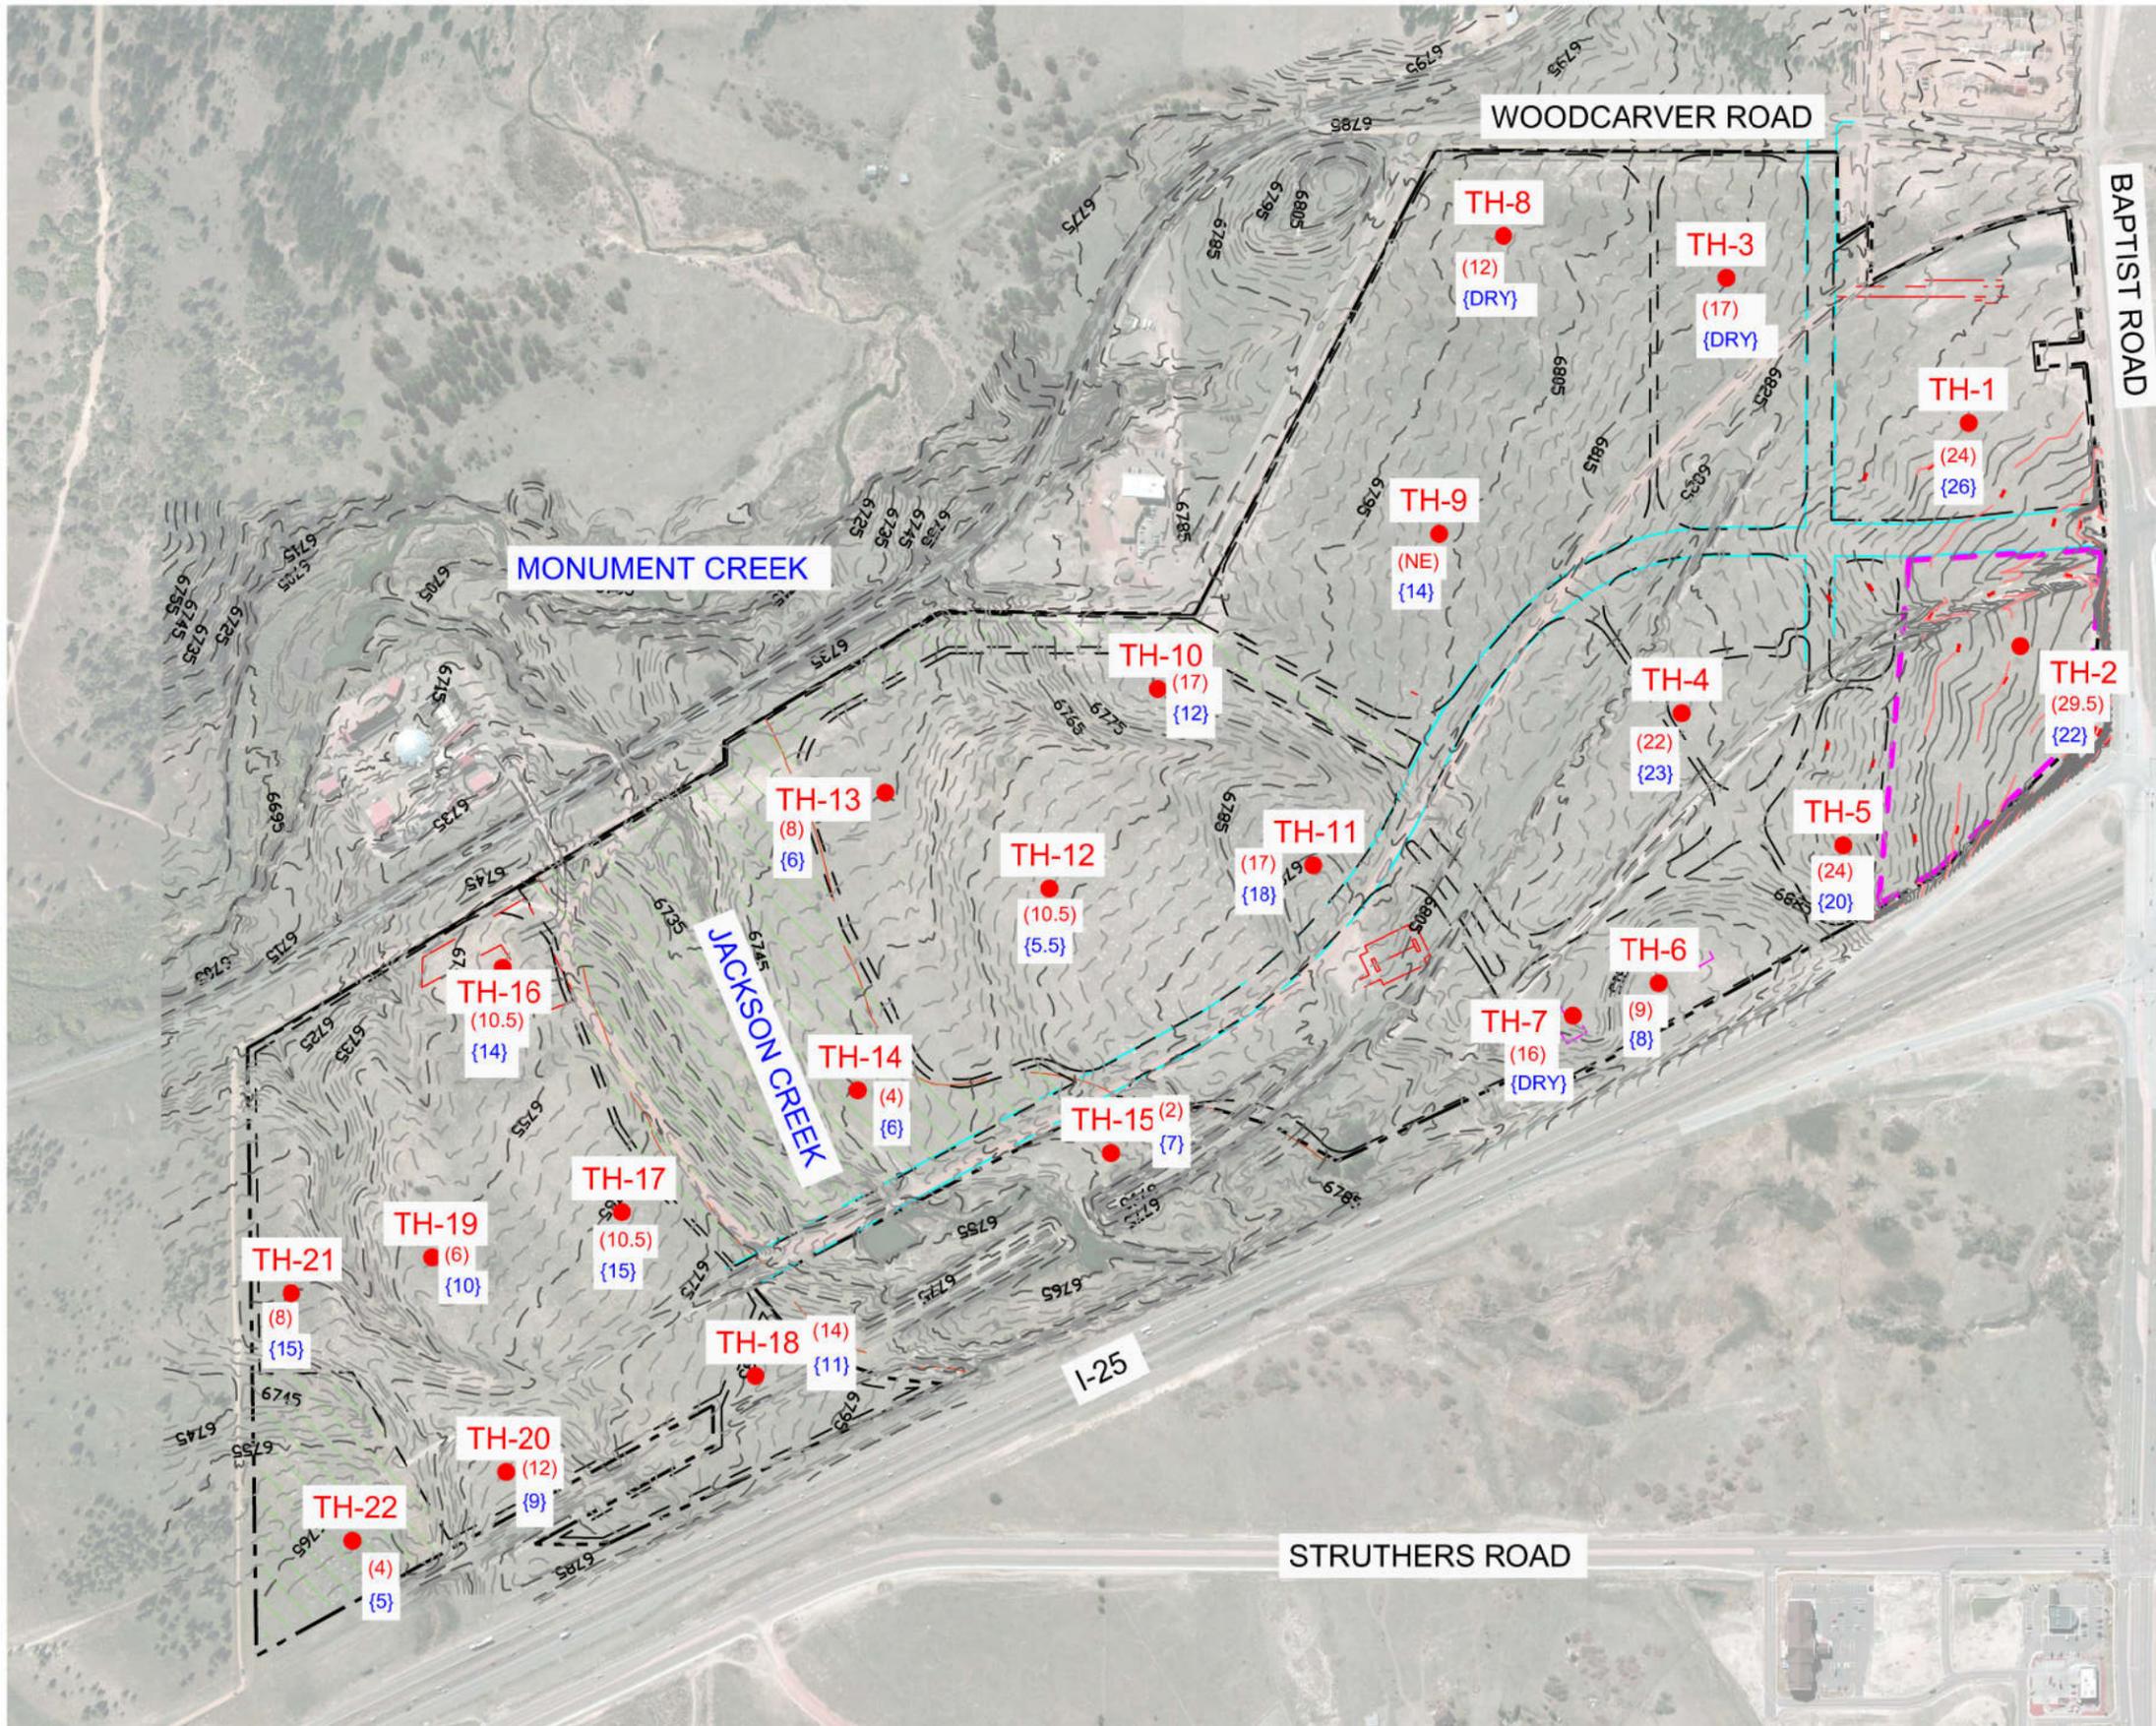
**Location of
Exploratory
Borings**

Shallow bedrock conditions exist generally in the southern portion of the site. Along the southeastern portion of the site bedrock was encountered at less than 5 feet below the ground surface. The depth to bedrock in our test borings advanced during our 1999 study is shown on Figure 1. The risk of damage to structures is significantly higher where expansive soils and bedrock are exposed at the ground surface as a result of site grading.

The depth to groundwater measured during our 1999 study is shown on Figure 1. Shallow groundwater is found in areas mapped as “sw”, and “Qal” on Fig.2. Depth to water will likely change due to natural environmental variations and from irrigation and modified surface drainage after development. The significant permeability differences between surficial sandy soils and the bedrock are favorable for the development of “perched” groundwater at the interface. When bedrock is naturally shallow or shallow due to grading “cuts”, conditions are favorable for the formation of a shallow perched water table. Man-induced conditions, such as lawn irrigation and changes in surface drainage, can contribute to the formation of shallow perched water tables. Potential mitigation procedures include construction of interceptor drains, subdrains below sewers, and foundation drains.

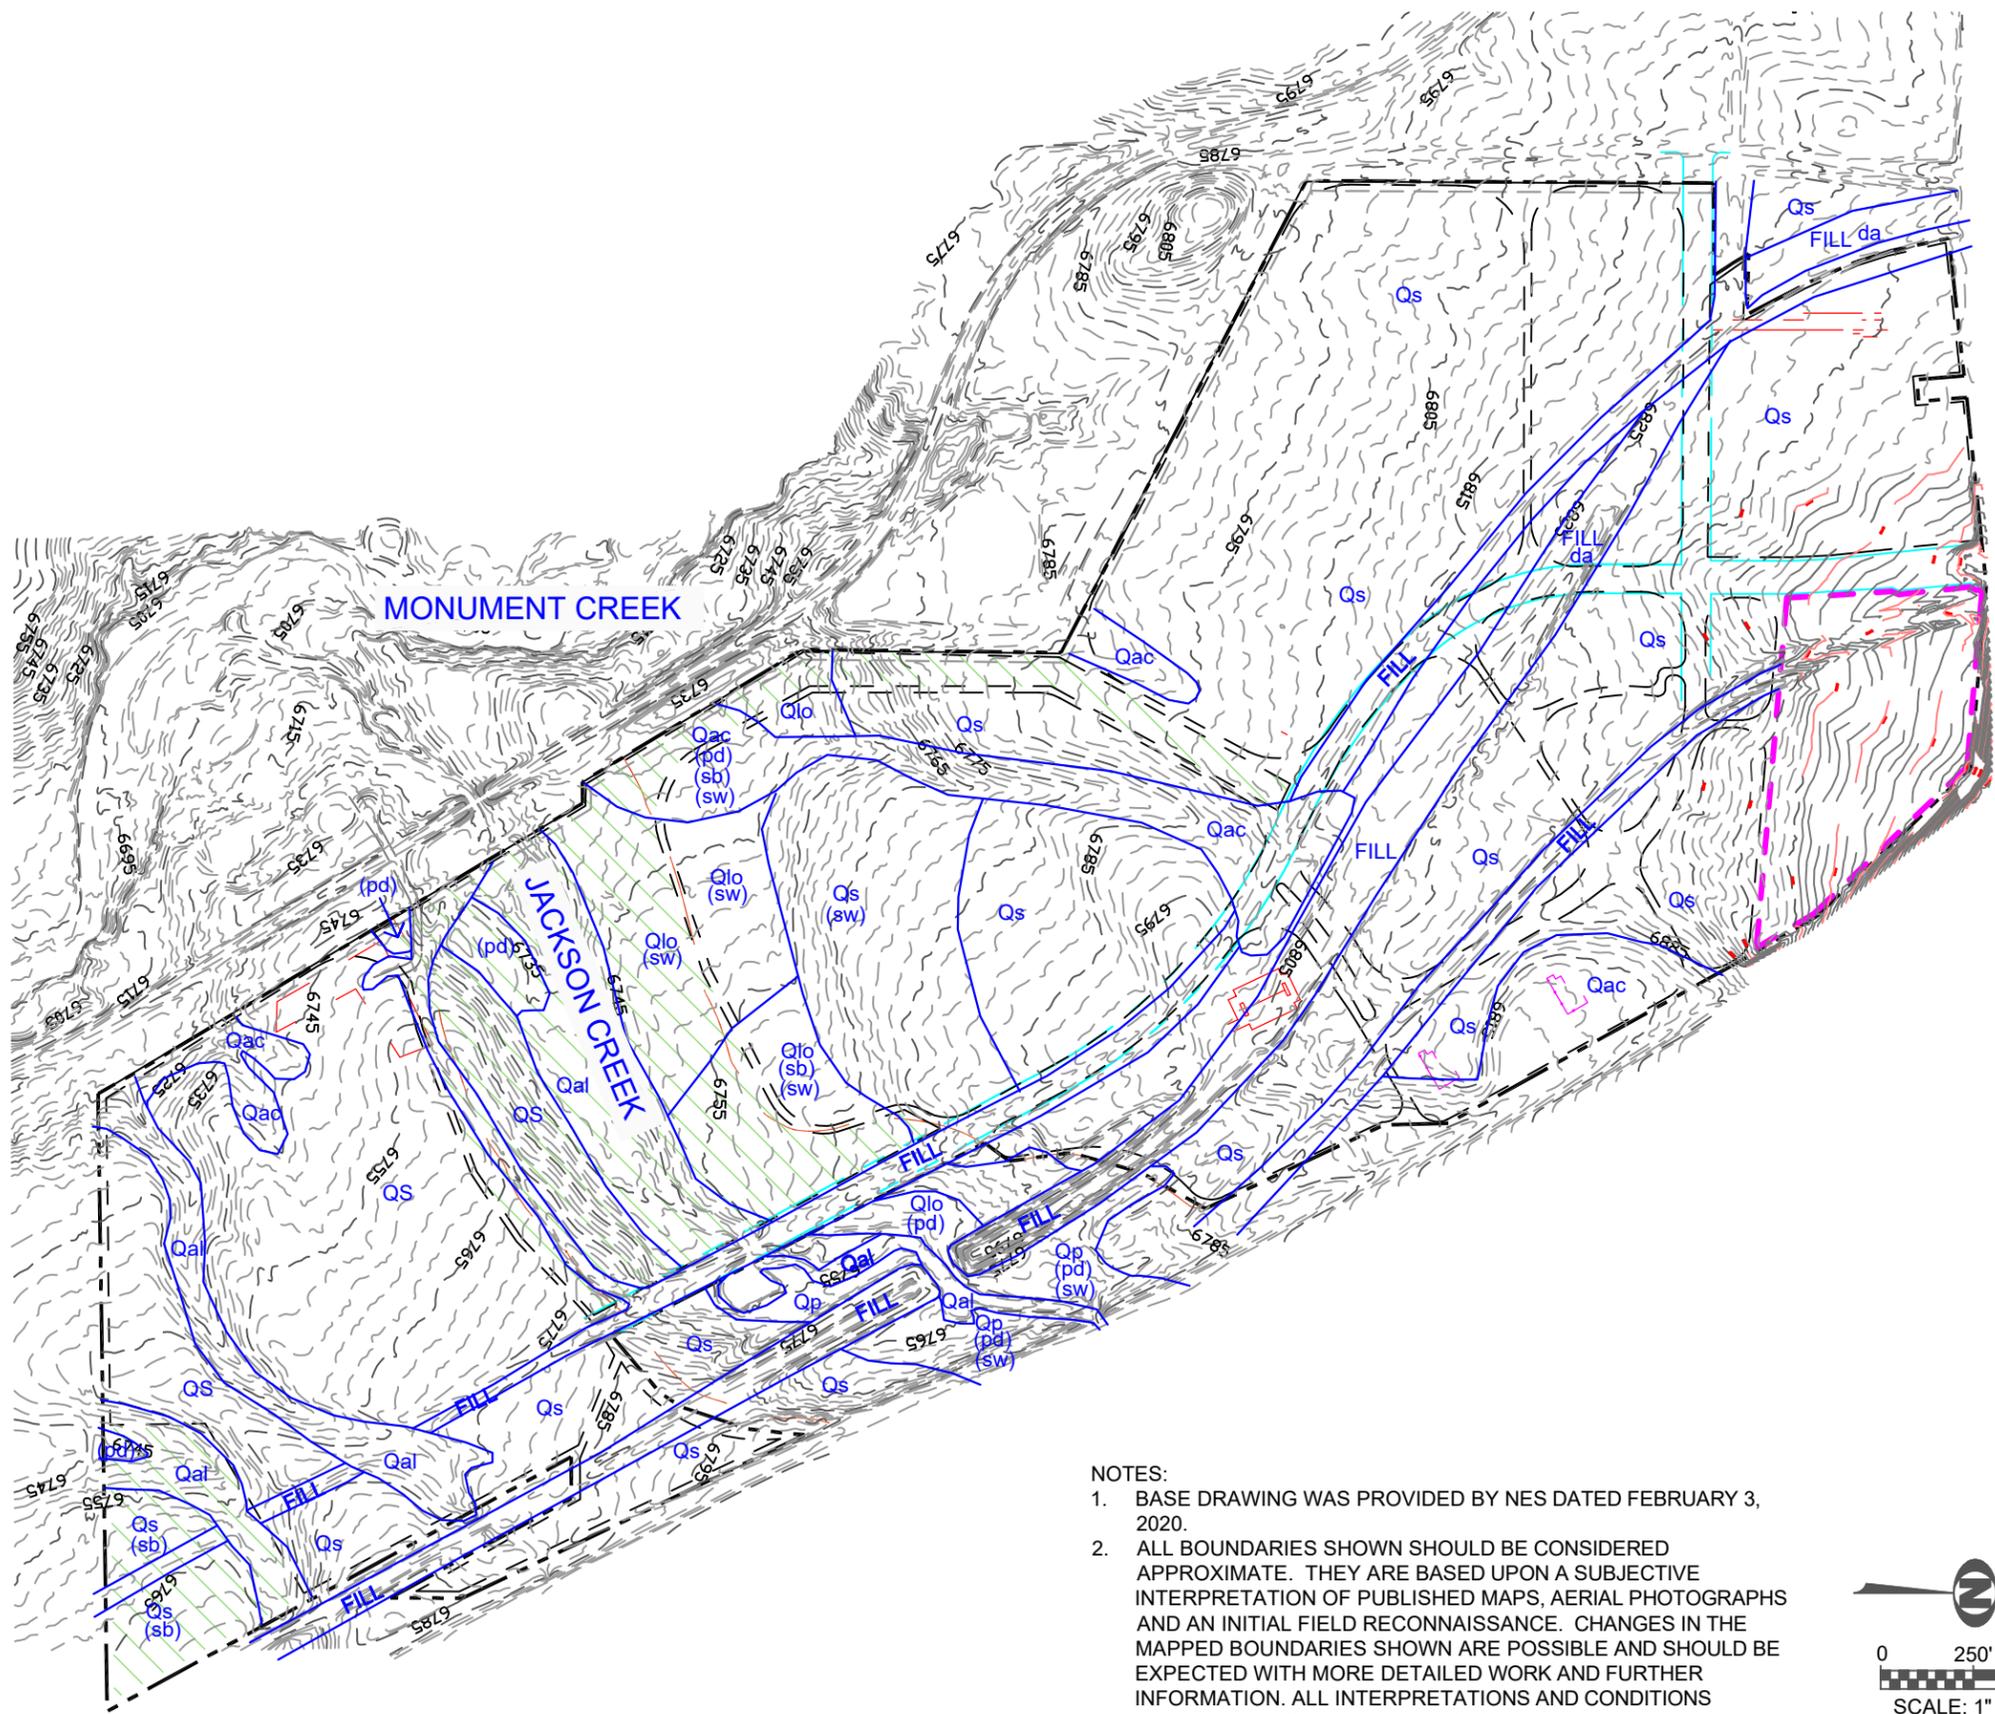
A former railroad grade crosses the site from north to south and fill associated with the railroad bed is located primarily along the sites eastern side. Several abandoned roads are also found crossing the site from north to south. These areas are mapped as “Fill/da” and are areas of fill and/or areas disturbed by previous grading activity.
