**SOIL, GEOLOGY, AND GEOLOGIC HAZARD STUDY  
STERLING RANCH FILING NO. 5  
PARCEL 16  
EL PASO COUNTY, COLORADO**

**Classic SRJ**

November 22, 2022  
Revised December 1, 2023  
Revised March 26, 2024

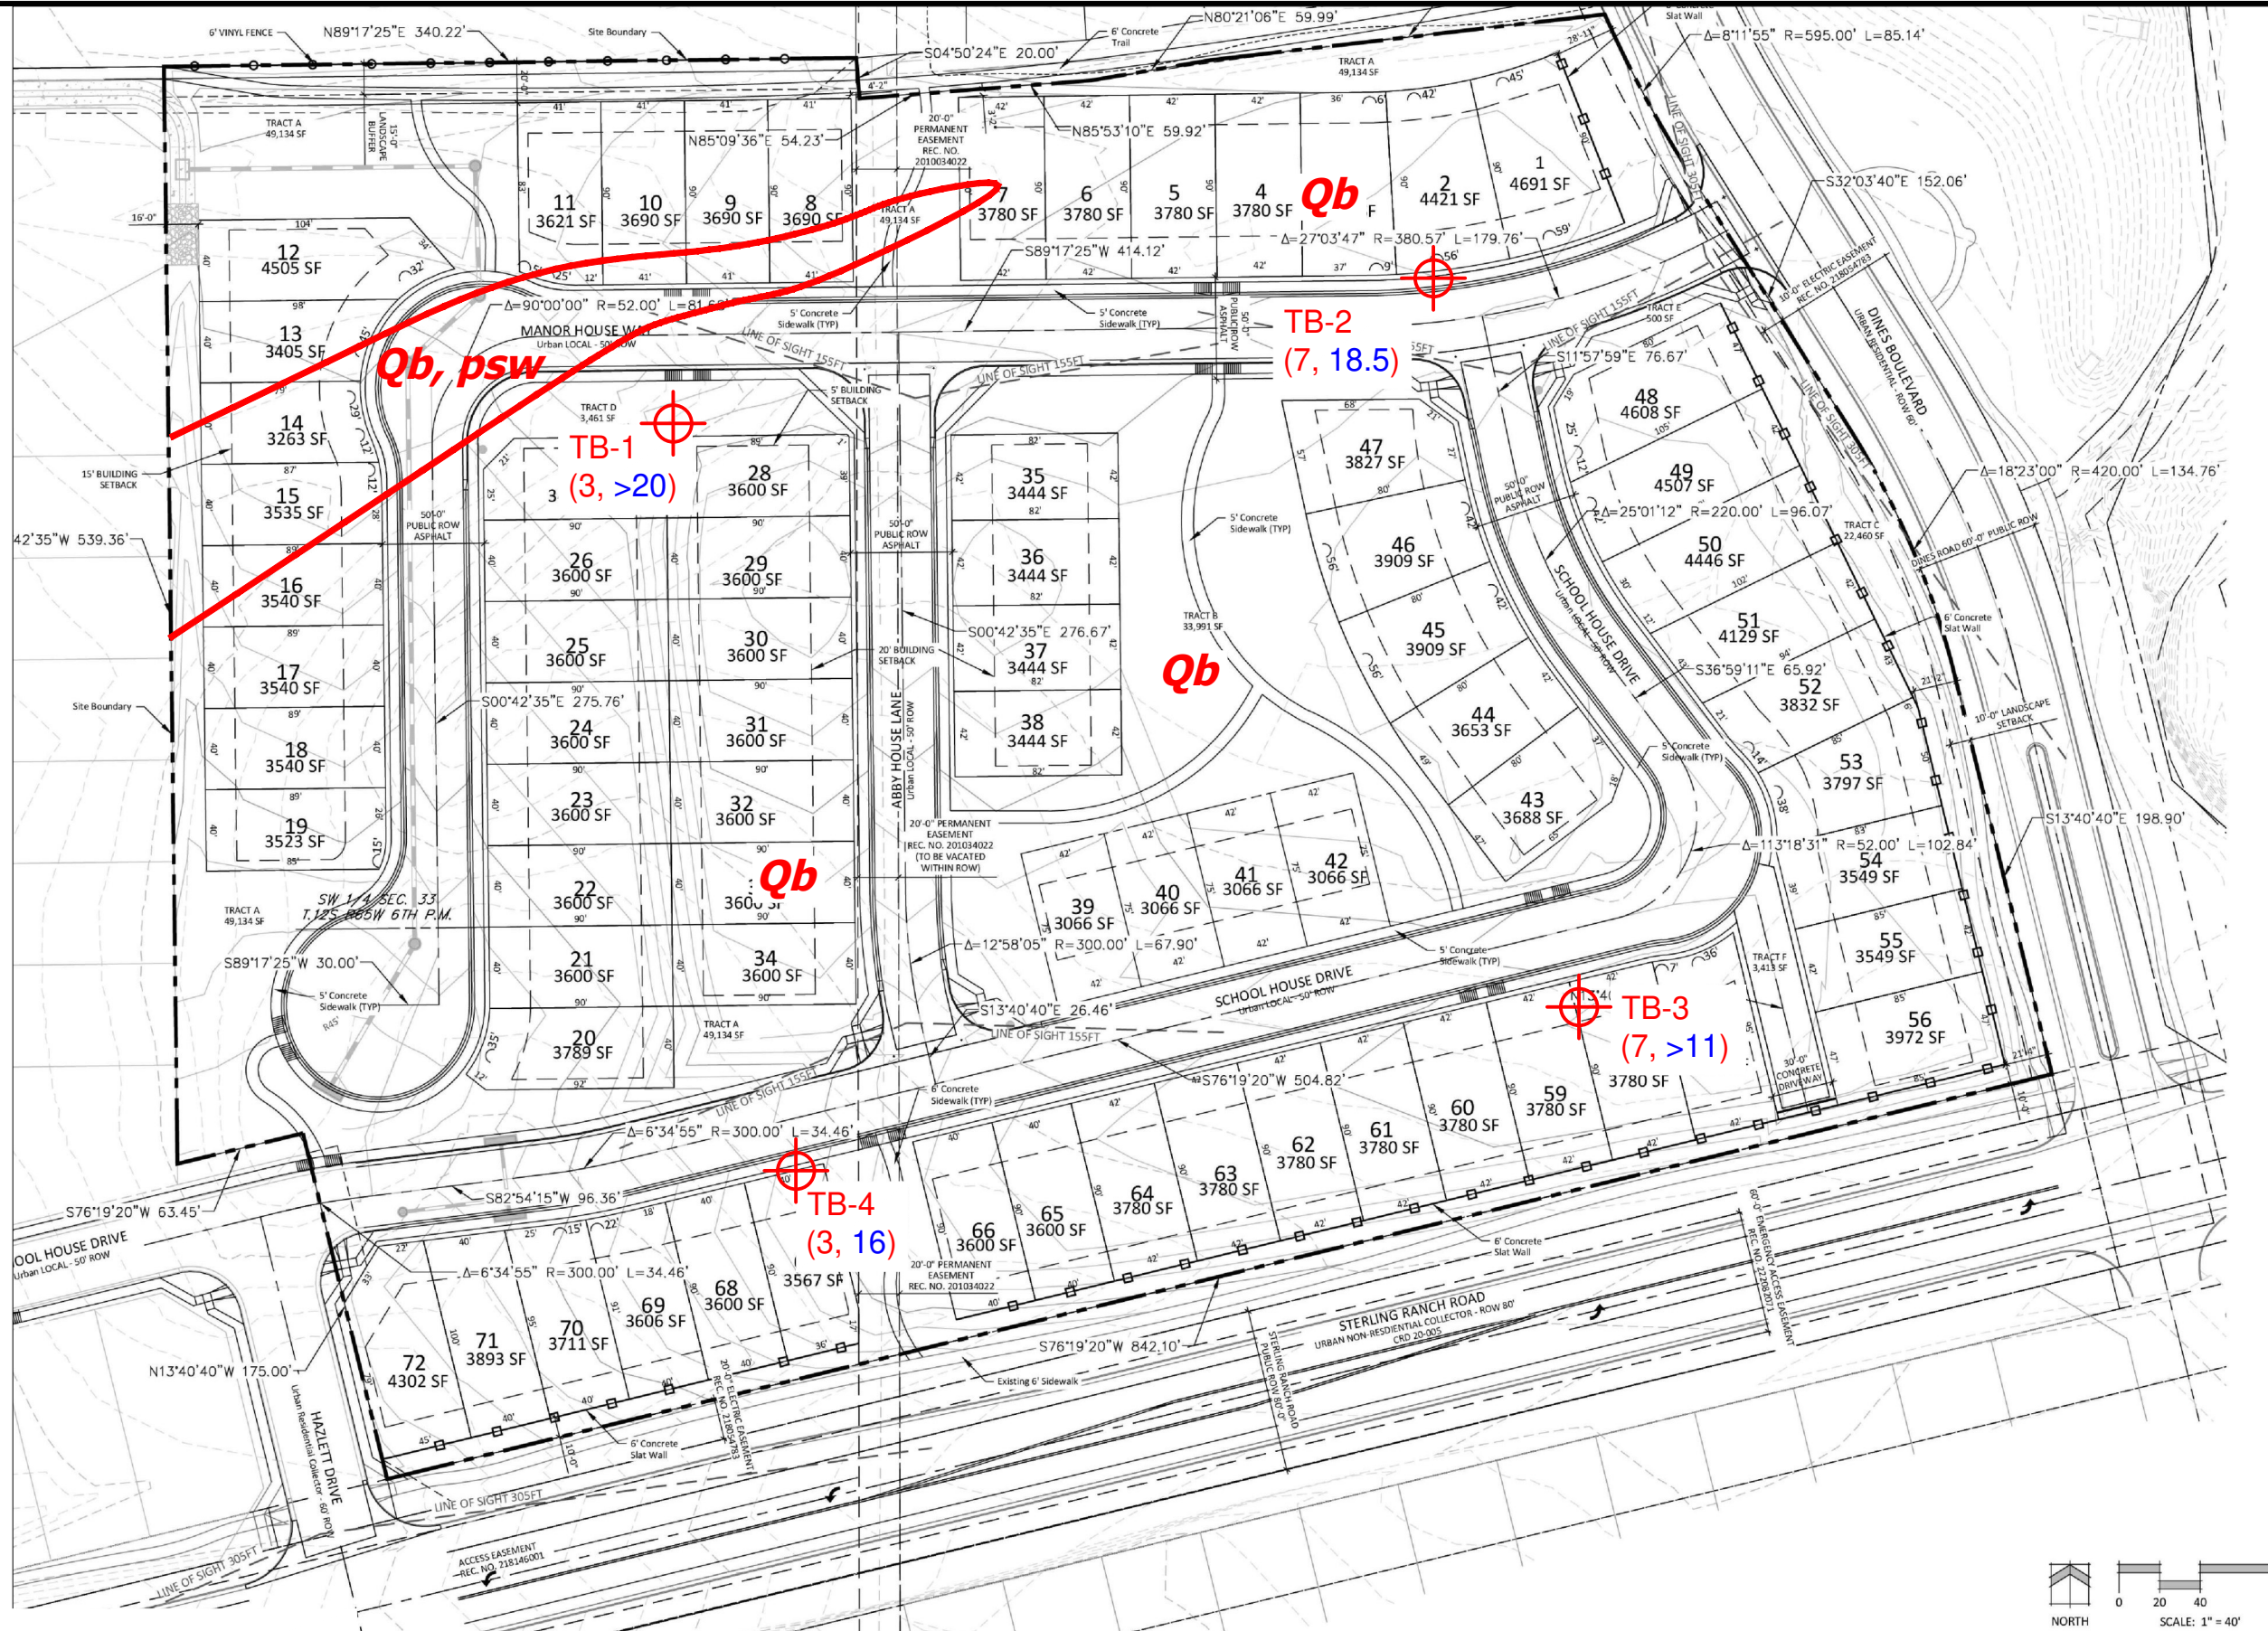
JOB NO.  
 222159  
**FIG. 7**

As mentioned previously, detailed mapping has been performed on this site to produce an Engineering Geology Map (Figure 7). This map shows the location of various geologic conditions of which the developers and planners should be cognizant during the planning, design and construction stages of the project. The hazards identified on this site include potentially expansive soils, potentially seasonal shallow groundwater areas, and shallow bedrock. The following hazards have been addressed:

Potentially Seasonal Shallow Groundwater: Groundwater depths of 16 and 18.5 feet encountered in two of the test borings drilled on site which are summarized in Table 2. Foundations should be kept as high as possible. Areas may experience higher groundwater levels during period of higher precipitation where water can flow through permeable sands on top of less permeable bedrock materials. According to the grading plan, these areas are to be filled, further raising foundations above the groundwater level.

Mitigation: In these locations, foundations subject to severe frost heave potential should penetrate sufficient depth so as to discourage the formation of ice lenses beneath foundations. At this location and elevation, a foundation depth for frost protection of 30 inches is recommended. Foundations should be kept a minimum of 3 feet above the highest anticipated groundwater level. Areas may experience higher groundwater levels during period of higher precipitation where water can flow through permeable sands on top of less permeable bedrock materials. Subsurface perimeter drains are recommended for any below grade useable space or crawlspaces, Figure 9. If groundwater conditions are encountered additional drains may be required. Typical drain details are presented in Figures 10 through 11. Structures should not block drainages. Swales should be created to intercept surface runoff and carry it safely around and away from structures. Additional investigation, after grading is completed, is recommended to provide final foundation and subsurface drain recommendations.

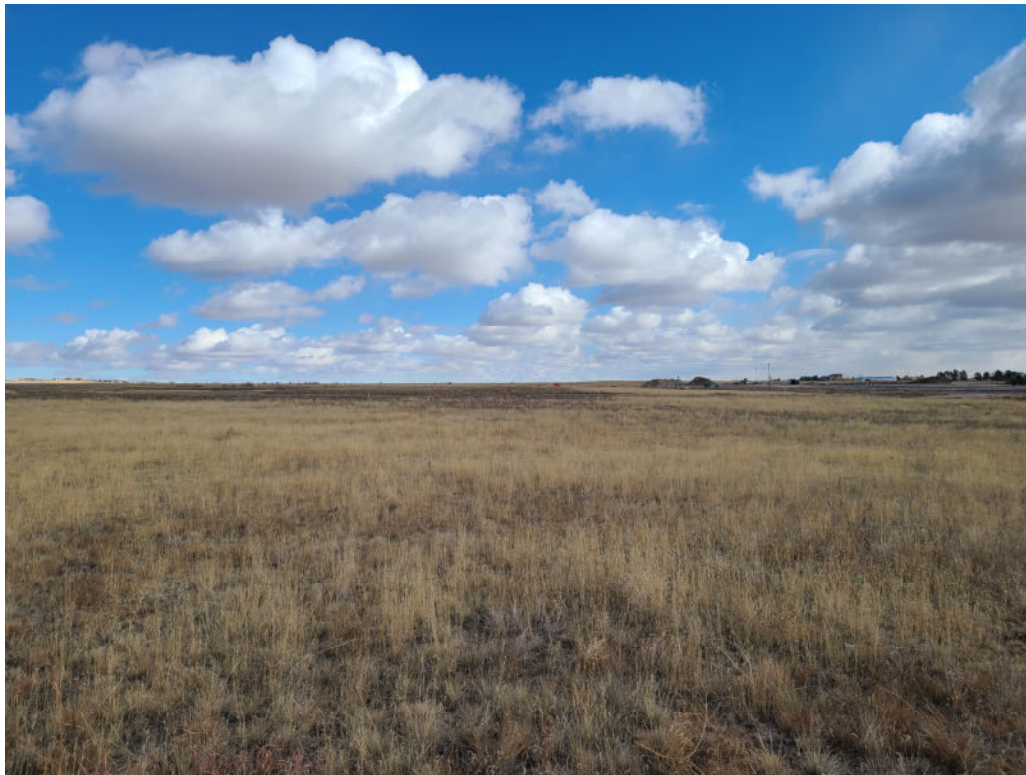
**Looking east from the southwestern portion of the site.**

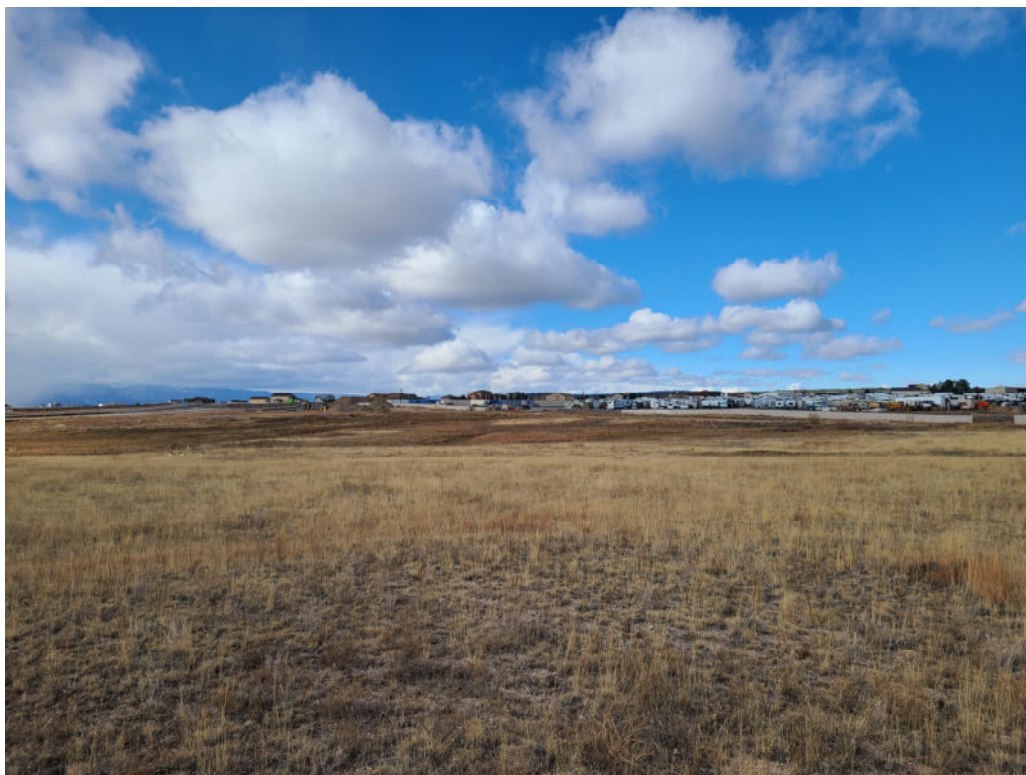
**Looking northwest from the southwestern portion of the site.**

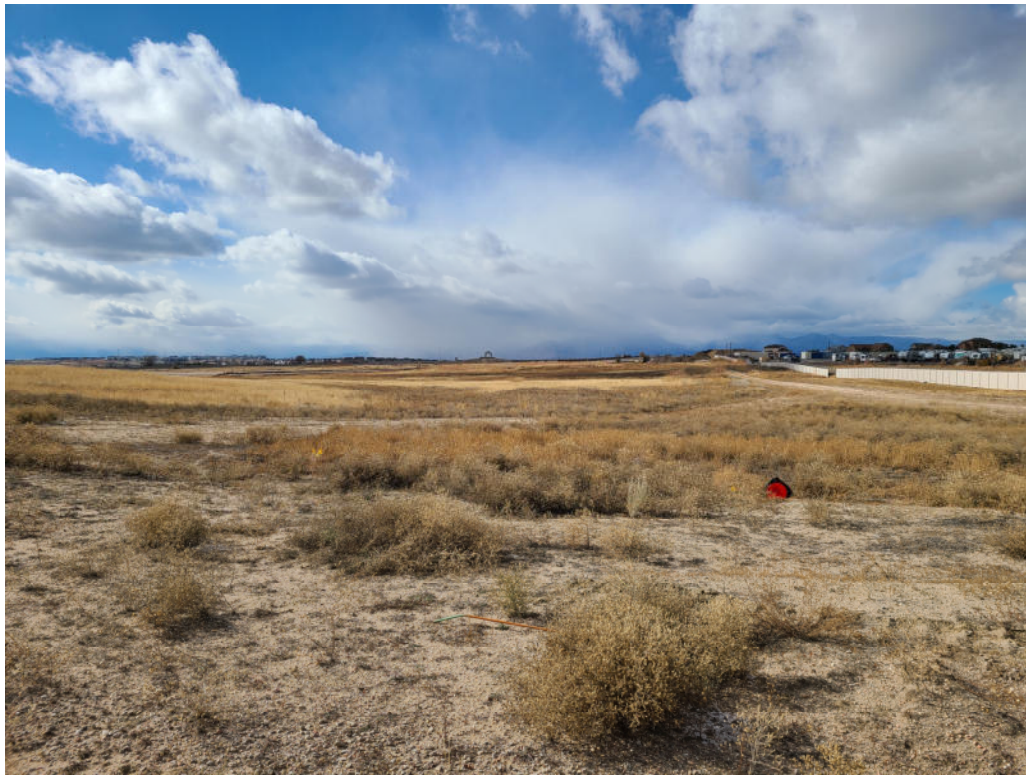
**Looking west from the north central portion of the site.**

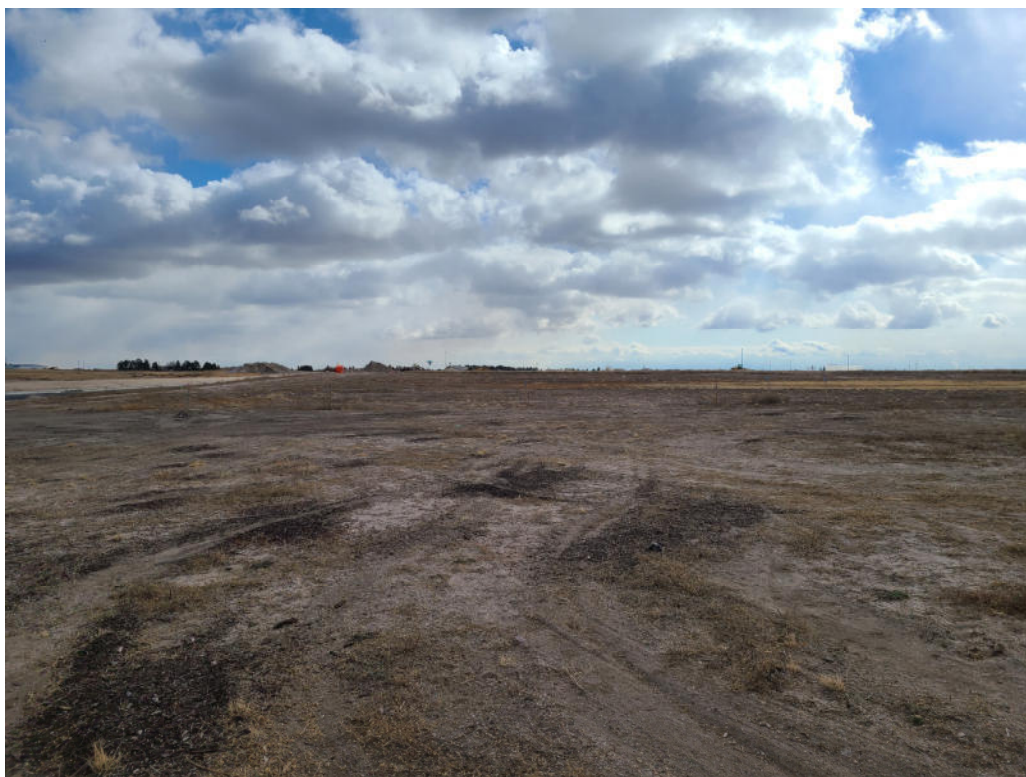
**Looking south from the northeastern portion of the site.**

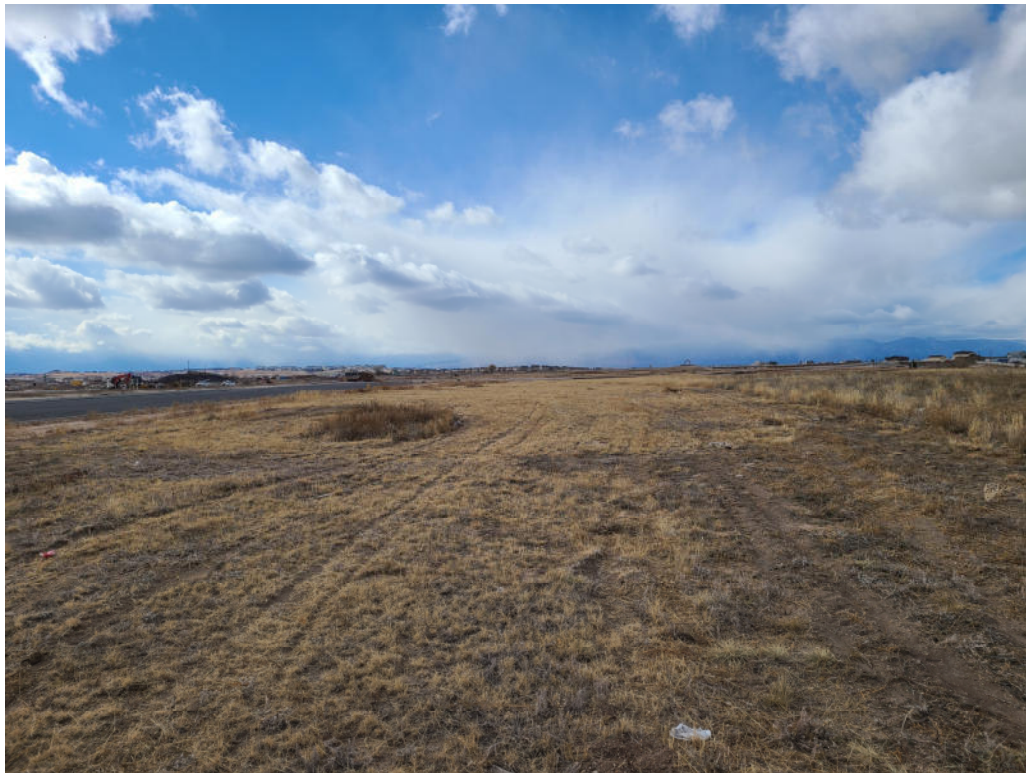
**Looking west from the southeastern portion of the site.**

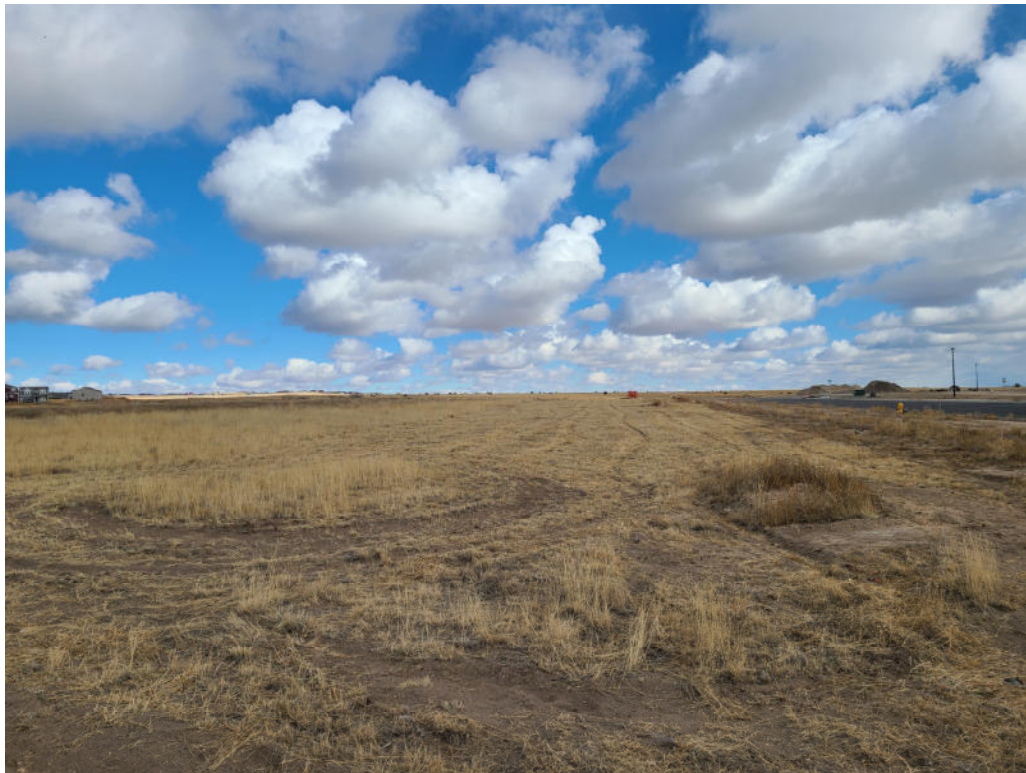
**Looking east from the southern portion of the site.**
