ENTECH
ENGINEERING, INC.

**SOILS AND GEOLOGY STUDY
HOMELAND ACRES
PARCEL NO. 56040-00-044
8180 KANE ROAD
EL PASO COUNTY, COLORADO**

June 14, 2024

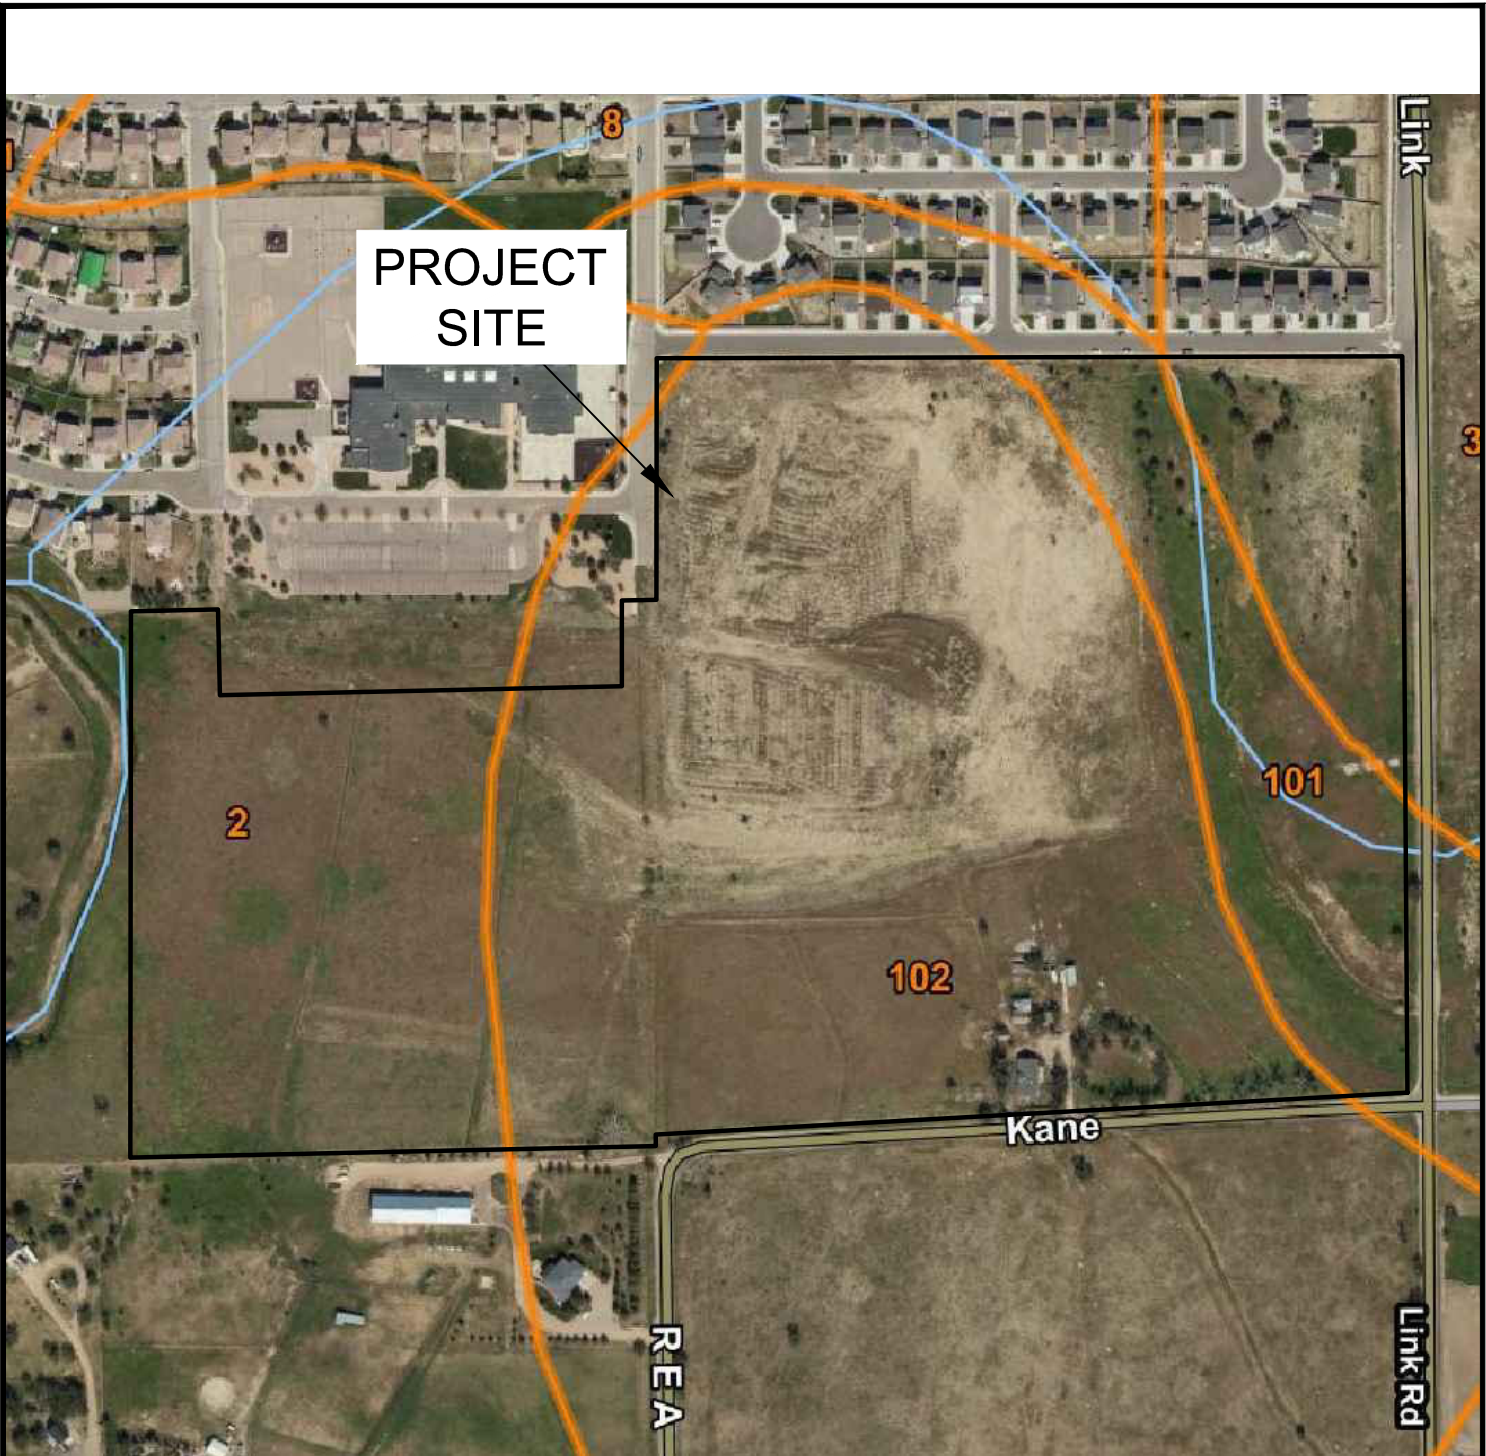
FIG. 4

The Natural Resource Conservation Service (Reference 3), previously the Soil Conservation Service (Reference 4), has mapped four soil types on the site (Figure 4). In general, the soils classify as sand, sandy loam, and loamy soils that are associated with floodplain and stream terrace landforms. The soils are described as follows:

Complete descriptions of each soil type are presented in Appendix B. The soils have generally been described to have moderate permeabilities. Possible hazards with soil erosion are present on the site. The erosion potential can be controlled with vegetation. The soils have been described as having moderate erosion hazards.

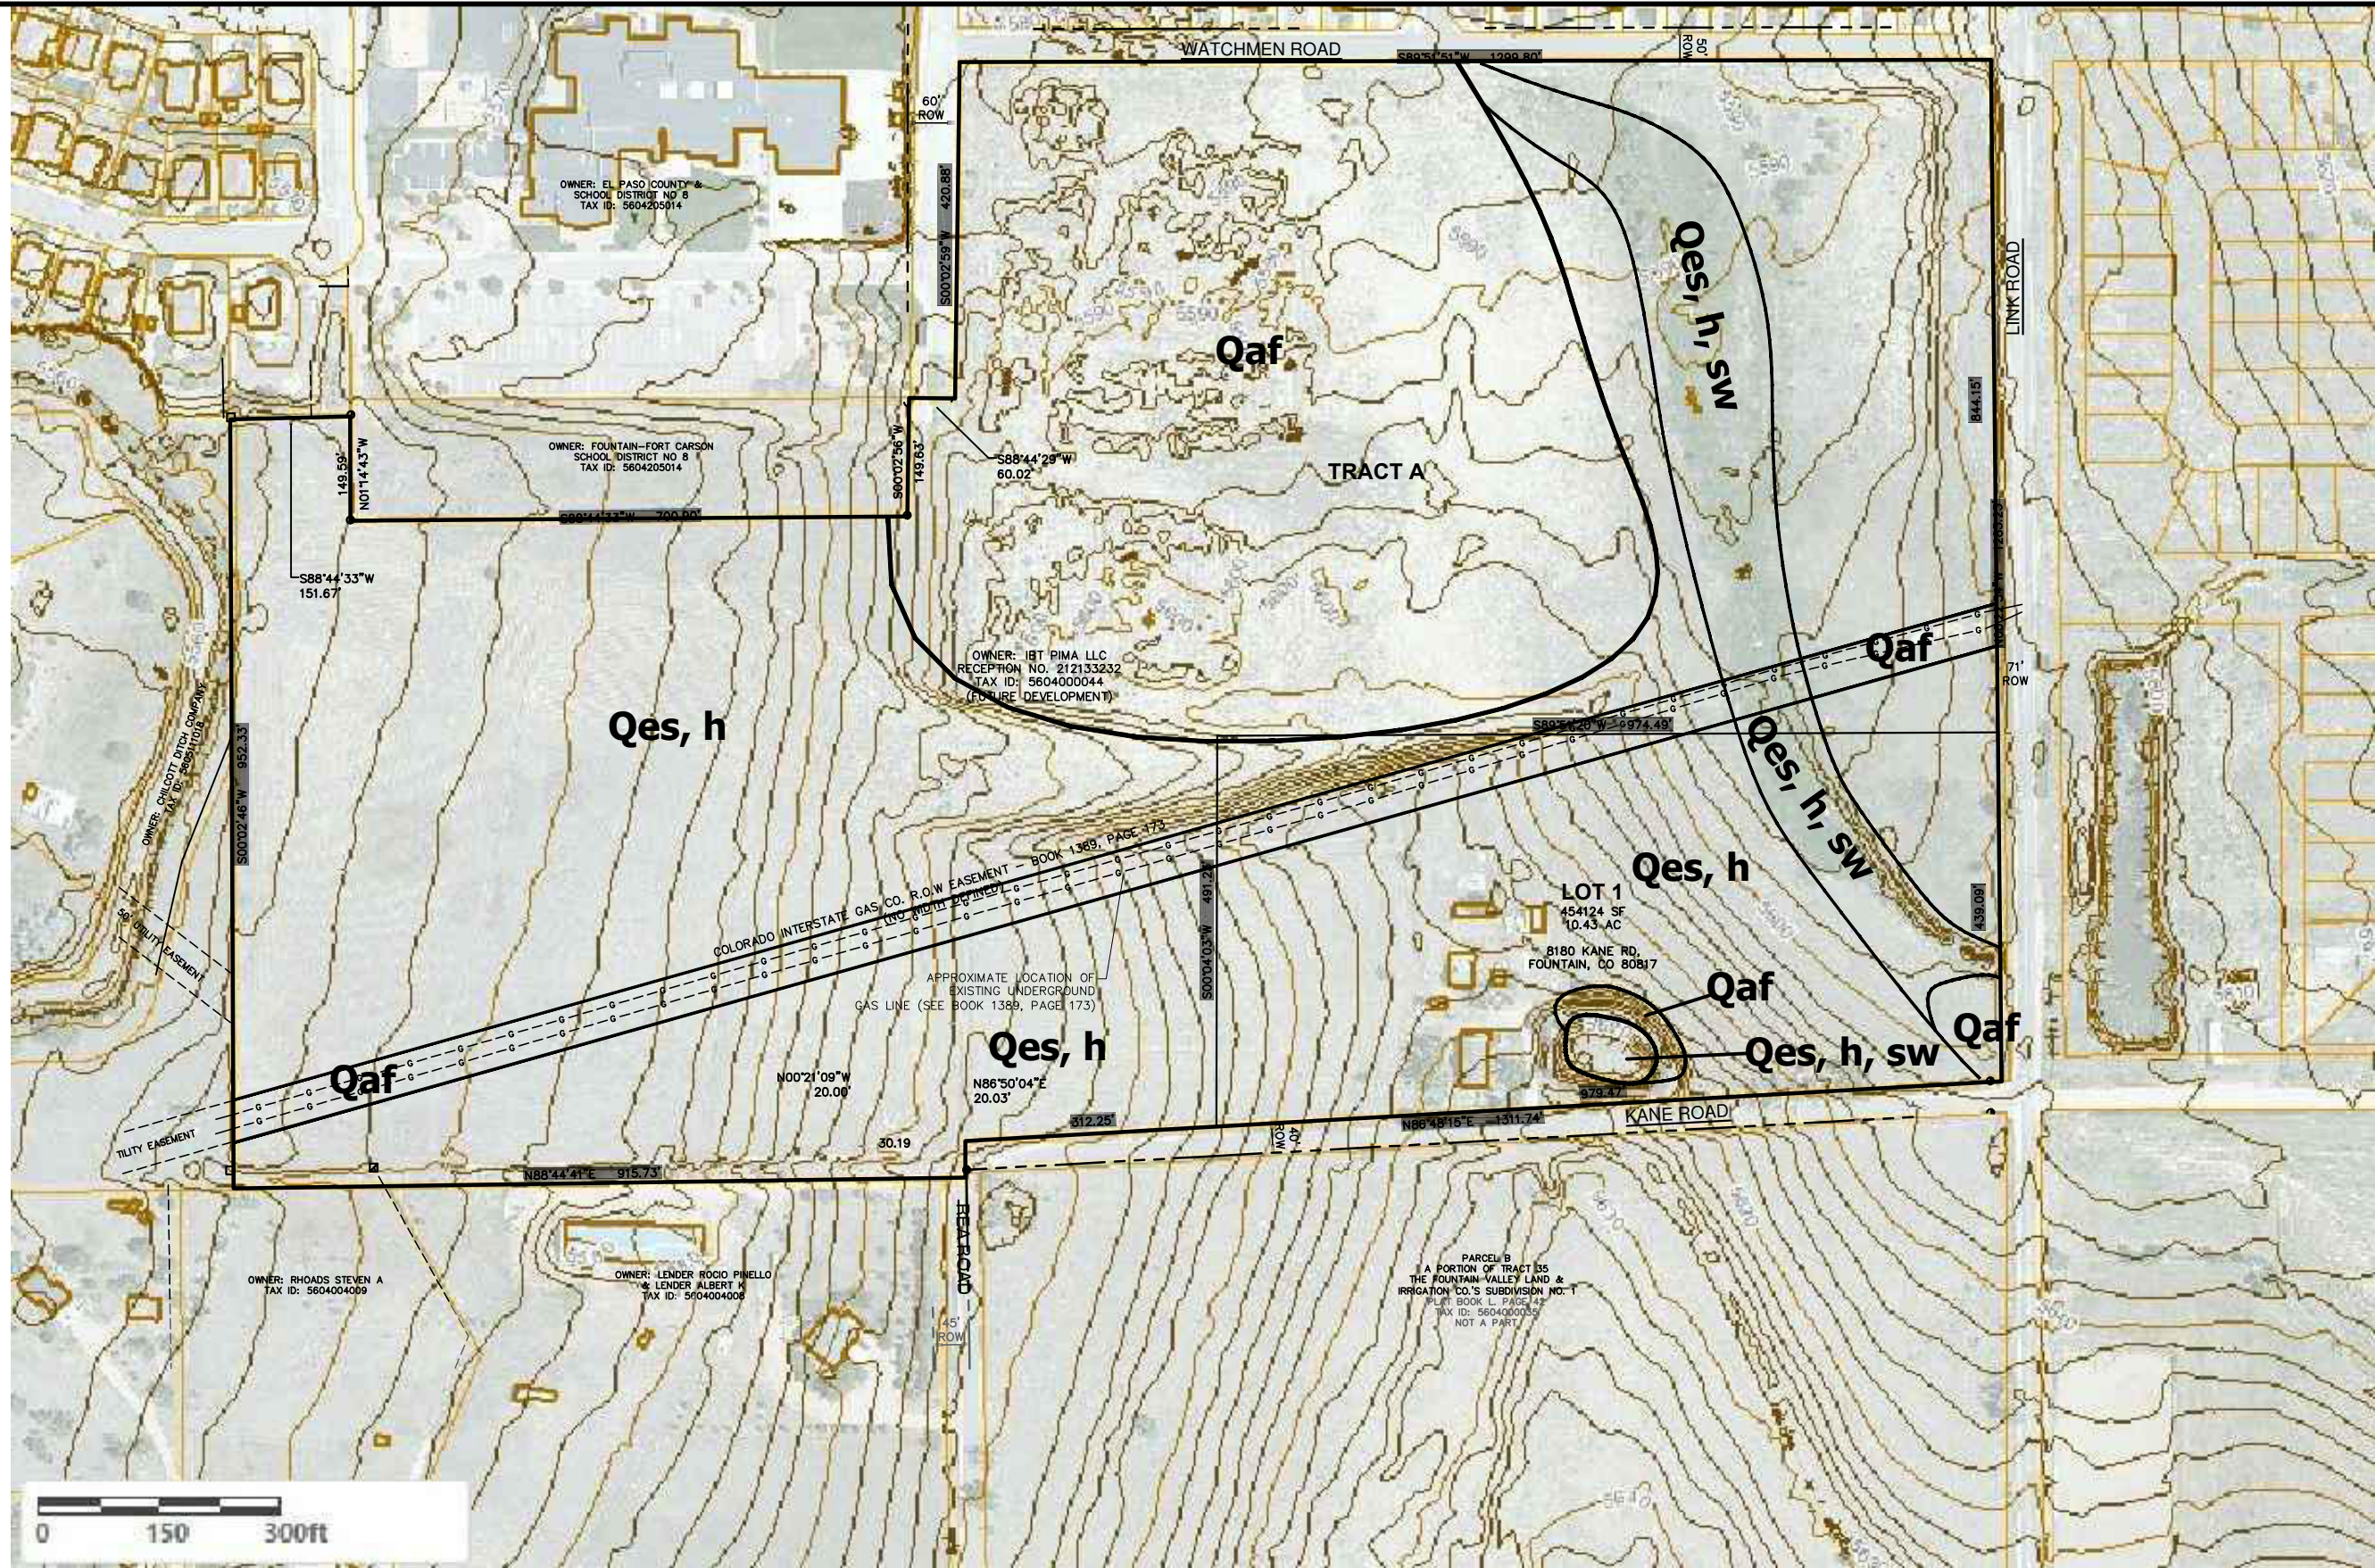
FIG. 6

Detailed mapping has been performed on this site to produce a Geology/Engineering Geology Map (Figure 6). This map shows the location of various geologic conditions the developers should consider during the planning, design, and construction stages of the project. These constraints/hazards and the recommended mitigation techniques are as follows:

are particularly susceptible to this type of phenomenon and have been identified on Figure 6. The potential for hydrocompaction can also exist in areas mapped as Eolian sand (Qes).

Areas of seasonal shallow groundwater have been identified on Figure 6. The areas identified with this constraint are the dry pond on proposed Lot 1 east of the existing residence, and the drainage in the eastern portion of the site. In these areas, high subsurface moisture condition, frost heave potential and highly organic soils may exist, particularly on a seasonal basis. It should be noted that shallow groundwater conditions might be encountered due to the variability in the soil profile. Isolated sand and gravel layers within the soils, sometimes only a few feet in thickness and width, can carry water in the subsurface.
