**SOIL, GEOLOGY, AND GEOLOGIC HAZARD STUDY
WINSOME SUBDIVISION – FILING NO. 3
PORTIONS OF PARCEL NOS. 51000-00-497 & 51000-00-510
17480 MERIDIAN ROAD NORTH
EL PASO COUNTY, COLORADO**

May 21, 2021
Revised February 15, 2023

Entech Job No. 210539
AAprojects/2021/210539 countysoil/geo/ww

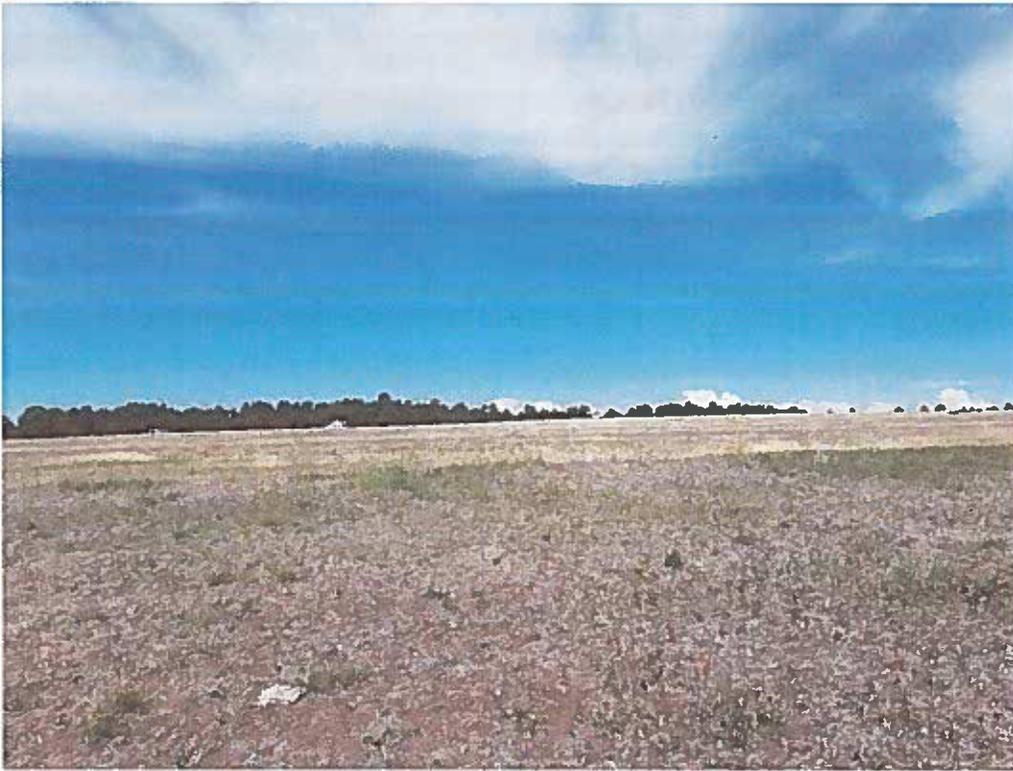
**Looking northwest
from the eastern
portion of Filing No. 2.**

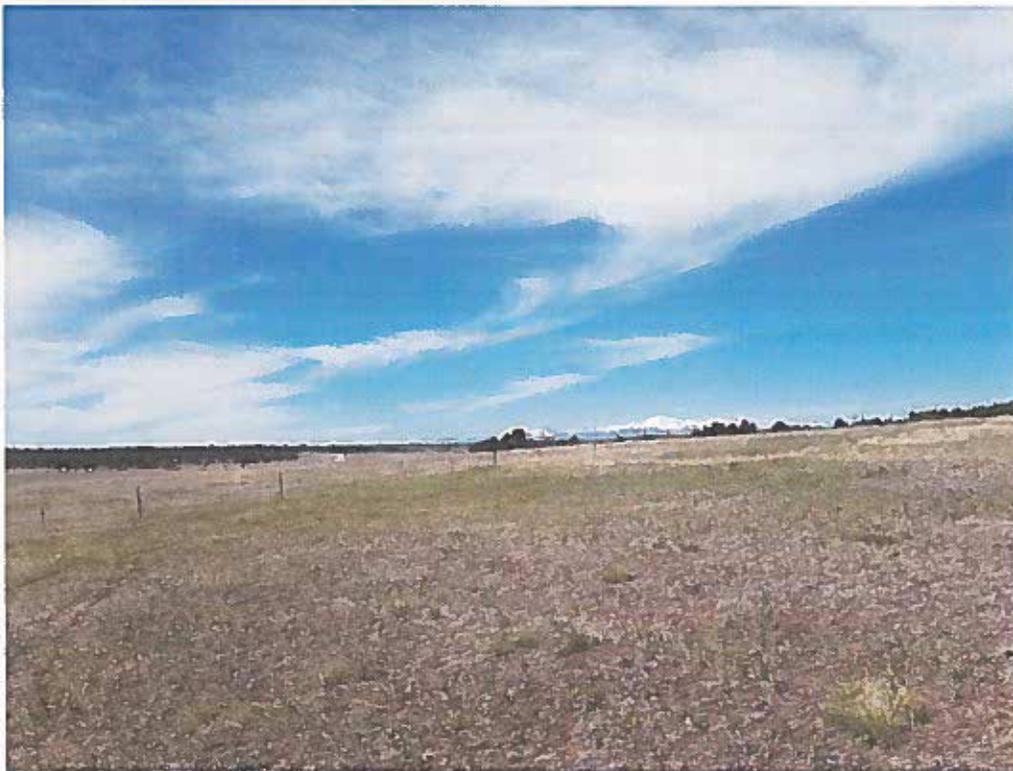
**Looking west from the
eastern portion of
Filing No. 3.**

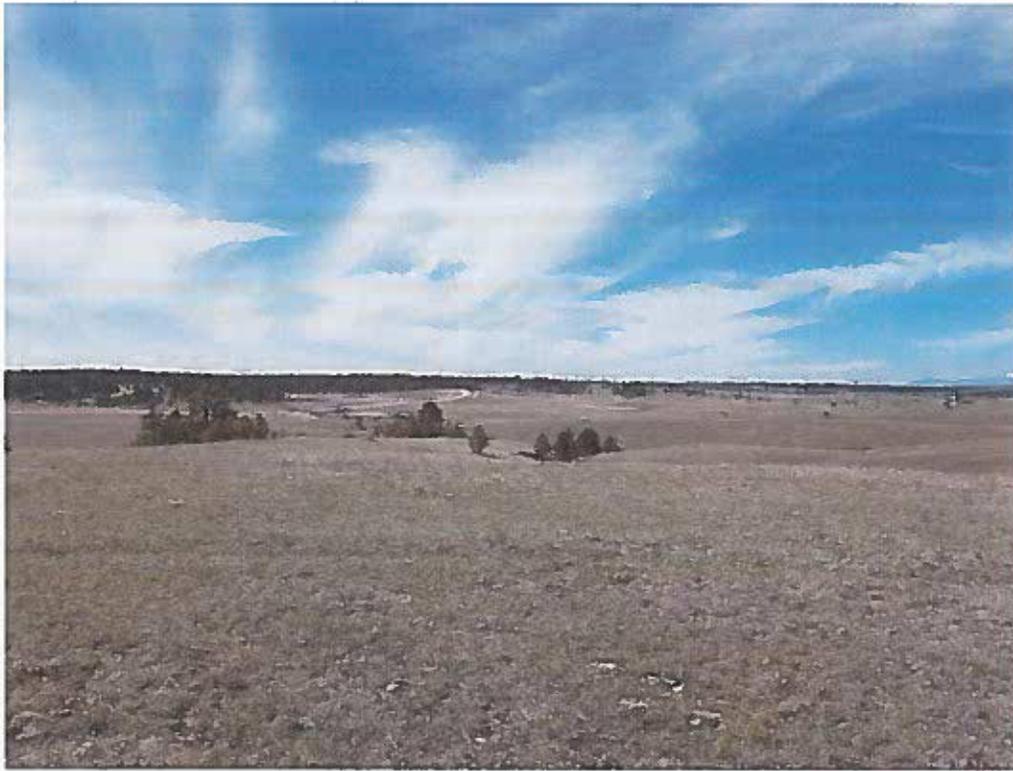
**Looking southwest
from the west central
portion of Filing No. 3.**

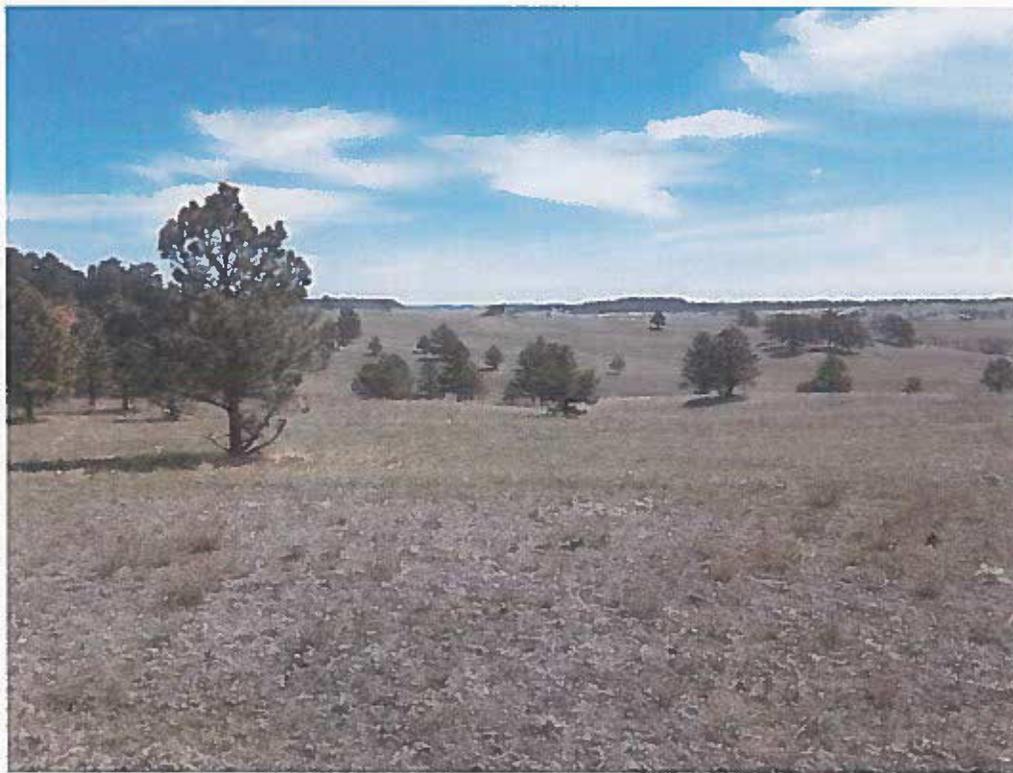
**Looking east from the
central portion of
Filing No. 3.**

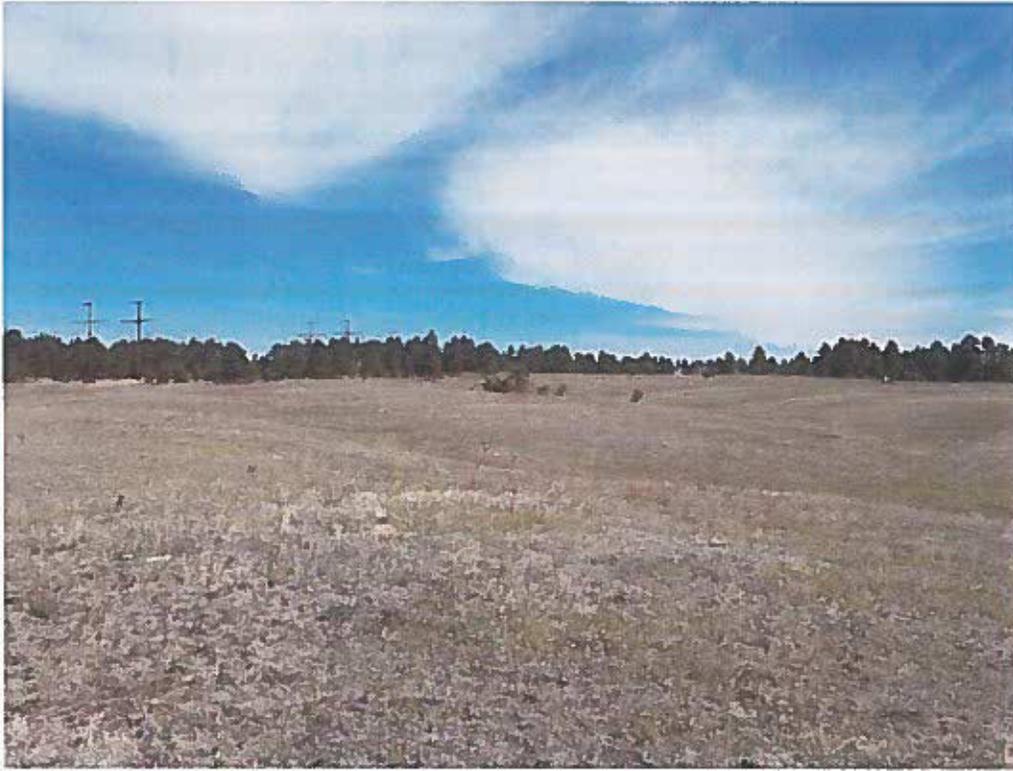
Looking north from the western side of Filing No. 3.

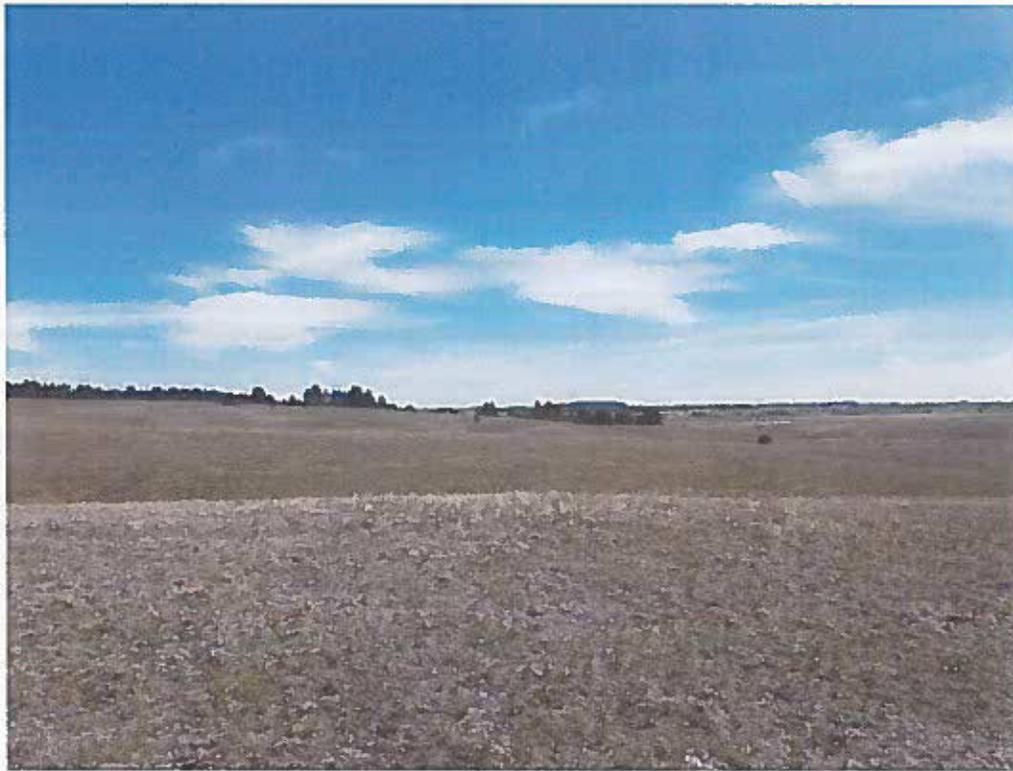
Looking east from the western side of Filing No. 3.

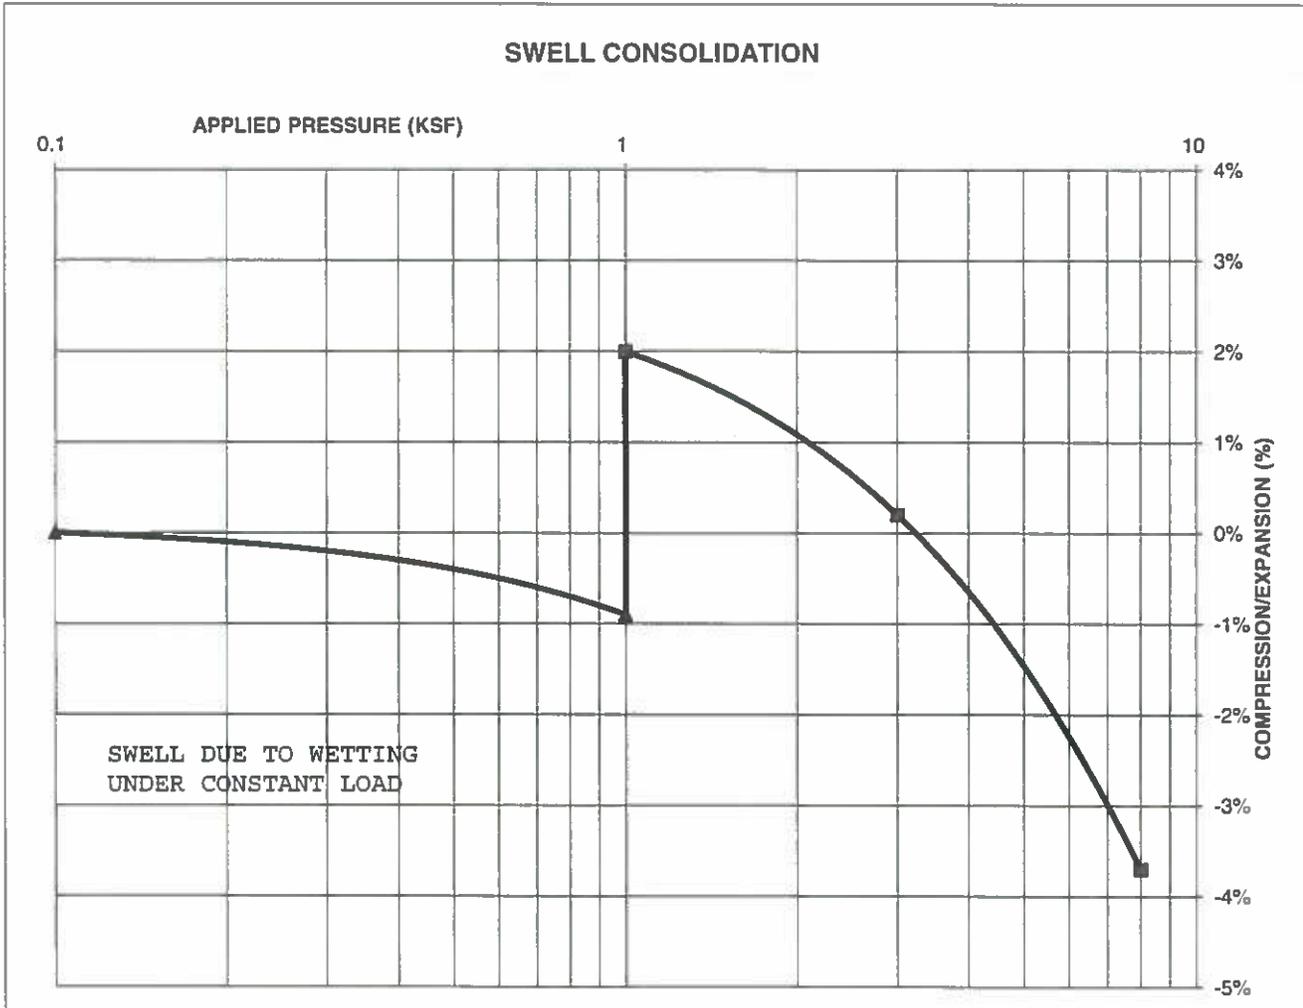
Soil Type 1 is a sandy clay (CL). This material was encountered in all of the test borings. The sand was encountered at the existing surface and extended to depths ranging from 1 to 4 feet, and to the termination of Test Boring No. 4 (20 feet). These soils were encountered at firm to very stiff consistencies and at moist conditions. Samples tested had 56 to 87 percent of the soil sized particles passing the No. 200 Sieve. Swell/Consolidation Testing resulted in a volume change of 2.9 percent, which indicates a moderate to high expansion potential.

TEST BORING #	6	DEPTH(ft)	2-3
DESCRIPTION	CL	SOIL TYPE	1
NATURAL UNIT DRY WEIGHT (PCF)			108
NATURAL MOISTURE CONTENT			9.7%
SWELL/CONSOLIDATION (%)			2.9%

Mitigation: Should expansive soils be encountered beneath the foundation; mitigation will be necessary. Mitigation of expansive soils will require special foundation design. Overexcavation and replacement with non-expansive soils at a minimum of 95% of its maximum Modified Proctor Dry Density, ASTM D-1557 is a suitable mitigation, which is common in the area. Another alternative in areas of highly expansive soils is the use of drilled pier foundation systems. Typical minimum pier depths are on the order of 25 feet or more and require penetration into the bedrock material a minimum of 4 to 6 feet, depending upon building loads. Floor slabs on expansive soils should be expected to experience movement. Overexcavation and replacement has been successful in minimizing slab movements. The use of structural floors should be considered for basement construction on highly expansive clays. Final recommendations should be determined after additional investigation of each building site.
