**SOIL, GEOLOGY, AND GEOLOGIC HAZARD STUDY  
WINSOME SUBDIVISION – FILING NO. 3  
PORTIONS OF PARCEL NOS. 51000-00-497 & 51000-00-510  
17480 MERIDIAN ROAD NORTH  
EL PASO COUNTY, COLORADO**

**Winsome, LLC**  
1864 Woodmoor Drive, Suite 100  
Monument, Colorado 80132

May 21, 2021

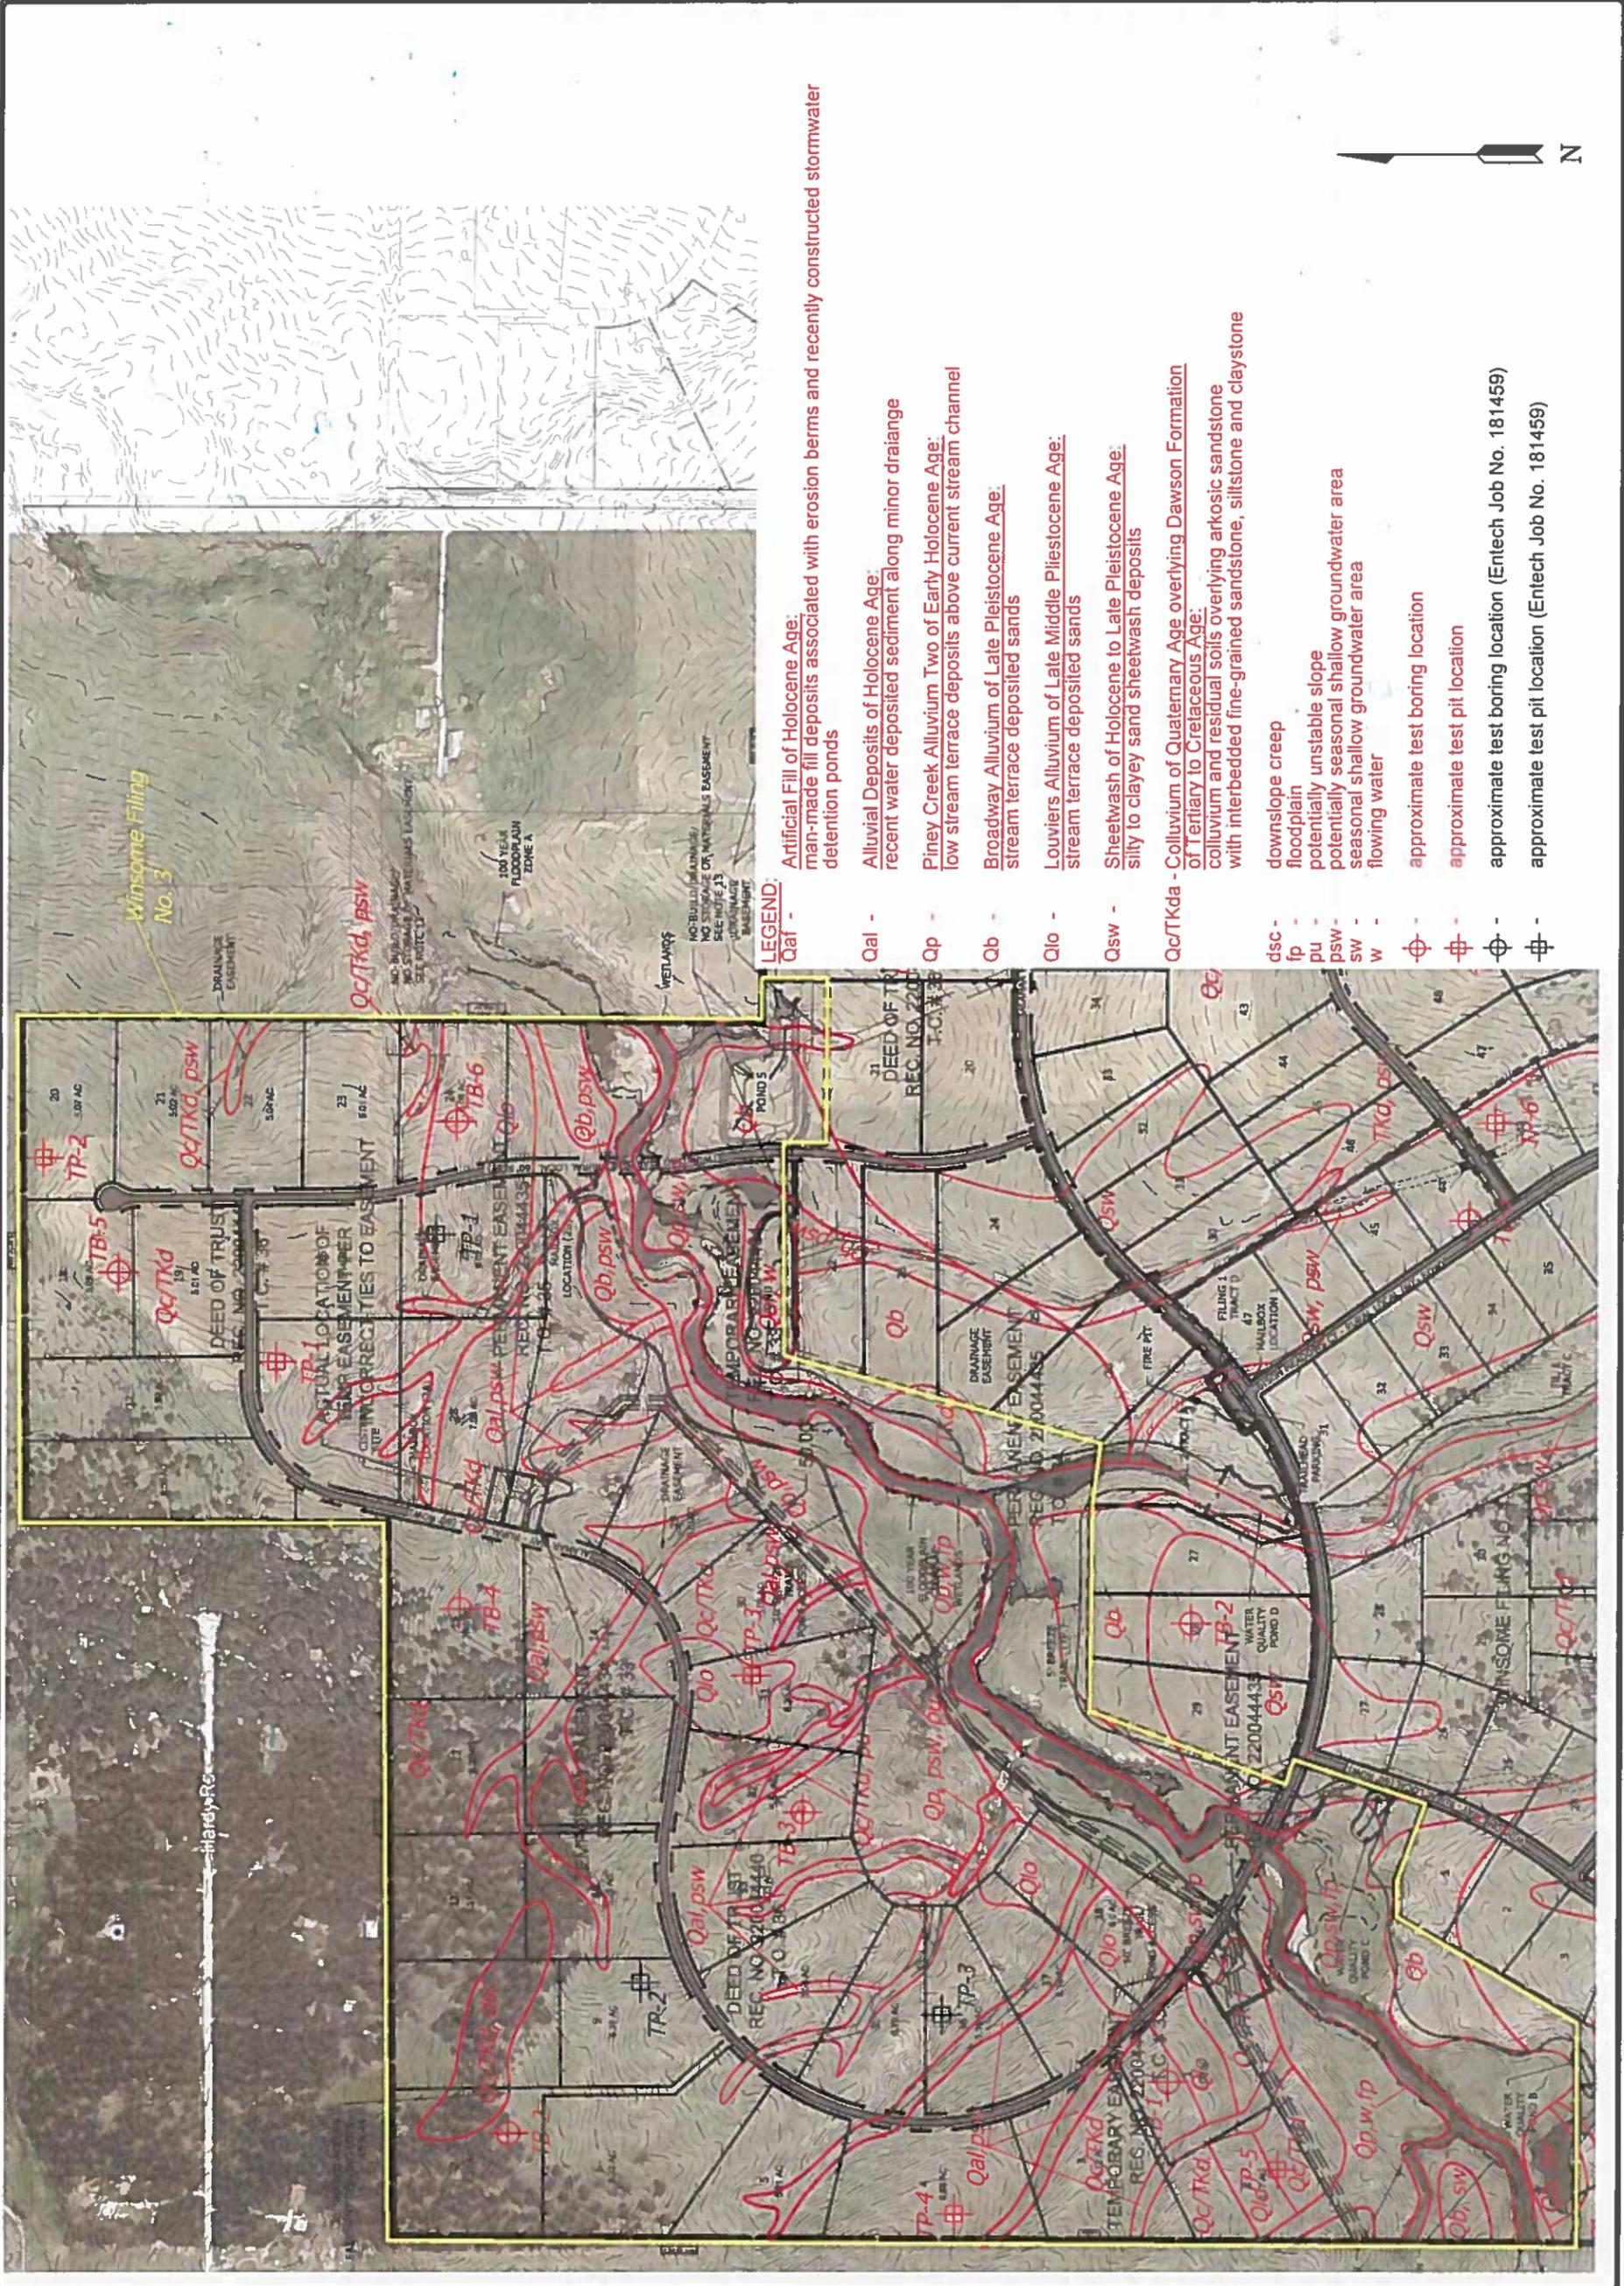
GEOLOGY/ENGINEERING GEOLOGY MAP  
WINSOME SUBDIVISION - FILING NO. 3  
HODGEN ROAD & MERIDIAN ROAD  
EL PASO COUNTY, CO.  
FOR: WINSOME, LLC

As mentioned previously, detailed mapping has been performed on this site to produce a Geology/Engineering Geology Map (Figure 6). This map shows the location of various geologic conditions of which the developers should be cognizant during the planning, design and construction stages of the project. These hazards and the recommended mitigation techniques are as follows:

The majority of the slopes in the building areas on site are gently to moderately sloping and do not exhibit any past or potential unstable slopes or landslides. However, the steeply sloping areas along the drainage in the central portion of the site have been identified as potentially unstable slopes. Additionally, areas of downslope creep have been mapped on the site. These areas are identified on the Geology/Engineering Geology Map, Figure 6. The recommendations for these areas are as follows:

The area identified with this hazard is located along a portion of a minor drainage where cut banks have created potentially unstable slopes. Considerable care must be exercised in these areas not to create a condition which would tend to activate instability.

The areas identified with this hazard includes some of the steeper slopes on site, particularly in the northwest portion of the site. In these areas, we would anticipate lateral and vertical movement of the near surface soils in the downslope direction. These areas are acceptable as building sites with the following constraints on construction.

Mitigation: Building should be avoided in these areas. The lots most significantly affected by potentially unstable slopes are Lot 31 and 32. The structures on these lots should be set back a minimum of 30 feet from the crest of these slopes. The recommended setback lies within the proposed no build area. There is sufficient room on the lots to avoid this hazard. Proper control of drainage at both the surface above the slope and the subsurface is extremely important. Areas of ponded water at the surface should be avoided. Utility trenches, basement excavations and other subsurface features should not be permitted to become water traps which may promote saturation of the subsurface materials. Drainage should not be permitted over the potentially unstable slope but directed in a non-erosive manner away from the slope. Irrigation above these slopes should be kept to a minimum to prevent saturation of the subsurface soils. The use of xeriscape landscaping utilizing native plantings is recommended to reduce the need for irrigation.

Mitigation: Building is possible in these areas if the following engineering and construction mitigation steps are taken: This type of movement will increase lateral pressures against foundation walls on the uphill side of structures. The design of foundations in these areas should account for this additional pressure. Additionally, the foundation should be designed to withstand pressures where steeper areas slope away from the foundation. Tie beams and buttresses are recommended to stiffen the foundation system.
