Circle K Retail Store and Shared Access Road

Geologic Hazard Assessment Review Report

February 22, 2023 | Terracon Project No. 23225154

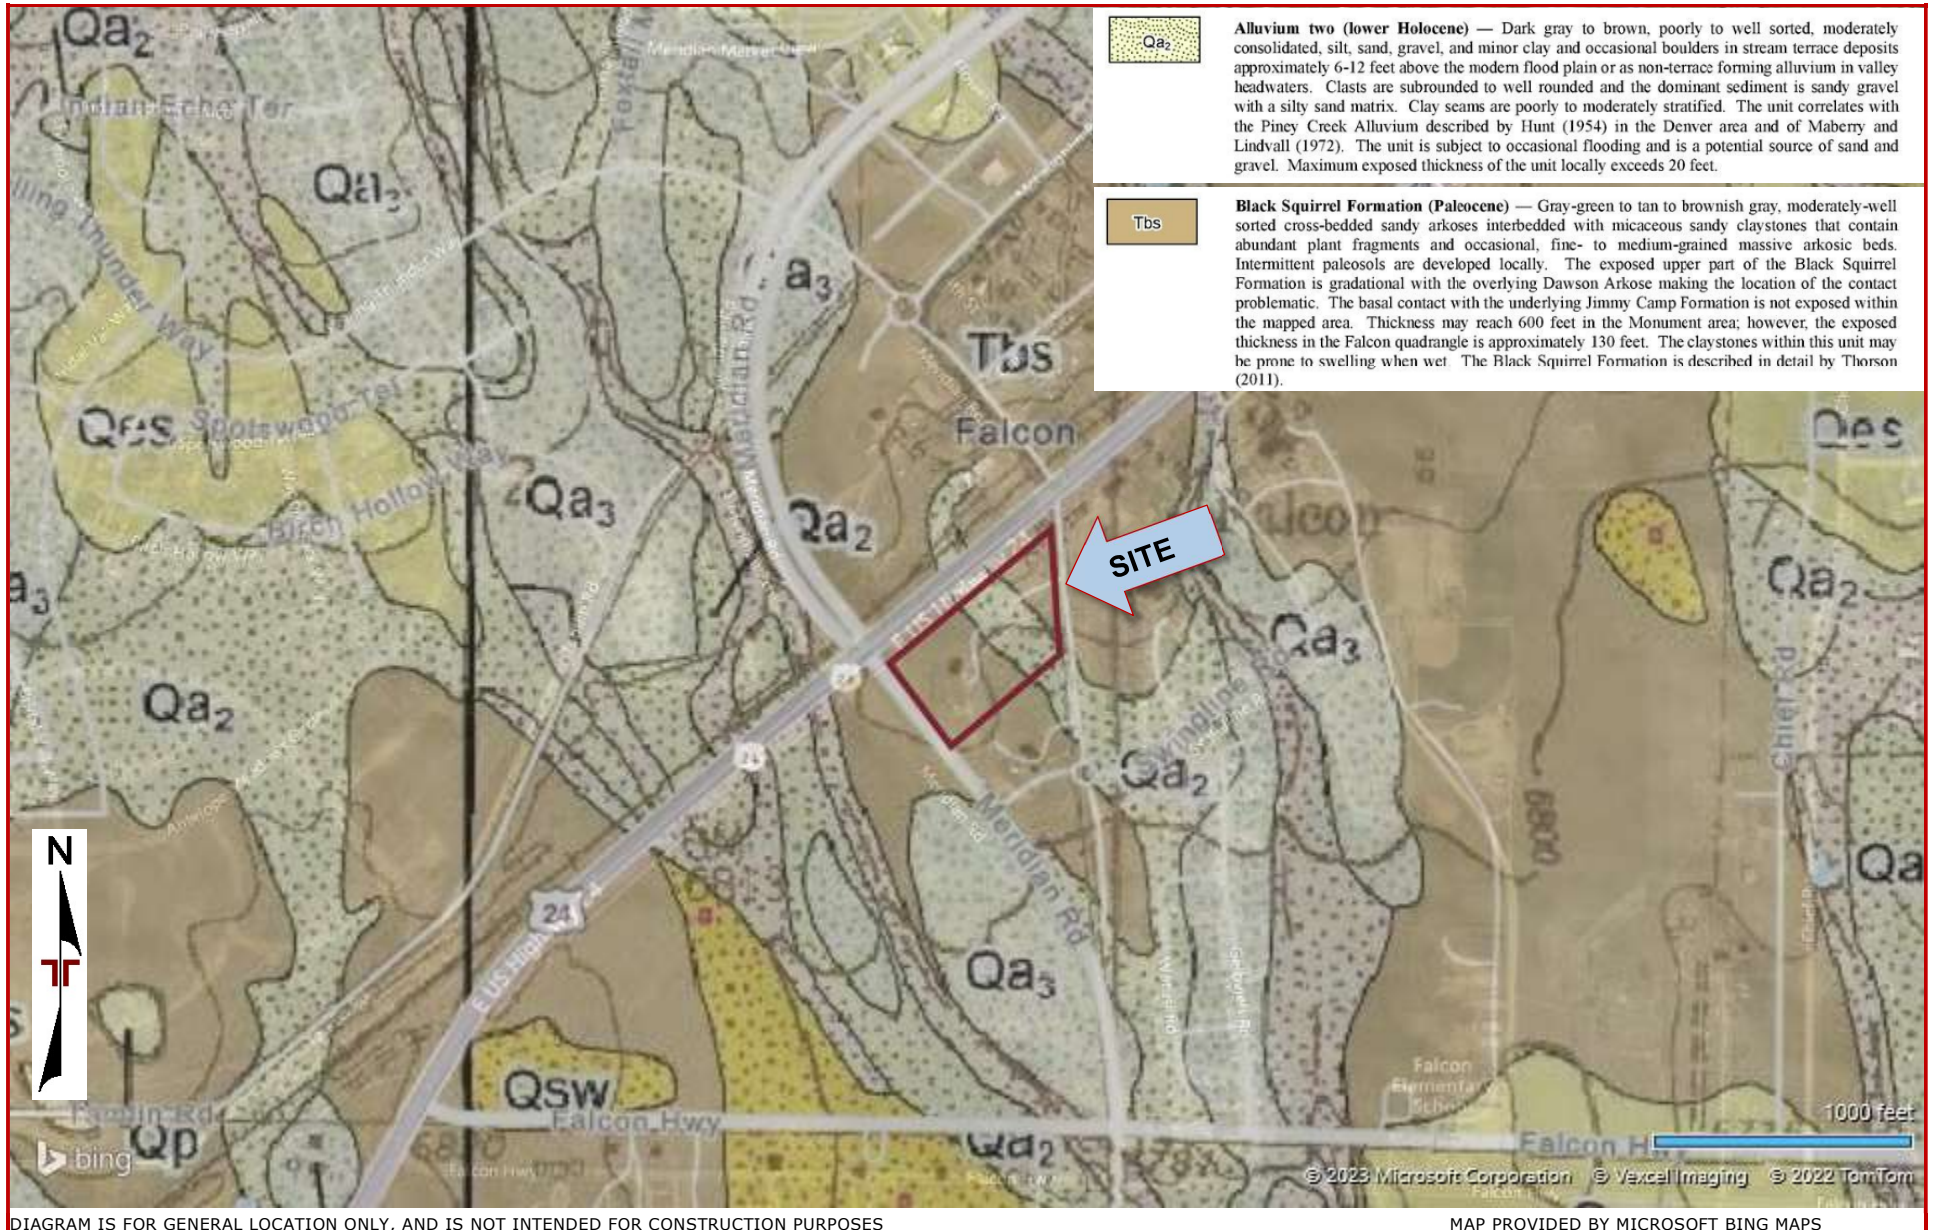
Figure 3 – Regional Geology Map (Morgan and White, 2012)

Based on the available information (See Figure 3) two geologic units are identified on the site and are described as follows:

Alluvium two (lower Holocene) – Dark gray to brown, poorly to well sorted, moderately consolidated silt, sand gravel, and minor clay and occasional boulders in stream terrace deposits approximately 6-12 feet above the modern flood plain or as non-terrace forming alluvium in valley headwaters. Clasts are subrounded to well rounded and dominant sediment is sandy gravel with a silty sand matrix. Clay seams are poorly to moderately stratified. The unit is subject to occasional flooding and is a potential source of sand and gravel.

Black Squirrel Formation (Paleocene) – gray-green to tan to brownish gray, moderately-well sorted cross-bedded sandy arkoses interbedded with micaceous sandy claystones that contain abundant plant fragments and occasional, fine-to-medium grained massive arkosic beds. Intermittent paleols are developed locally. The exposed upper part of the Black Squirrel formation is gradation with the overlying Dawson Arkose making the location of the contract problematic. The claystones within this unit may be prone to swelling when wet.

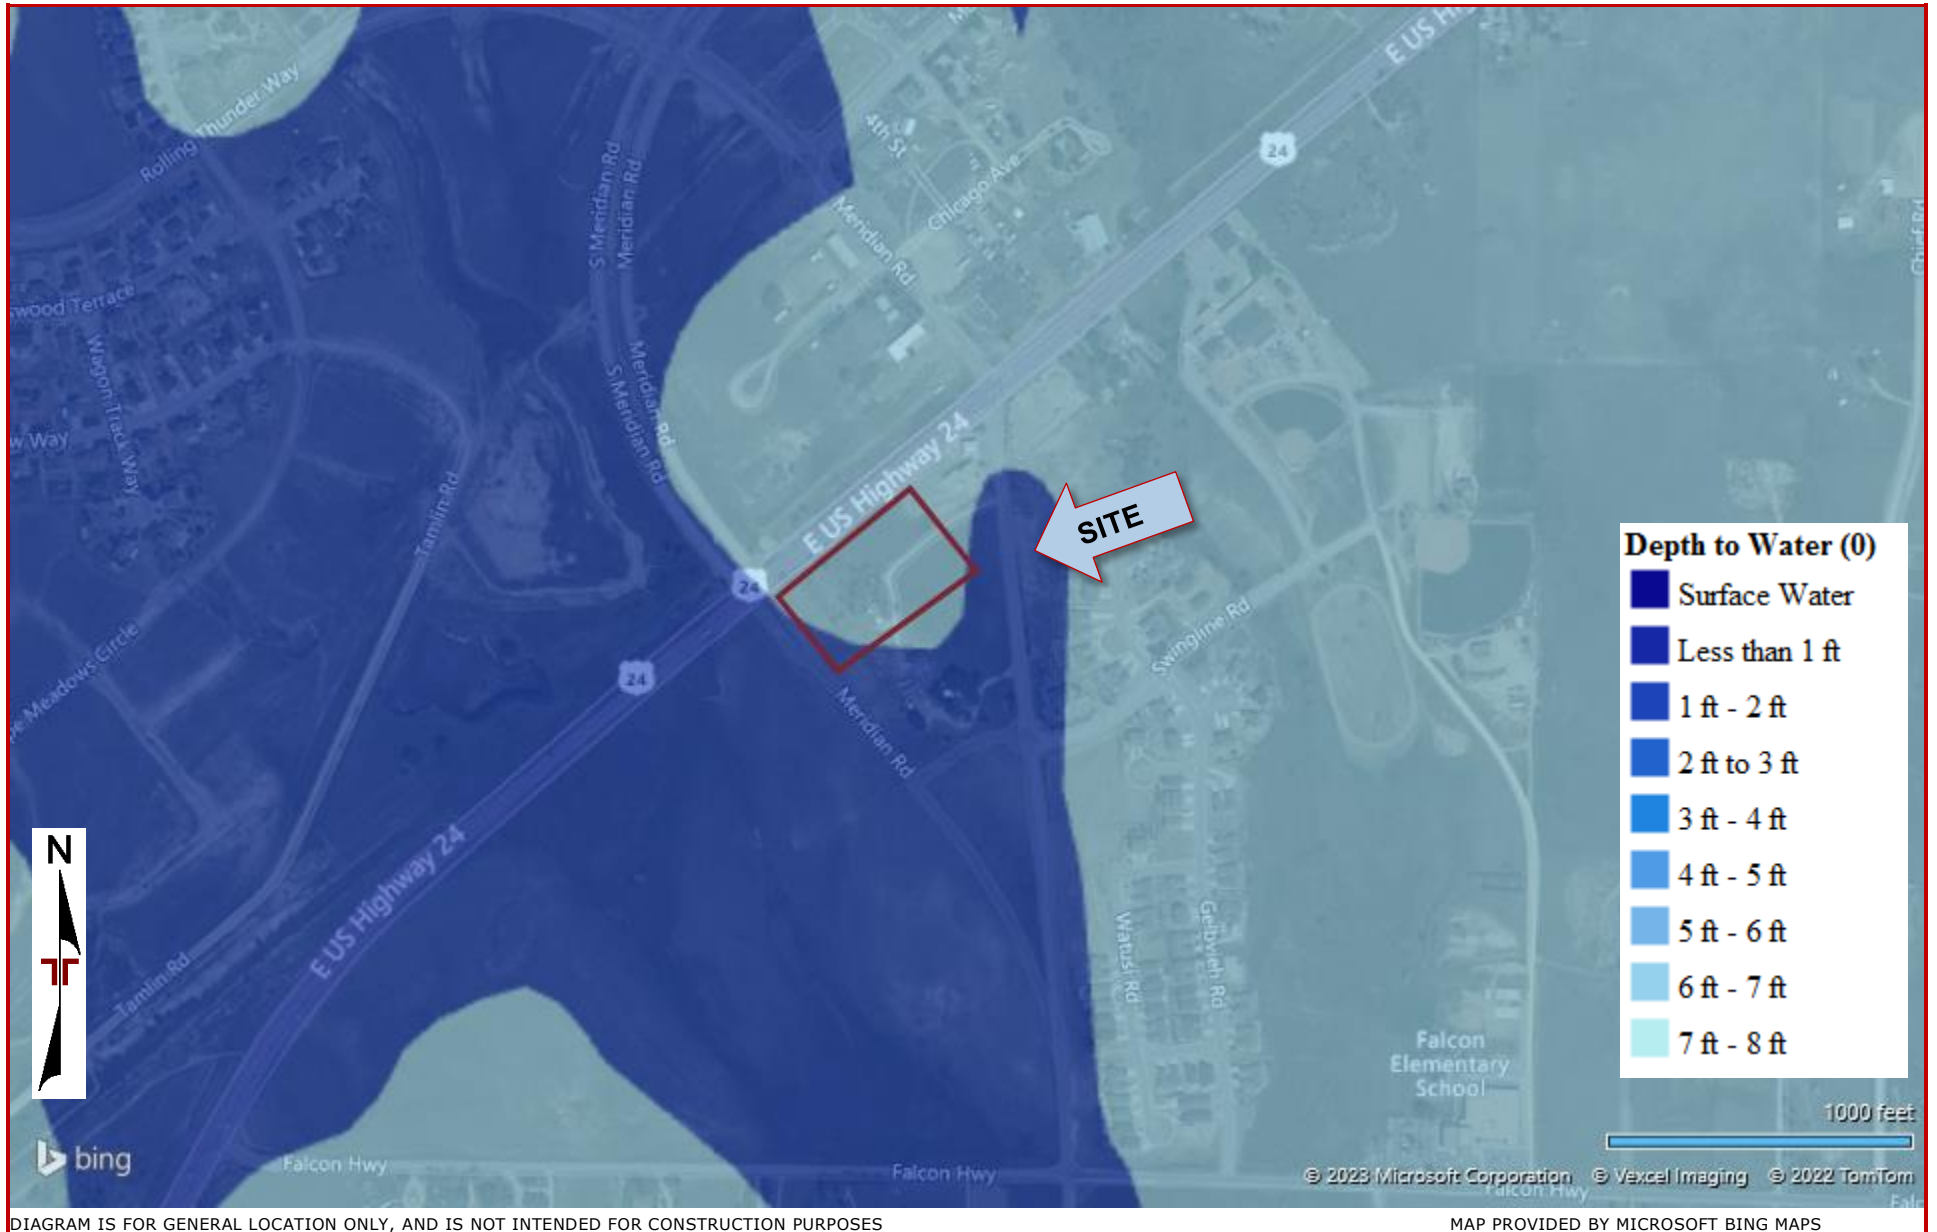
Figure 7 – Depth to Groundwater

<p>Shallow Groundwater</p>	<p>The proposed site has a shallow ground water table with groundwater as shallow as 5½ feet encountered</p>	<p>High</p>	<ul style="list-style-type: none"> ■ According to the field investigations, performed in 2018 and 2022, the site has a shallow ground water table groundwater was observed from depth ranging from about 5½ to 8 feet below existing site grades. ■ Underground storage tanks should be designed for buoyant uplift forces.

Hazard	Evaluation	Estimated Risk Level	Proposed Mitigation
	during the exploration. (Figure 7 – Depth to Groundwater)		<ul style="list-style-type: none"> ■ Temporary dewatering may be required during site construction. ■ The earthwork and Geotechnical recommendations provided in Terracon Geotechnical Reports #23185069 and #23225154 should be followed.
Flood Prone Areas	The proposed site is within 100 feet of a mapped flood area. (Figure 8 – 100-year floodplain map)	High	<ul style="list-style-type: none"> ■ Based on our review of the Colorado Geological Survey NFHL Hazard Zones interactive map, El Paso County, Colorado, the proposed development area is adjacent to a FEMA flood-prone area. ■ Adequate drainage structures and flood mitigation techniques should be used to reduce the risk of flooding on the proposed development area. ■ The earthwork recommendations provided in Terracon Geotechnical Reports #23185069 and #23225154 should be followed.
