July 13, 2018

ENTECH
ENGINEERING, INC.

Re: Soil, Geology and Geologic Hazard Evaluation
Lot 2, Appaloosa Hwy 24 Subdivision Filing No. 2
El Paso County, Colorado

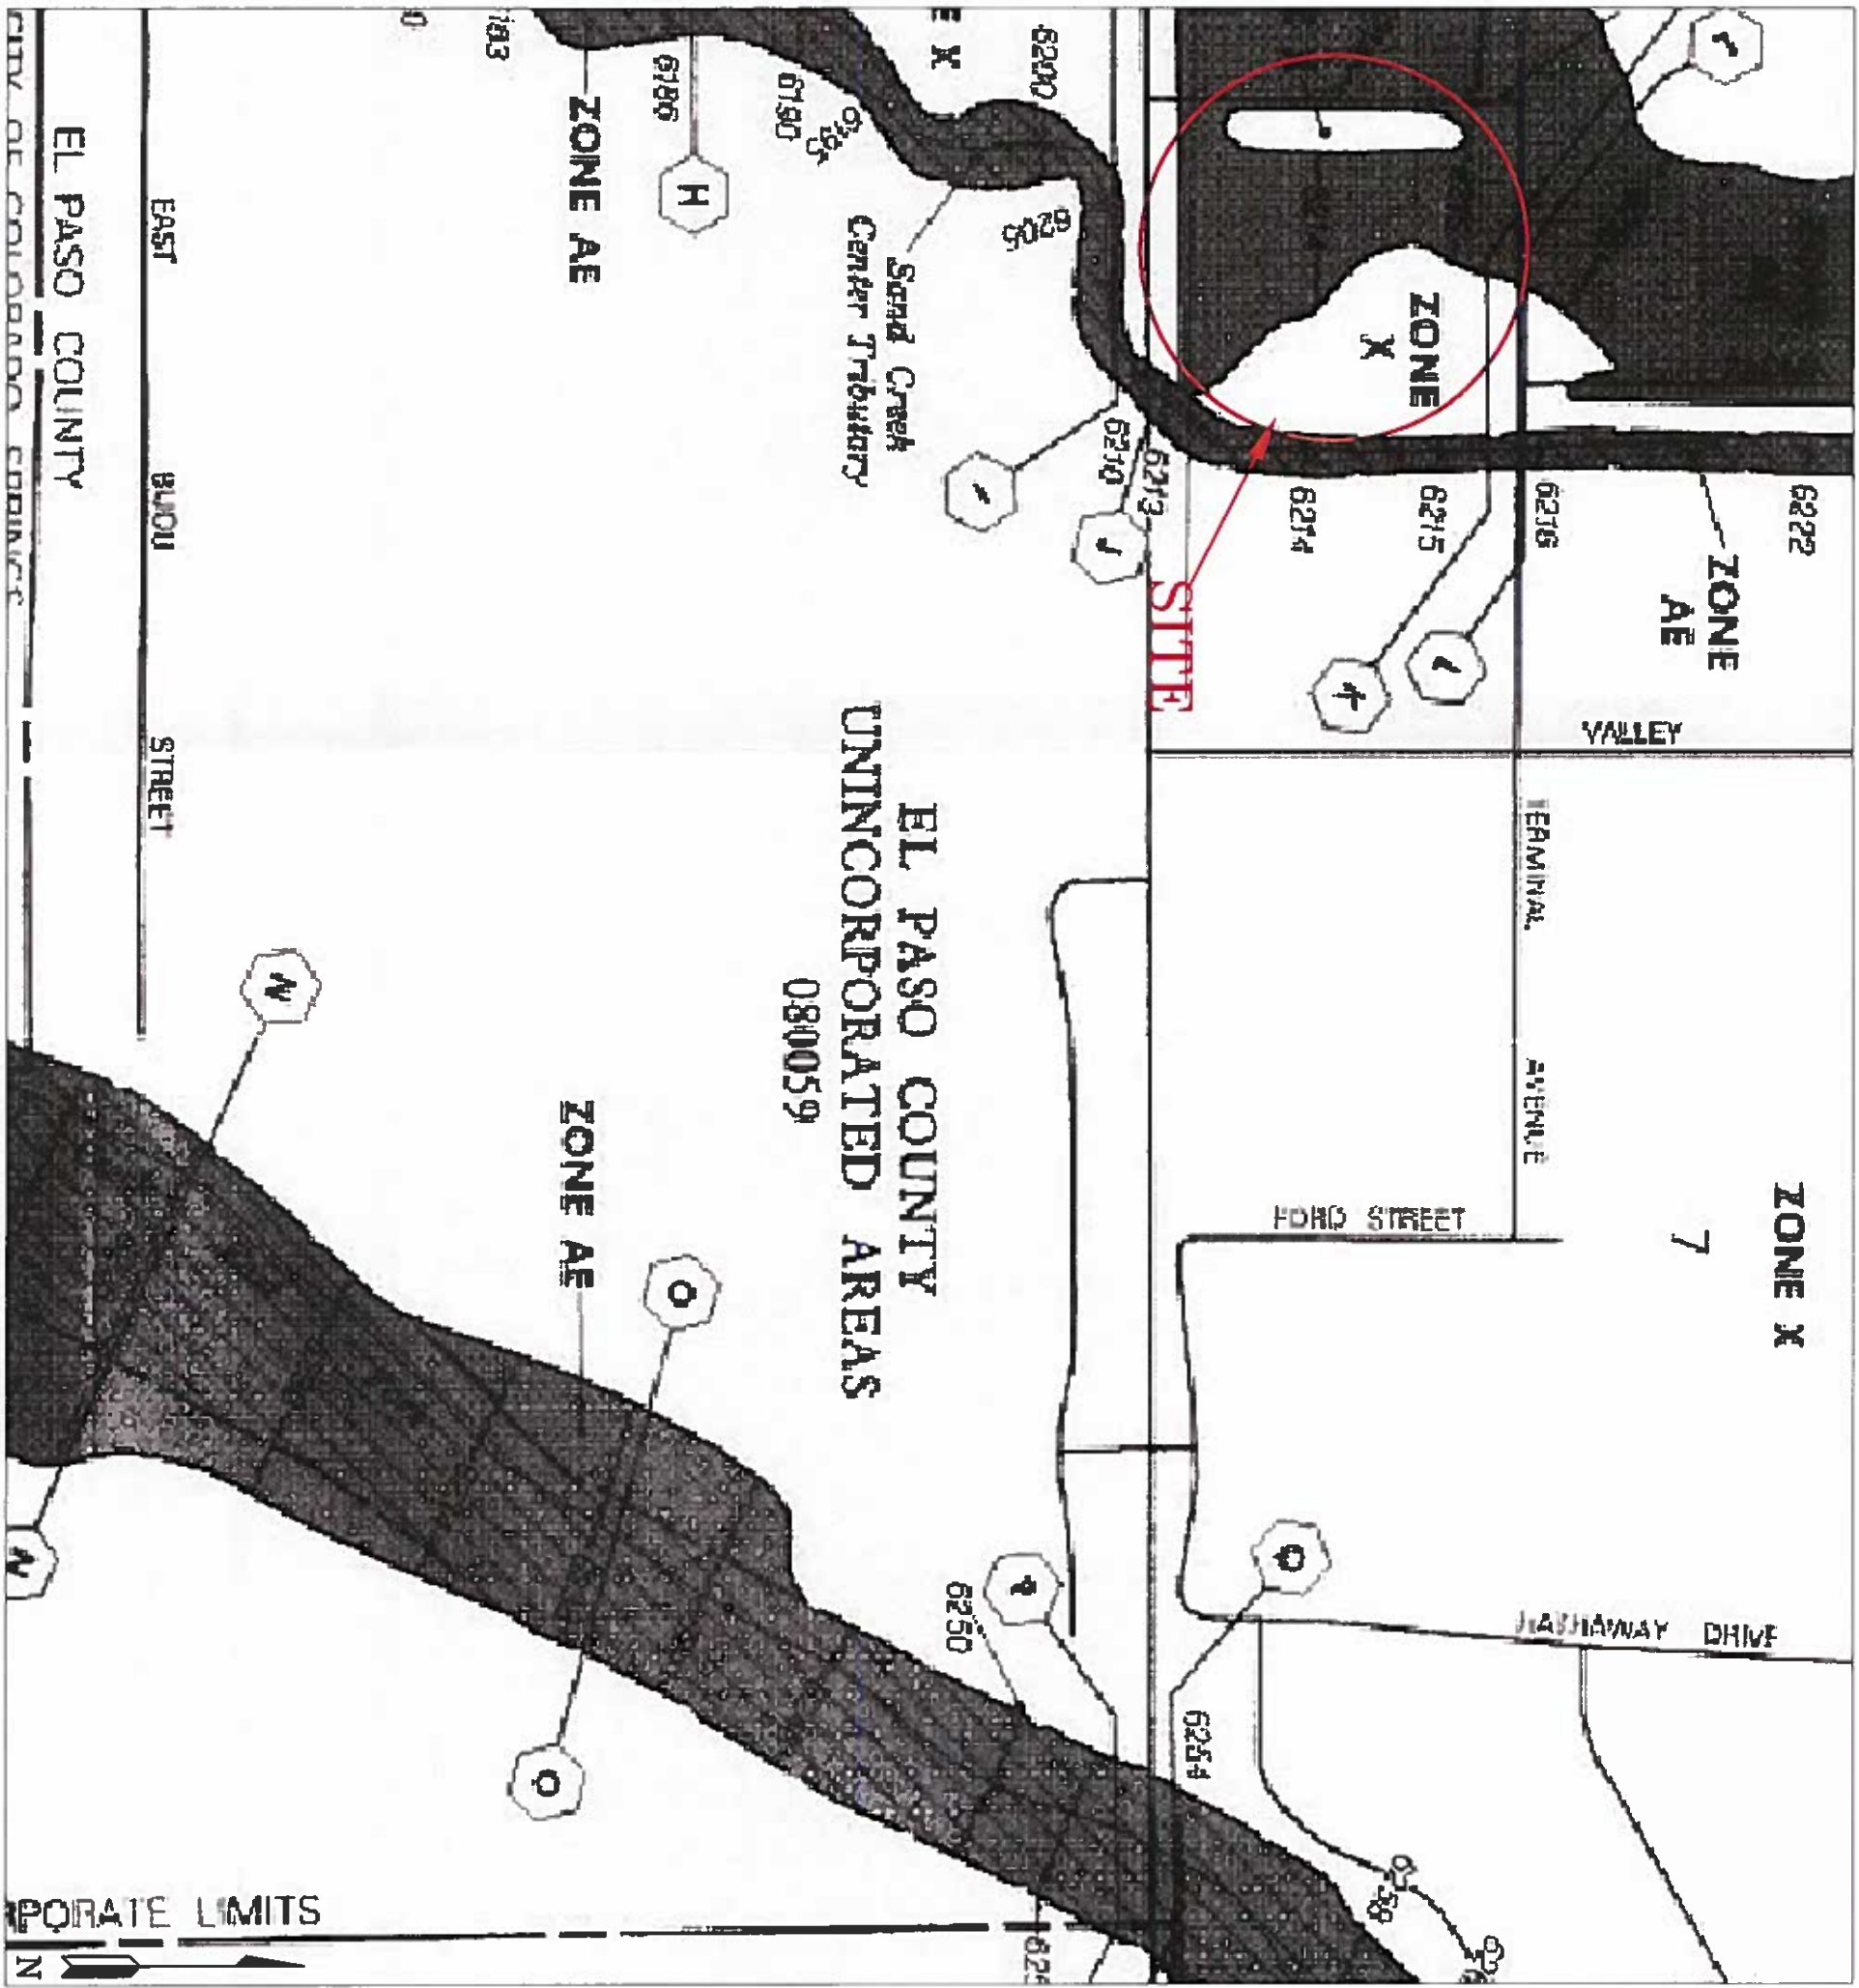
DATE	BY
7/13/18	AS SHOWN
AS SHOWN	AS SHOWN
181189	181189
6	6

Portions of the site lie within a floodplain according to the FIRM Map, No. 08041CO754F (Reference 5, Figure 6). Finished floors must be a minimum of one foot above the floodplain level. Any site grading considered should be modified to direct surface flows around the structures or roads, or carried off-site so as to not produce any areas of ponded water. Additionally, subsurface perimeter drains may be required. Specific drainage studies and exact floodplain locations are beyond the scope of this report.

Groundwater was encountered at 20 feet in Test Boring No. 2. It is anticipated groundwater will not affect a shallow foundation with slab-on-grade construction and no basement construction. According to the FEMA FIRM Map No. 08041CO0754F (Reference 5, Figure 6) a portion of the site is located in a floodplain. Finished floors must be a minimum of one foot above the floodplain level. Specific drainage studies and exact floodplain locations are beyond the scope of this report.

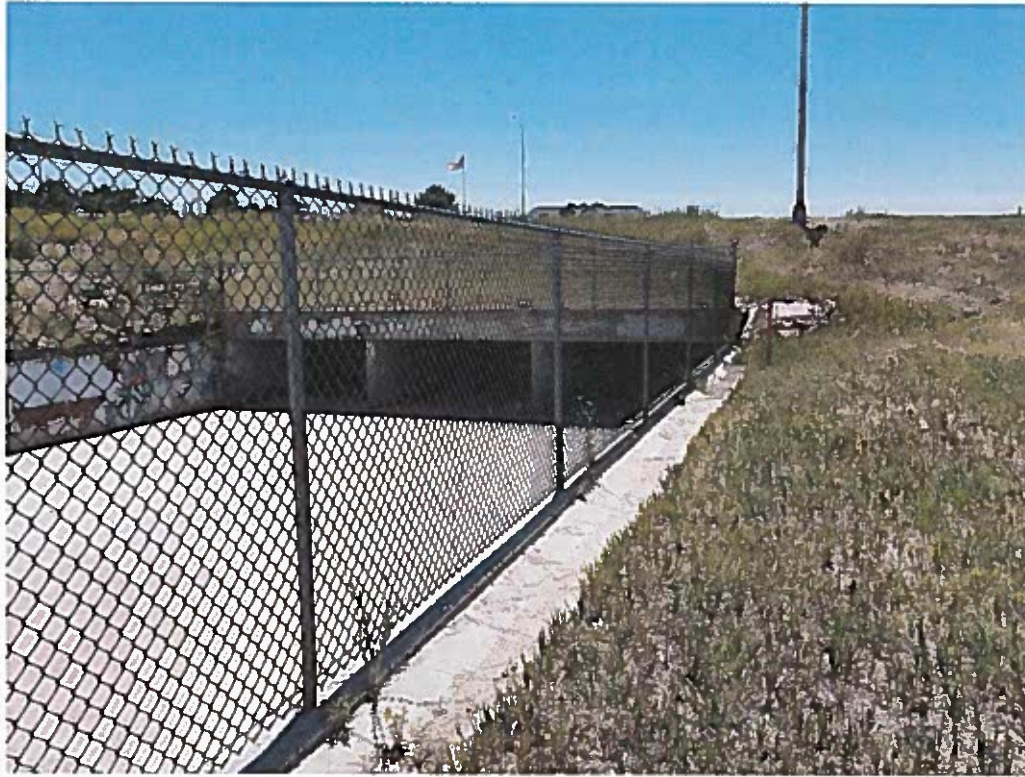
**Looking east at
concrete drainage way
along the southeast
boundary of site.**

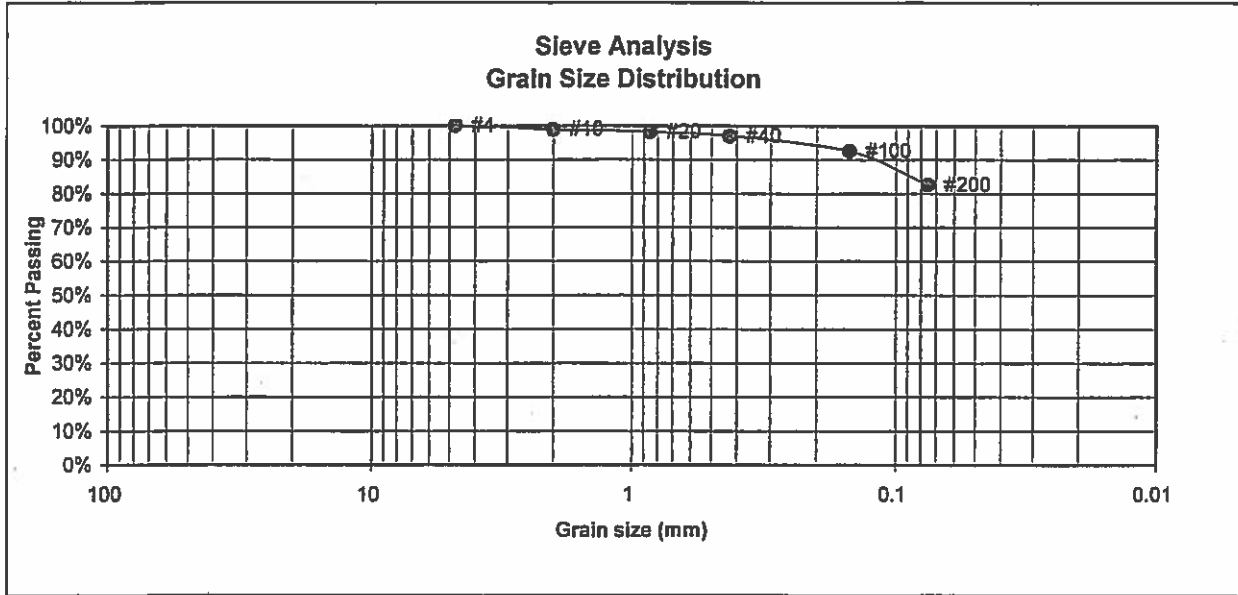
B-4

The soils encountered in the Test Boring Nos. 1, 2 and 3 from Subsurface Soil Investigation (Reference 1) consisted of four to six feet of silty to clayey sand fill/possible fill, native silty to slightly silty and gravelly sand and sandy clay. Bedrock was not encountered in the test borings, which were drilled on the subject site to 20 feet. The upper soils were encountered at loose to medium dense states and moist conditions. The sand soils are considered to have low expansion potential. A FHA Swell pressure of 750 psf was measured on the sandy clay, indicating low expansion potential.

A layer of expansive soils was encountered in one the test borings. Expansive clays, if encountered beneath foundations, can cause differential movement in the structure foundation.

Mitigation: Should expansive soils be encountered beneath the foundation, mitigation will be necessary. Mitigation of expansive soils will require special foundation design. Overexcavation and replacement with non-expansive soils at a minimum of 95% of its maximum Modified Proctor Dry Density, ASTM D-1557 is a suitable mitigation, which is common in the area. Floor slabs on expansive soils should be expected to experience movement. Overexcavation and replacement has been successful in minimizing slab movements.
