ENTECH
ENGINEERING, INC.

Re: Soil, Geology and Geologic Hazard Evaluation
12265 Highway 94
Tax Schedule No. 44000-00-237
El Paso County, Colorado

Rockwood Homes
Soil, Geology and Geologic Hazard Evaluation
12265 Highway 94
Tax Schedule No. 44000-00-237
El Paso County, Colorado

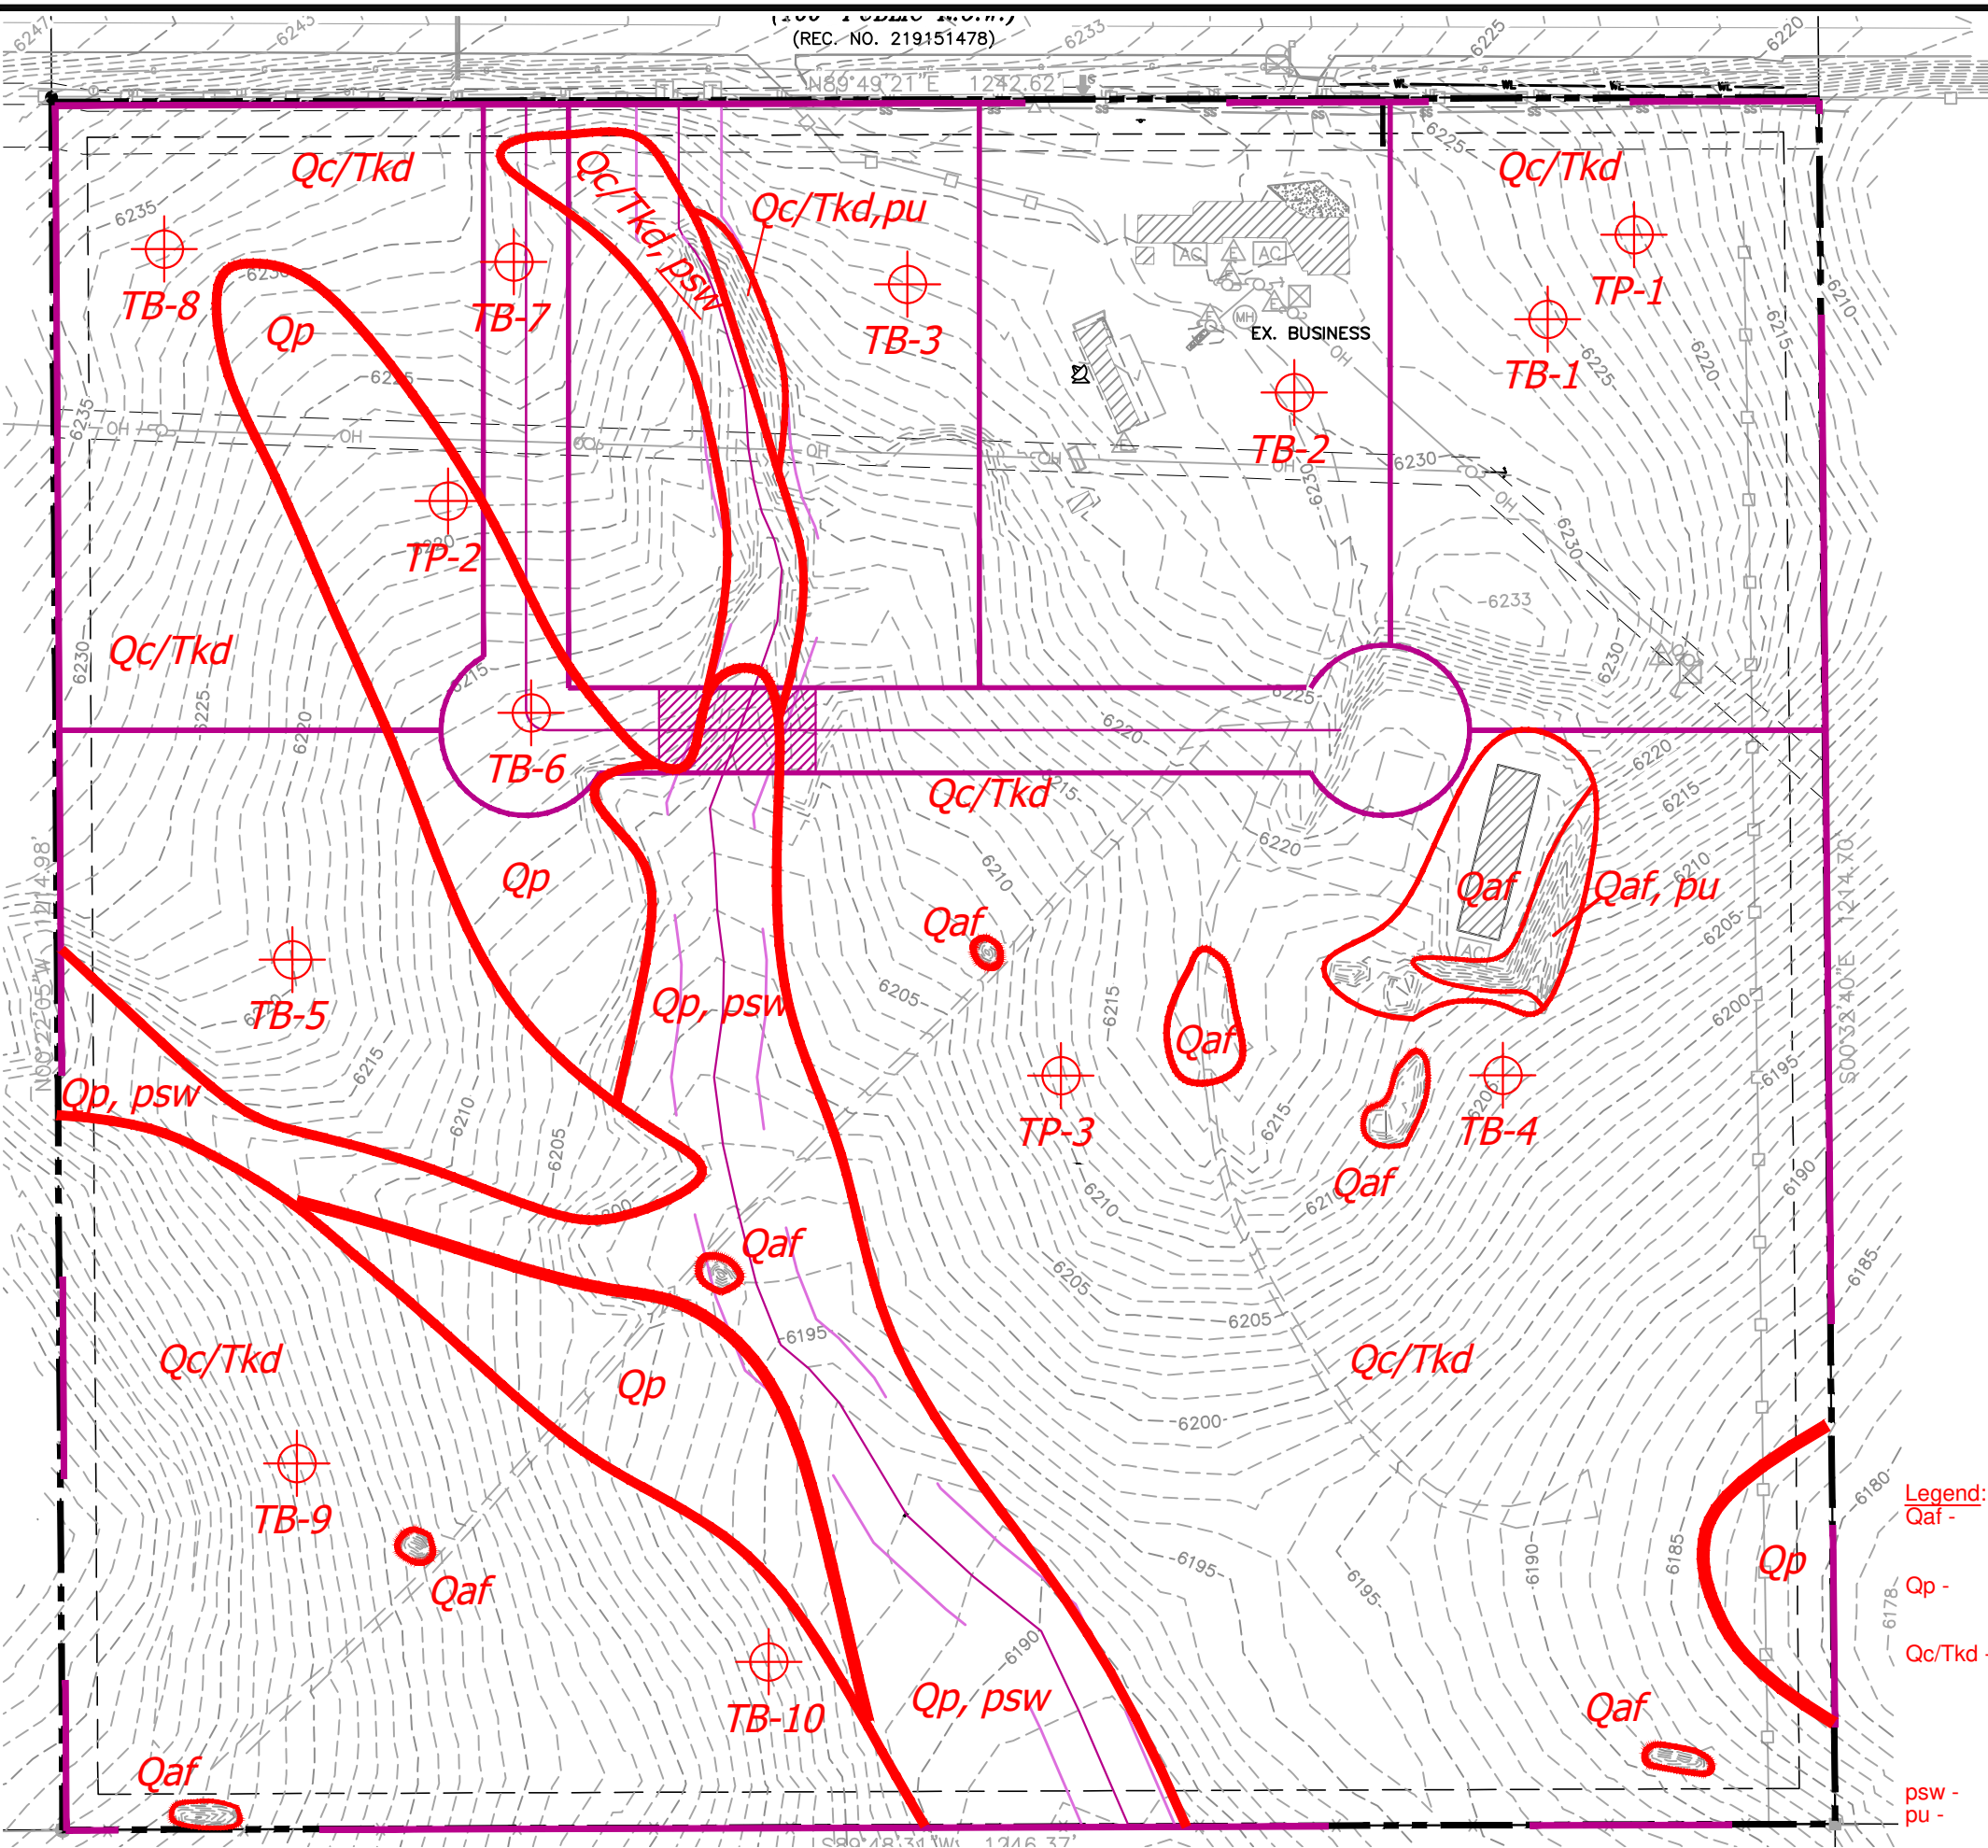
DRAWN LLL
CHECKED
DATE 5/17/22
SCALE AS SHOWN
JOB NO. 220535
FIGURE No. 6

The areas identified with this constraint area located along the drainage in the central portion of the site, and the fill slope in the eastern portion of the site. These areas are indicated on the Geology/Engineering Geology Map, Figure 6. The slopes are considered stable in their present condition; however, considerable care should be exercised in these areas not to create areas of instability.

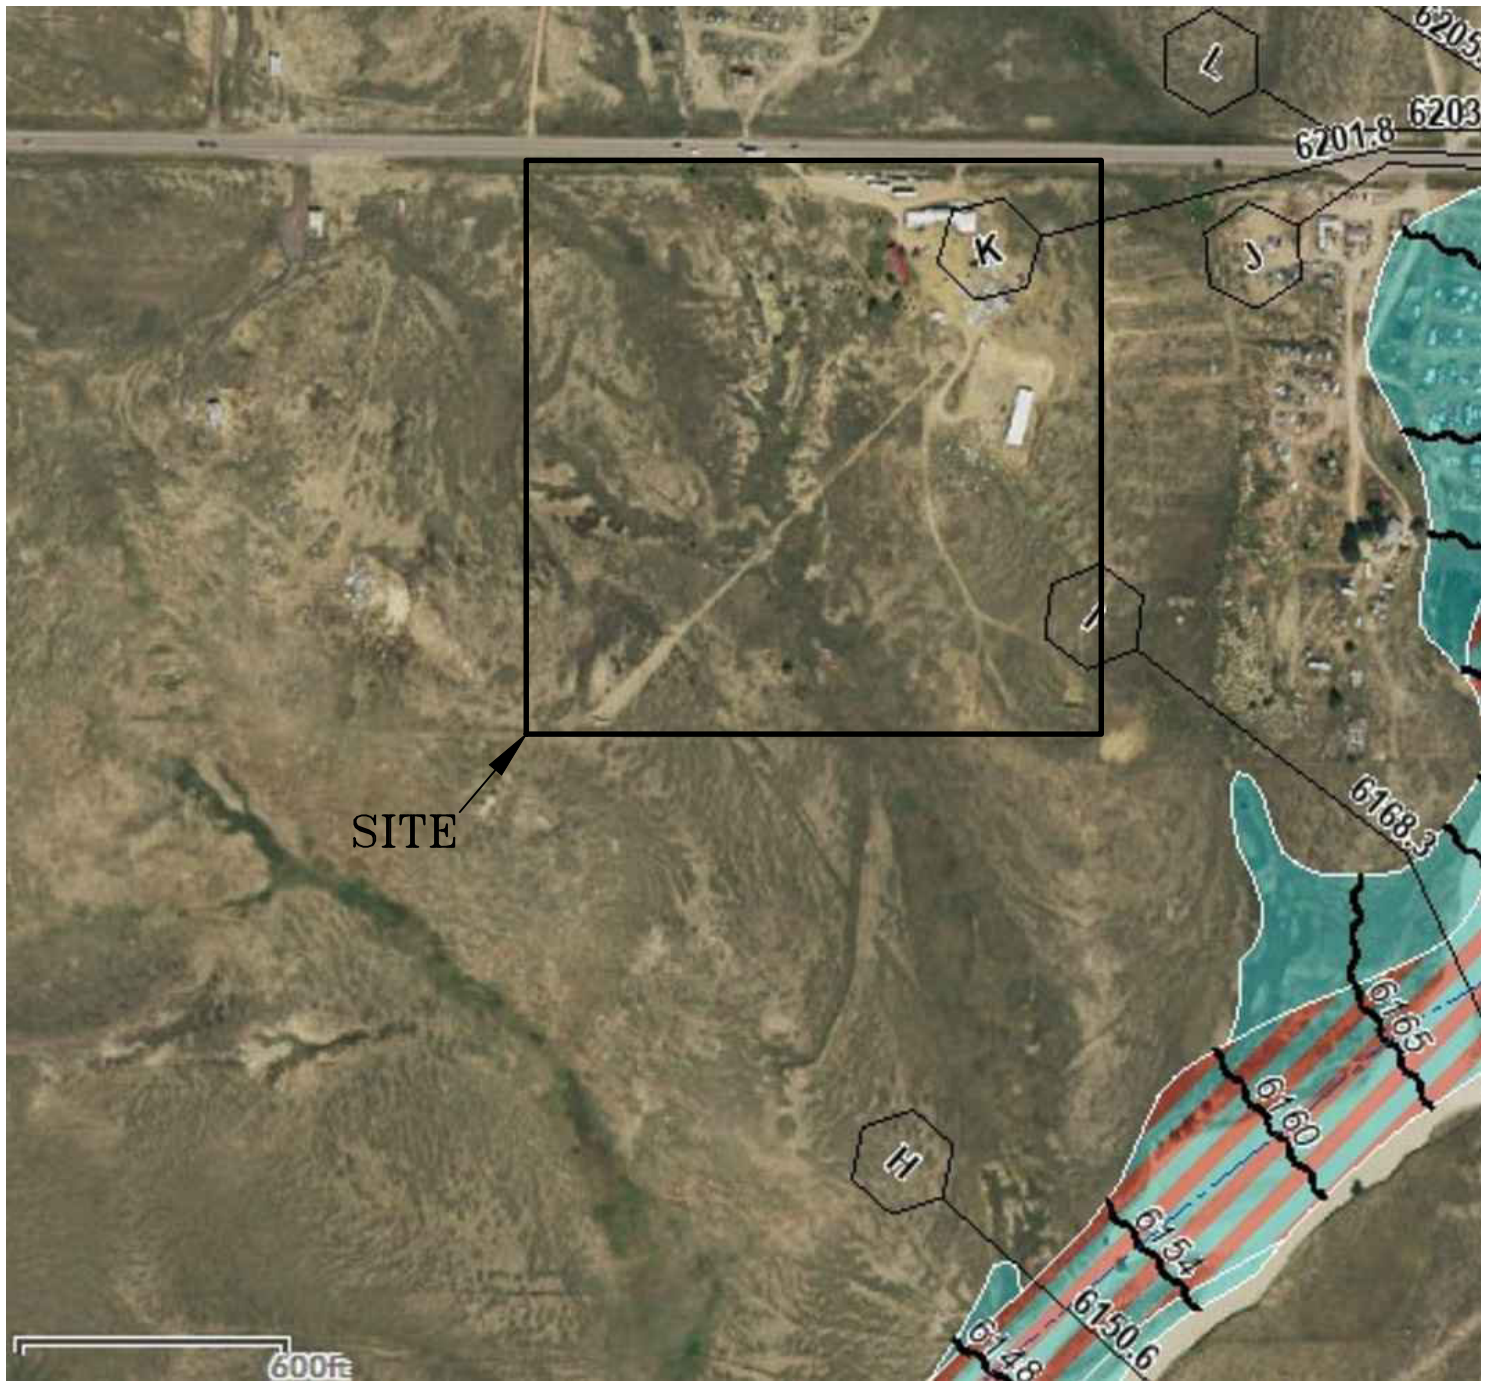
FIG NO.:
7

The site does not lie within a mapped floodplain zone according to the FEMA Map Nos. 08041CO780G dated December 7, 2018 (Figure 7, Reference 6). Finished floor levels must be a minimum of one foot above any floodplain level. Exact locations of floodplain and specific drainage studies are beyond the scope of this report. A drainage was observed in the central portion of the site flowing in a southerly direction. Water was not observed in the drainage at the time of our site investigation. The drainage area has been identified as a potentially seasonal shallow groundwater area and is further discussed below. The drainage area has been included in a proposed drainage easement and will be avoided future development.

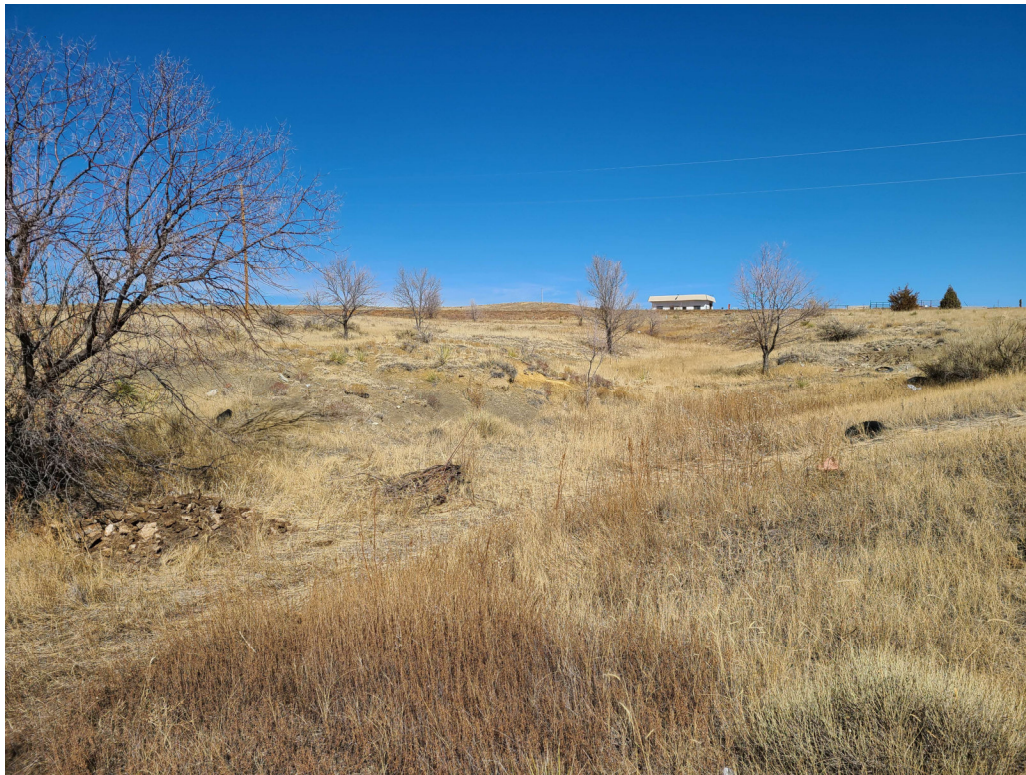
**Looking north along
drainage from the west
central portion of the
site.**

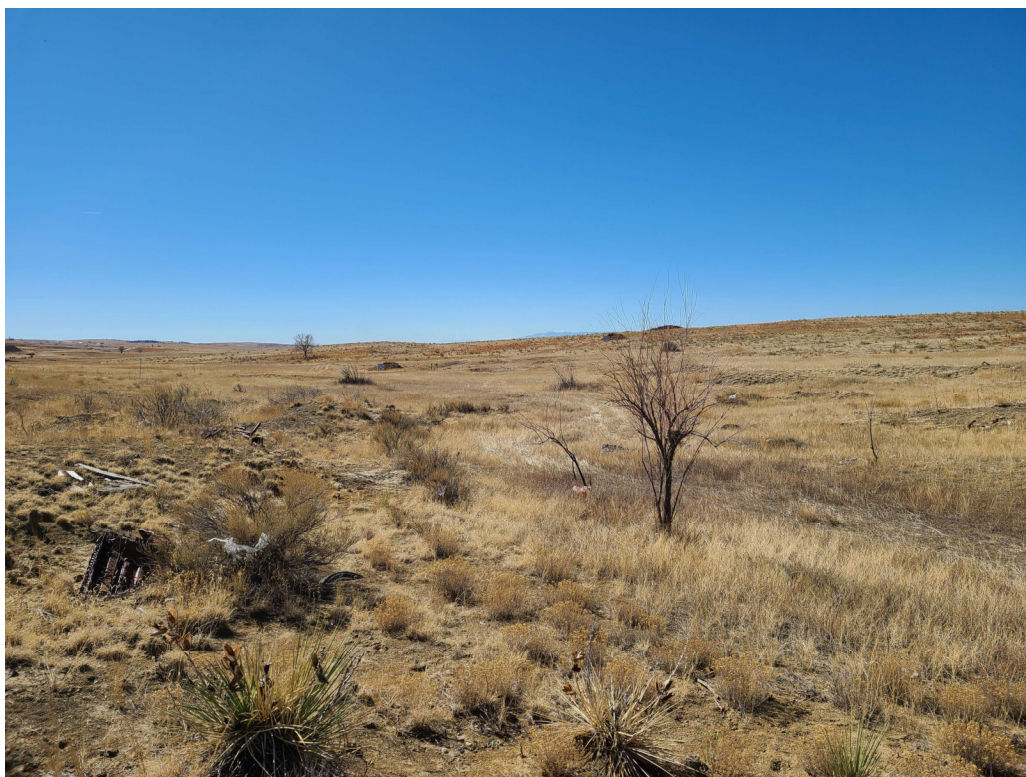
**Looking south along
drainage in the central
portion of the site.**
