ENTECH
ENGINEERING, INC.

**SOILS AND GEOLOGY STUDY
IRON RIDGE SUBDIVISION – WALKER ROAD
EL PASO COUNTY, COLORADO**

September 24, 2025

LLL/JCG
Entech Job No. 251117

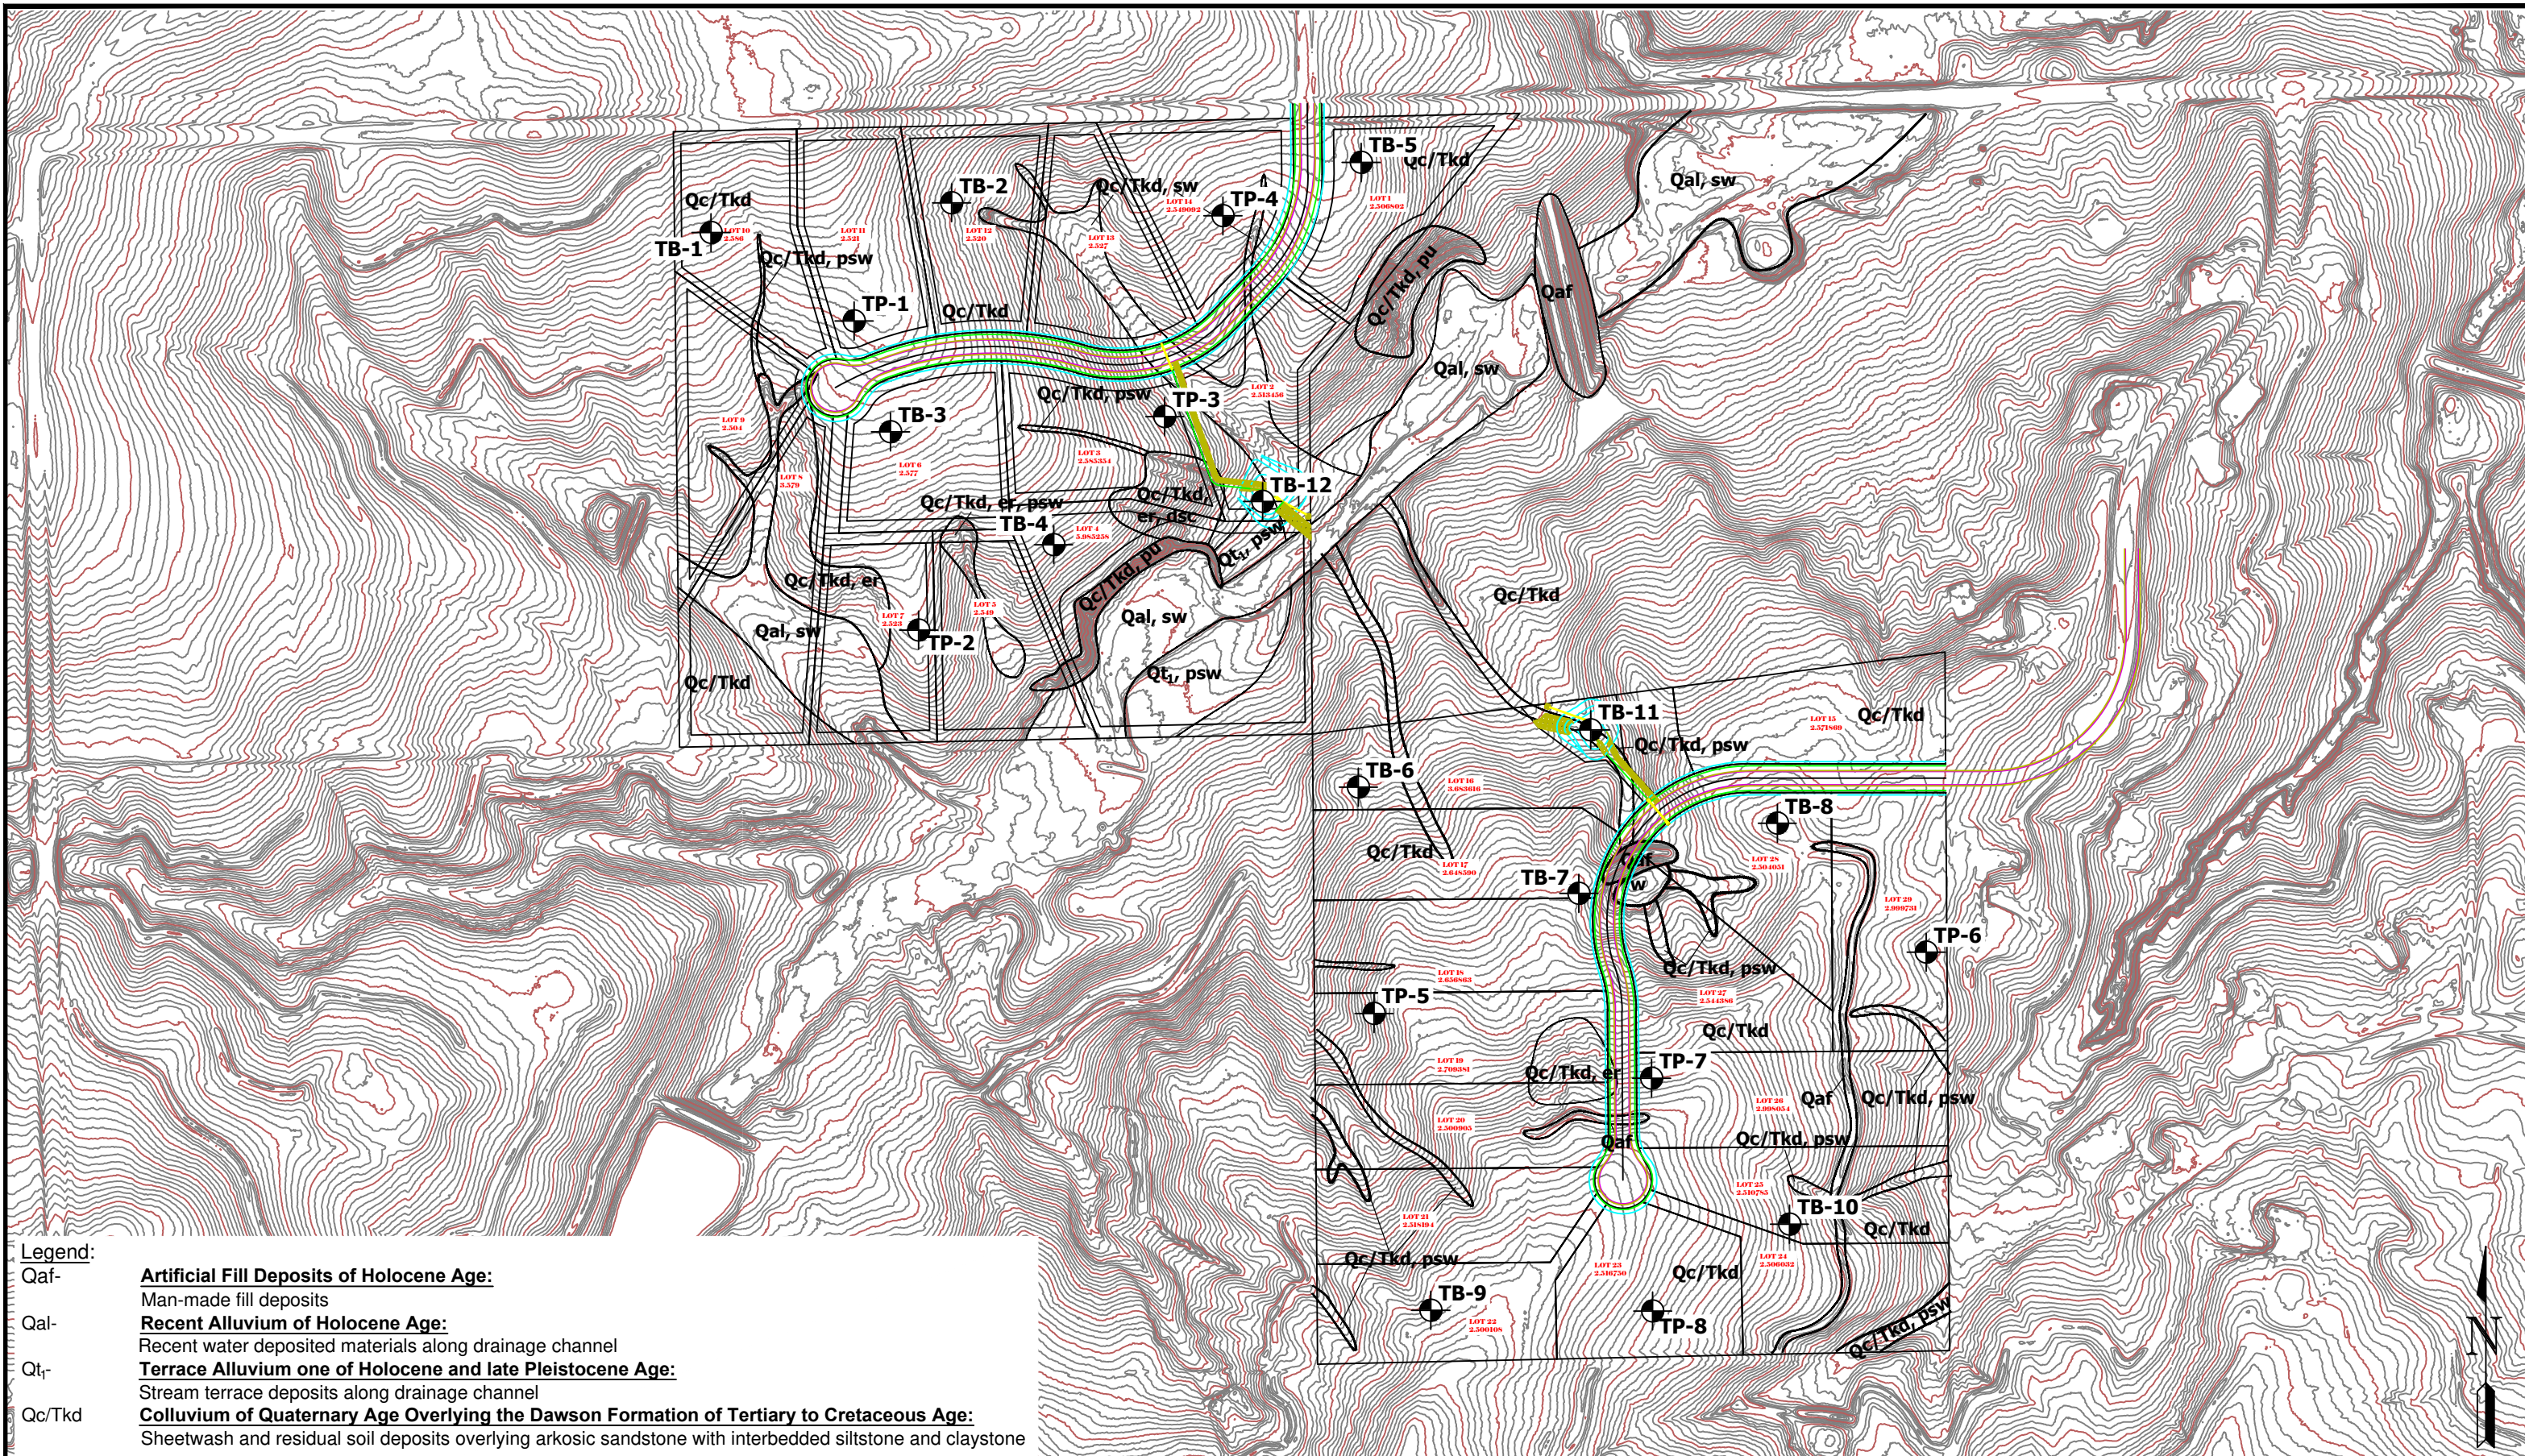
FIG. 6

Detailed mapping has been performed on this site to produce a Geology/Engineering Geology Map (Figure 6). This map shows the location of various geologic conditions the developers should monitor during the planning, design, and construction stages of the project. No significant geologic hazards were identified on the site; however, the following constraints have been identified on the site: artificial fill, potentially expansive soils, downslope creep, potentially unstable slopes, seasonal and potentially seasonal shallow groundwater areas, areas of ponded water, erosion, and the potential for elevated radon levels. These constraints and the recommended mitigation techniques include:

These are areas of man-made fill associated with earthen dams and erosion berms observed on the site.

The majority of the slopes on the site are gradually to moderately sloping and do not exhibit any past or potential unstable slopes or landslides. Potentially unstable slopes have been identified along portions of the drainage in the central portion of the site and are further discussed below. It is recommended that any future grading or fill slopes be 3:1 or flatter.

The areas identified with this hazard include portions of the moderate to steep slopes in the northern portion of the site. In these areas we would anticipate lateral and vertical movement of the near surface soils in the downslope direction. These areas are acceptable as building sites with the following constraints on construction.

These majority of these slopes are considered stable in their present condition; however, care must be exercised in these areas not to create a condition which would tend to activate instability. An area of accelerated erosion was observed on the northeastern portion of the potentially unstable slope located on Lot 4. The steeper slopes along the drainage in the central portion of the site located on Lots 1 and 4. Additional investigation may be warranted once building locations are determined on the lots with this constraint, however, based on the size of the proposed lots it is anticipated development these areas can likely be avoided or mitigated.

Areas exist on-site that are affected by the potential for seasonally high groundwater conditions. In these areas, the potential exists for periodically high subsurface moisture conditions and possible frost heave potential, depending on the soil conditions. These areas include those areas mapped as sw-seasonal shallow groundwater on Figure 6 associated with the main drainage in the central portion of the site.

Mitigation: The earthen dams lie within defined drainages and should be avoided as building sites. The berms can either be avoided or penetrated by foundations. The fill on this site is considered uncontrolled for construction purposes. Any uncontrolled fill encountered beneath foundations will require removal and recompaction at a minimum of 95% of the Modified Proctor (ASTM D1557) maximum dry density.

Mitigation: Downslope creep will increase lateral pressures against foundation walls on the uphill side of structures. The design of foundations in these areas should account for this additional pressure. A lateral pressure detail is shown in Figure 7. Where possible in areas of downslope creep, structures should be designed to be as compact and rigid as possible. This will help them better tolerate the vertical and lateral movements to which the foundation system may be subjected. Long, rambling, irregular structures should be avoided in these areas as they are associated with a much greater potential for damaging differential movement. Tie walls and buttresses are often used to stiffen the foundation system.

Mitigation: It is anticipated the majority of these areas can be avoided. Building should be avoided on the potentially unstable slopes unless they are stabilized. A minimum setback of 30 feet from the crest of these slopes is recommended. Stabilization could involve regrading to slope angles no steeper than 3:1 or the use of engineer-designed retaining walls, tiebacks, or buttresses. Where retaining walls are not used, erosion protection may be necessary to prevent undercutting by the creek during periods of high water.

Mitigation: Foundations must have a minimum 30-inch depth for frost protection. Buildings should be a minimum of 3 feet above groundwater levels. Subsurface perimeter drains are recommended for any usable below grade areas including crawlspaces. Groundwater was not encountered in the test borings and is not anticipated to effect the construction of the proposed riding arena. Any grading in these areas should be done to direct surface flow around construction to avoid areas of ponded water. Structures should not block drainages. All organic material should be completely removed prior to any fill placement. Septic fields should not be placed in areas where there is the potential for shallow groundwater.

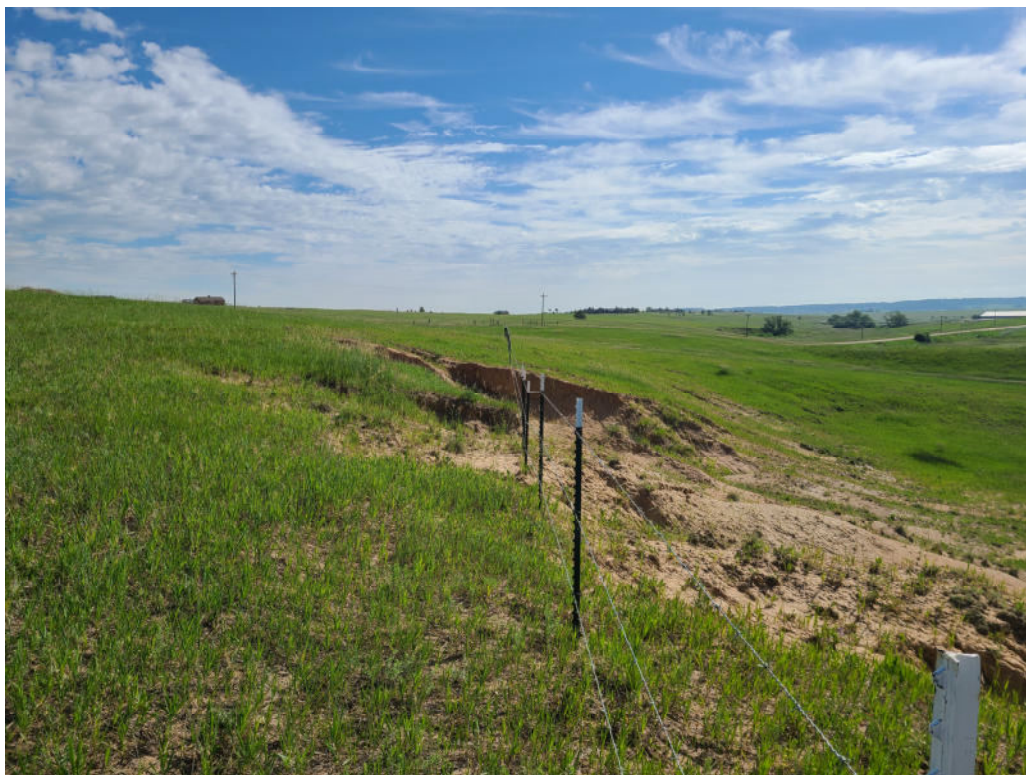
Looking northeast along potentially unstable slope from Lot 1.

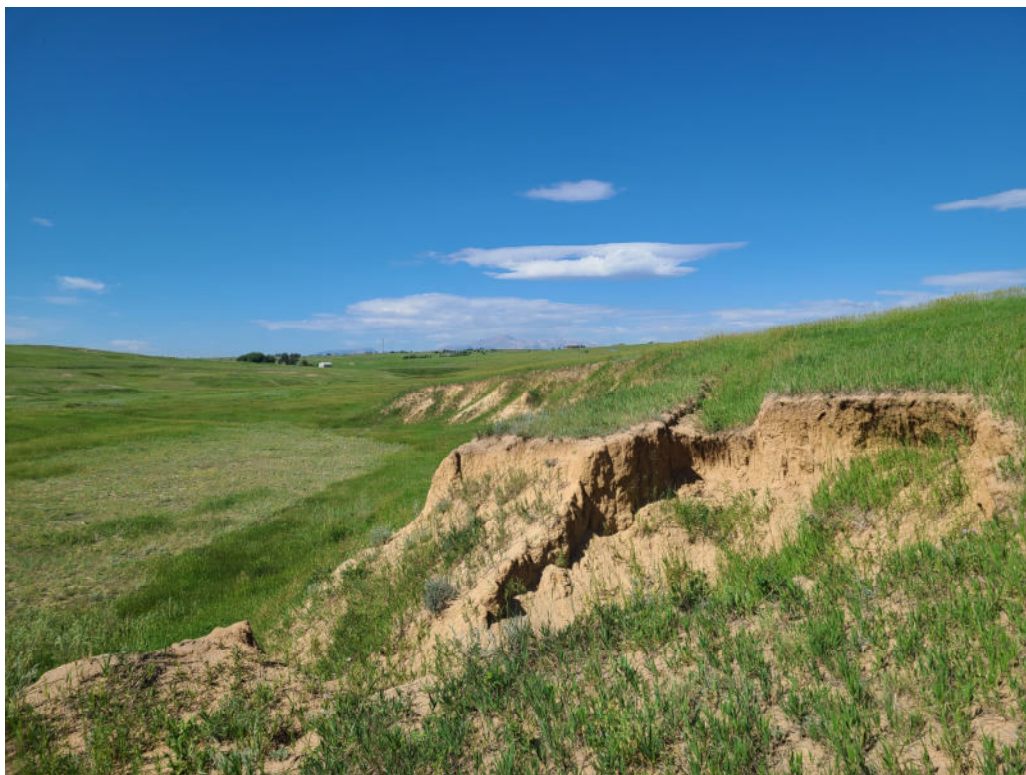
**Looking southwest
along potentially
unstable slope and
drainage on proposed
Lot 4.**

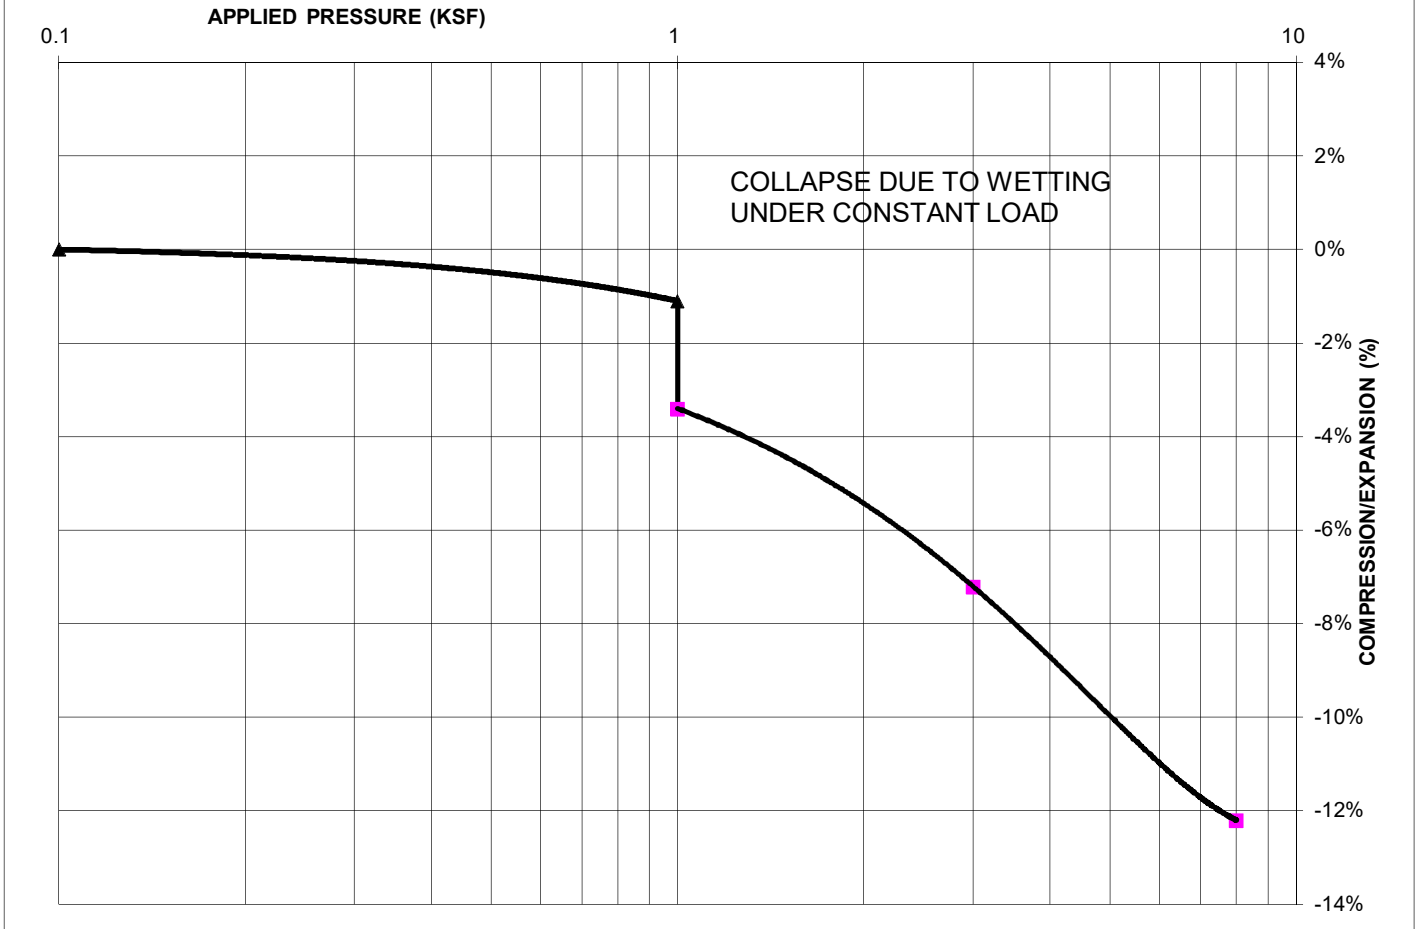
NATURAL UNIT DRY WEIGHT (PCF): 100
NATURAL MOISTURE CONTENT: 9.7%
SWELL/COLLAPSE (%): -2.3%

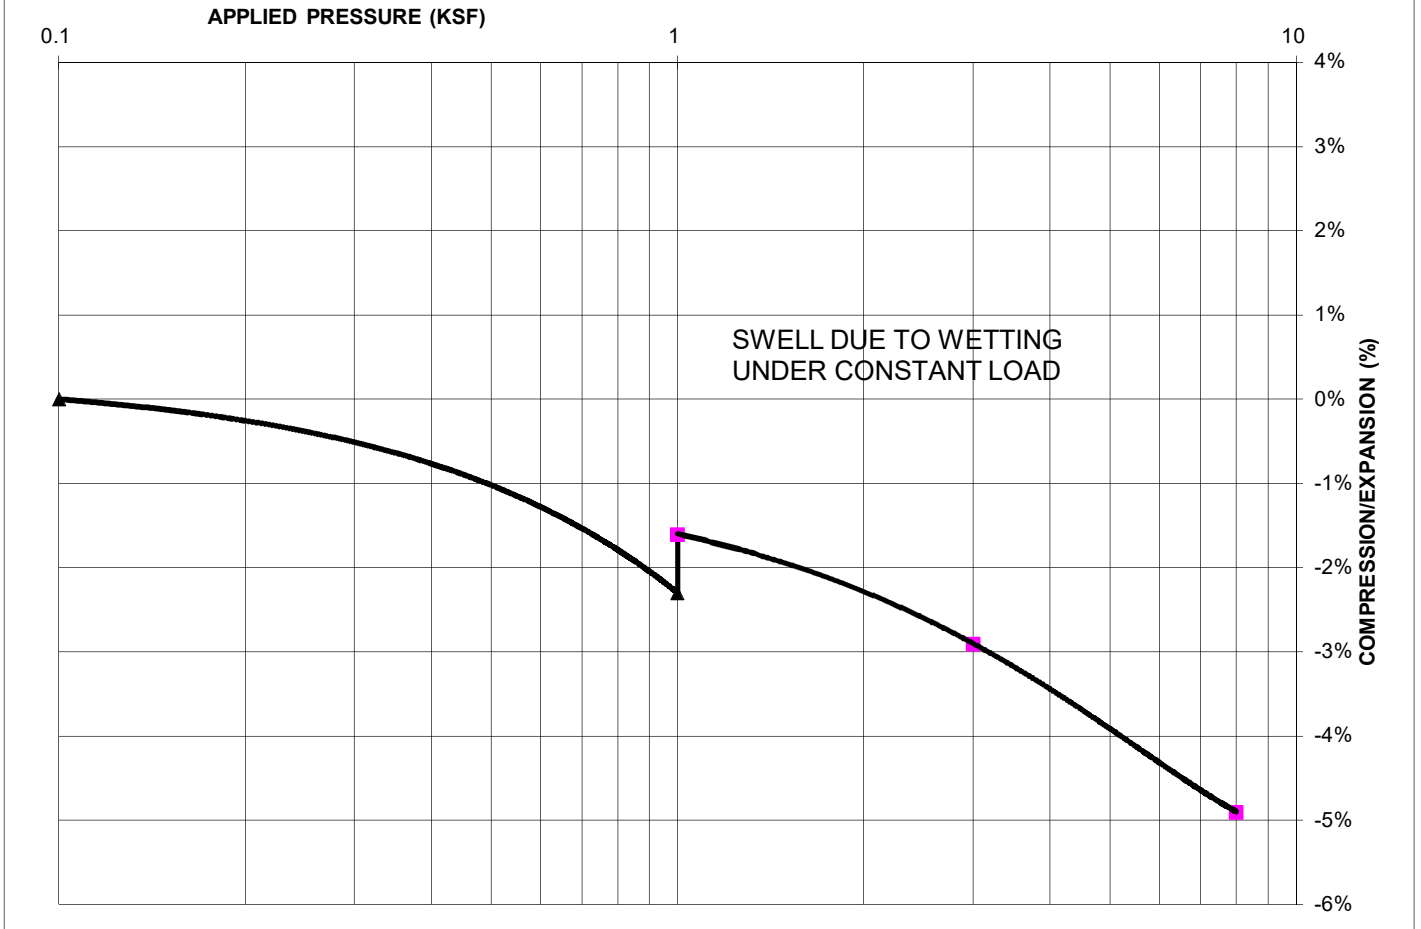
NATURAL UNIT DRY WEIGHT (PCF): 116
NATURAL MOISTURE CONTENT: 16.3%
SWELL/COLLAPSE (%): 0.7%

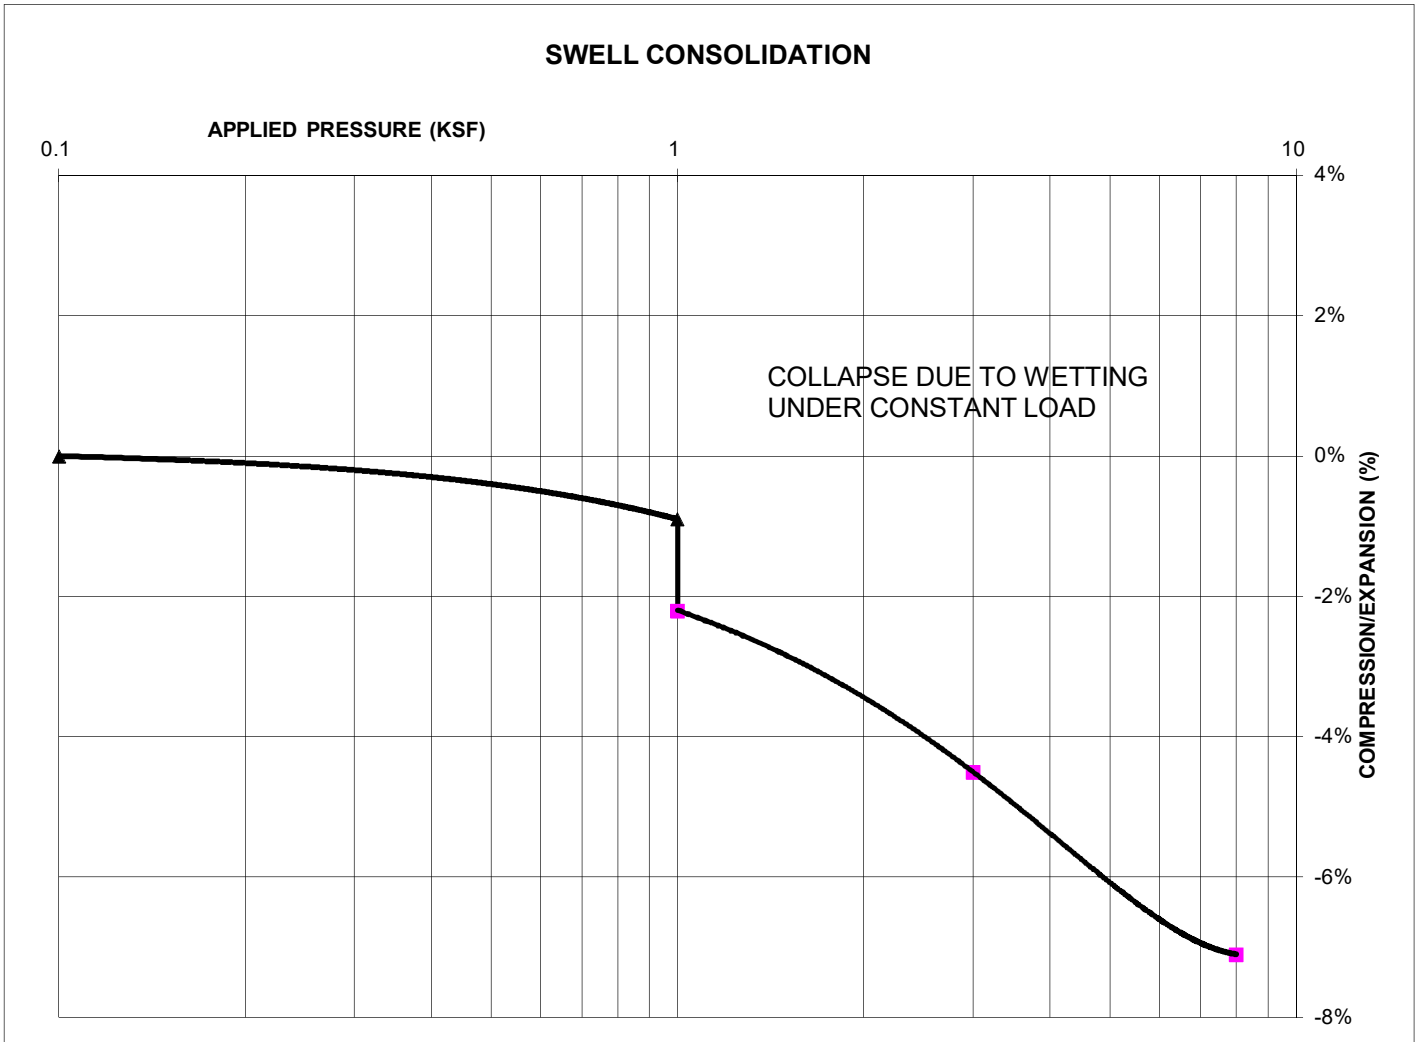
TEST BORING 10
DEPTH (FT) 10

NATURAL UNIT DRY WEIGHT (PCF): 102
NATURAL MOISTURE CONTENT: 9.1%
SWELL/COLLAPSE (%): -1.3%
