**ENTECH**  
ENGINEERING, INC.

**SOILS AND GEOLOGY STUDY  
IRON RIDGE SUBDIVISION – WALKER ROAD  
EL PASO COUNTY, COLORADO**

September 24, 2025

LLL/JCG  
Entech Job No. 251117

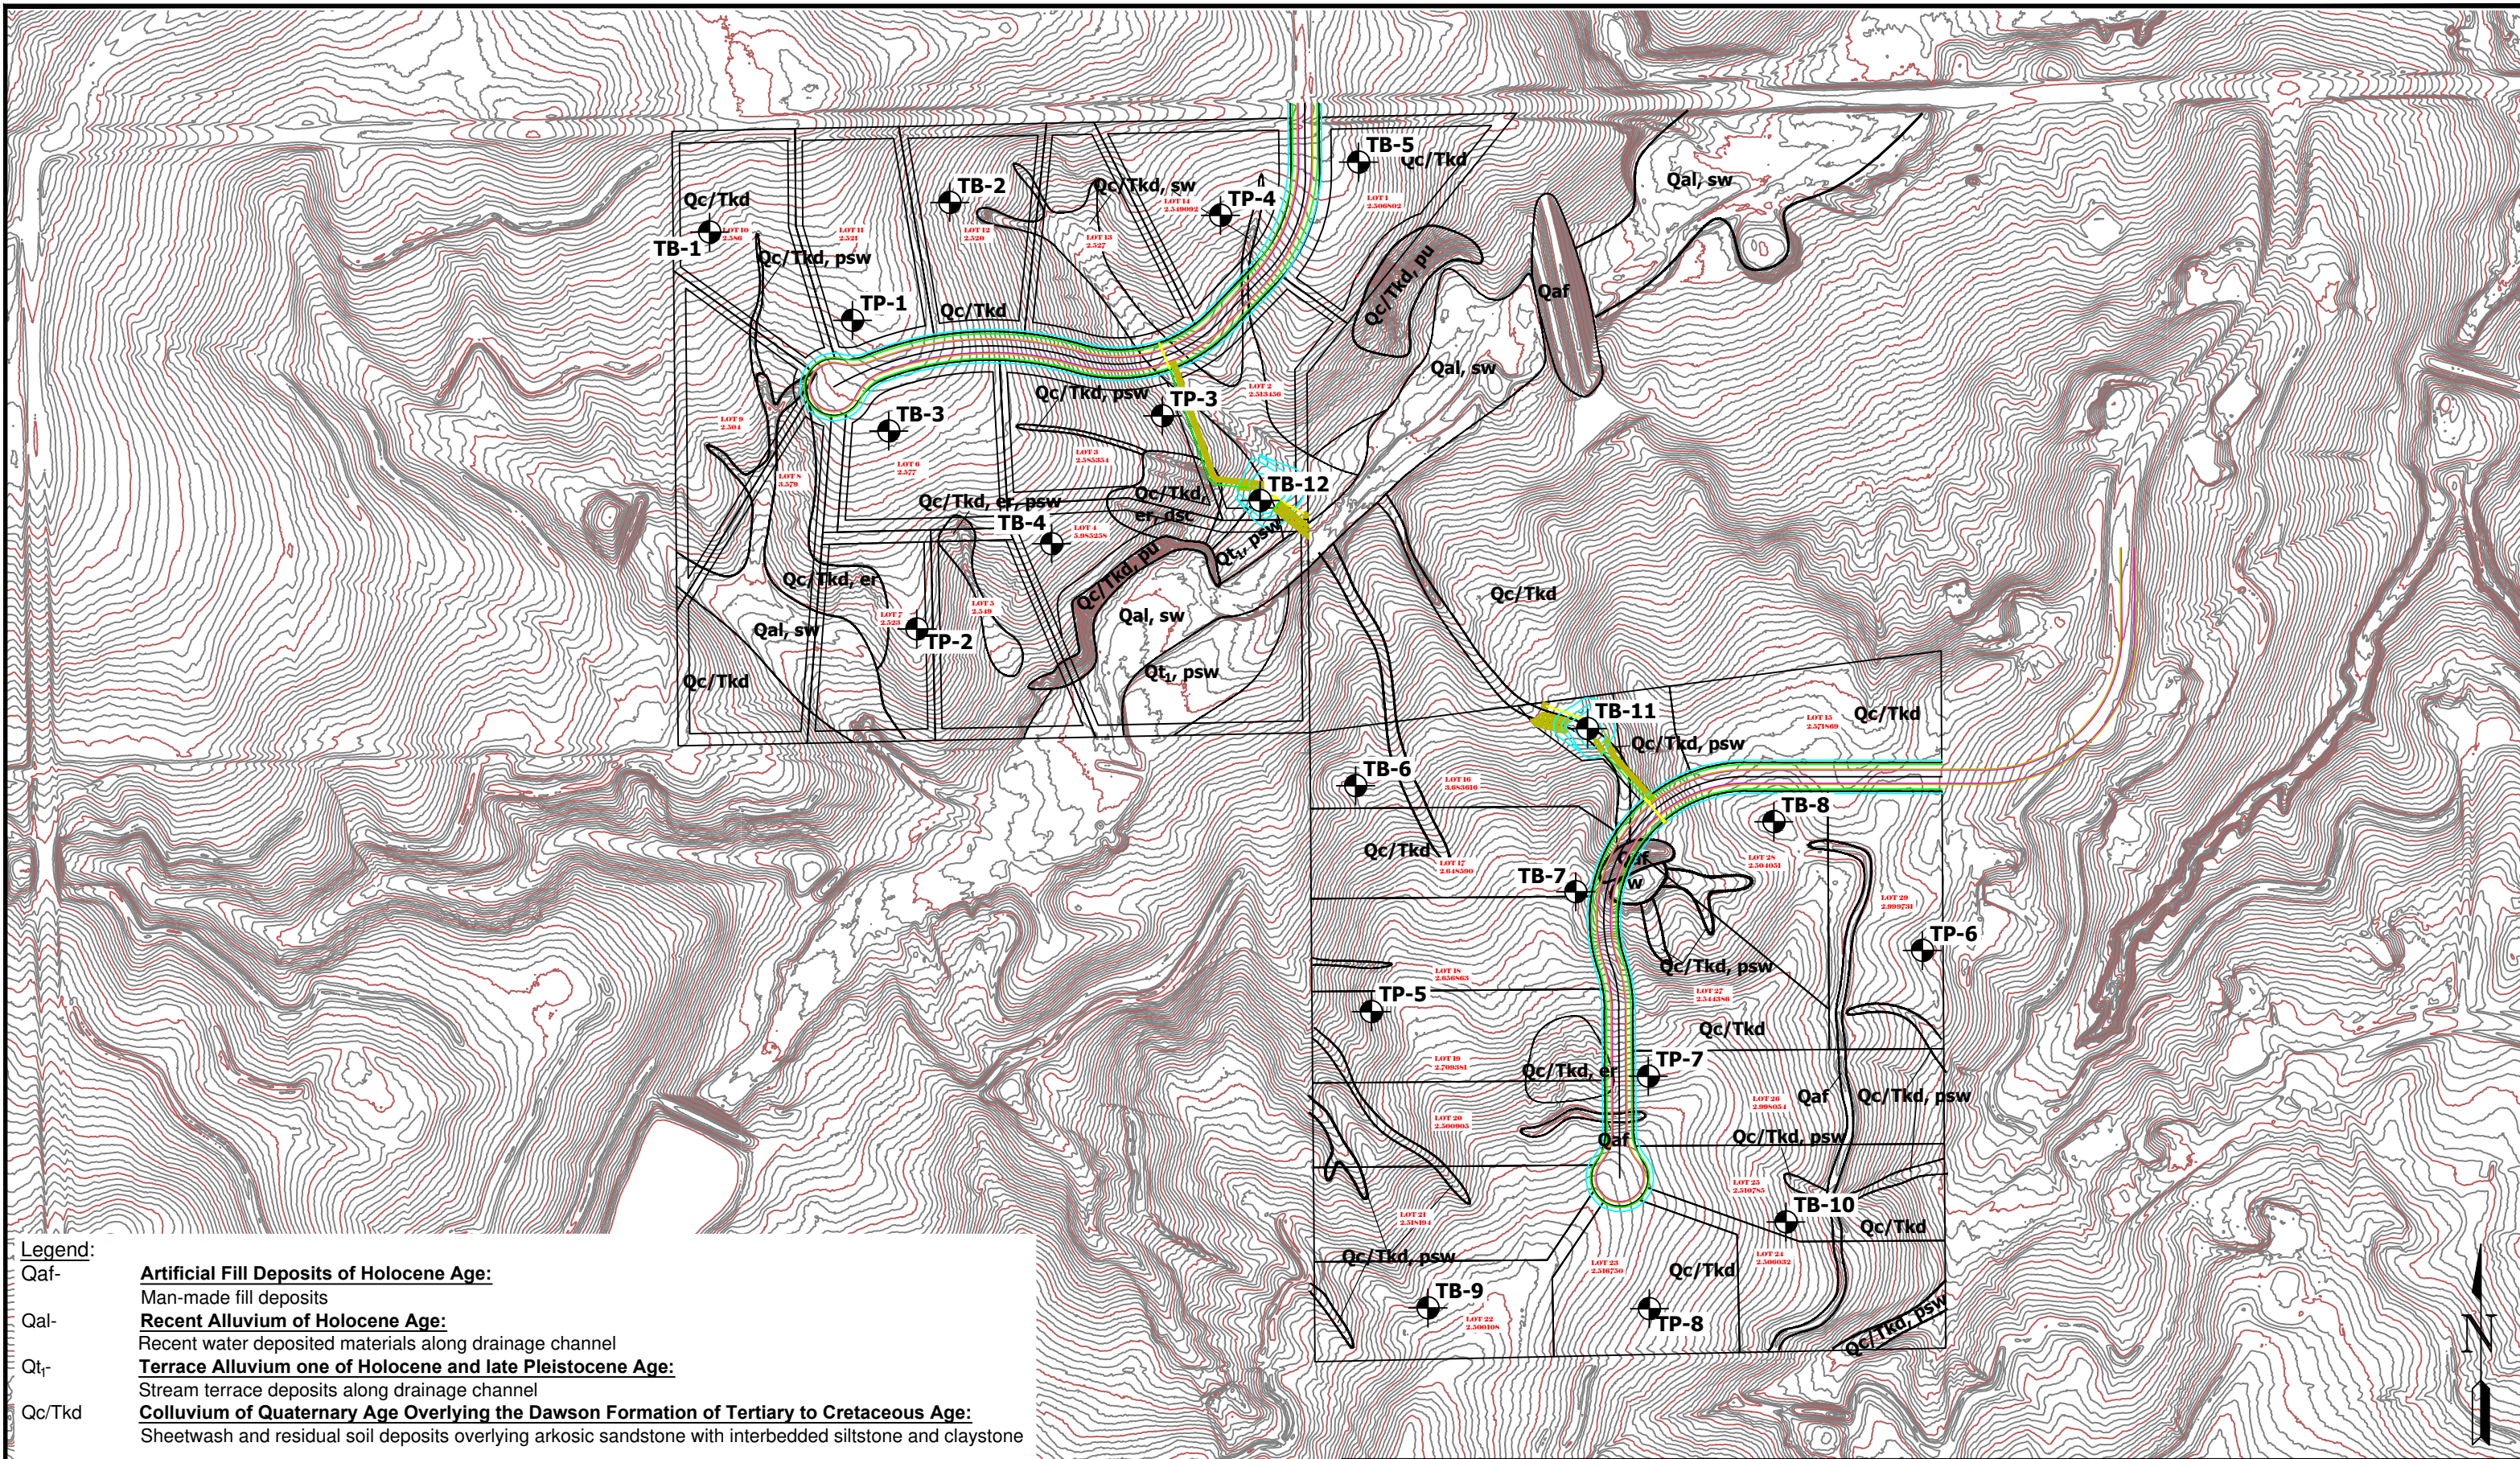
JOB NO.  
251117  
**FIG. 6**

Detailed mapping has been performed on this site to produce a Geology/Engineering Geology Map (Figure 6). This map shows the location of various geologic conditions the developers should monitor during the planning, design, and construction stages of the project. No significant geologic hazards were identified on the site; however, the following constraints have been identified on the site: artificial fill, potentially expansive soils, downslope creep, potentially unstable slopes, seasonal and potentially seasonal shallow groundwater areas, areas of ponded water, erosion, and the potential for elevated radon levels. These constraints and the recommended mitigation techniques include:

These are areas of man-made fill associated with earthen dams and erosion berms observed on the site.

The majority of the slopes on the site are gradually to moderately sloping and do not exhibit any past or potential unstable slopes or landslides. Potentially unstable slopes have been identified along portions of the drainage in the central portion of the site and are further discussed below. It is recommended that any future grading or fill slopes be 3:1 or flatter.

These majority of these slopes are considered stable in their present condition; however, care must be exercised in these areas not to create a condition which would tend to activate instability. An area of accelerated erosion was observed on the northeastern portion of the potentially unstable slope located on Lot 4. The steeper slopes along the drainage in the central portion of the site located on Lots 1 and 4. Additional investigation may be warranted once building locations are determined on the lots with this constraint, however, based on the size of the proposed lots it is anticipated development these areas can likely be avoided or mitigated.

Areas exist on-site that are affected by the potential for seasonally high groundwater conditions. In these areas, the potential exists for periodically high subsurface moisture conditions and possible frost heave potential, depending on the soil conditions. These areas include those areas mapped as sw-seasonal shallow groundwater on Figure 6 associated with the main drainage in the central portion of the site.

Mitigation: The earthen dams lie within defined drainages and should be avoided as building sites. The berms can either be avoided or penetrated by foundations. The fill on this site is considered uncontrolled for construction purposes. Any uncontrolled fill encountered beneath foundations will require removal and recompaction at a minimum of 95% of the Modified Proctor (ASTM D1557) maximum dry density.

Mitigation: It is anticipated the majority of these areas can be avoided. Building should be avoided on the potentially unstable slopes unless they are stabilized. A minimum setback of 30 feet from the crest of these slopes is recommended. Stabilization could involve regrading to slope angles no steeper than 3:1 or the use of engineer-designed retaining walls, tiebacks, or buttresses. Where retaining walls are not used, erosion protection may be necessary to prevent undercutting by the creek during periods of high water.

Mitigation: Foundations must have a minimum 30-inch depth for frost protection. Buildings should be a minimum of 3 feet above groundwater levels. Subsurface perimeter drains are recommended for any usable below grade areas including crawlspaces. Groundwater was not encountered in the test borings and is not anticipated to effect the construction of the proposed riding arena. Any grading in these areas should be done to direct surface flow around construction to avoid areas of ponded water. Structures should not block drainages. All organic material should be completely removed prior to any fill placement. Septic fields should not be placed in areas where there is the potential for shallow groundwater.

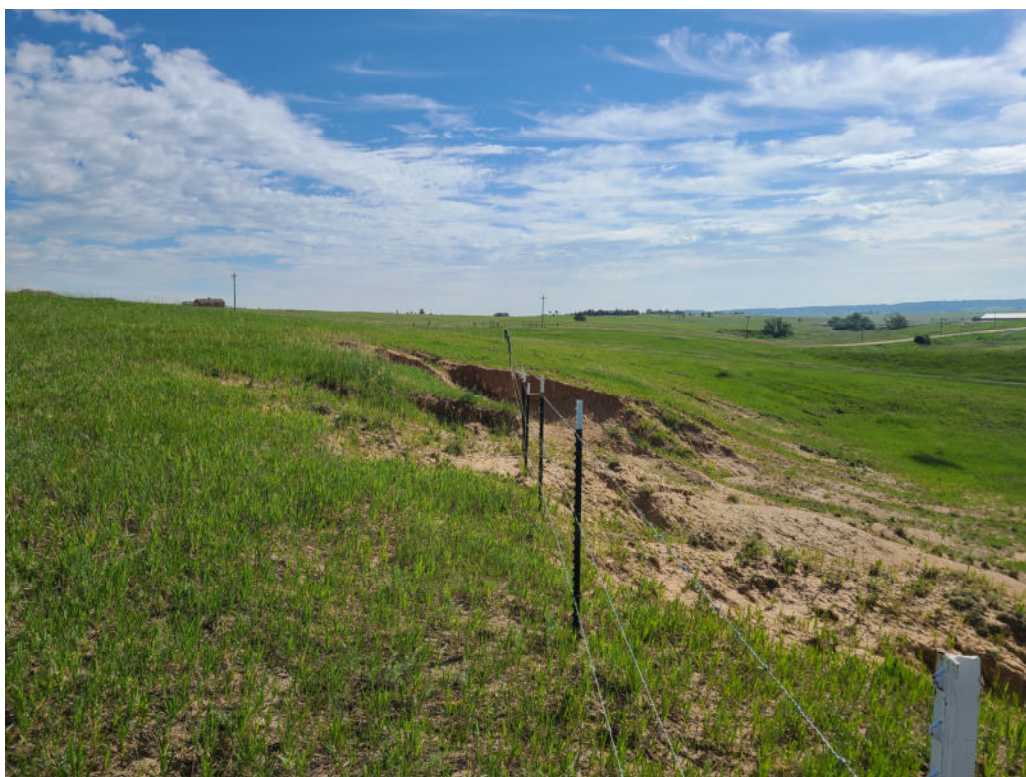
**Looking northeast  
along potentially  
unstable slope from  
Lot 1.**

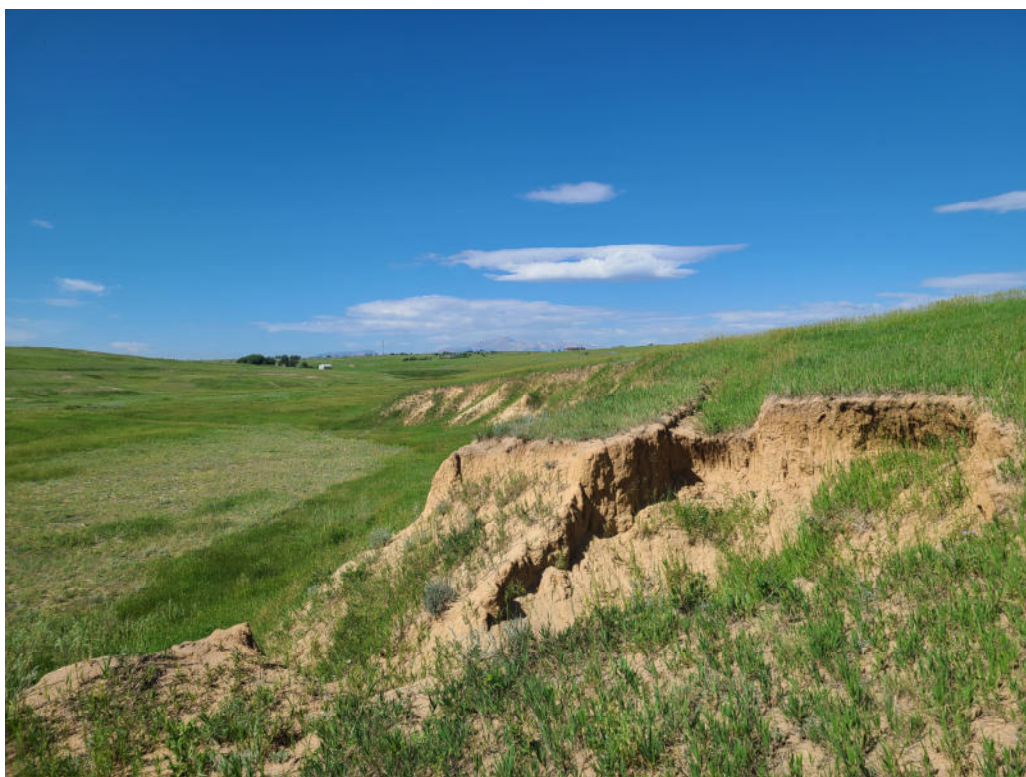
**Looking southwest  
along potentially  
unstable slope and  
drainage on proposed  
Lot 4.**

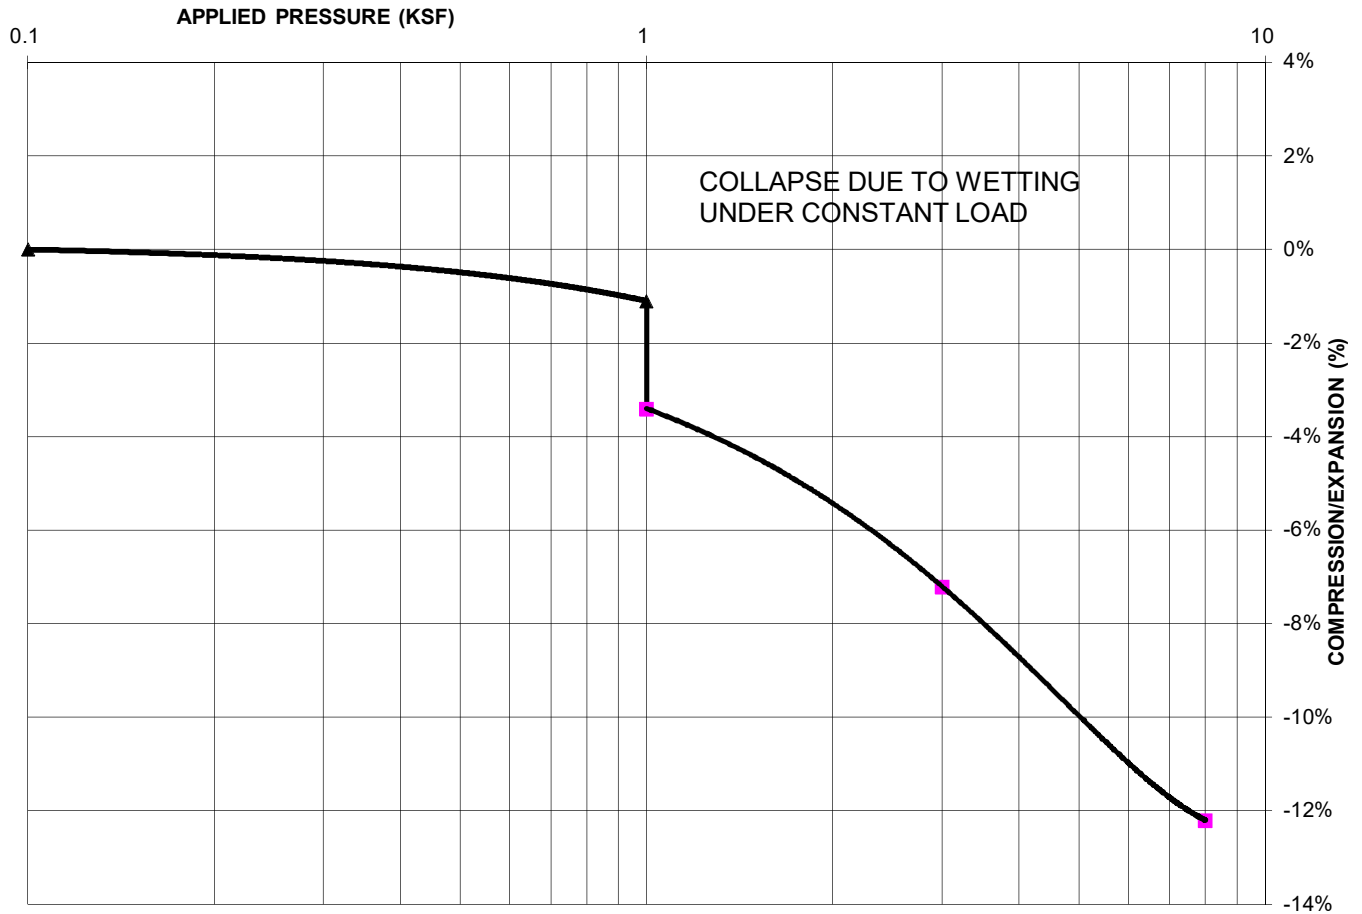
Soil Type 2 classified as a sandy silt and sandy clay (ML, CL). The silt and clay were encountered in all test borings at depths ranging from the existing surface to 8 feet bgs and extending to 3 to 12 feet bgs. The silt and clay were encountered at stiff to very stiff states and moist conditions. One dimensional swell/collapse testing on a samples of the silt and clay resulted in consolidations of 1.3 to 2.3% indicating moderate consolidation potentials.

NATURAL UNIT DRY WEIGHT (PCF): 100  
NATURAL MOISTURE CONTENT: 9.7%  
SWELL/COLLAPSE (%): -2.3%

Mitigation: Should loose collapsible soils be encountered beneath foundations, removal and recompaction of the upper 2 feet with thorough moisture conditioning at 95% of its maximum Standard Proctor Dry Density, ASTM D698 will be necessary. Specific recommendations should be made after additional investigation of each building site

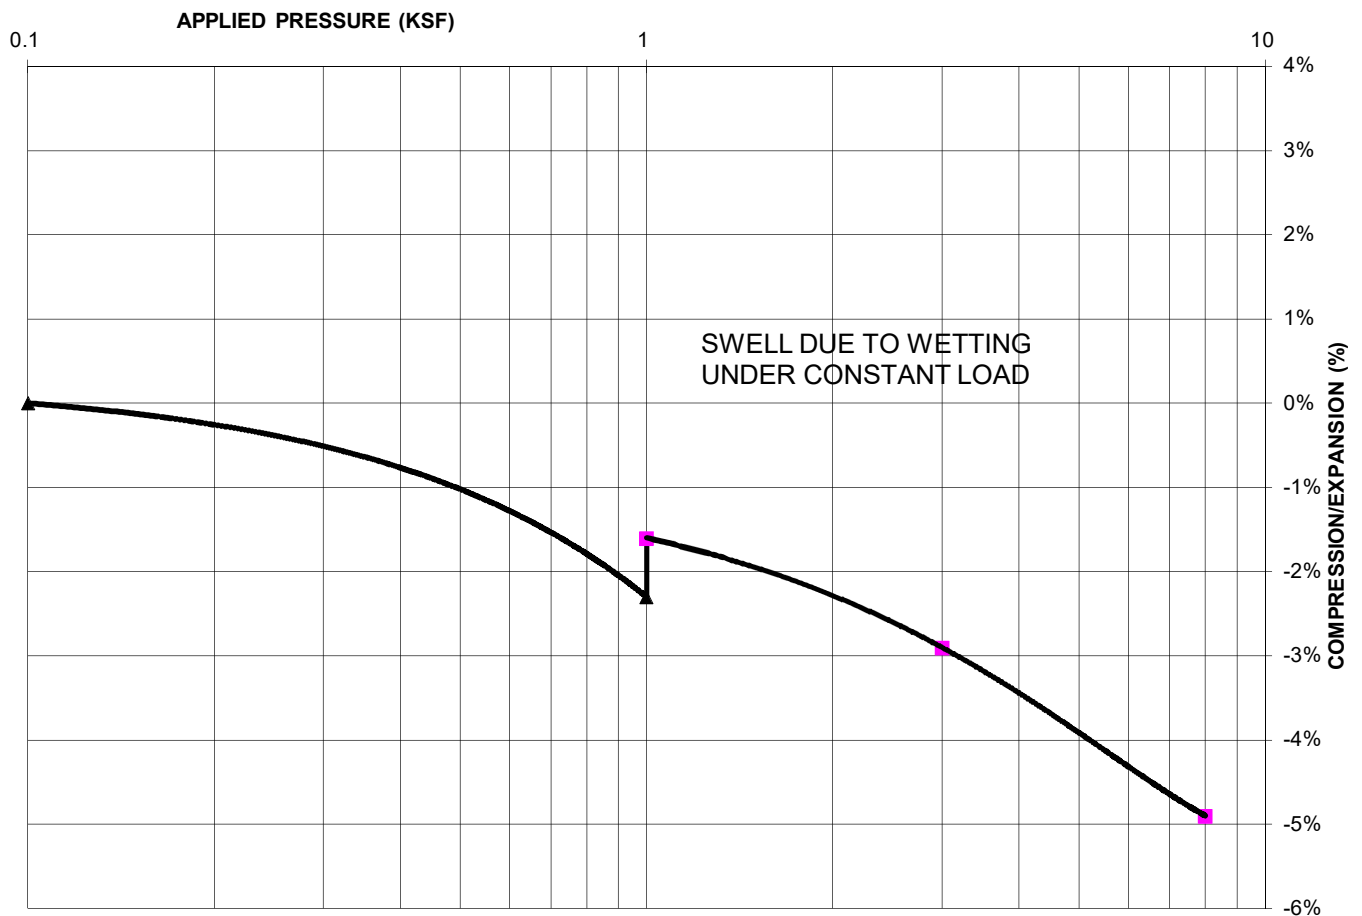
Soil Type 1 classified as a sand with varying amounts of silt and clay (SM, SC). The sand was encountered in all of the test borings at depths ranging from the existing surface to 3 feet bgs and extending to 3 to 18 feet bgs and to the termination of TB-3, TB-6, TB-7, and TB-12. The sand was encountered at loose to dense states and dry to moist conditions. The majority of the sand was encountered at medium dense states. One dimensional swell/collapse testing on a sample of the clayey sand resulted in an expansion of 0.7% indicating a low expansion potential.

NATURAL UNIT DRY WEIGHT (PCF): 116  
NATURAL MOISTURE CONTENT: 16.3%  
SWELL/COLLAPSE (%): 0.7%

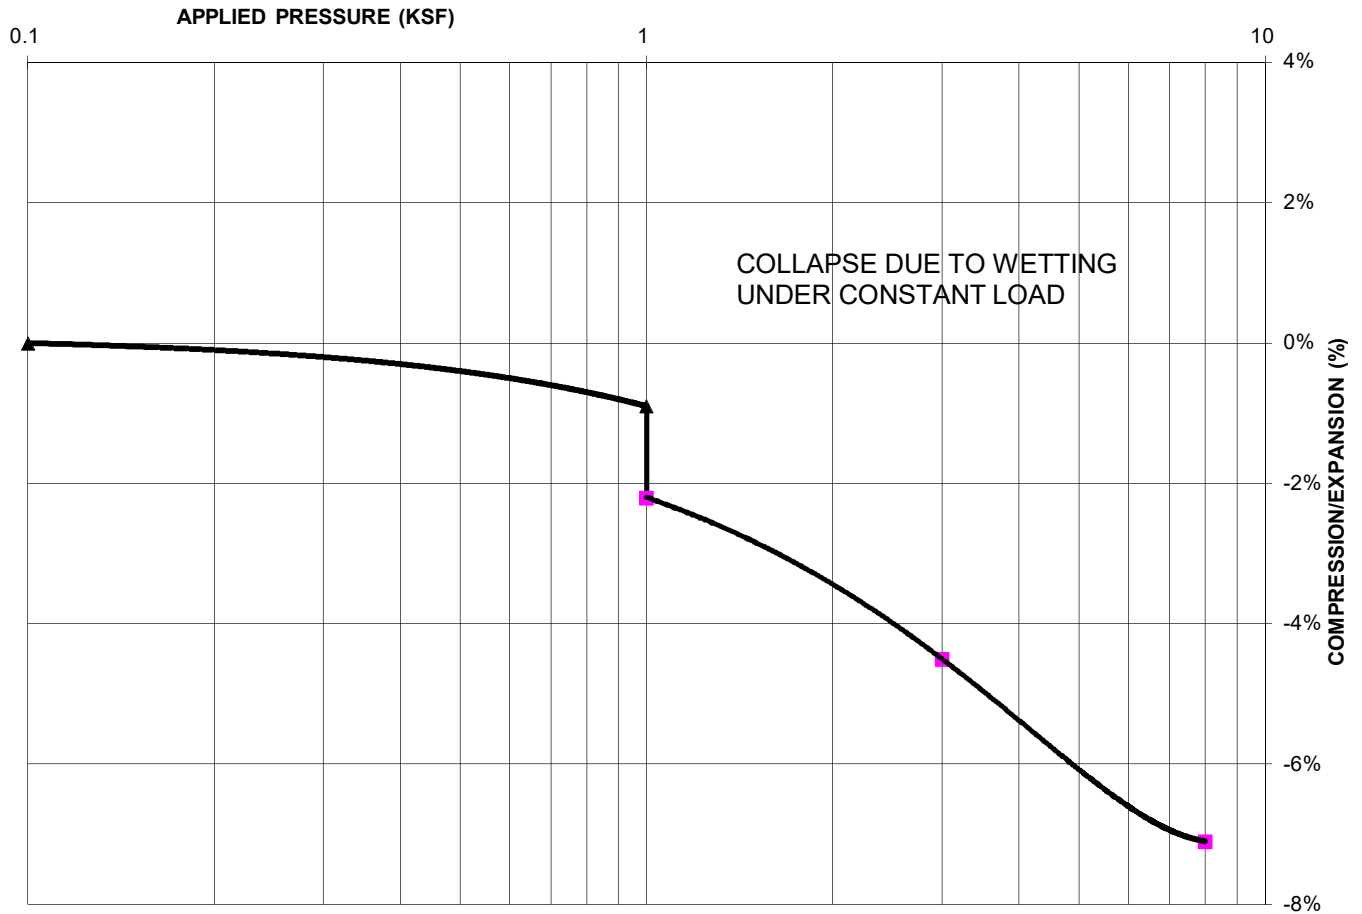
NATURAL UNIT DRY WEIGHT (PCF): 102  
NATURAL MOISTURE CONTENT: 9.1%  
SWELL/COLLAPSE (%): -1.3%
