ENTECH ENGINEERING, INC.

May 29, 2020

Re: Soil, Geology and Geologic Hazard Evaluation

Judge Orr Eastonville Commercial Center Lot 1177, Woodmen Hills Filing No. 10 Judge Orr Road and Eastonville Road

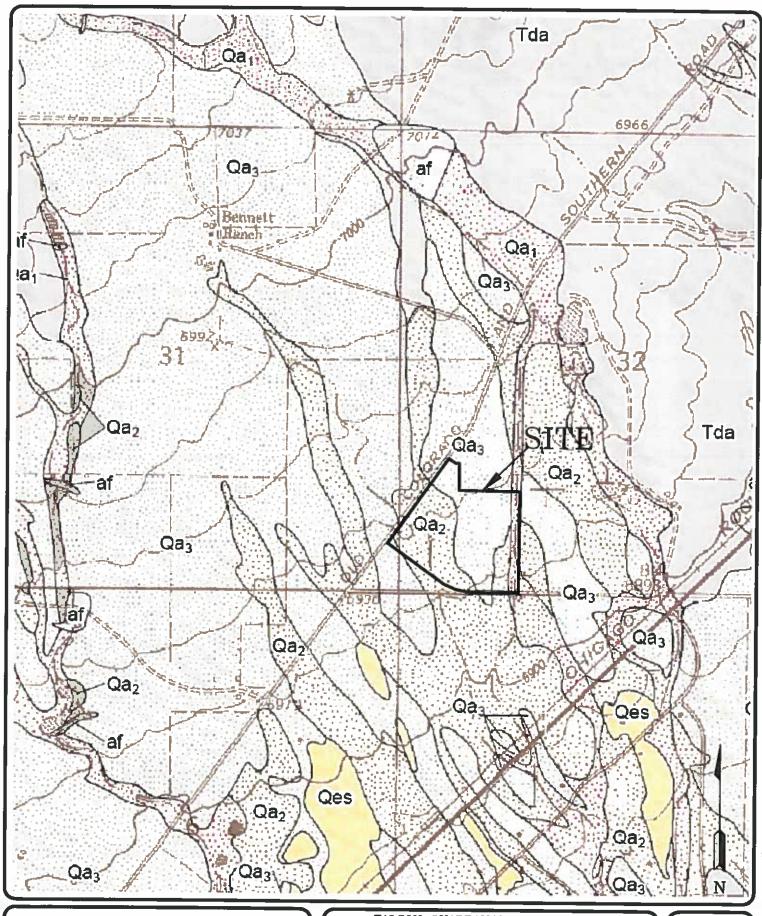
FALCON QUADRANGLE GEOLOGY MAP
JUDGE ORR EASTONVILLE COMMERCIAL CENTER
EASTONVILL ROAD AND JUDGE ORR ROAD
EL PASO COUNTY, CO.
FOR: PHILLIP BUFORD

The geology of the site was evaluated using the *Geologic Map of the Falcon Quadrangle*, by Madole and Thorson in 2003, (Reference 4, Figure 5). The Geology for the site is presented in Figure 6. Four mappable units were identified on this site which, are described as follows:

- **Qaf Artificial Fill of Late Holocene Age:** These are man-made fill deposits associated with fill piles and erosion berms observed across the site. Areas of fill other than those mapped may be encountered.

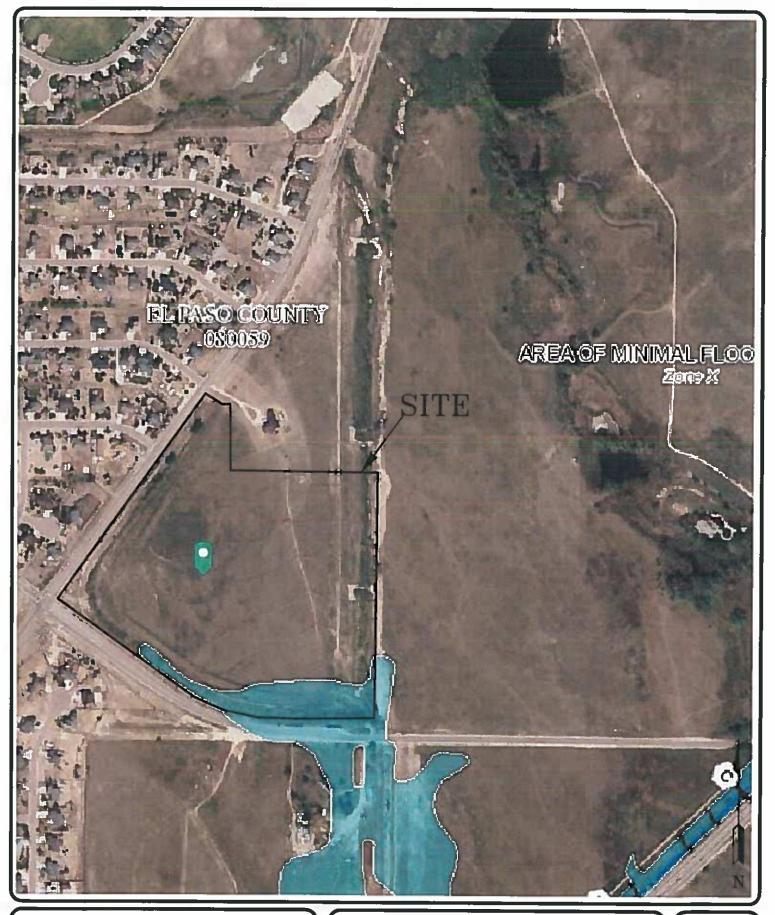
FEMA FLOODPLAIN MAP
JUDGE ORR EASTONVILLE COMMERCIAL CENTER
EASTONVILL ROAD AND JUDGE ORR ROAD
EL PASO COUNTY, CO.
FOR: PHILLIP BUFORD

The southeastern portion of the site lies within a floodplain according to the FIRM Map, No. 08041CO554G (Reference 6, Figure 7). The proposed development is located at a higher elevation and away from the floodplain. Finished floors must be a minimum of one foot above the floodplain level. Any site grading considered should be modified to direct surface flows around the structures or roads, or carried off-site so as to not produce any areas of ponded water. Additionally, subsurface perimeter drains may be required. Specific drainage studies and exact floodplain locations are beyond the scope of this report.

Groundwater was encountered in all of the test borings at depths ranging from 8.5 to 13.5 feet (Appendix B). Areas where shallow groundwater was encountered should not affect the construction of shallow foundations anticipated for this site. Groundwater may affect deeper excavations for utilities. Unstable conditions should be expected where excavations approach the groundwater level. Stabilization using shot rock or geo grids may be necessary. According to the FEMA FIRM Map No. 08041CO0554G (Reference 6, Figure 7) the eastern and southern portions of the site are located in a floodplain. Additionally, drainage ditches exist along the southern and western portions of the site where seasonal shallow groundwater has been mapped. The proposed development is located at a higher elevation and away from the floodplain and drainage ditches. Subsurface perimeter drains may be necessary for areas below grade adjacent to the drainages. It is anticipated proposed commercial development will use slab-on-grade construction. Finished floors must be a minimum of one foot above the floodplain level. Specific drainage studies and exact floodplain locations are beyond the scope of this report.

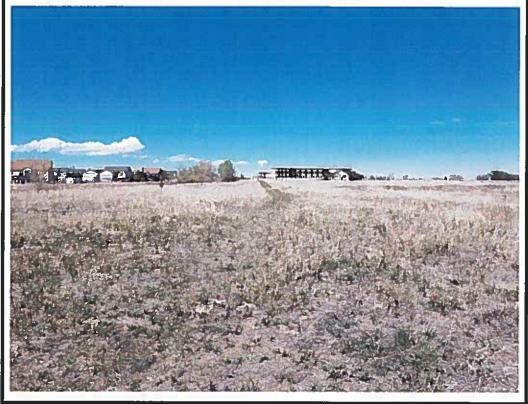
Looking northeast from the southwest corner of the site.

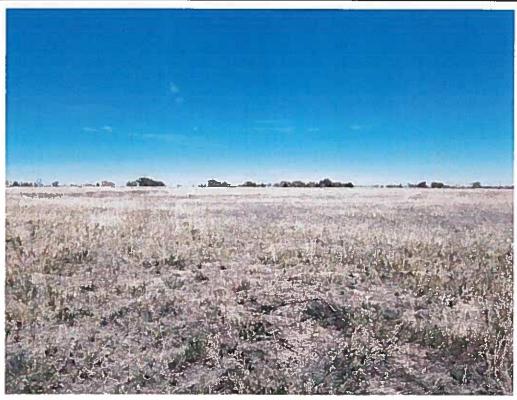
Looking east from the southwestern portion of the site.

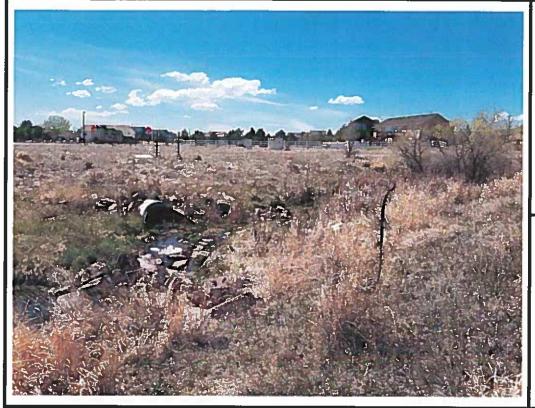
Looking west towards drainage culvert in the southwest corner of the site.

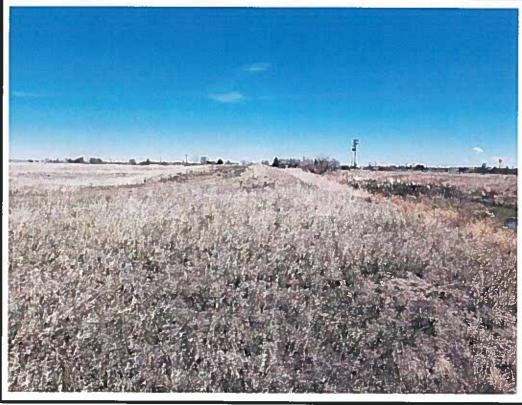
Looking east along drainage in the southwestern portion of the site.

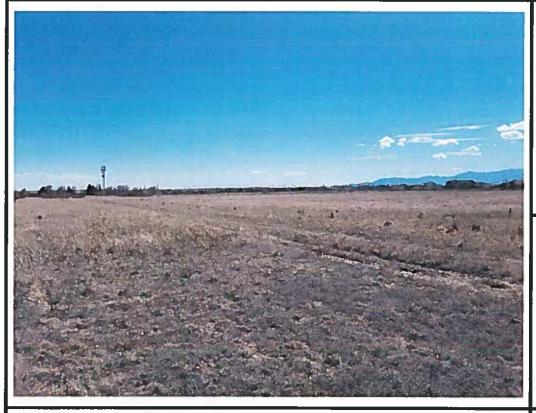
Looking southwest from the northeastern portion of the site.

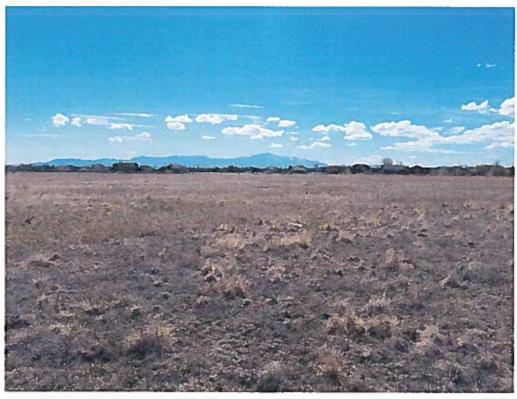
Looking west from the northeastern portion of the site.

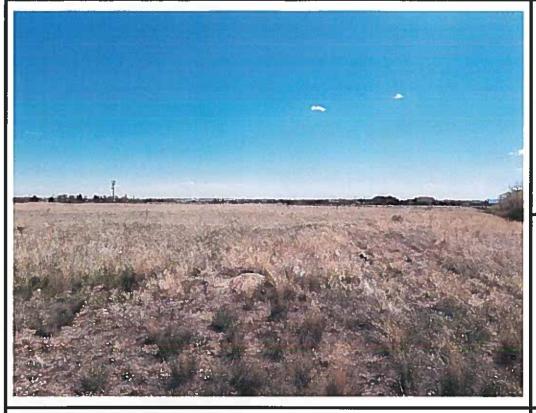
Looking south from the northern portion of the site.

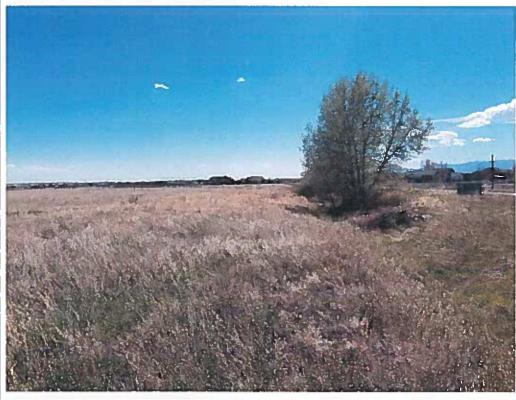
Looking southwest from the northern portion of the site.
