**SOILS AND GEOLOGY STUDY
STERLING RANCH EAST – FILING NO. 3
EL PASO COUNTY, COLORADO**

Prepared for:
Classic SRJ
2138 Flying Horse Club Drive
Colorado Springs, CO 80921

October 15, 2024

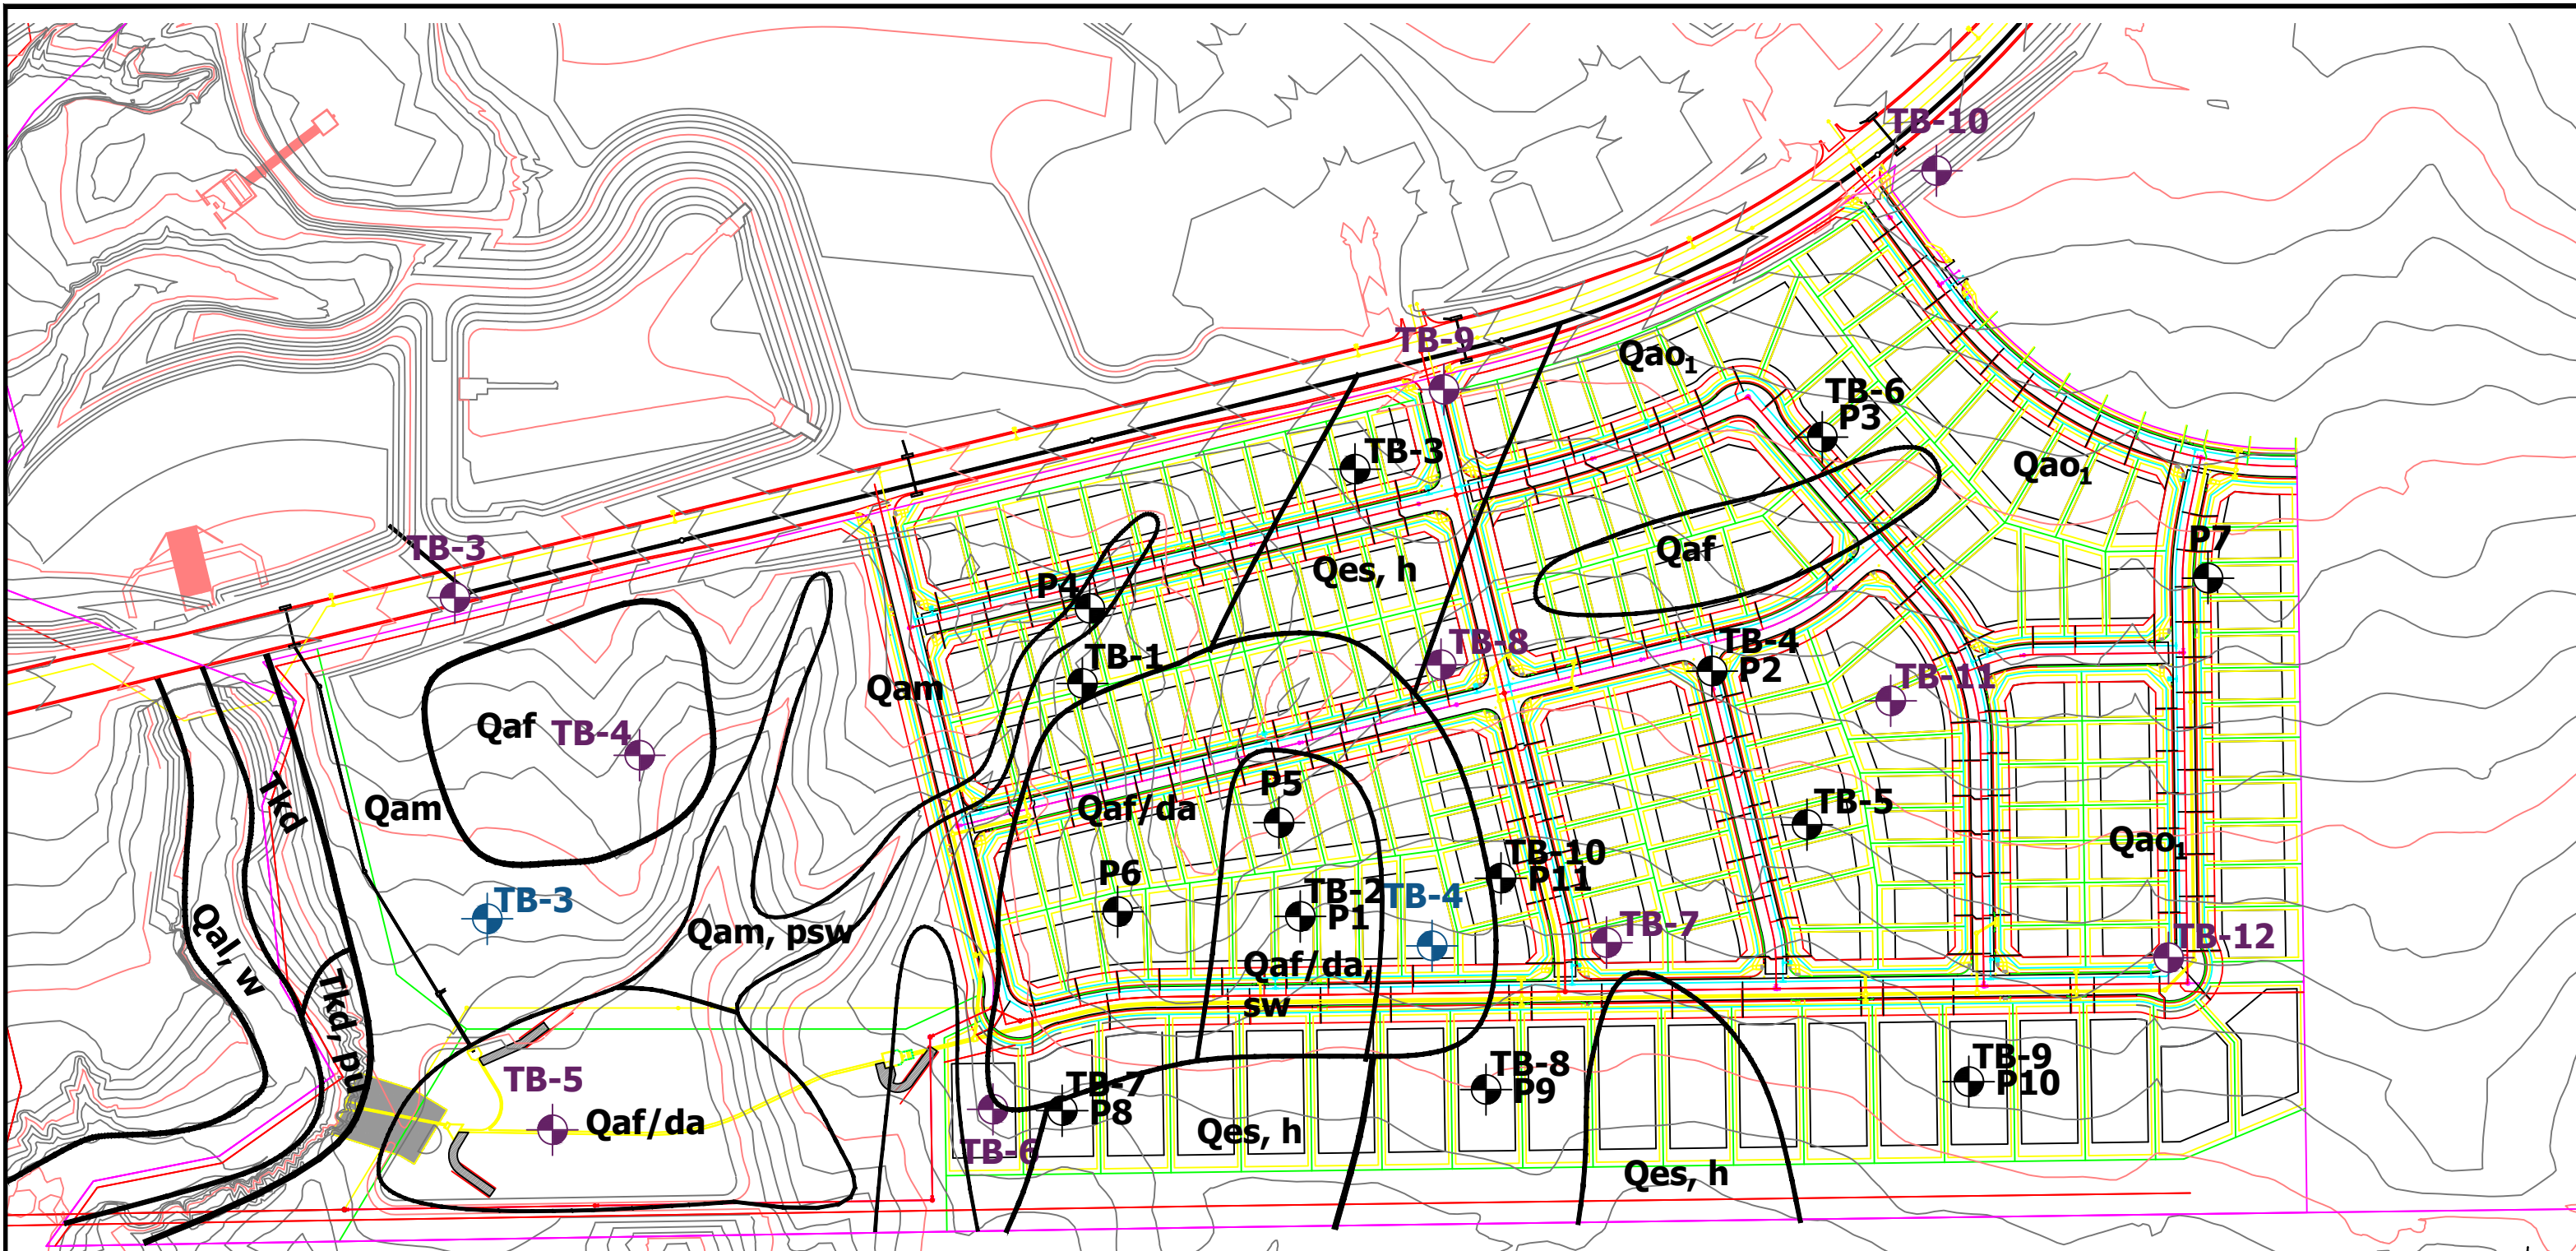
GEOLOGY / ENGINEERING MAP
 STERLING RANCH EAST FIL. NO. 3
 CLASSIC SRJ

Detailed mapping has been performed on this site to produce an Engineering Geology Map Figure 7. This map shows the location of various geologic conditions of which the developers should be cognizant during the planning, design and construction stages of the project. These hazards and the recommended mitigation techniques are as follows:

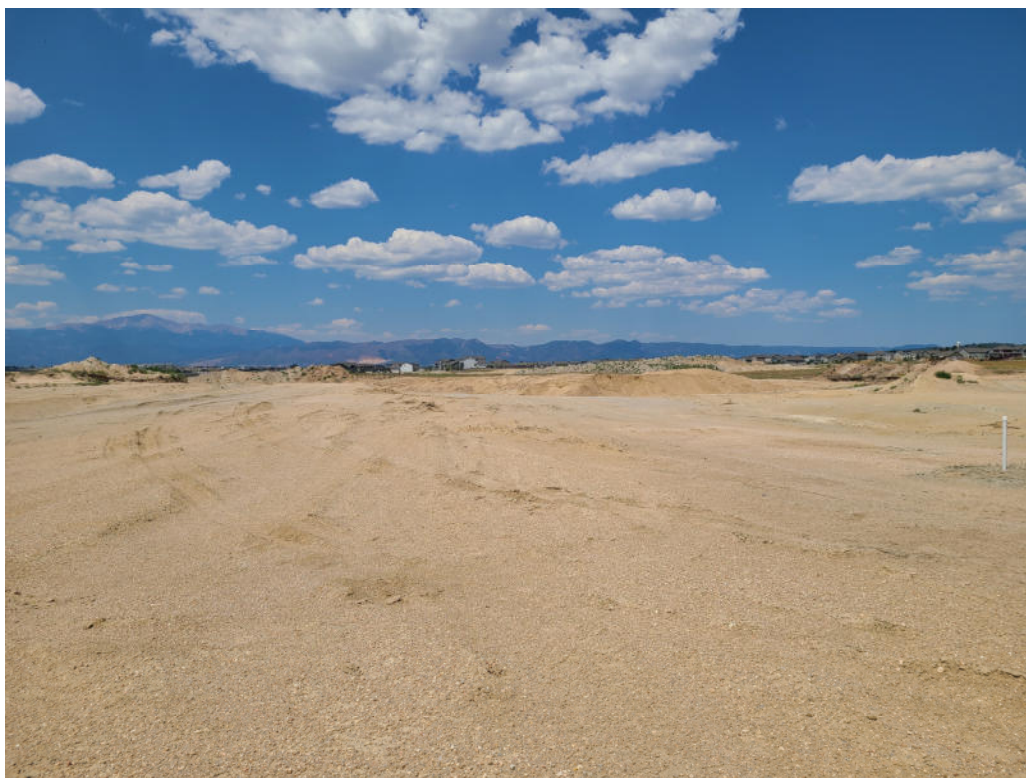
**Looking west from the
central portion of the
site Piezometer No. 1
right side of frame.**
