**SOIL, GEOLOGY, GEOLOGIC HAZARD,  
AND WASTEWATER STUDY,  
HODGEN ROAD SUBDIVISION  
PARCEL NO. 51990-01-009  
NORTHWEST OF HODGEN ROAD  
AND BLACK FOREST ROAD  
EL PASO COUNTY, COLORADO**

**Savage Development, Inc.**  
8605 Explorer Drive  
Colorado Springs, Colorado 80920

April 20, 2018  
Revised February 1, 2019

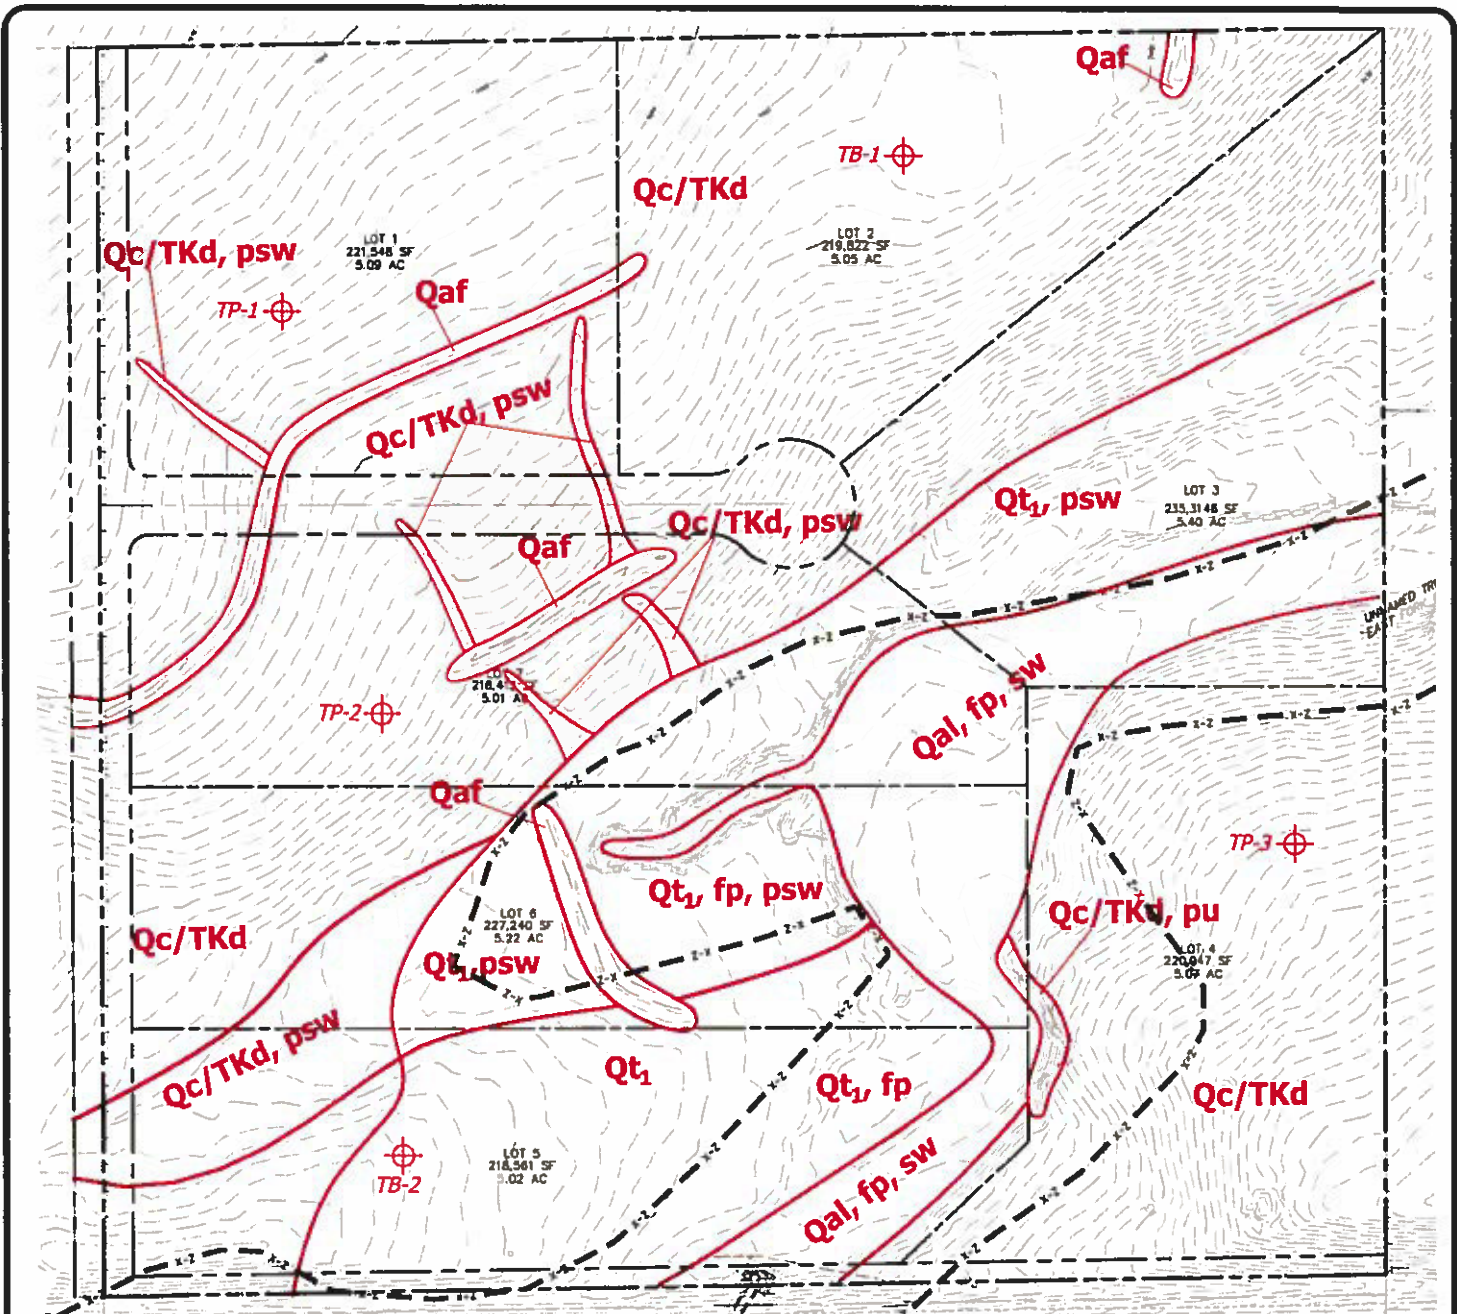
FIG NO.:  
**6**

As mentioned previously, detailed mapping has been performed on this site to produce an Geology/Engineering Geology Map (Figure 6). This map shows the location of various geologic conditions of which the developers should be cognizant during the planning, design and construction stages of the project. These hazards and the recommended mitigation techniques are as follows:

The majority of the slopes in the building areas on site are gently to moderately sloping and do not exhibit any past or potential unstable slopes or landslides. However, the steeply sloping areas along the drainage in the southeastern portion of the site have been identified as potentially unstable slopes. These areas are identified on the Geology/Engineering Geology Map, Figure 6. The recommendations for these areas are as follows:

The area identified with this hazard is located along the southeastern side of the drainage where a cut bank of the tributary has created an unstable slope. The slope is located in portions of Lots 4, 5, and 6. These slopes are considered stable in their present condition; however, considerable care must be exercised in these areas not to create a condition which would tend to activate instability.

Mitigation: Building should be avoided in these areas. The lot most significantly affected by potentially unstable slope is Lot 4. The structure on this lot should be set back a minimum of 40 feet from the crest of this slope. There is sufficient room on the lot to avoid this hazard. Proper control of drainage at both the surface above the slope and the subsurface is extremely important. Areas of ponded water at the surface should be avoided. Utility trenches, basement excavations and other subsurface features should not be permitted to become water traps which may promote saturation of the subsurface materials. Drainage should not be permitted over the potentially unstable slope but directed in a non-erosive manner away from the slope. Irrigation above these slopes should be kept to a minimum to prevent saturation of the subsurface soils. The use of xeriscope landscaping utilizing native plantings is recommended to reduce the need for irrigation.

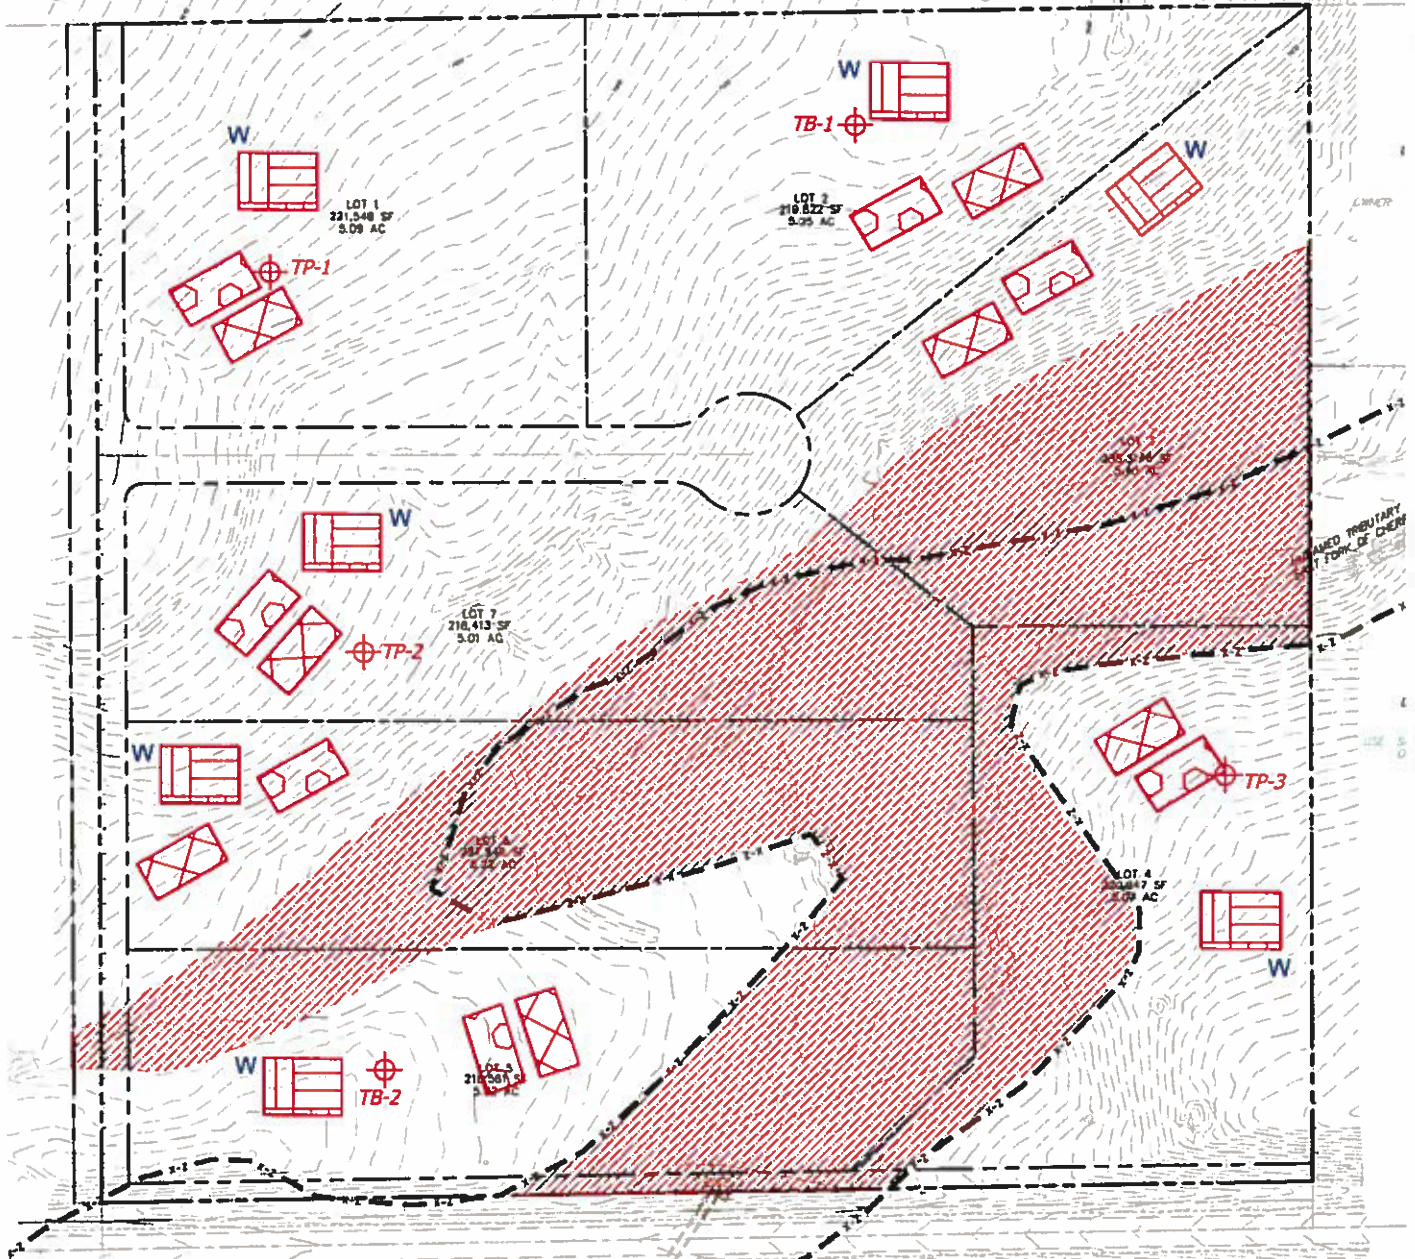
FIG NO.:  
9

Soils encountered in the tactile test pits consisted of loamy sand, sandy clay loam and sandy clay. Bedrock was not encountered in the test pits which were excavated to 8 feet. The limiting layers encountered in the test pits are the sandy loam (Soil Type 2), and sandy clay (Soil Type 4) which corresponds to LTAR values of 0.60 to 0.20 gallons per day per square foot. The conditions encountered in the Test Pit Nos. 1 and 2 will require a designed system. Additional investigation may identify areas where suitable for conventional systems could be used.

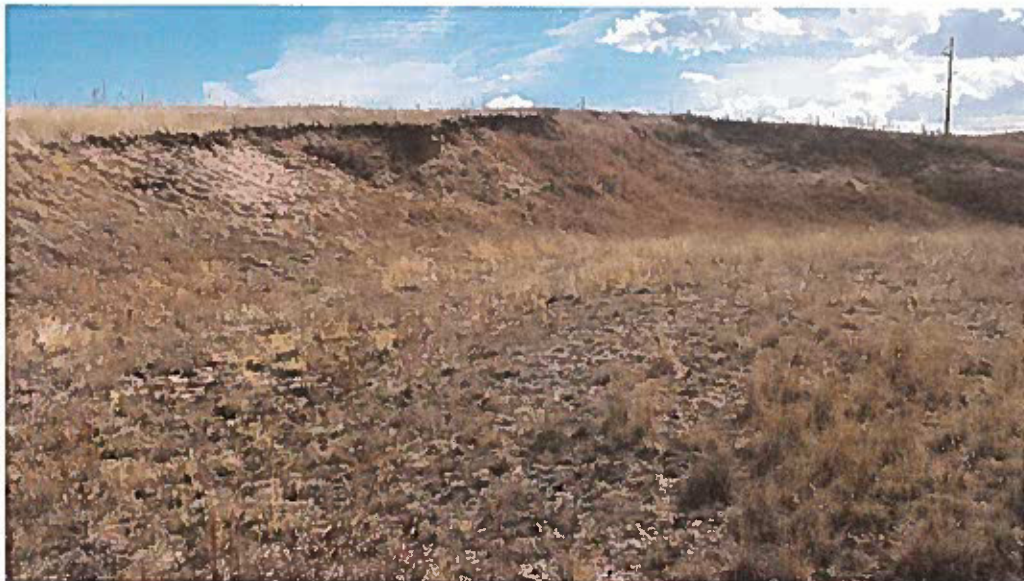
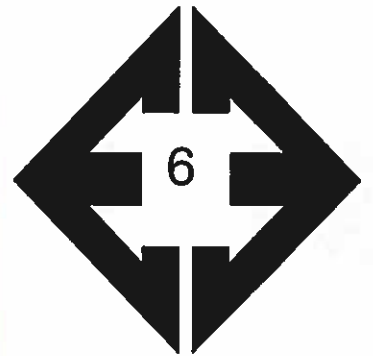
**Looking southeast  
towards the potentially  
unstable slope on Lot  
4.**

A potentially unstable slope exists in the southeastern portion of the site where the stream has eroded a cut bank. This mostly affects Lot 4. A 40-foot building setback from the crest of the slope is recommended. Septic fields should not be located within the building setback as well. It appears there is sufficient room on the lot to avoid the potentially unstable slope.

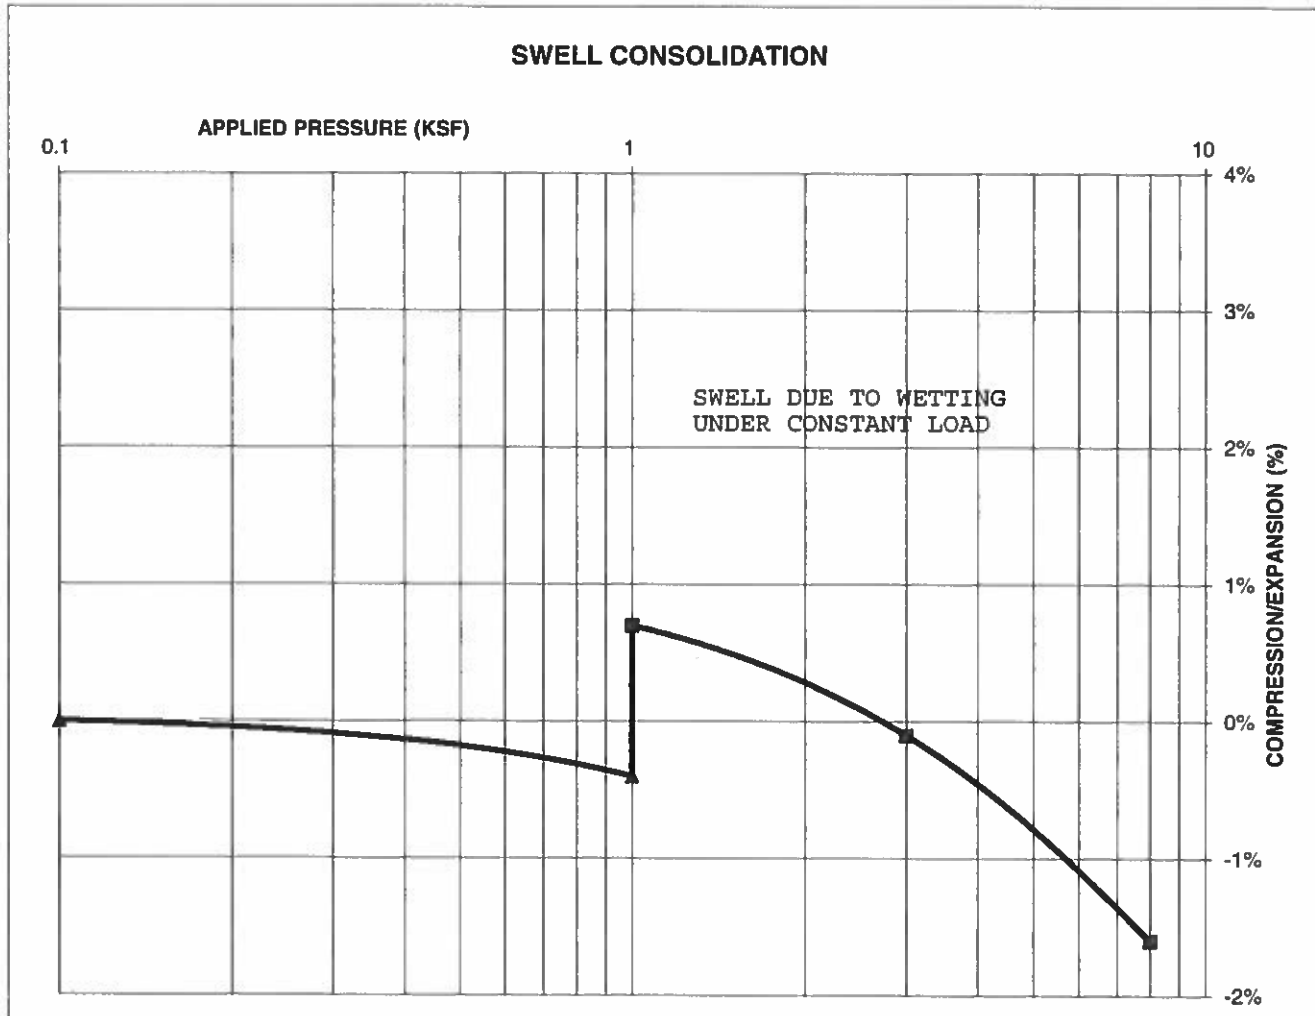
Soil Type 2 is a sandy clay (CL). This material was encountered in Test Boring No. 1 and in Test Pit Nos. 1 and 2. The clays were encountered at the existing surface grade and extended to depths up to 10 feet bgs. The clays were encountered at firm to stiff consistencies and moist conditions. Samples tested had 51 to 83 percent of the soil sized particles passing the No. 200 sieve. FHA Swell Testing on a sample of clayey sand resulted in an expansion pressure of 540 psf. Swell/Consolidation Testing resulted in a volume change of 1.1 percent. These test results indicated the clay exhibits a low to moderate expansion potential.

SAMPLE FROM:	1	DEPTH(ft)	10
DESCRIPTION	CL	SOIL TYPE	2
NATURAL UNIT DRY WEIGHT (PCF)			115
NATURAL MOISTURE CONTENT			10.8%
SWELL/CONSOLIDATION (%)			1.1%

Mitigation: Should expansive soils be encountered beneath the foundation, mitigation will be necessary. Mitigation of expansive soils will require special foundation design. Overexcavation and replacement with non-expansive soils at a minimum of 95% of its maximum Modified Proctor Dry Density, ASTM D-1557 is a suitable mitigation, which is common in the area. Another alternative in areas of highly expansive soils is the use of drilled pier foundation systems. Typical minimum pier depths are on the order of 20 feet or more and require penetration into the bedrock material a minimum of 4 to 6 feet, depending upon building loads. Floor slabs on expansive soils should be expected to experience movement. Overexcavation and replacement has been successful in minimizing slab movements. The use of structural floors should be considered for
