ENTECH
ENGINEERING, INC.

**SOILS AND GEOLOGY STUDY
FLYING HORSE NORTH, FILING NO. 5
EL PASO COUNTY, COLORADO**

Flying Horse North, LLC
2138 Flying Horse Club Drive
Colorado Springs, Colorado 80921

October 2, 2024

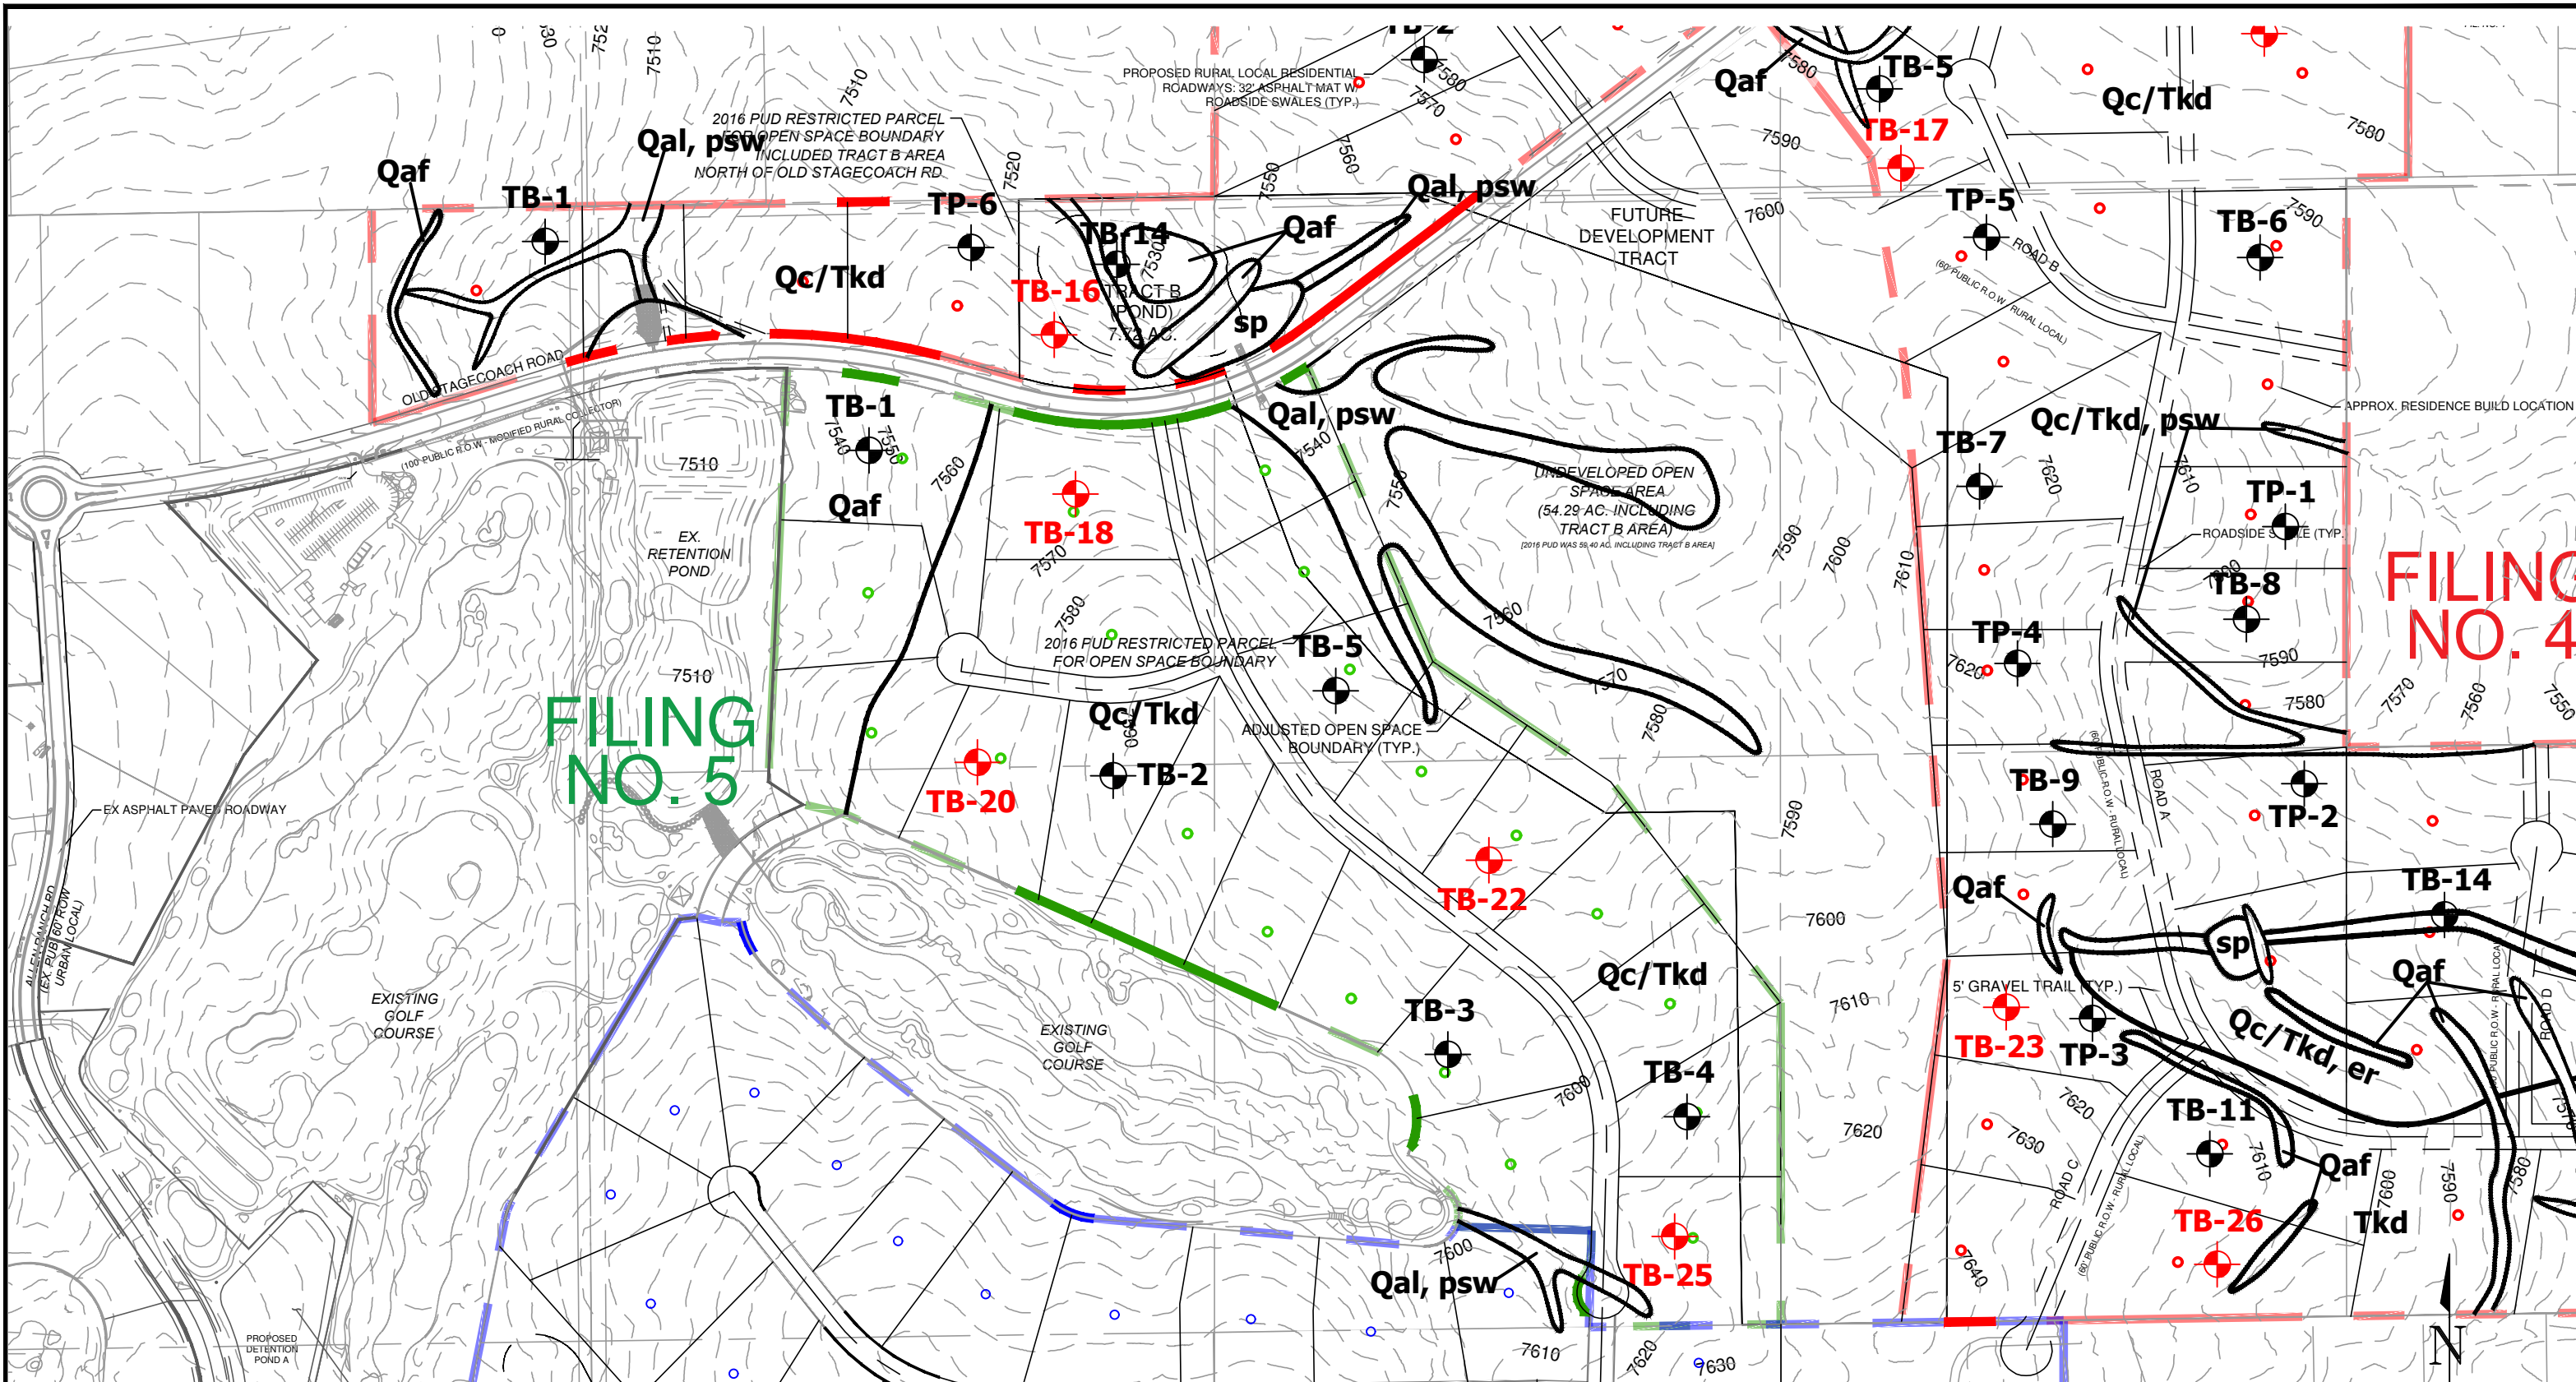
<p>GEOLOGY / ENGINEERING MAP</p> <p>FLYING HORSE NORTH, FILING NO. 5 FLYING HORSE NORTH, LLC</p>	<p>JOB NO. 241421</p> <p>FIG. 6</p>
---	---	--

Detailed mapping has been performed on this site to produce an Engineering Geology Map Figure 6. This map shows the location of various geologic conditions of which the developers should be cognizant during the planning, design and construction stages of the project. These hazards and the recommended mitigation techniques are as follows:

Groundwater was not encountered in any of the test borings within Filing No. 5 which were drilled to 20 feet. Areas of potential seasonally shallow groundwater were observed on the site and are further discussed below. Buildings should maintain a minimum separation of 3 feet between the lowest foundation grade and the maximum anticipated groundwater level. Subsurface perimeter drains are recommended for structures with useable below grade space, and additional drains may be required in building areas close drainages to help prevent the intrusion of water into areas below grade. Shallow groundwater areas can be mitigated with the installation of drains. Typical drain options/details are presented in Figures 8 through 11. These areas are discussed as follows:
