**SOIL, GEOLOGY, & GEOLOGIC HAZARD STUDY
RETREAT AT TIMBERRIDGE, FILING 3
VOLLMER ROAD AND ARROYA LANE
EL PASO COUNTY, COLORADO**

June 10, 2022

Entech Job No. 221106

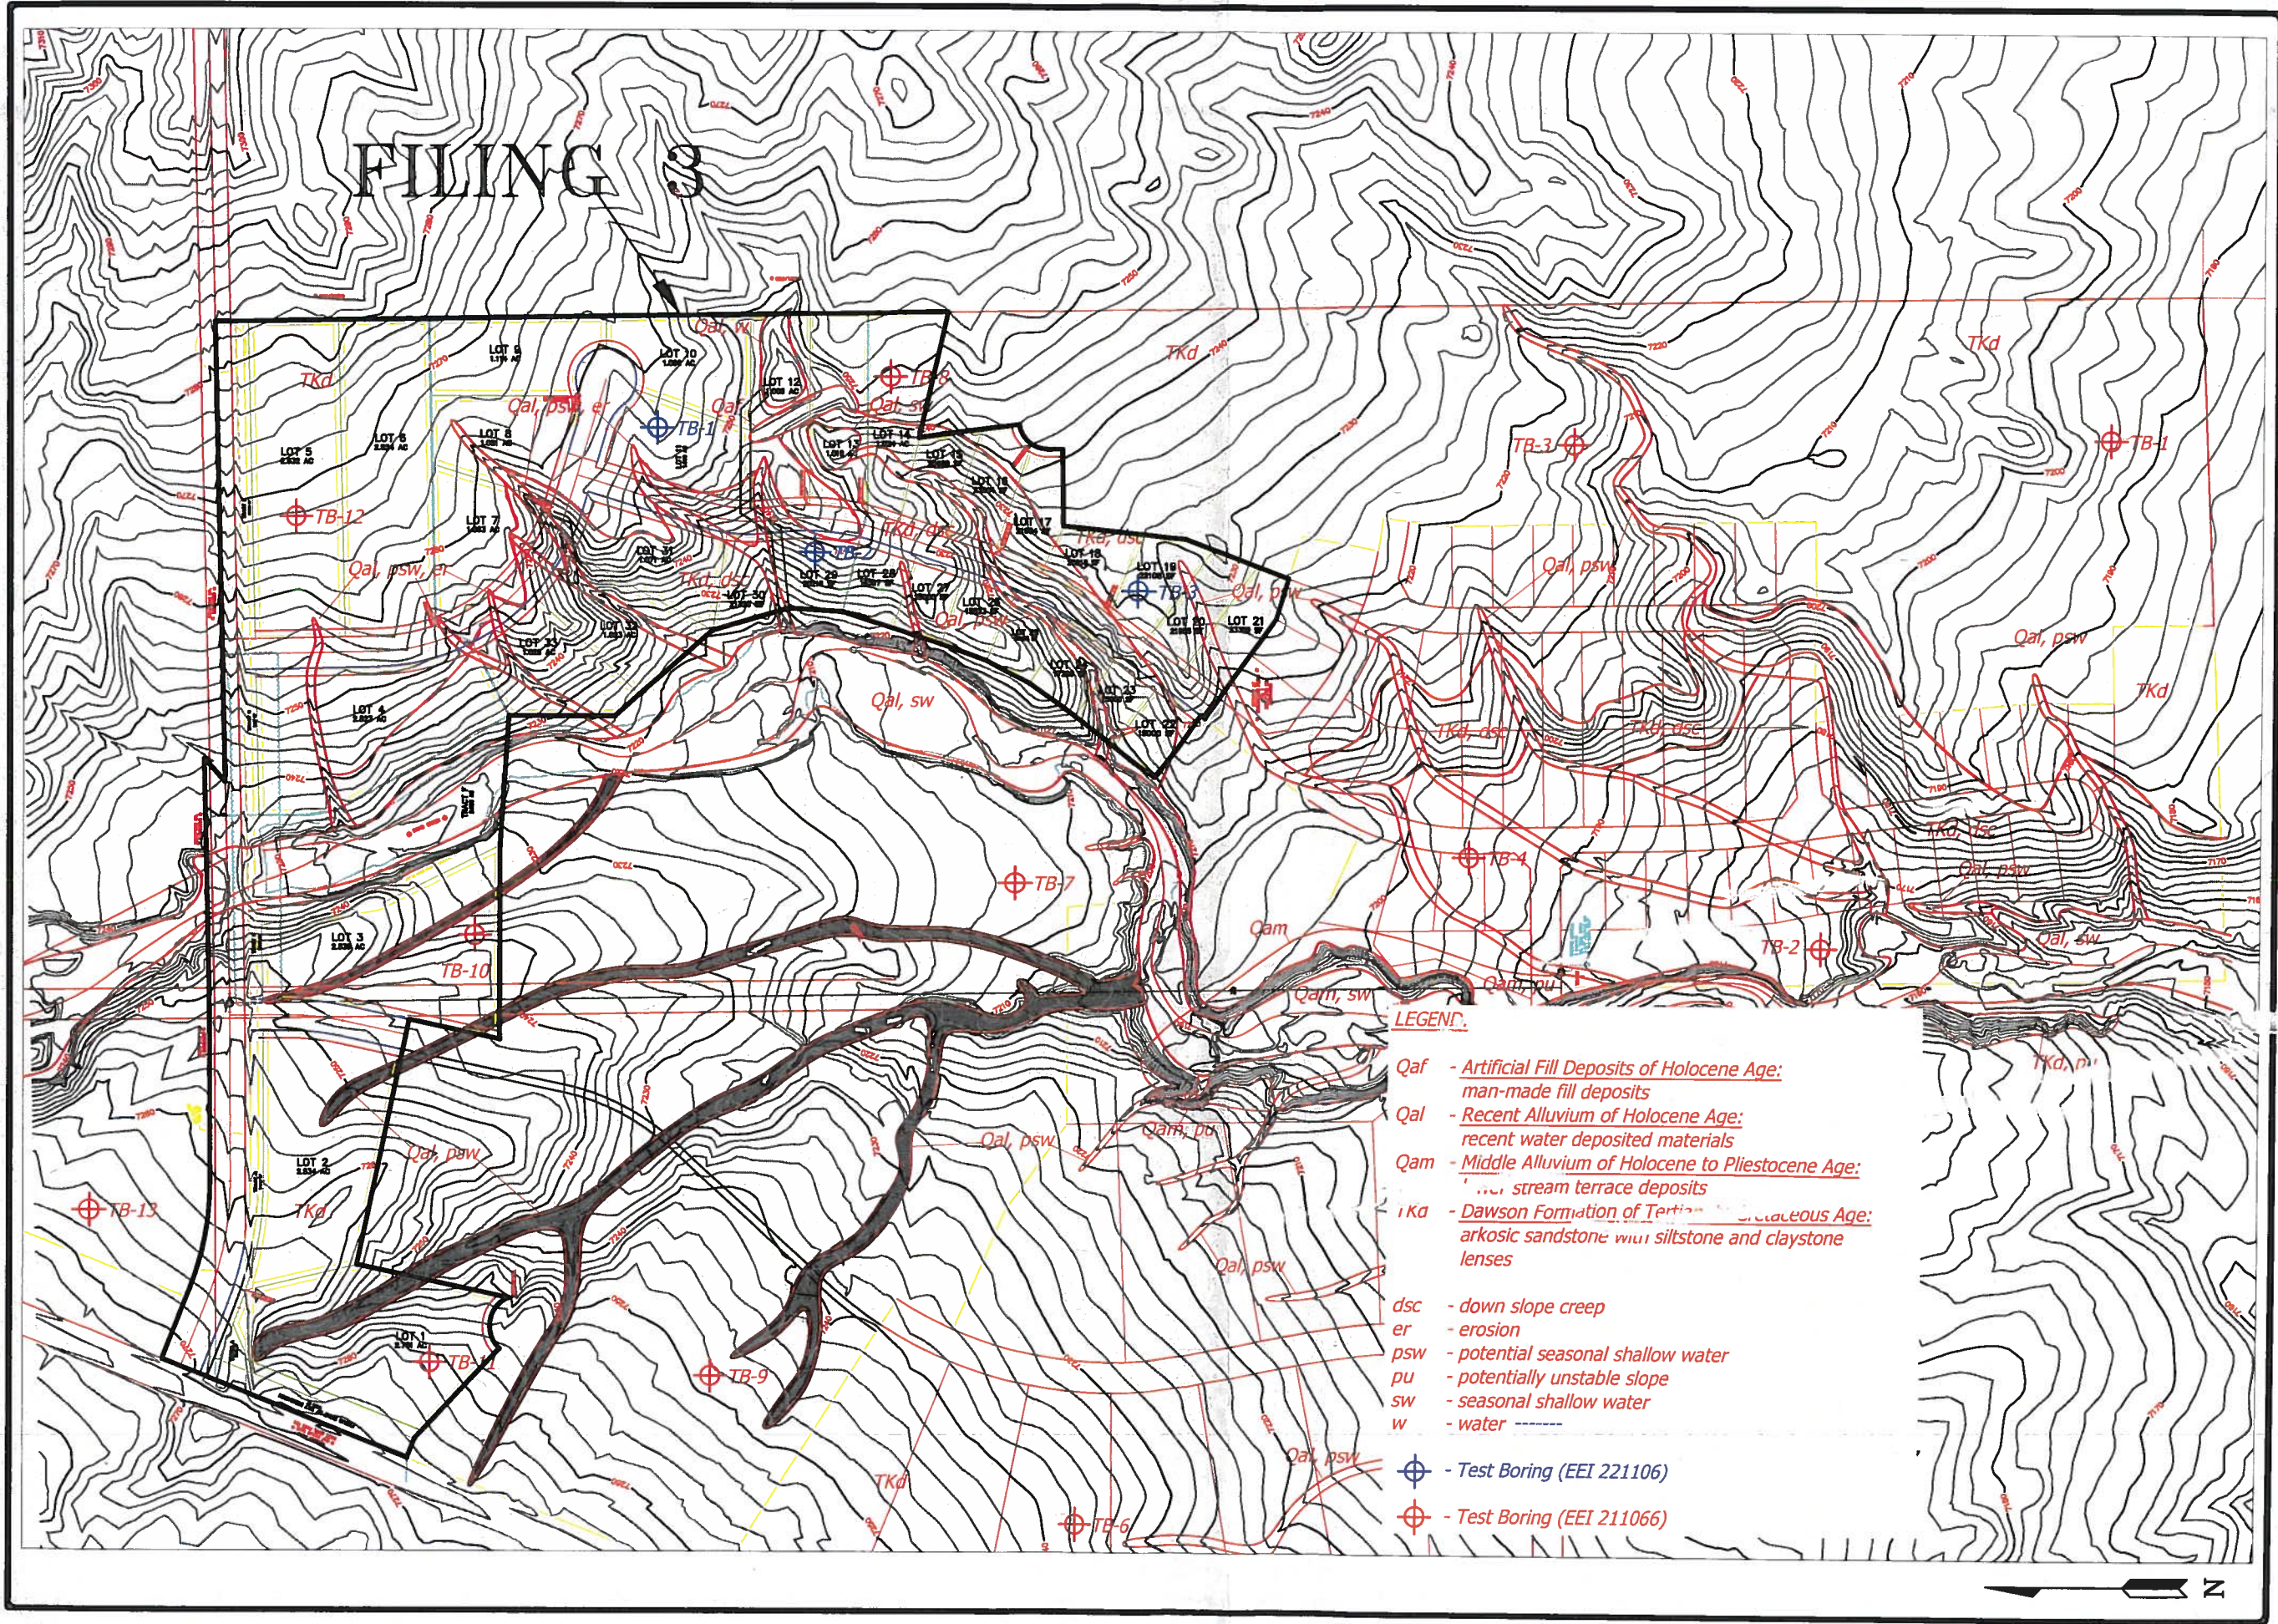
DATE 6/7/22
SCALE AS SHOWN
JOB NO. 221106
FIGURE NO. 6

As mentioned previously, detailed mapping has been performed on this site to produce an Engineering Geology Map Figure 6. This map shows the location of various geologic conditions of which the developers should be cognizant during the planning, design and construction stages of the project. These hazards and the recommended mitigation techniques are as follows:

These are recent man-made fill deposits associated with the two dams located across the site. One of the dams is located north of Arroya Lane and is not within the proposed developed area. One dam is located on the eastern side of Filing 3. It is anticipated that this dam will be removed and filled during the site grading process. At the time of the investigation, the condition of the

dams was observed, and appeared to be in good condition. Additional areas of fill associated with temporary stockpiles are located east of Sand Creek, and along the southern side of Filing 3 located within Filing 2.

Areas within the drainages on-site have been identified as areas of seasonally wet and/or seasonally high groundwater areas. Water was observed in the three ponds on-site, and flowing in Sand Creek. The majority of the drainages across the site were dry. The site is mapped within floodplain zones according to the FEMA Map No. 08041CO535G, Figure 7 (Reference 8). The floodplain area is to consist of open space/ park for the development. These areas are discussed as follows:

Downslope Creep Areas - hazard

These areas are acceptable as building sites, however, in areas identified with this hazard classification, we would anticipate accelerated lateral and vertical movement of the near surface soils in the downslope direction. It is anticipated that many of these areas will be mitigated by the overlot grading.

Potentially Unstable Slope Areas - hazard

These slopes are considered stable in their present condition; however, considerable care must be exercised in these areas not to create a condition which would tend to activate instability. These areas are primarily located along the banks of Sand Creek, which are proposed as open space.

Mitigation: The earthen dams lie within defined drainages and should be avoided as building sites. Fill stockpiles will likely be removed during site grading. The fill on this site is considered uncontrolled for construction purposes. Any uncontrolled fill encountered beneath foundations will require removal and recompaction at a minimum of 95% of its maximum Modified Proctor Dry Density, ASTM D-1557.

Mitigation: Foundations must have a minimum 30-inch depth for frost protection. In areas where high subsurface moisture conditions are anticipated periodically, subsurface perimeter drains are recommended to help prevent the intrusion of water into areas below grade. Typical drain details are presented in Figure 9. Any grading in these areas should be done to direct surface flow around construction to avoid areas of ponded water. Structures should not block drainages.

Mitigation: The design of foundations in these areas should account for the additional pressure on the uphill side of the structure due to the creep potential. The lateral pressure distribution for sloping conditions in downslope creep area is presented in Figure 10. Tie-beams, buttresses and counterforts may be necessary in some areas. Where possible, in areas of downslope creep, structures should be designed to be as compact and rigid as possible. This will help them better tolerate the vertical and lateral movements to which the foundation system may be subjected with minimal damage. Long, rambling, irregular structures should be avoided, as they are associated with much greater potential for damaging differential movement. Additionally, structures should be designed to step up the slope. Deep cuts in these areas should be avoided. Any retaining walls proposed in these areas should also be properly designed for by a

qualified professional engineer for the global slope stability. Proper control of drainage at both the surface and subsurface is important. Saturation of materials should be avoided that may create unstable conditions.

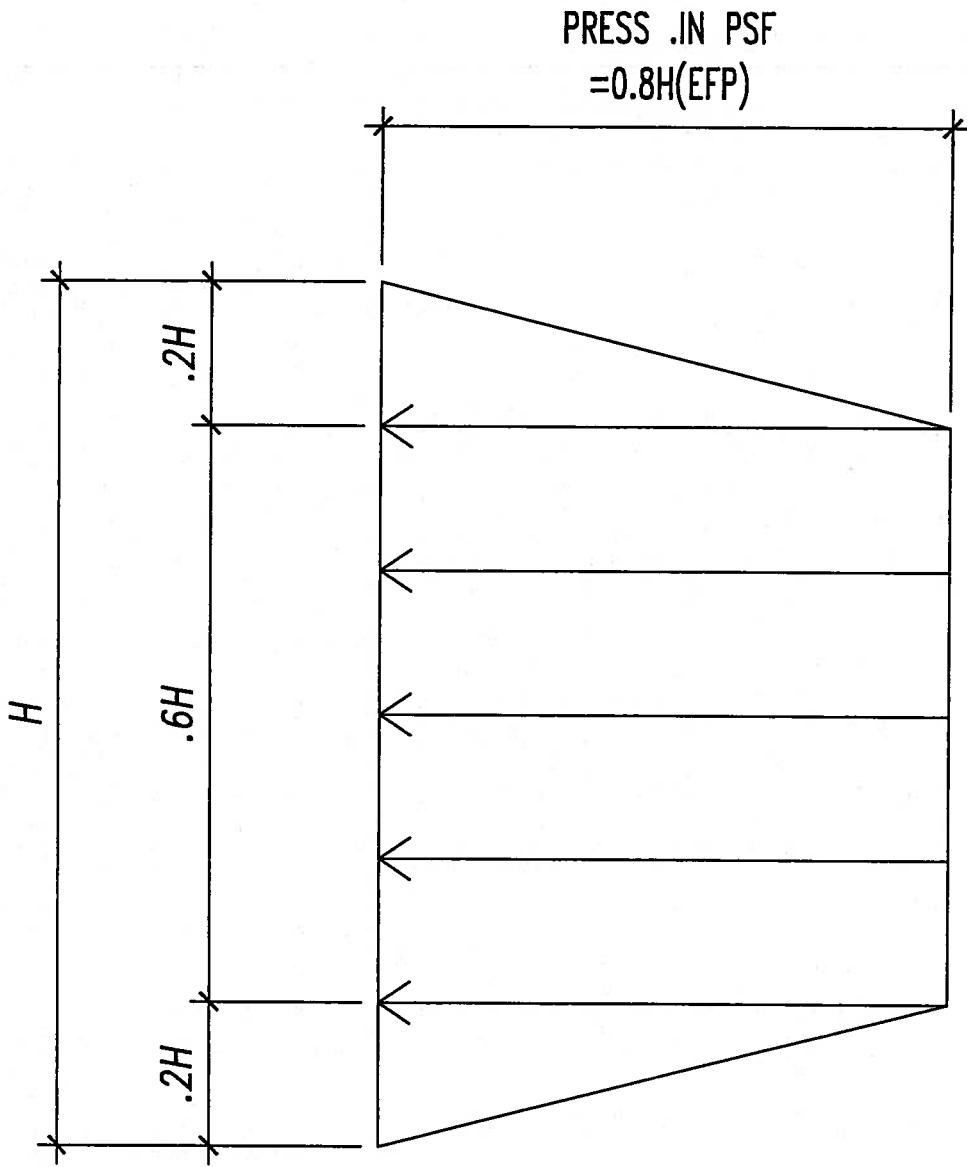
FIG. NO.:
9

PRESSURE DISTRIBUTION
