**SOIL, GEOLOGY, AND GEOLOGIC HAZARD STUDY  
STERLING RANCH HOMESTEAD NORTH FILING NO. 1  
PARCEL NO. 9  
EL PASO COUNTY, COLORADO**

July 22, 2020  
Revised February 18, 2022

Entech Job No. 201421  
F:/AAPProjects/2020/201421 Geohaz

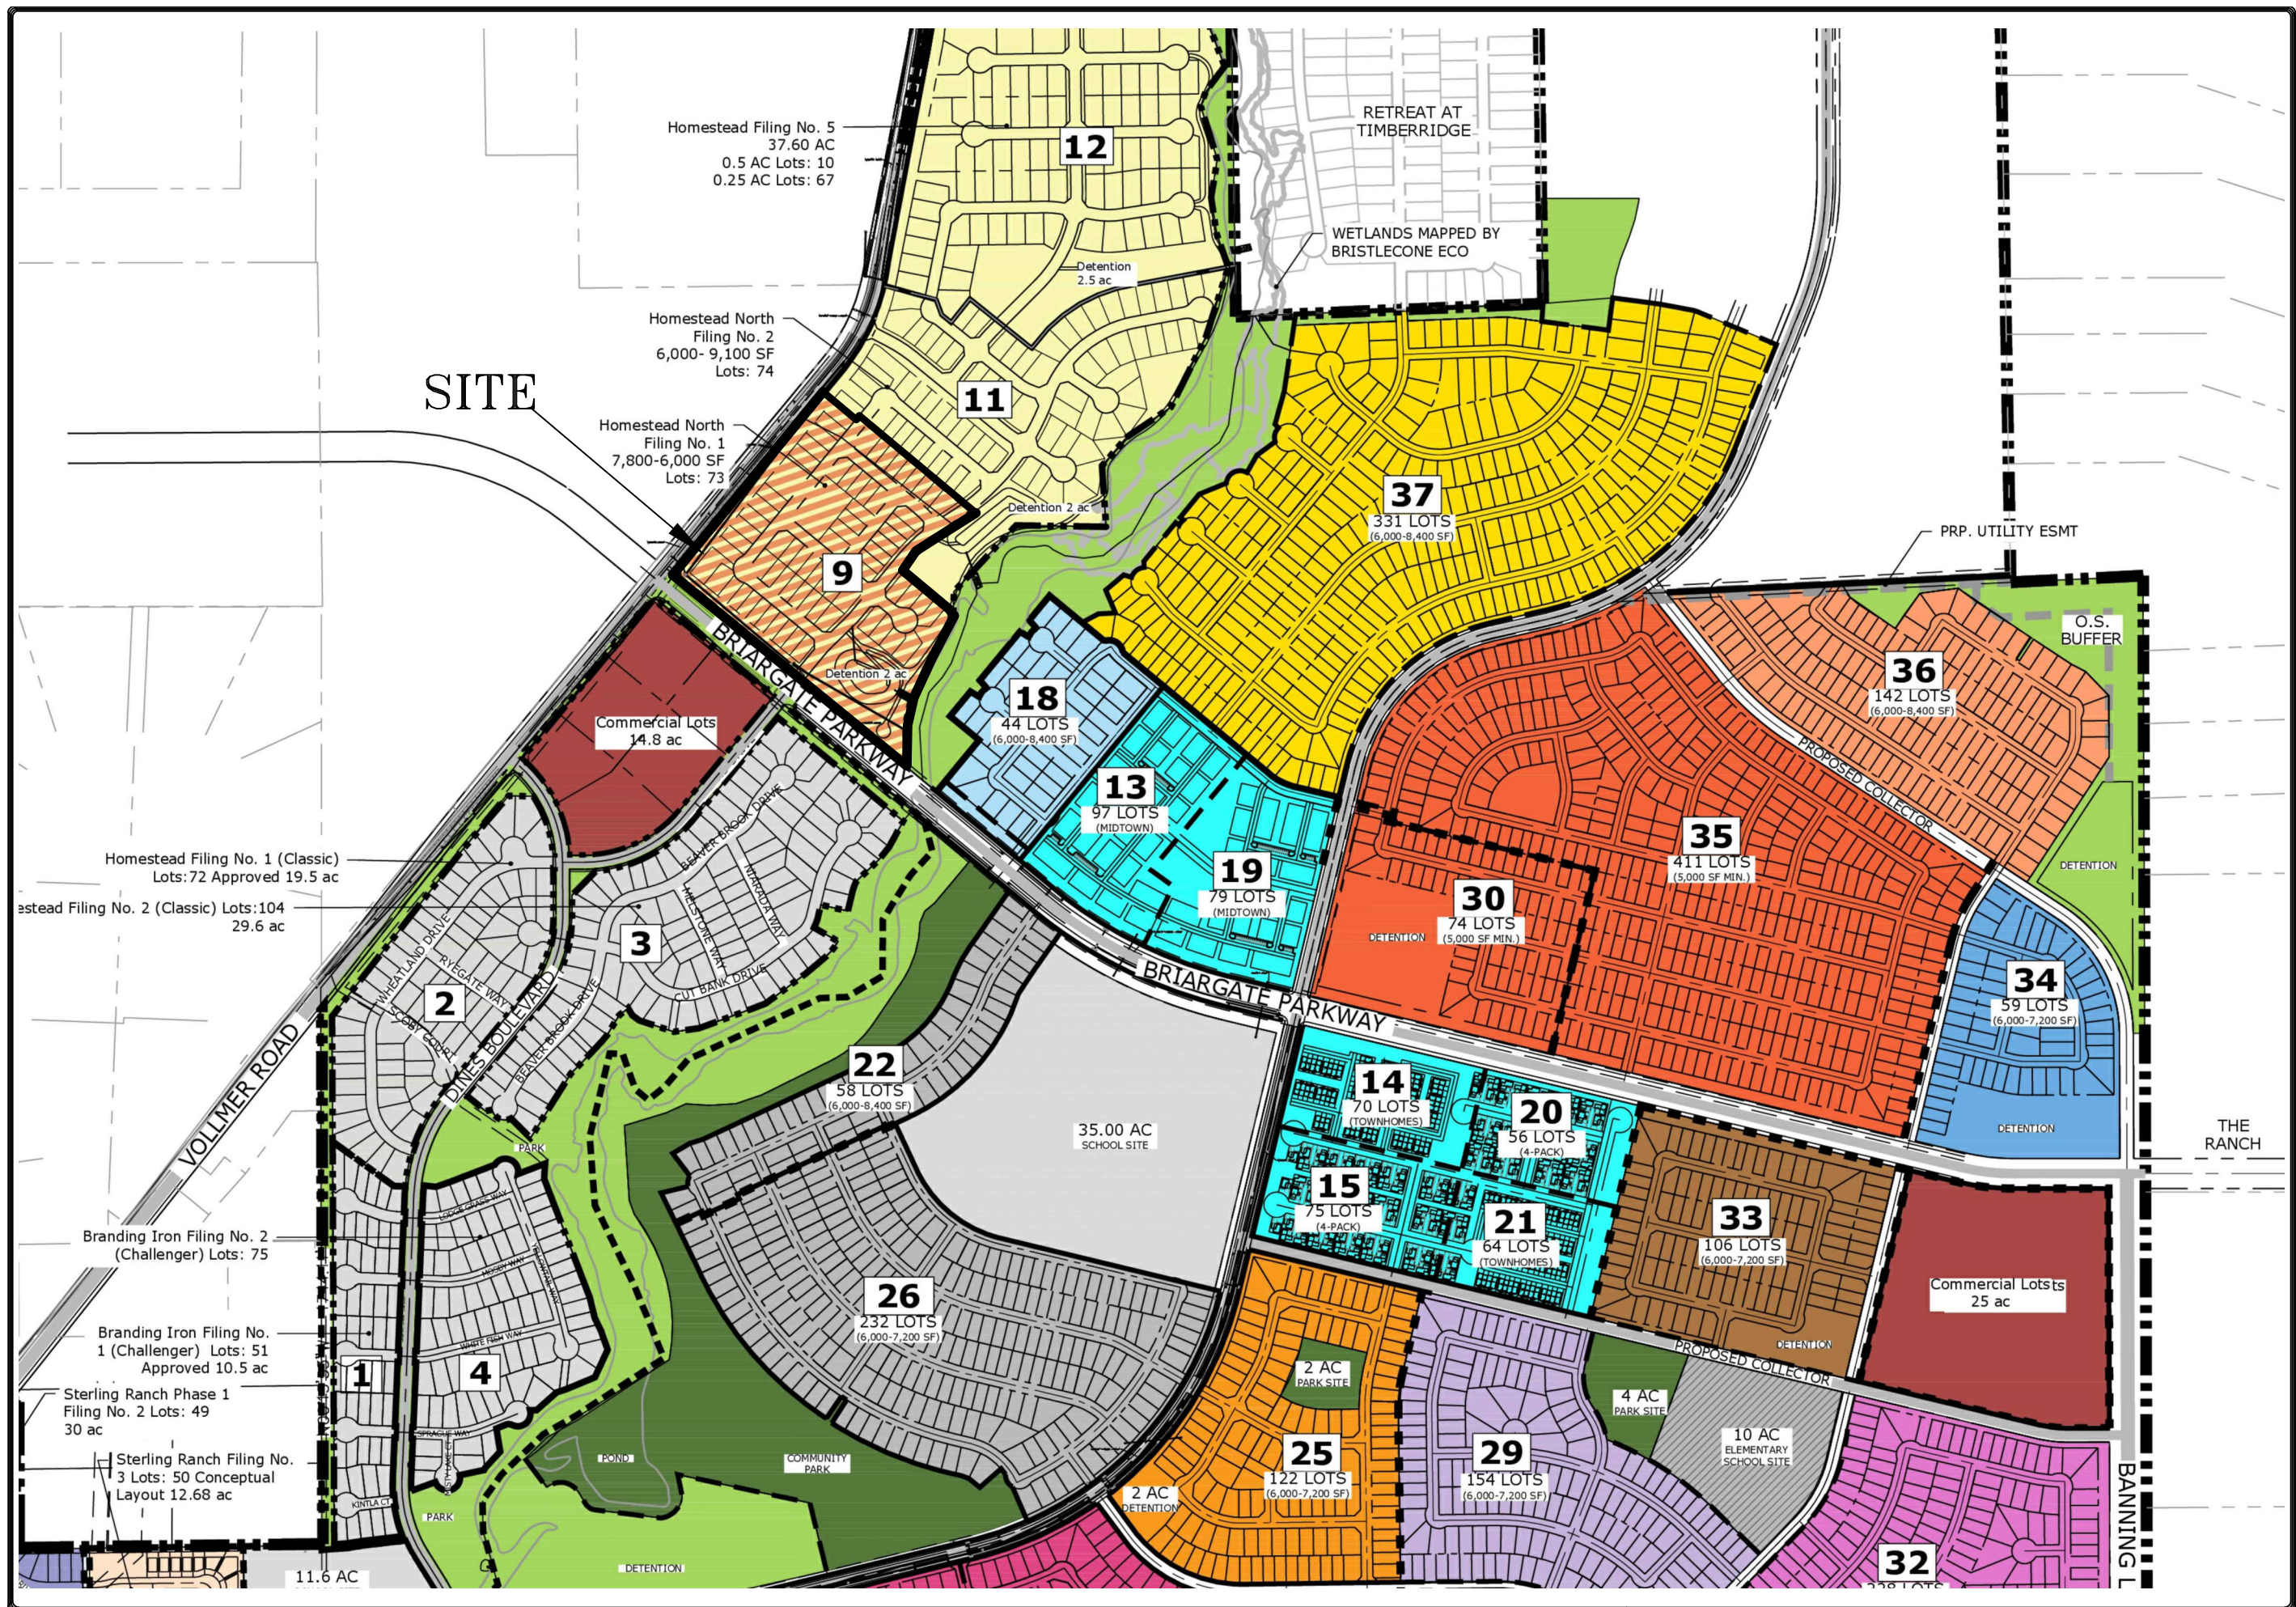
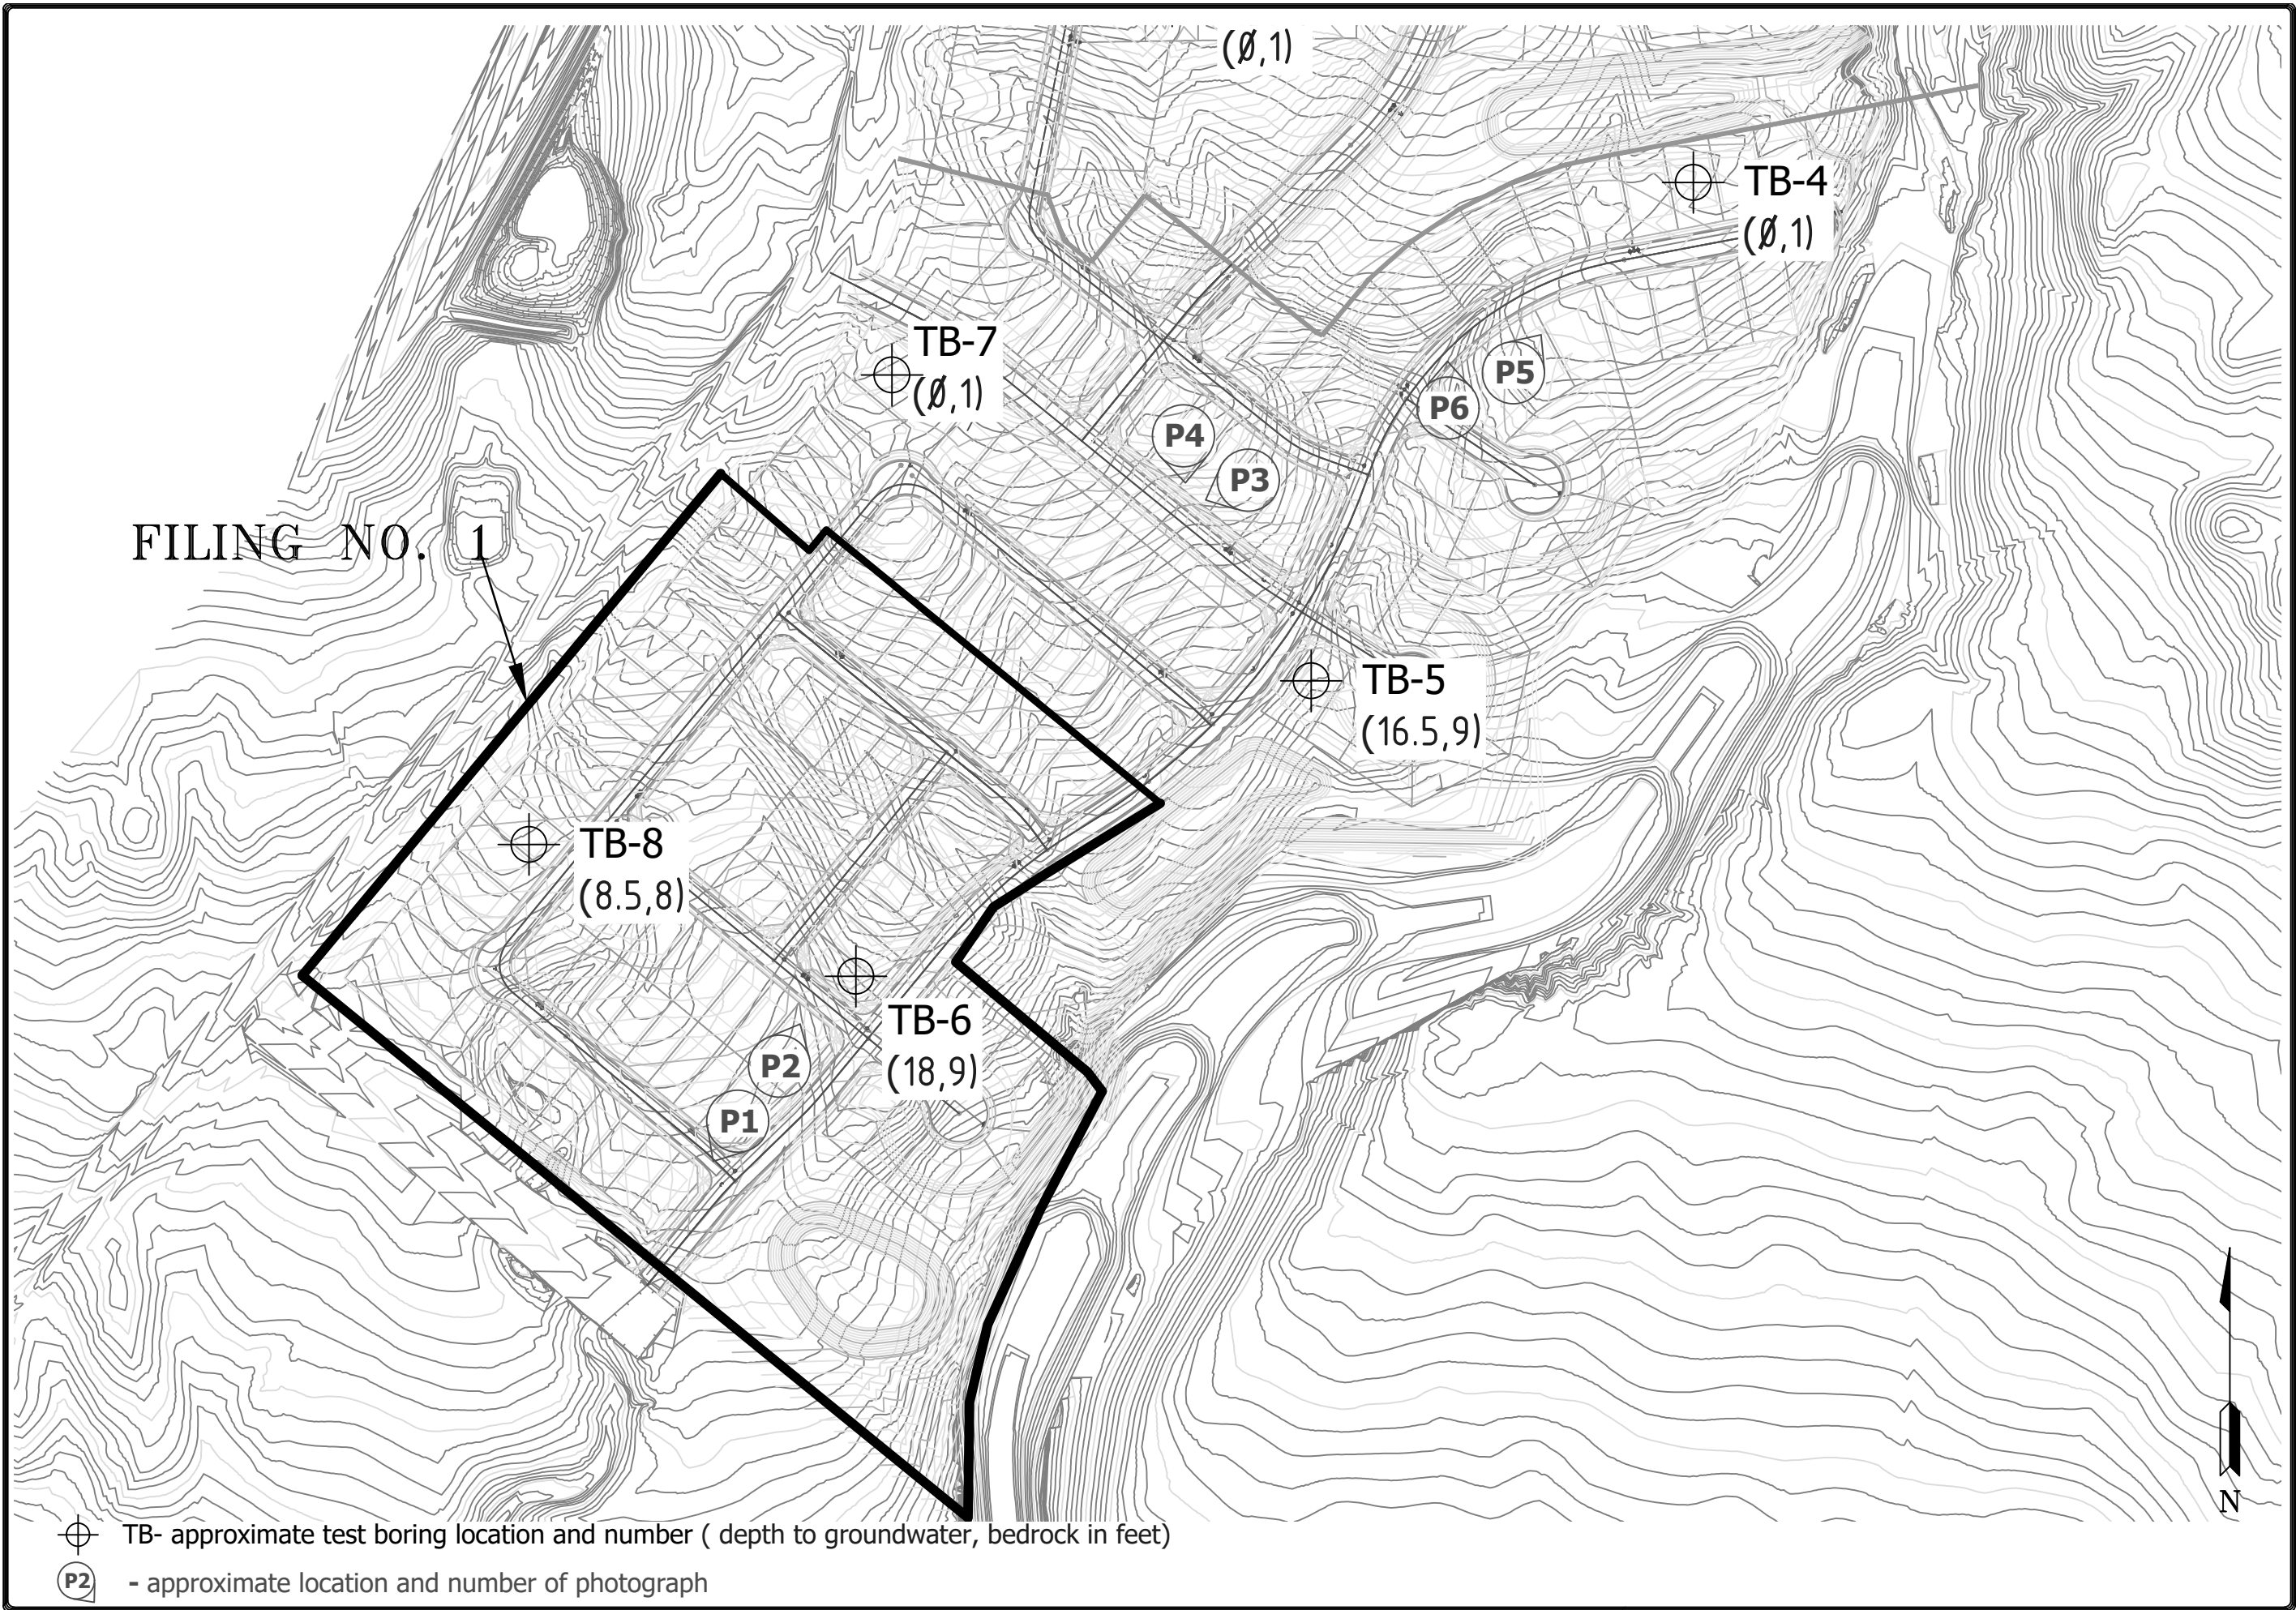
<b>DRAWN</b> L.L.L.
<b>CHECKED</b>
<b>DATE</b> 2/16/22
<b>SCALE</b> AS SHOWN
<b>JOB NO.</b> 201421
<b>FIGURE No.</b> 4

Groundwater was encountered in four of the test borings (Test Boring Nos. 1, 5, 6, and 8) at depths ranging from 8.5 to 18 feet bgs. Groundwater was not encountered in the other test borings which were drilled to 20 feet. Groundwater depths are summarized in Table 2. Fluctuations in the groundwater conditions may occur due to conditions such as variations in rainfall, precipitation infiltration and development of nearby areas. Areas of floodplains and potentially seasonal shallow groundwater have been identified on the site. These areas will be discussed in the following section.

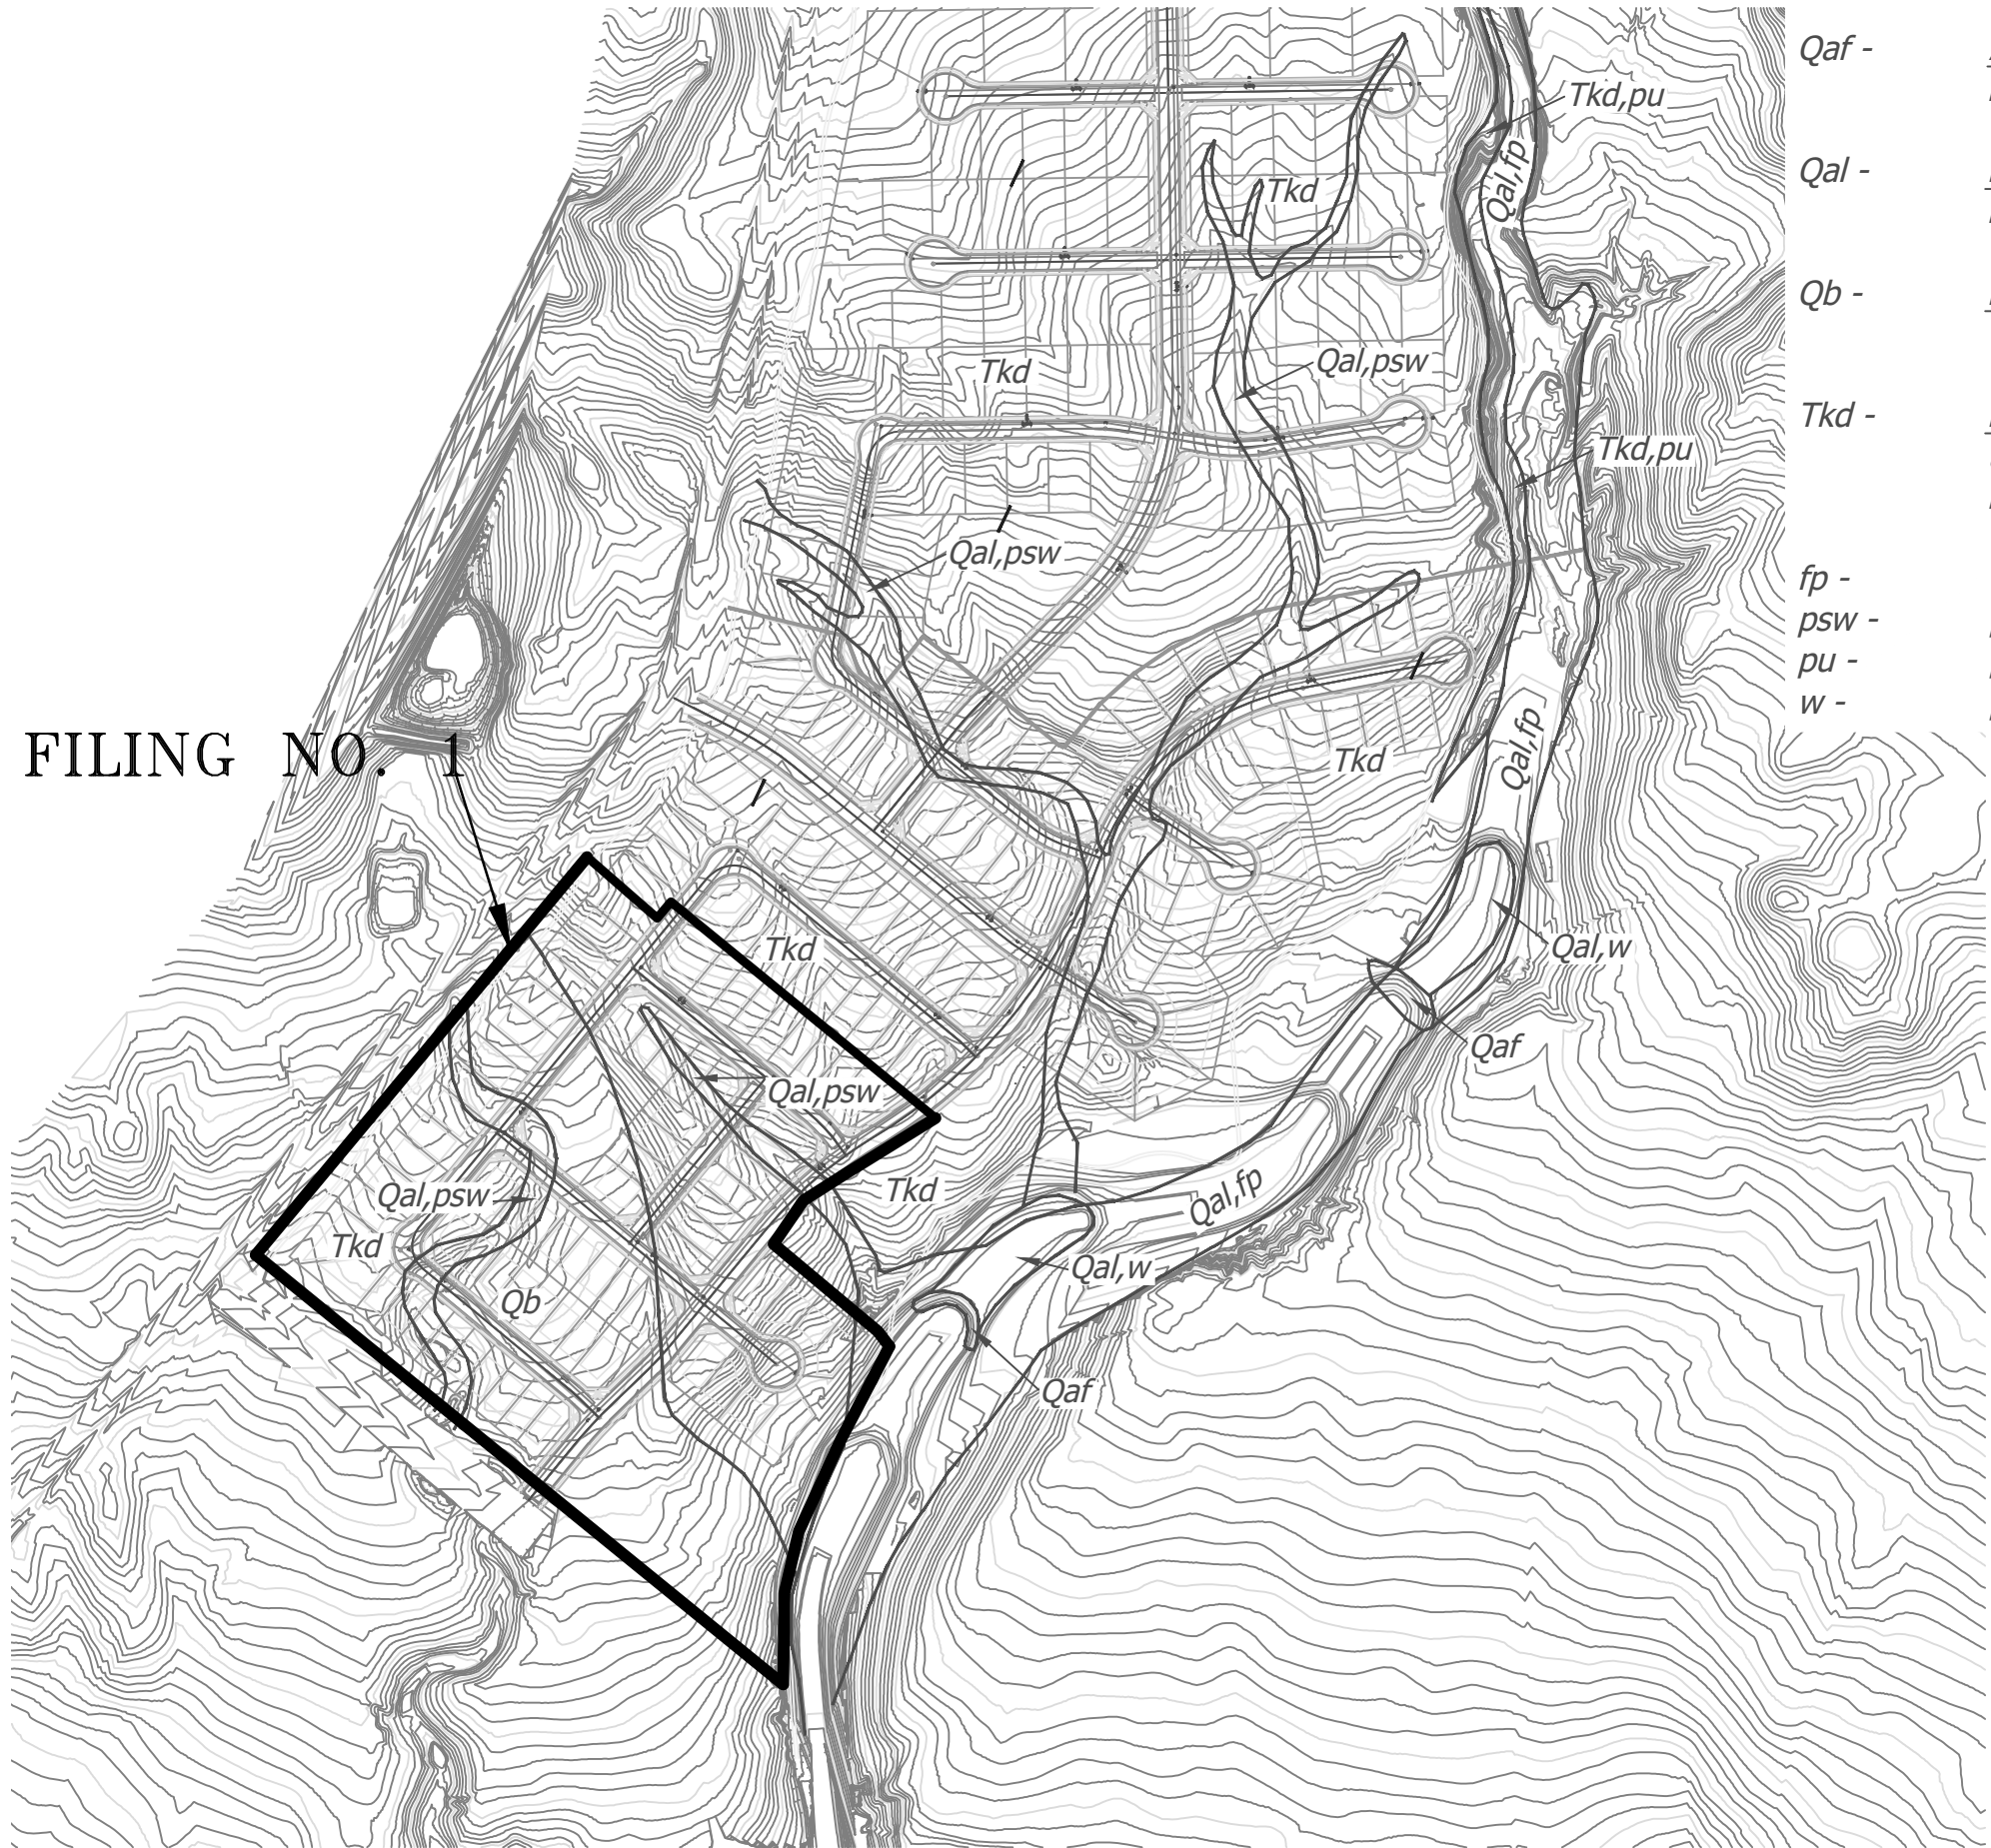
DRAWN L.L.L. CHECKED
DATE 2/16/22
SCALE AS SHOWN
JOB NO. 201421
FIGURE No. 7

Detailed mapping has been performed on this site to produce an Engineering Geology Map (Figure 7). This map shows the location of various geologic conditions of which the developers and planners should be cognizant during the planning, design and construction stages of the project. The hazards identified on this site include artificial fill, potentially unstable slopes, potentially expansive soils, floodplains, and potentially seasonal shallow groundwater areas. The following hazards have been addressed:

Some of the steep slopes along the Sand Creek drainage have been identified as potentially unstable. Considerable care must be exercised in these areas not to create a condition which would tend to activate instability.

*Mitigation:* According to the grading plan shown on Figure 7, Much of this area is to be regraded or avoided by development. Building should be avoided on any remaining potentially unstable slopes unless stabilized. A setback of 20 feet from the crest of these slopes is recommended. Stabilization could involve regrading to slope angles no steeper than 3:1 or the use of engineer-designed retaining walls, tiebacks, or buttresses. Where retaining walls are not used, erosion protection may be necessary to prevent undercutting

by the creek during periods of high water. It is our understanding the project will include drainage improvements and the construction of a regional trail along the Sand Creek drainage and stabilization of the slopes will be a part of the improvements. Specific slope stabilization recommendations are beyond the scope of this report.

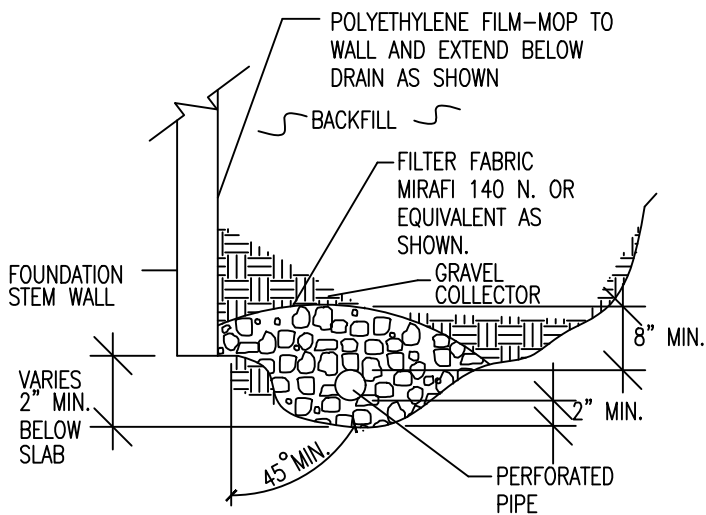
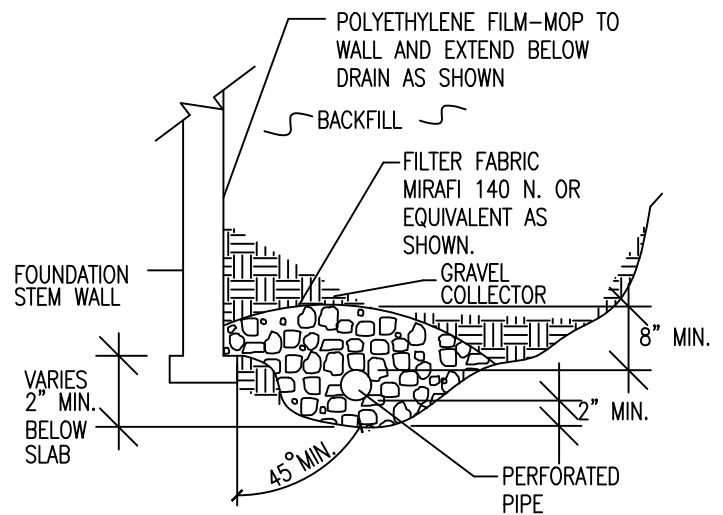
FIG NO.:  
9

Areas of potentially seasonal shallow groundwater have been mapped in minor drainage swales and low areas on the site. According to the grading plans, these areas are to be regraded. Structures immediately adjacent to the detention ponds or Sand Creek may experience higher water levels during periods of high moisture. Water was encountered in TB-8 at 8.5 feet. This area is to be filled during site grading. Shallow groundwater areas may also affect utility installation. Geo-grids or shotrock may be necessary to stabilize excavation. In or adjacent to seasonal shallow groundwater areas, drains may be necessary to control seepage within the foundation zone. A typical perimeter drain detail is presented in Figure 9.
