ENTECH
ENGINEERING, INC.

October 28, 2022
Revised November 3, 2023

Re: Soil, Geology, and Geologic Hazard Study
Hill Subdivision
Parcel Nos. 51290-04-018 and 51290-09-002
Alpaca Heights and Black Forest Road
El Paso County, Colorado
Entech Job No. 221947

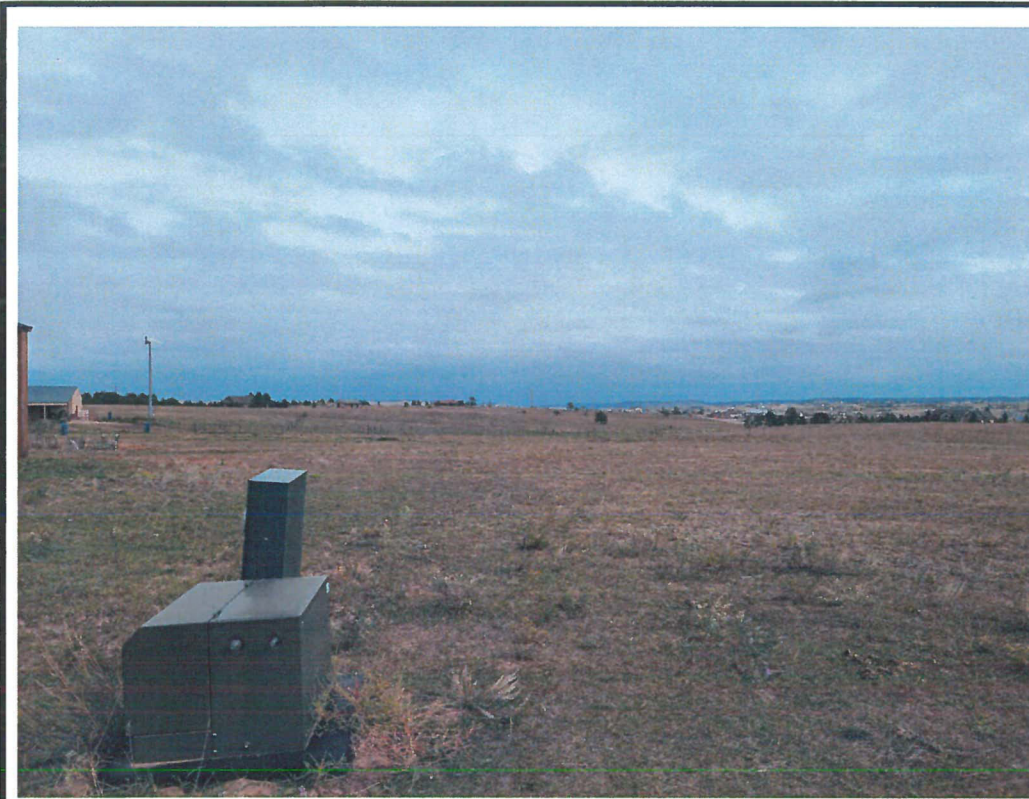
**Looking northwest
from the southern
portion of the site.**

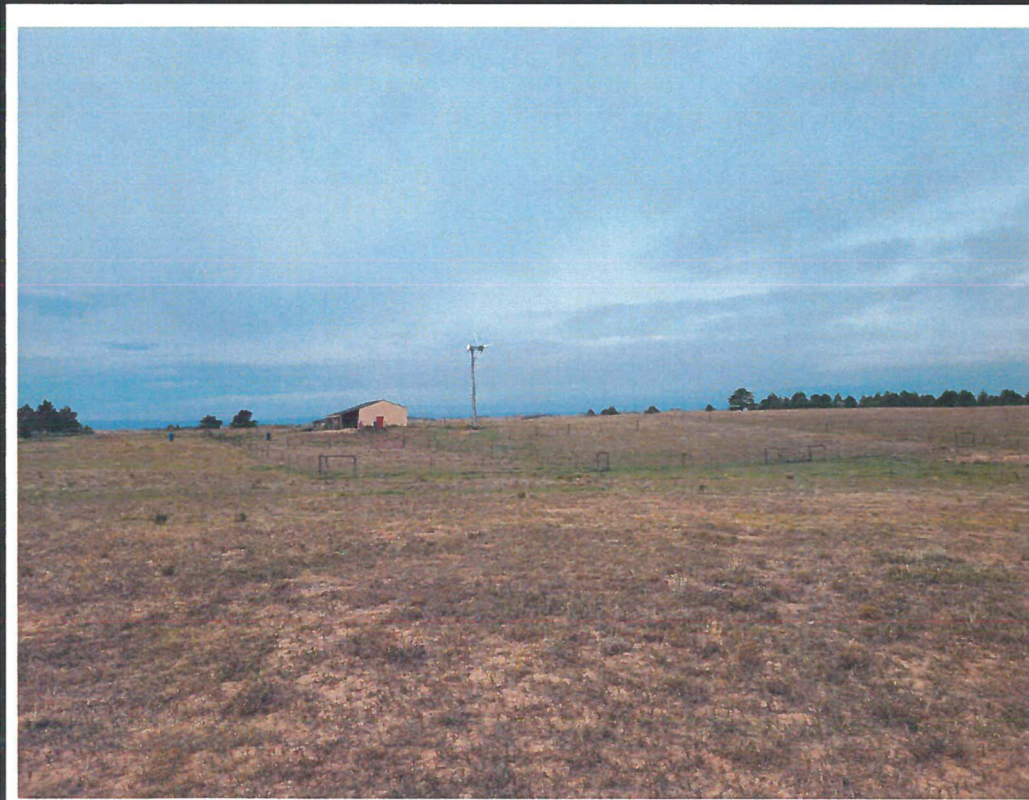
**Looking northwest
from the central
portion of the site.**

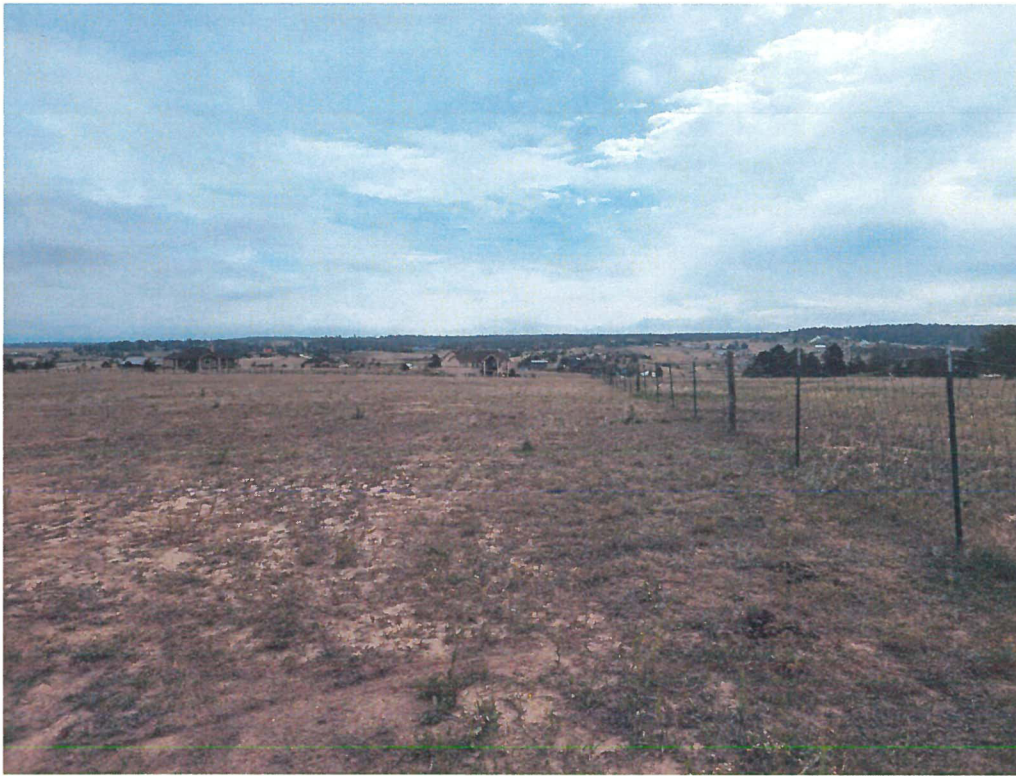
**Looking north along
from the southeastern
portion of the site.**

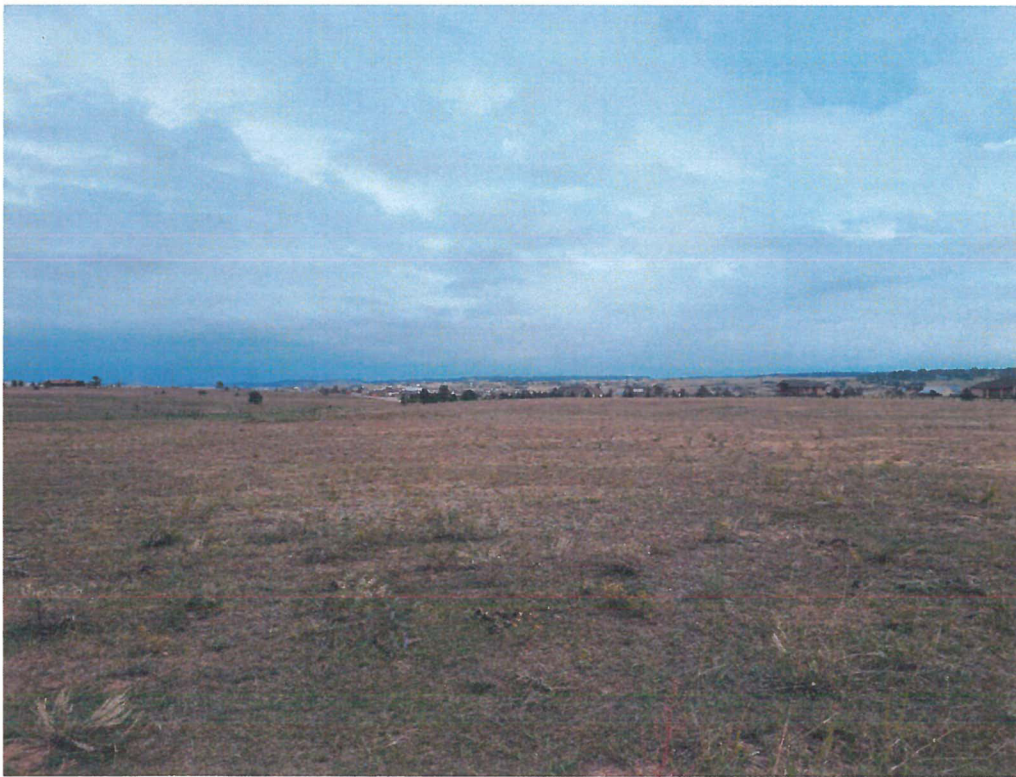
**Looking northeast
from the southern
portion of the site.**

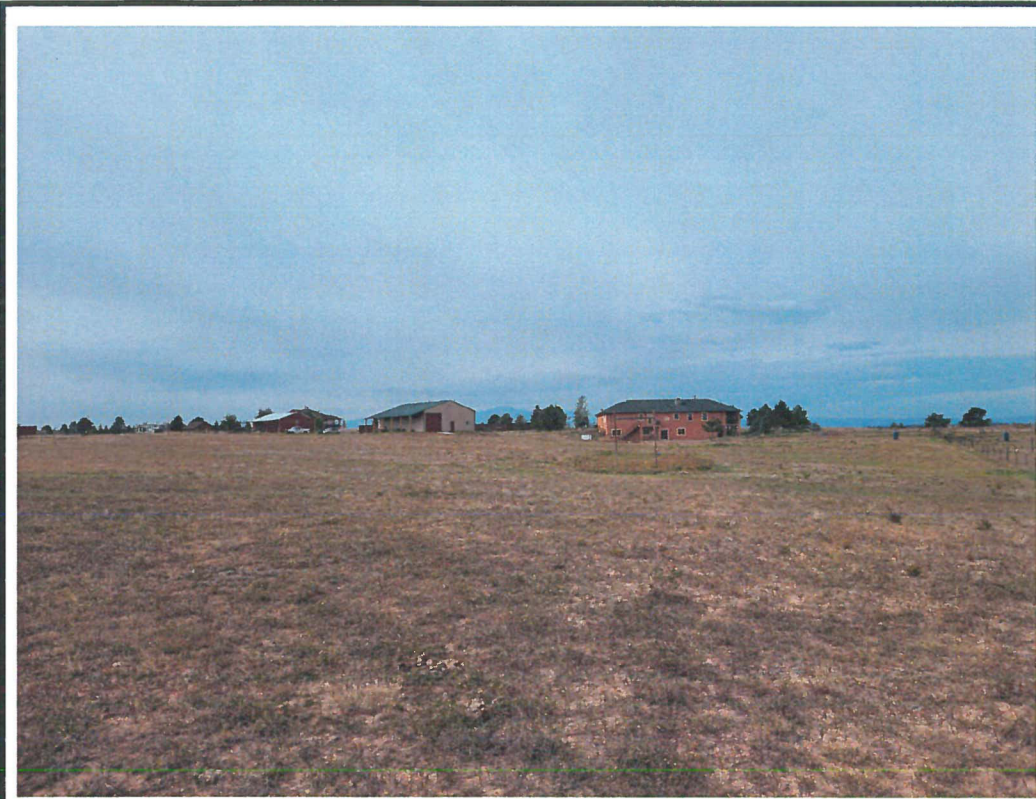
**Looking southwest
from the northeastern
portion of the site.**

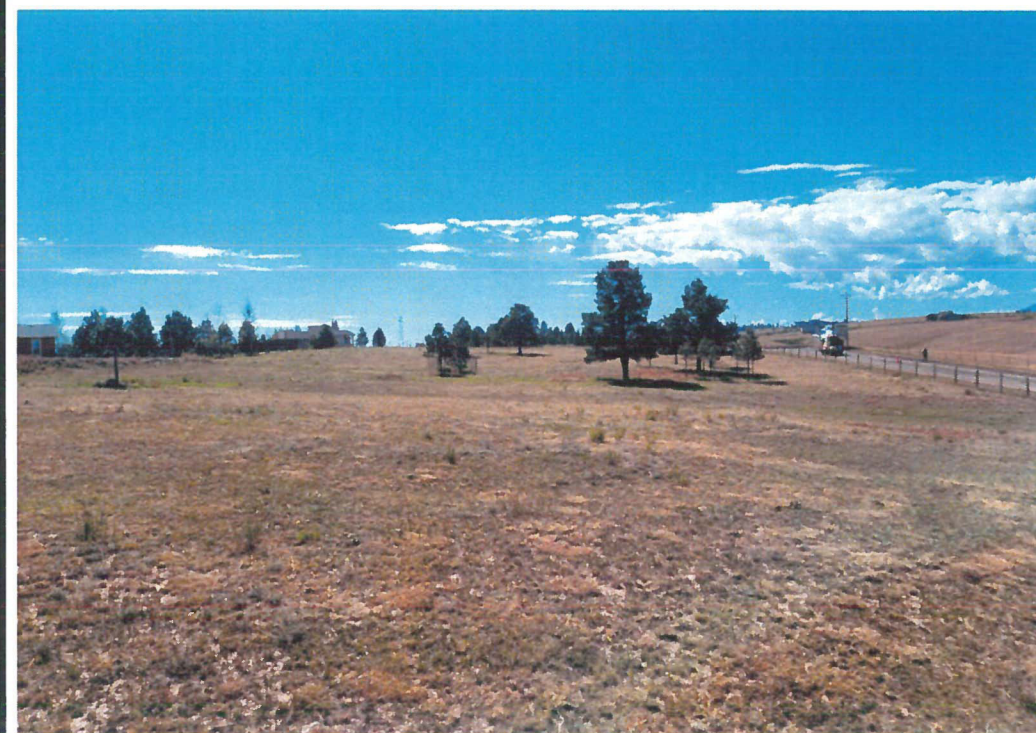
**Looking south from
the northwestern
portion of the site.**
