ENTECH
ENGINEERING, INC.

October 28, 2022
Revised November 3, 2023

Re: Soil, Geology, and Geologic Hazard Study
Hill Subdivision
Parcel Nos. 51290-04-018 and 51290-09-002
Alpaca Heights and Black Forest Road
El Paso County, Colorado
Entech Job No. 221947

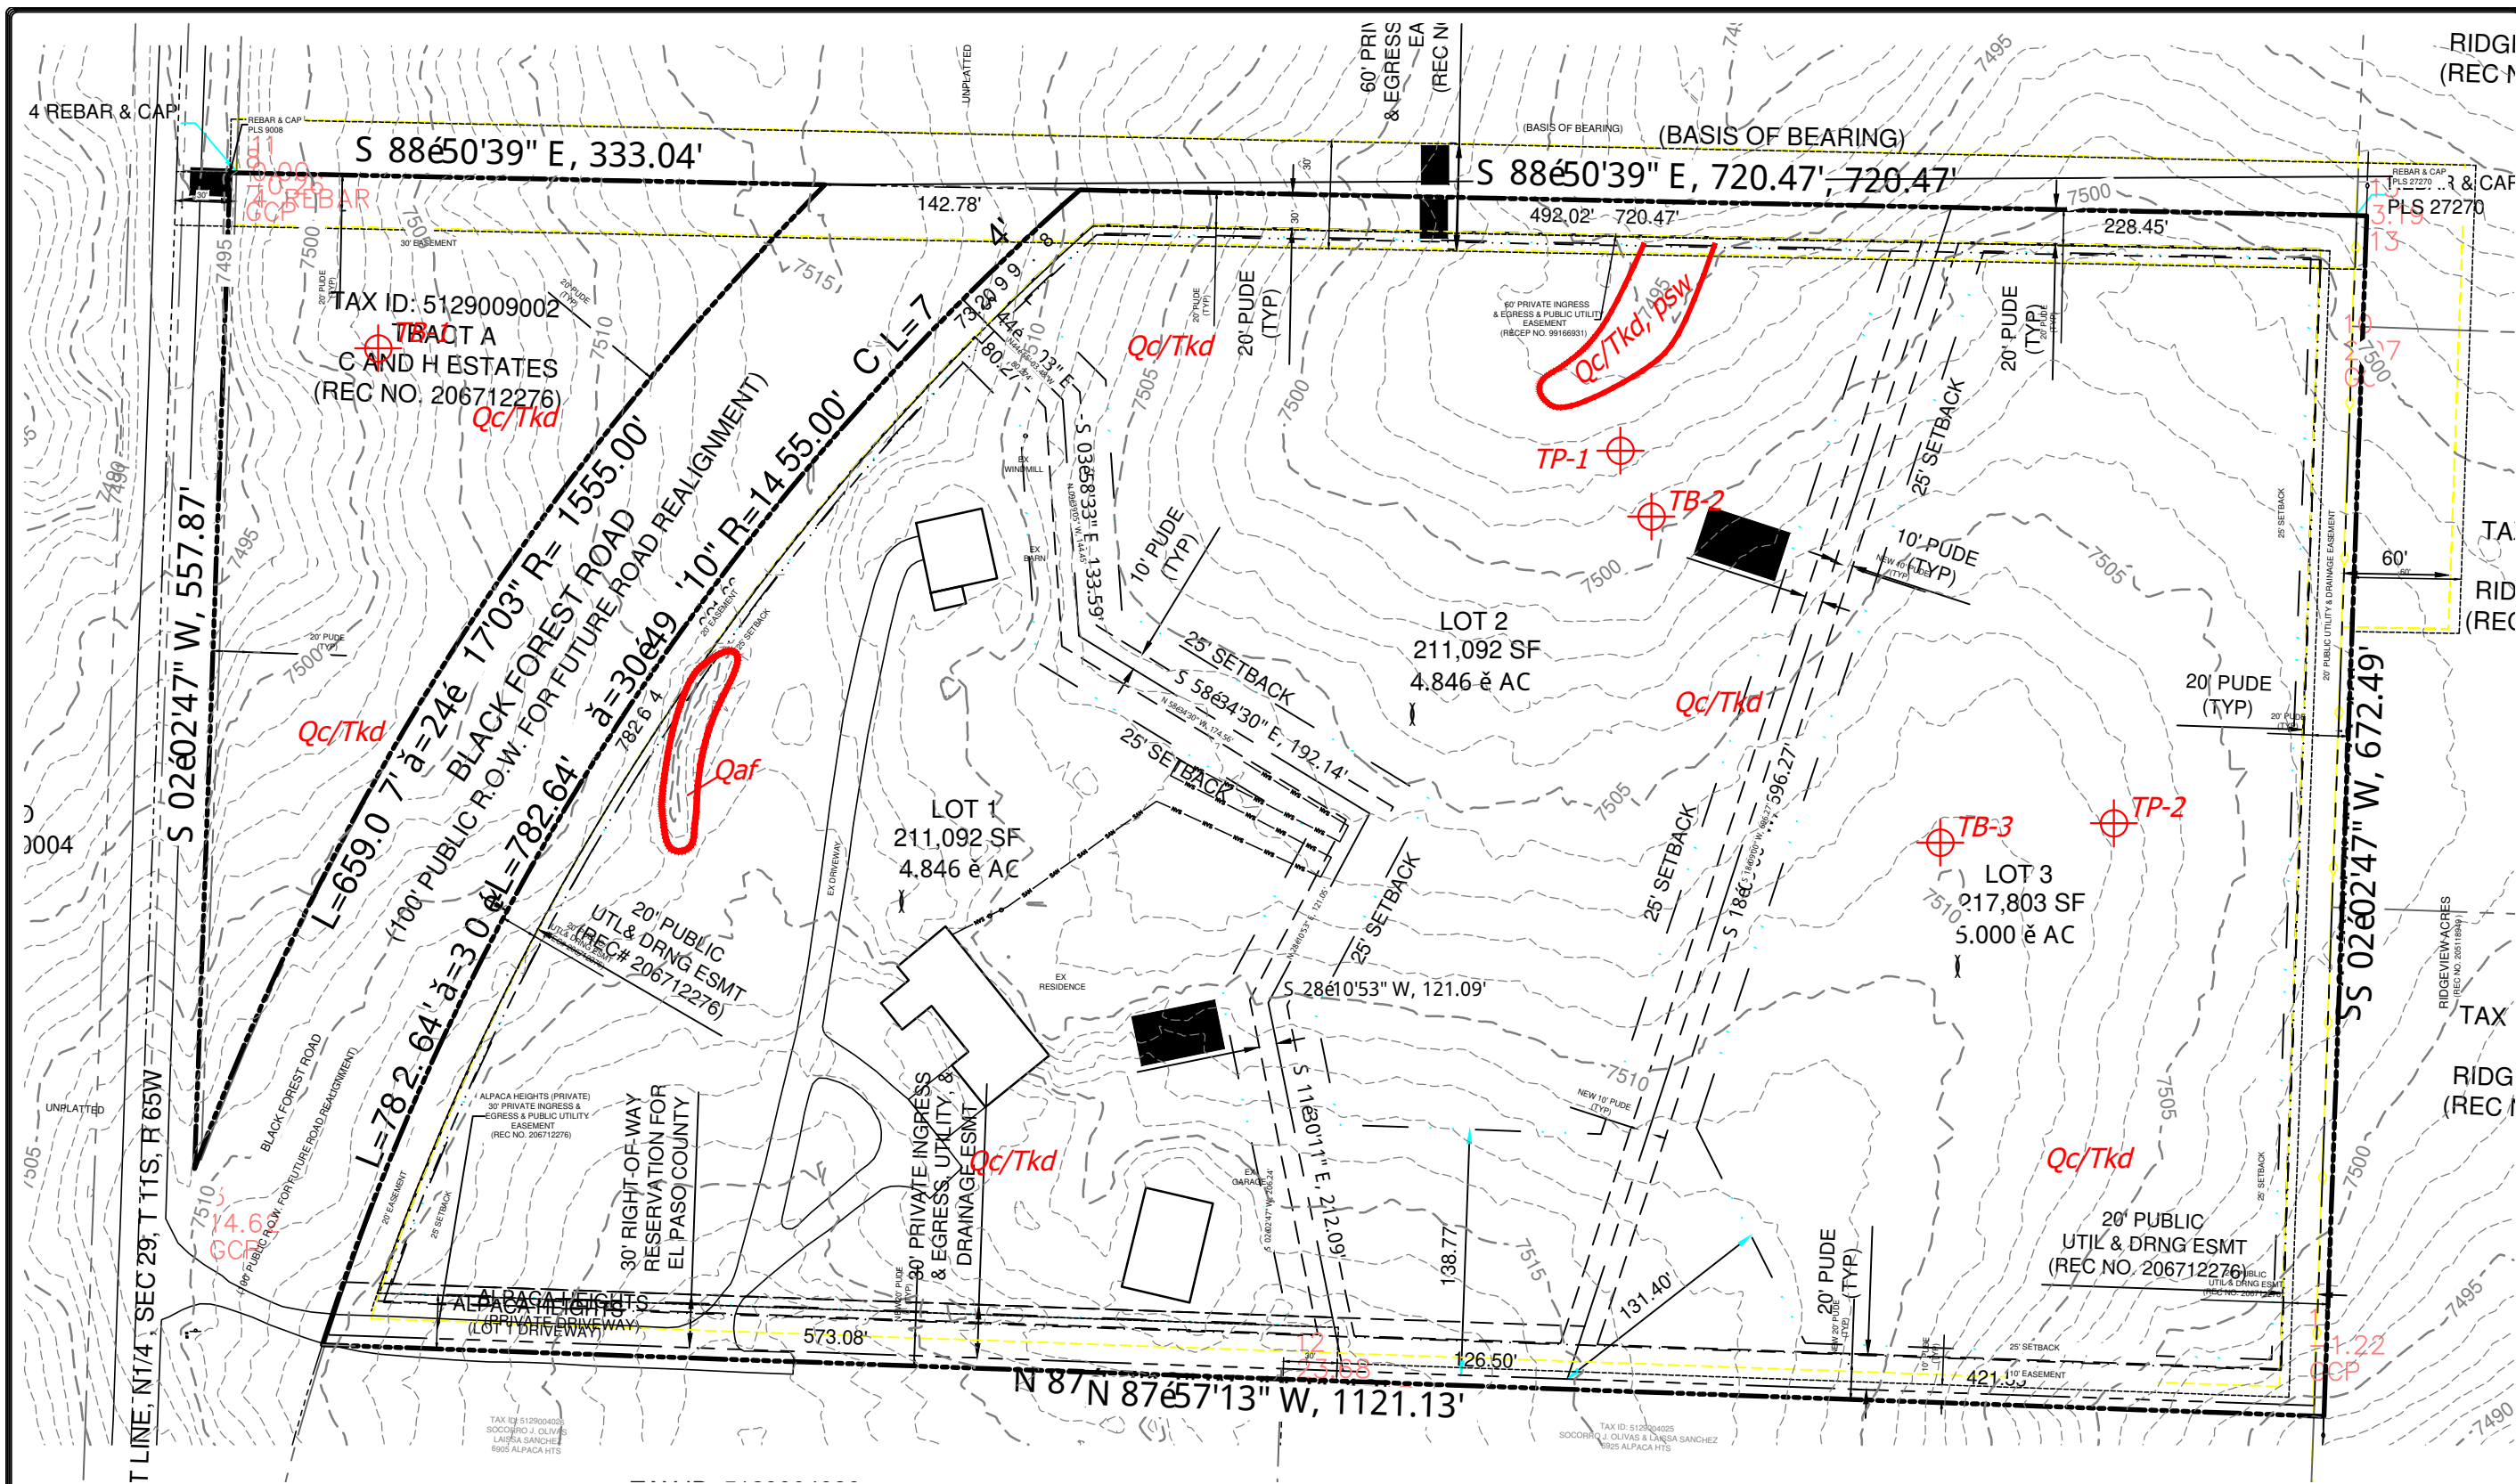
DRAWN L.L.
CHECKED
DATE 11/3/23
SCALE AS SHOWN
JOB NO. 221947
FIGURE No. 6

These are areas of man-made fill associated with an embankment located in the western portion of Lot 1. Areas of fill other than those mapped may exist on the site.

A minor drainage areas exist in the northeastern portion of proposed Lot 2. No water was observed flowing in the drainage, however, this area has the potential for seasonal shallow groundwater. This area is indicated in the Geology/Engineering Geology Map (Figure 6) and are discussed below. Due to the size of the proposed lot this area can be avoided or redirected around proposed structures or proposed soil treatment areas. The site does not lie within any floodplain zones according to the FEMA Map No. 08041CO305G dated December 7, 2018 (Figure 7, Reference 7). Exact locations of floodplain and specific drainage studies are beyond the scope of this report.

The minor drainage area in the northeastern portion of proposed Lot 2 has been identified as a potentially seasonal shallow groundwater area. In this area we would anticipate the potential for periodically high subsurface moisture conditions, frost heave potential and highly organic soils. This area lies within defined minor drainage and can be avoided by the proposed development. Construction in any portions of these areas, if required, or immediately adjacent to these areas should follow these precautions.

Mitigation: It is anticipated these would be avoided by development or regraded. Should any uncontrolled fill be encountered beneath foundations, removal and recompaction at a minimum of 95% of its maximum Modified Proctor Dry Density, ASTM D-1557 will be required.

Mitigation: Foundations must have a minimum 30-inch depth for frost protection. In areas where high subsurface moisture conditions are anticipated periodically, subsurface perimeter drains are recommended to help prevent the intrusion of water into areas below grade. Typical drain details are presented in Figure 8. Any grading in these areas should be done to direct surface flow around construction to avoid areas of ponded water. All organic material would be completely removed prior to any fill placement. **Specific drainage studies are beyond the scope of this report.**
