October 28, 2022

ENTECH
ENGINEERING, INC.

Re: Soil, Geology, and Geologic Hazard Study
Hill Subdivision
Parcel Nos. 51290-04-018 and 51290-09-002
Alpaca Heights and Black Forest Road
El Paso County, Colorado

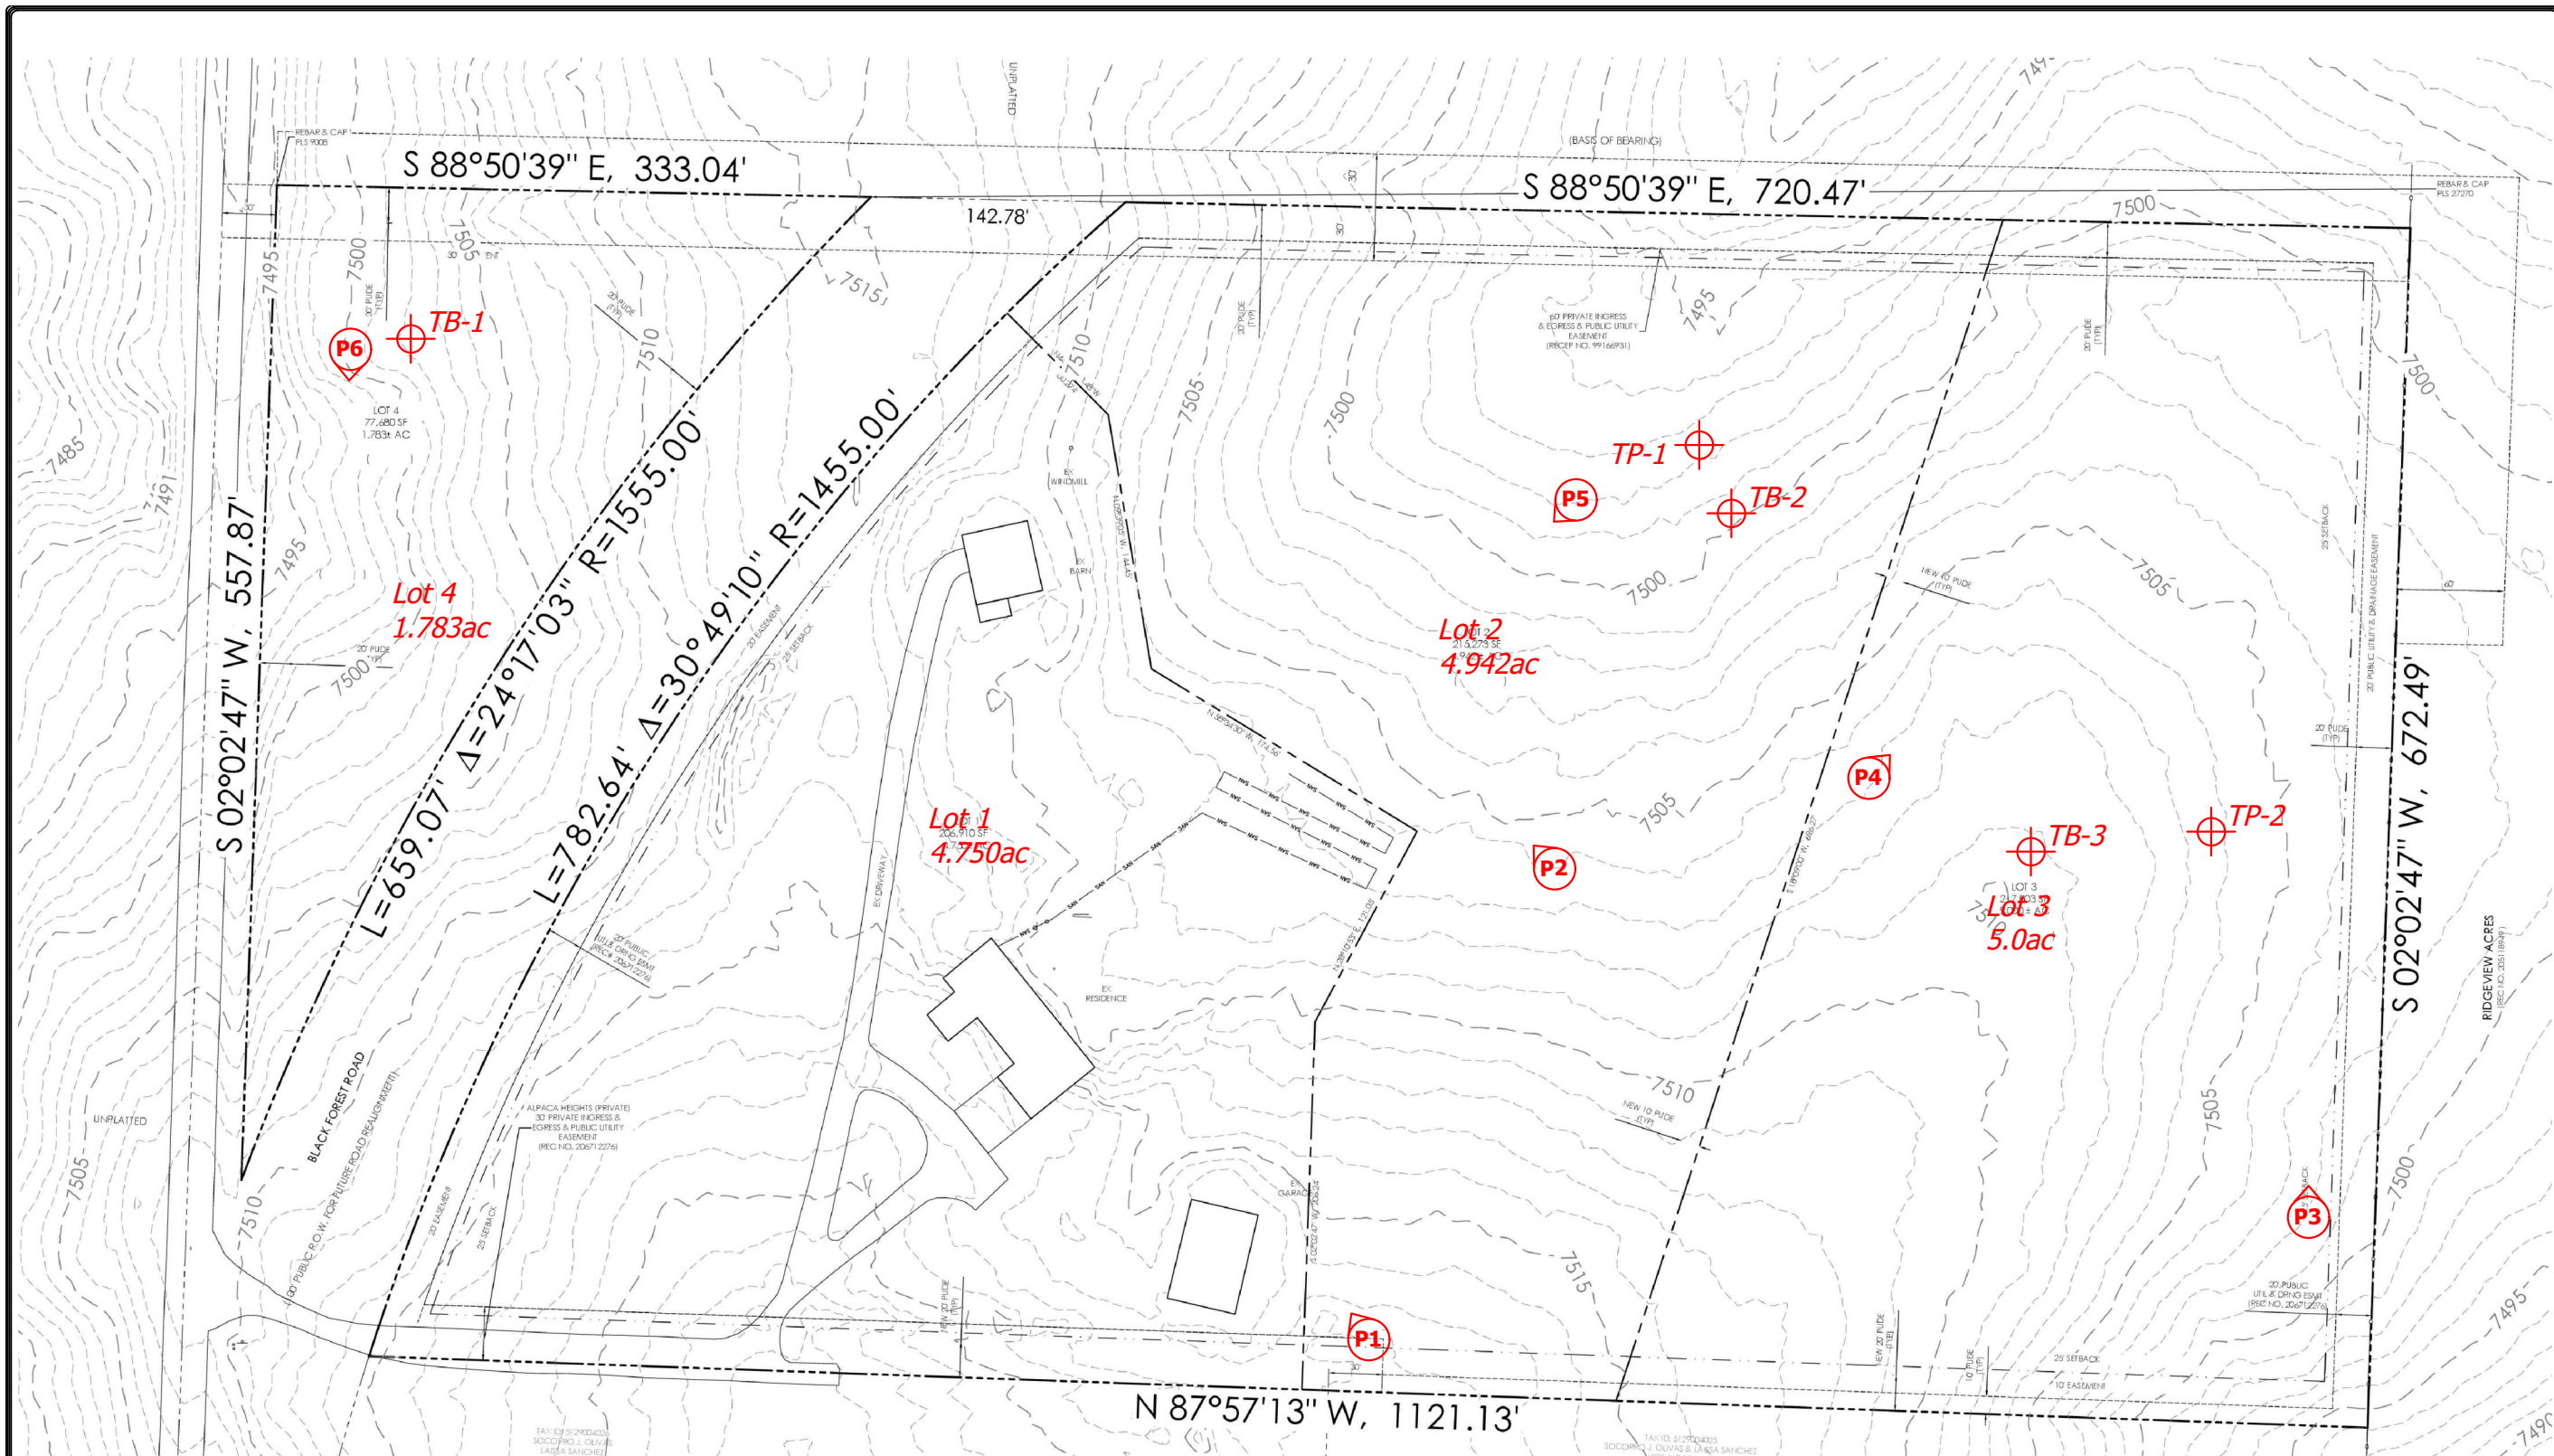
DRAWN L.L.
CHECKED
DATE 10/20/22
SCALE AS SHOWN
JOB NO. 221947
FIGURE No. 3

Total acreage involved in the proposed subdivision is 16.49-acres. Four rural residential lots are proposed. The proposed lot sizes range from 1.78-acres to 5.0-acres. The existing house and barns located on Lot 1 will remain. The new lots will be serviced by individual wells and on-site wastewater treatment systems. The Site Plan is presented in Figure 3.

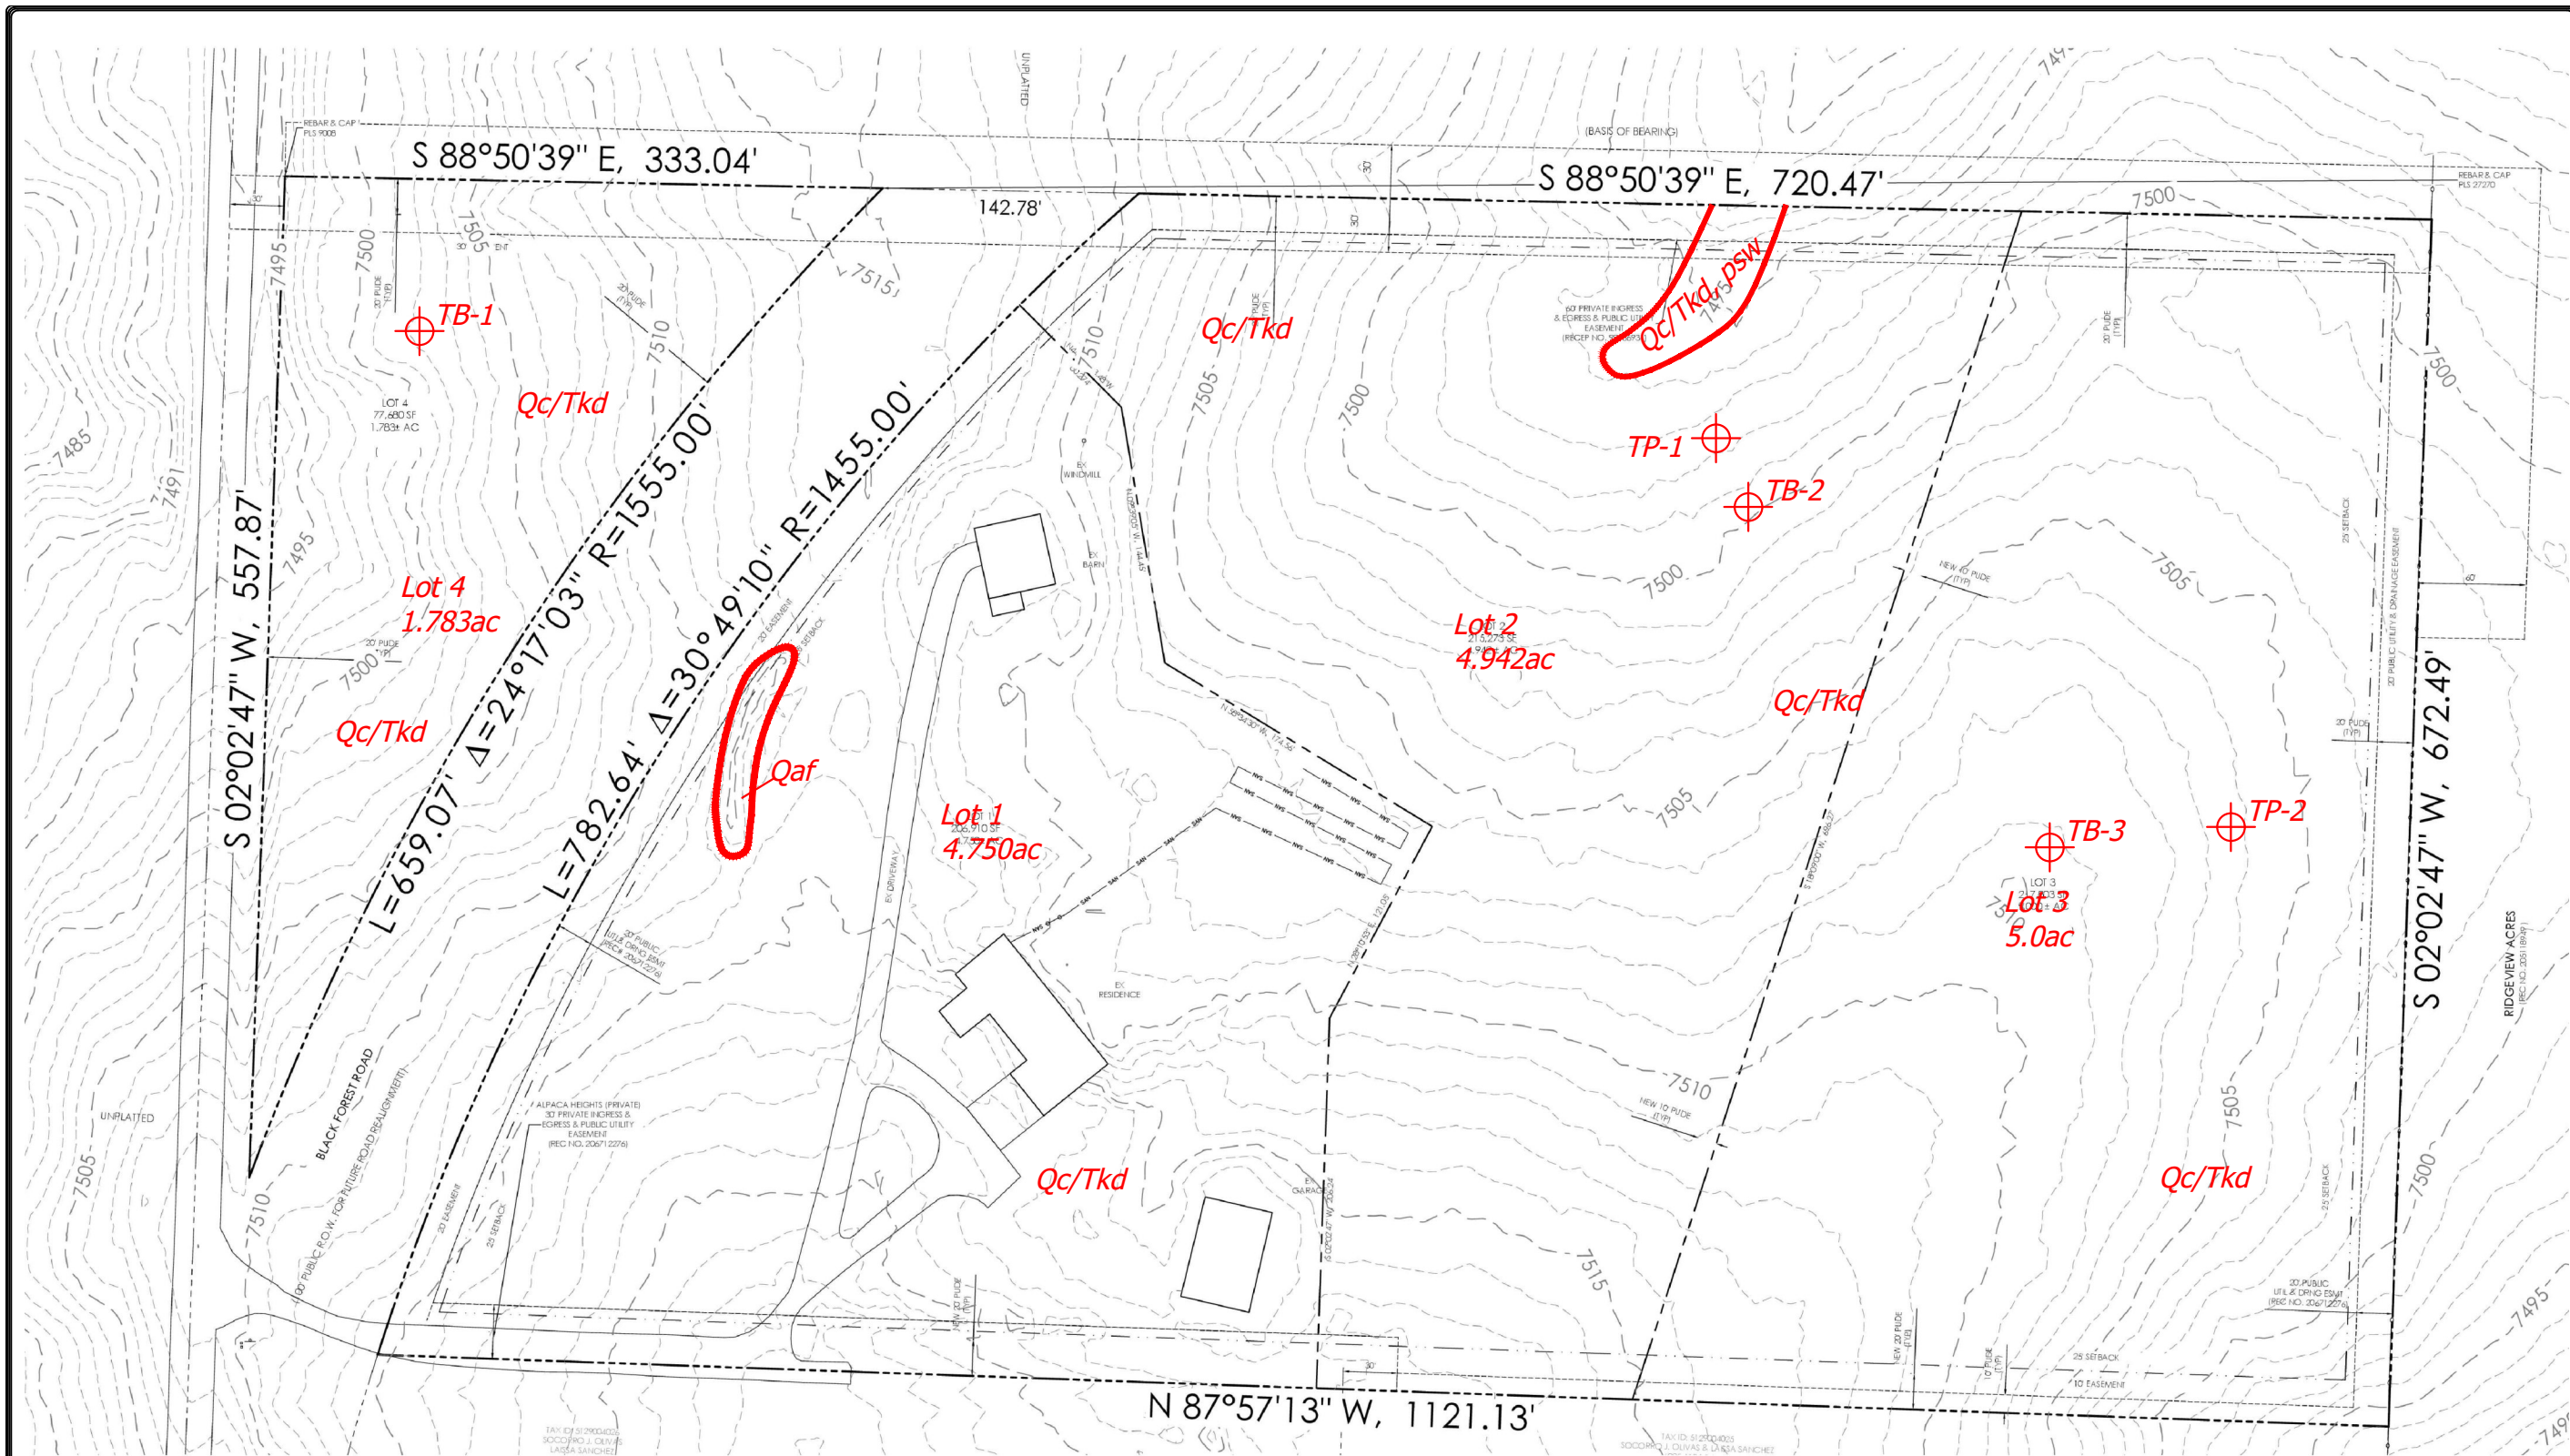
FIGURE No.
6

Qaf Artificial Fill of Holocene Age: These are man-made fill deposits associated with a small embankment in the western portion of Lot 1.

Qc/Tkd Colluvium of Quaternary Age overlying Dawson Formation of Tertiary to Cretaceous Age: The materials consist of colluvial or residual soils overlying the bedrock materials on-site. The colluvial soils were deposited by the action of sheetwash and gravity. The residual soils were derived from the in-situ weathering of the bedrock on site. These materials typically consist of silty to clayey sand with potential areas of sandy clays. The bedrock consists of the Dawson Formation. The Dawson Formation typically consists of coarse-grained, arkosic sandstone with interbedded lenses of fine-grained sandstone, siltstone and claystone.

These are areas of man-made fill associated with an embankment located in the western portion of Lot 1. Areas of fill other than those mapped may exist on the site.

A minor drainage areas exist in the northeastern portion of proposed Lot 2. No water was observed flowing in the drainage, however, this area has the potential for seasonal shallow groundwater. This area is indicated in the Geology/Engineering Geology Map (Figure 6) and are discussed below. Due to the size of the proposed lot this area can be avoided or redirected around proposed structures or proposed soil treatment areas. The site does not lie within any floodplain zones according to the FEMA Map No. 08041CO305G dated December 7, 2018 (Figure 7, Reference 7). Exact locations of floodplain and specific drainage studies are beyond the scope of this report.

The minor drainage area in the northeastern portion of proposed Lot 2 has been identified as a potentially seasonal shallow groundwater area. In this area we would anticipate the potential for periodically high subsurface moisture conditions, frost heave potential and highly organic soils. This area lies within defined minor drainage and can be avoided by the proposed development. Construction in any portions of these areas, if required, or immediately adjacent to these areas should follow these precautions.

Mitigation: It is anticipated these would be avoided by development or regraded. Should any uncontrolled fill be encountered beneath foundations, removal and recompaction at a minimum of 95% of its maximum Modified Proctor Dry Density, ASTM D-1557 will be required.

Mitigation: Foundations must have a minimum 30-inch depth for frost protection. In areas where high subsurface moisture conditions are anticipated periodically, subsurface perimeter drains are recommended to help prevent the intrusion of water into areas below grade. Typical drain details are presented in Figure 8. Any grading in these areas should be done to direct surface flow around construction to avoid areas of ponded water. All organic material would be completely removed prior to any fill placement. **Specific drainage studies are beyond the scope of this report.**

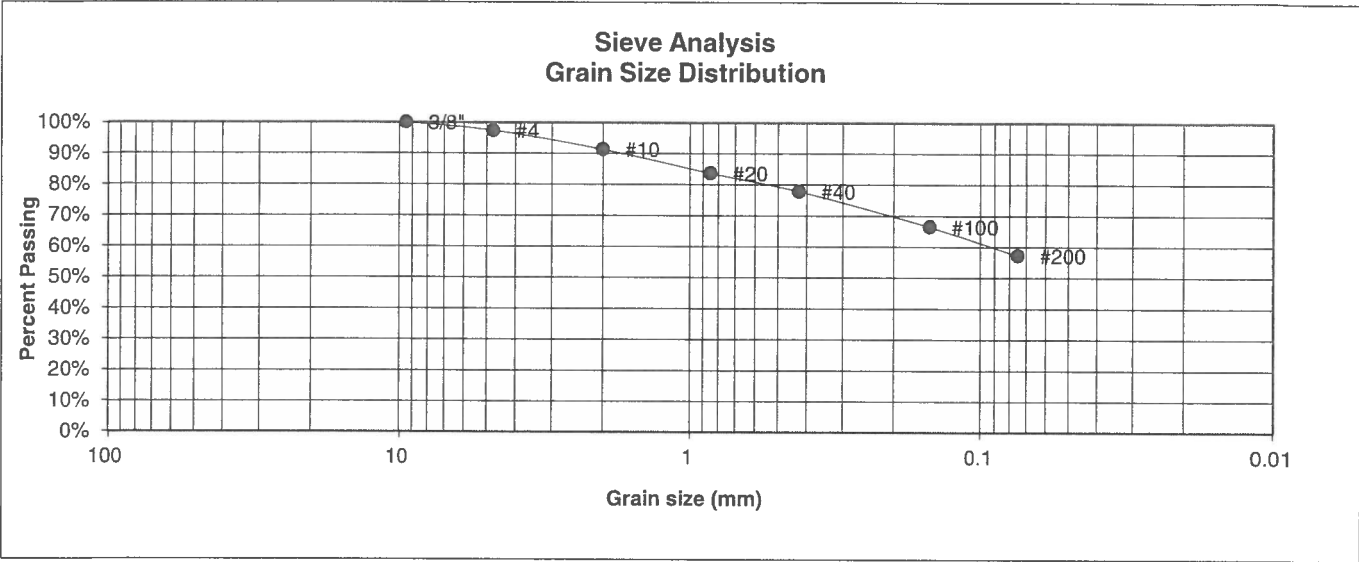
FIG NO.:
C-2

Soil Type 2 is a sandy clay to very sandy clay (CL). The clay soils were encountered in Test Boring No. 3, and in Test Pit Nos. 1 and 2. The clays were encountered at the existing ground surface and extended to depths of 3 feet bgs in Test Boring No. 3, and to the termination of the test pits (6 to 8 feet). The clay was encountered at firm to stiff consistencies and dry to moist conditions. The samples tested had 57 to 77 percent of the soil size particles passing the No. 200 sieve. Expansion pressure of 580 psf was determined by laboratory tests on samples of the clay soils. This magnitude of expansion is in the low expansion range.
