**SOIL, GEOLOGY, & GEOLOGIC HAZARD STUDY
STERLING RANCH EAST – PRELIMINARY PLAN NO. 1
PARCEL NOS. 17, 18, 22, 23, 24, 26, 37, & 38
EL PASO COUNTY, COLORADO**

April 19, 2022

Entech Job No. 220571

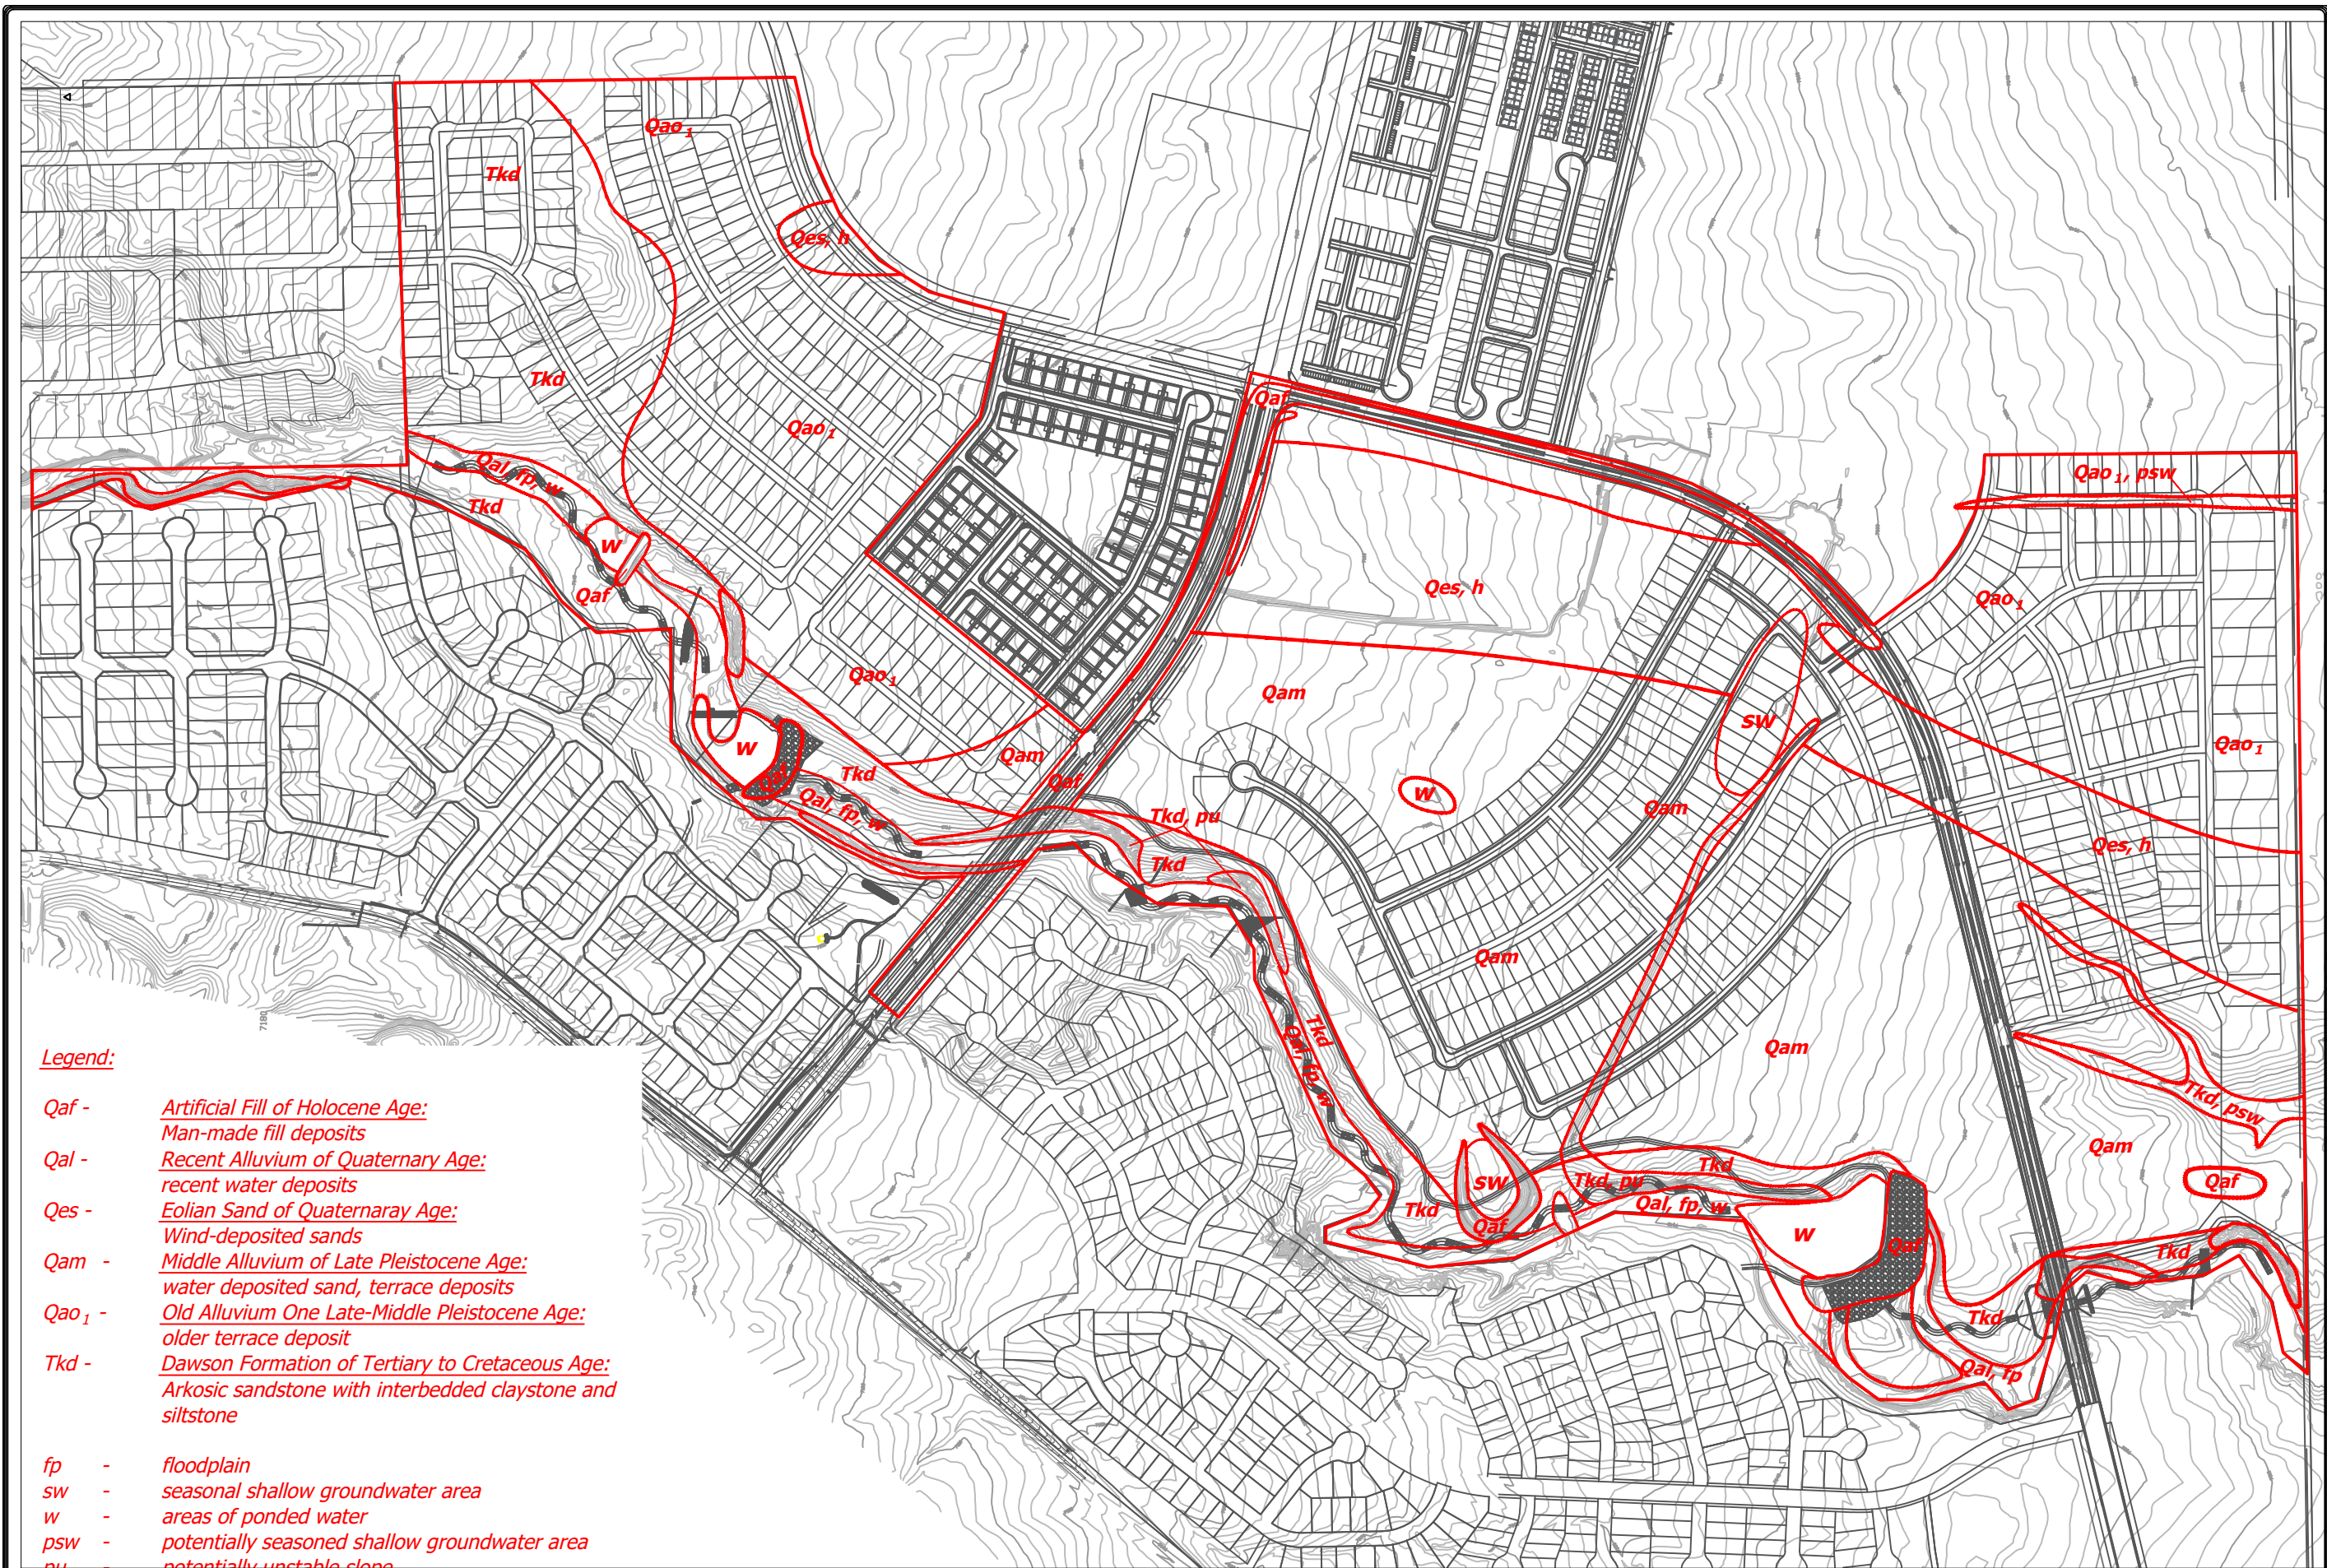
DRAWN L.L.L.
CHECKED
DATE 4/19/22
SCALE AS SHOWN
JOB NO. 220571
FIGURE No. 2

As mentioned previously, detailed mapping has been performed on this site to produce an Engineering Geology Map Figure 7. This map shows the location of various geologic conditions of which the developers should be cognizant during the planning, design and construction stages of the project. These hazards and the recommended mitigation techniques are as follows:

Areas of artificial fill were observed in areas of the site. The majority of these areas are associated with recent grading and fill stockpiling.

The majority of the slopes on-site are gently sloping and do not exhibit any past or potential unstable slopes or landslides. Some of the steeper slopes along Sand Creek west of the site, and the cut slopes from fill borrow areas in the central portion of the site have been identified as potentially unstable slopes. The mitigation recommendation for these areas is as follows:

These slopes are considered stable in their present condition; however, considerable care must be exercised in these areas not to create a condition which would tend to activate instability. The steeper slopes along portions of Sand Creek which are located within open-space or park areas and will be avoided by the planned development. Other areas of potentially unstable slopes are associated with cut slopes in the fill borrow areas in the central portion of the site will likely be regraded during the development of the site.

Seasonal Shallow Groundwater: In these areas, we would anticipate the potential for periodically high subsurface moisture conditions and possible frost heave potential, depending on the soil conditions. These areas are located within the drainage swale/trench that exists in the proposed school area of the site. Shallow groundwater was encountered in the test boring drilled adjacent to the trench. It is anticipated this area would be regraded and filled prior to construction. Areas of shallow groundwater may exhibit unstable subgrade conditions in terms of bearing support of construction equipment during overlot grading. Areas immediately adjacent to drainage may also experience higher subsurface moisture conditions during periods of higher flows.

Mitigation: It is anticipated the fill piles will be removed prior to construction during site grading. In the areas of site grading, fill records should be obtained to determine if the fill was placed in a controlled manner. Where uncontrolled fill is encountered beneath foundations, mitigation will be necessary. Mitigation typically involves removal and recompaction at a minimum of 95 percent of its maximum Modified Proctor Dry Density, ASTM D-1557. Any new fill added to the site should be placed on native or controlled fill soils, compacted as recommended above.

Mitigation: According to the development plan shown on Figure 3, the majority of these areas are to be avoided. Building should be avoided on the potentially unstable slopes unless stabilized. A setback of 20 feet from the crest of these slopes is recommended unless stabilized. Stabilization could involve regrading to slope angles no steeper than 3:1 or the use of engineer-designed retaining walls, tiebacks, or buttresses. Where retaining walls are not used, erosion protection may be necessary to prevent undercutting by the creek during periods of high water. It is our understanding the project will include drainage improvements and the construction of a regional trail along the Sand Creek drainage and stabilization of the slopes will be a part of the improvements. Specific slope stabilization recommendations are beyond the scope of this report.

Mitigation: In these locations, foundations subject to severe frost heave potential should penetrate sufficient depth so as to discourage the formation of ice lenses beneath foundations. At this location and elevation, a foundation depth for frost protection of 30 inches is recommended. In areas where high subsurface moisture conditions are anticipated periodically, a subsurface perimeter drain will be necessary to help prevent the intrusion of water into areas located below grade. A typical perimeter drain detail is presented in Figure 9. Structures should not block drainages. Swales should be created to intercept surface runoff and carry it safely around and away from structures.

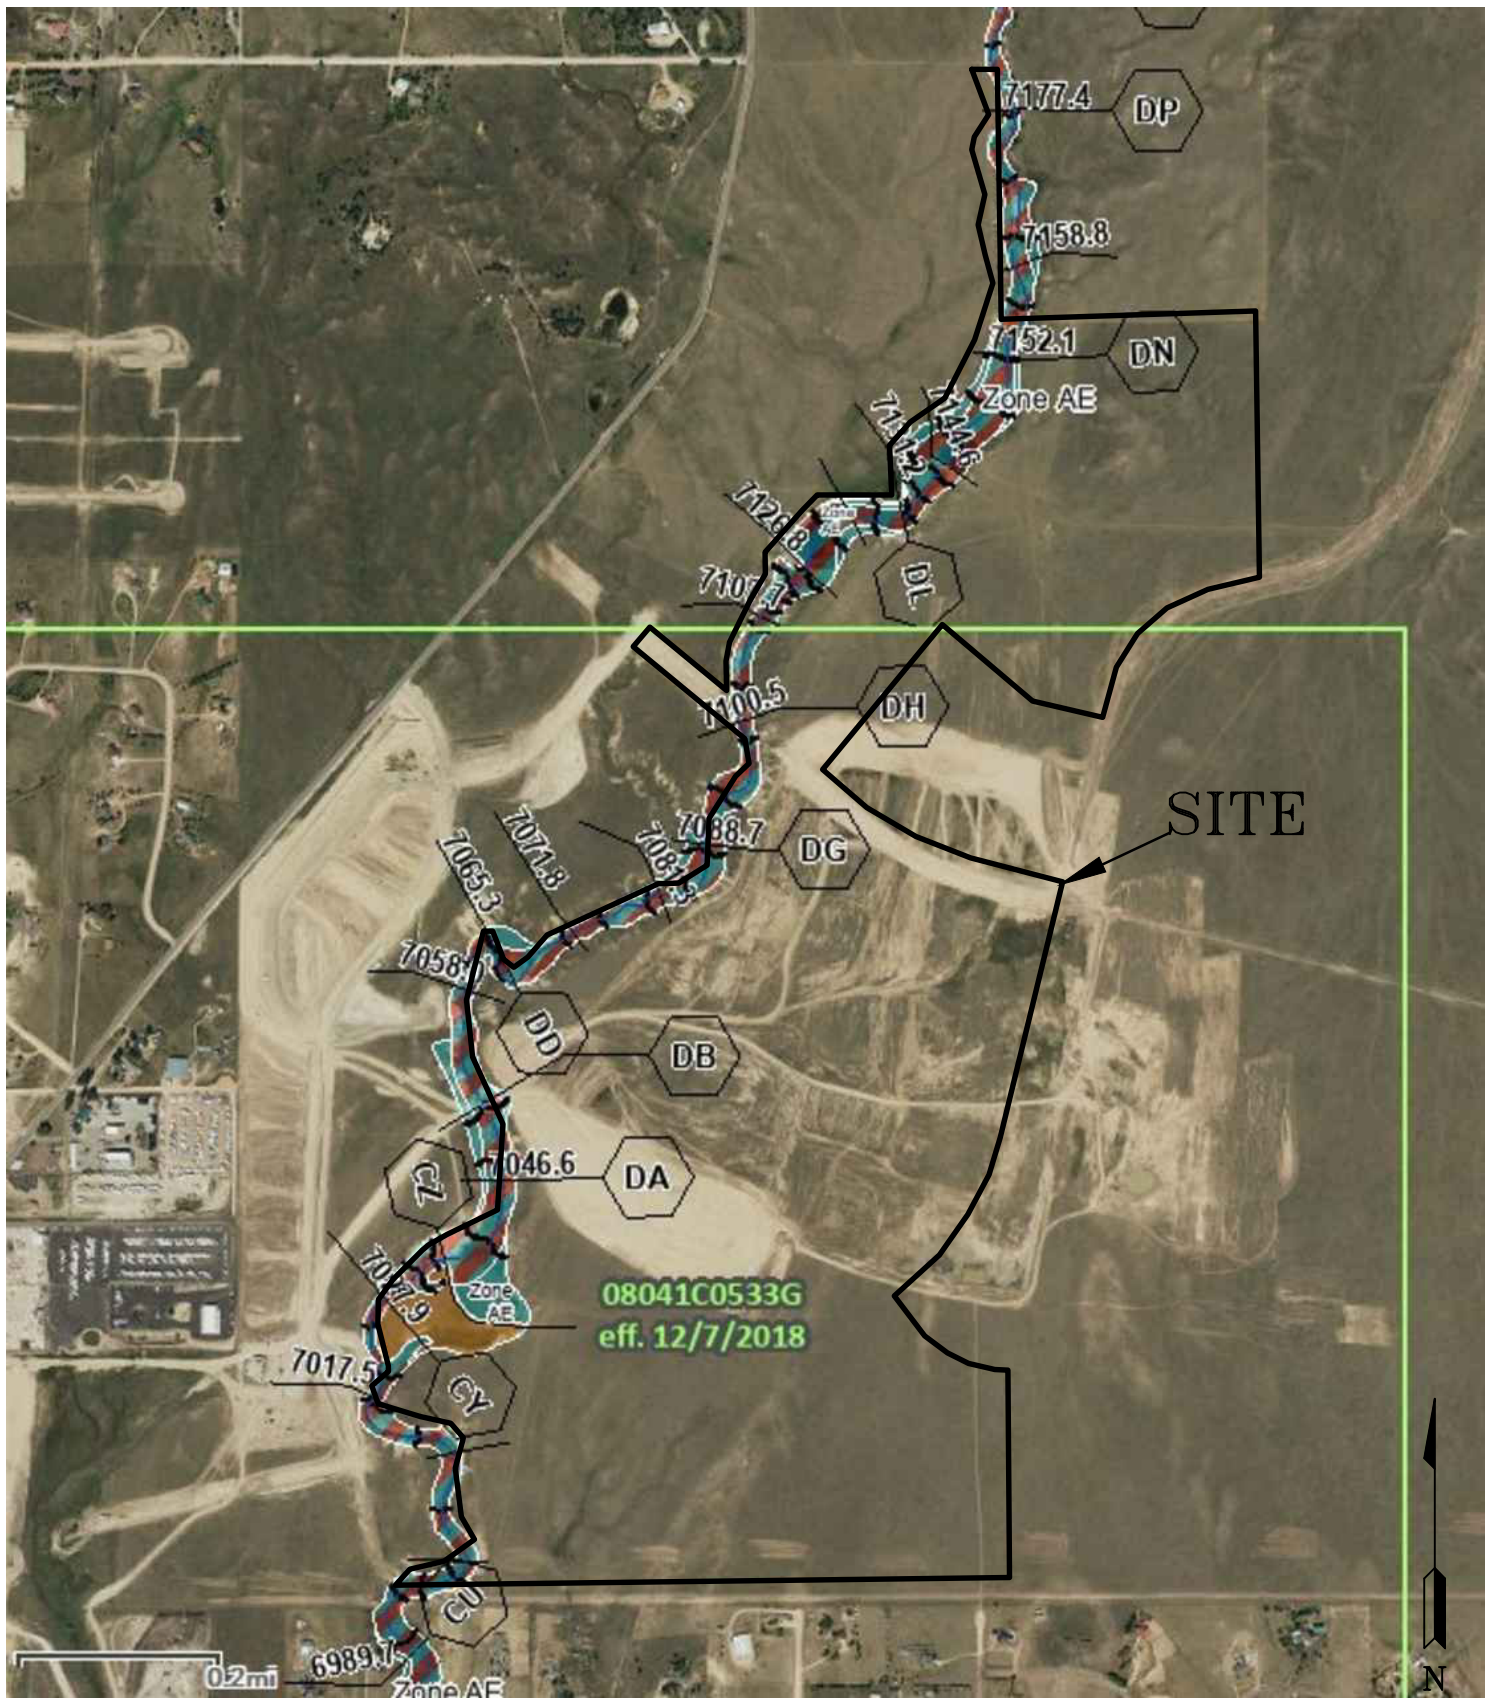
FIG NO.:
8

The Sand Creek drainage lies west of the site and has been mapped as a floodplain zone according to the FEMA Map Nos. 08041CO533G and 08041CO535G, Figure 8 (Reference 12). Additionally, areas of ponded water exist along Sand Creek. Other areas of standing water were observed on the site to the south of the site at the northwest corner of future Briargate Parkway and Sterling Ranch Road, within the central portion of the site south west of the middle school site. Groundwater was encountered in nine of the test borings at depths of 3 to 19 feet, the remaining borings were dry. A minimum separation of 3 feet between foundation components and groundwater levels are recommended. These areas are discussed as follows:

The Sand Creek drainage lies west of the site and has been mapped as a floodplain zone according to the FEMA Map Nos. 08041CO533G and 08041CO535G, Figure 8 (Reference 12). The building areas of the site do not lie within the floodplain zone as indicated in Figure 8. Any construction considered in a floodplain area will require approval of the drainage plan. Lots immediately adjacent to the floodplain may experience higher groundwater levels during peak flows. Subsurface perimeter drains are recommended for structures adjacent to the floodplain to help prevent the intrusion of water into areas below grade. Typical drain details are presented in Figure 9. Finished floor levels must be a minimum of one floor above the floodplain level. Exact floodplain locations by drainage studies are beyond the scope of this report.

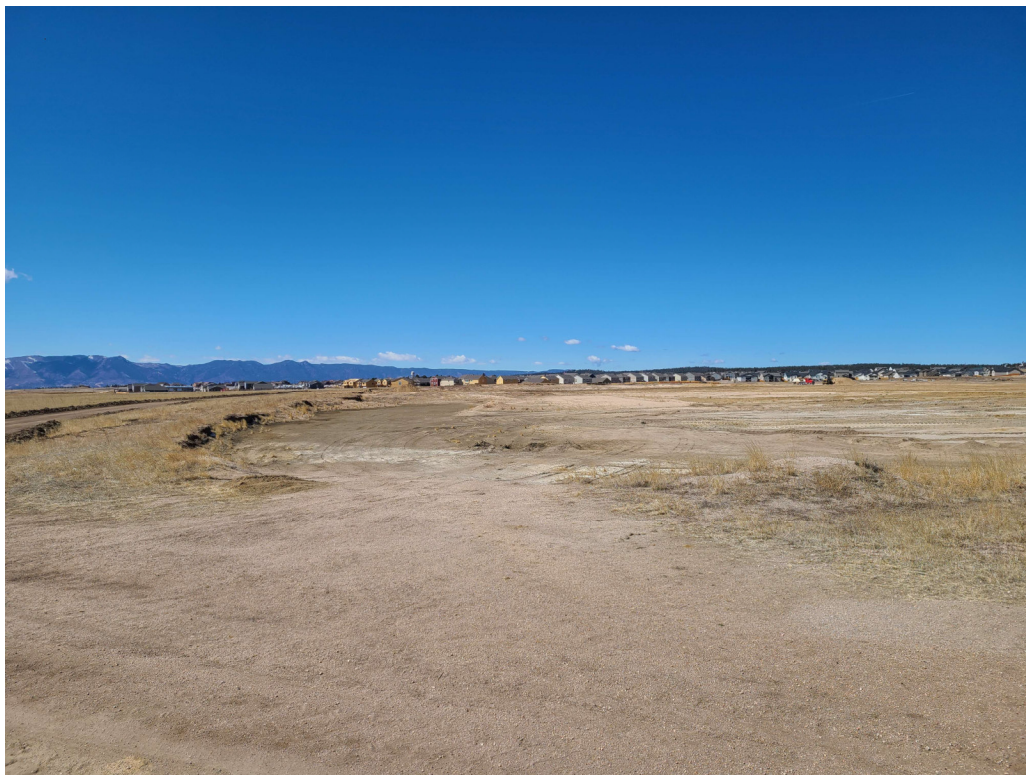
**Looking northwest
from the southeastern
portion of the site
towards low-lying
seasonal wet area.**

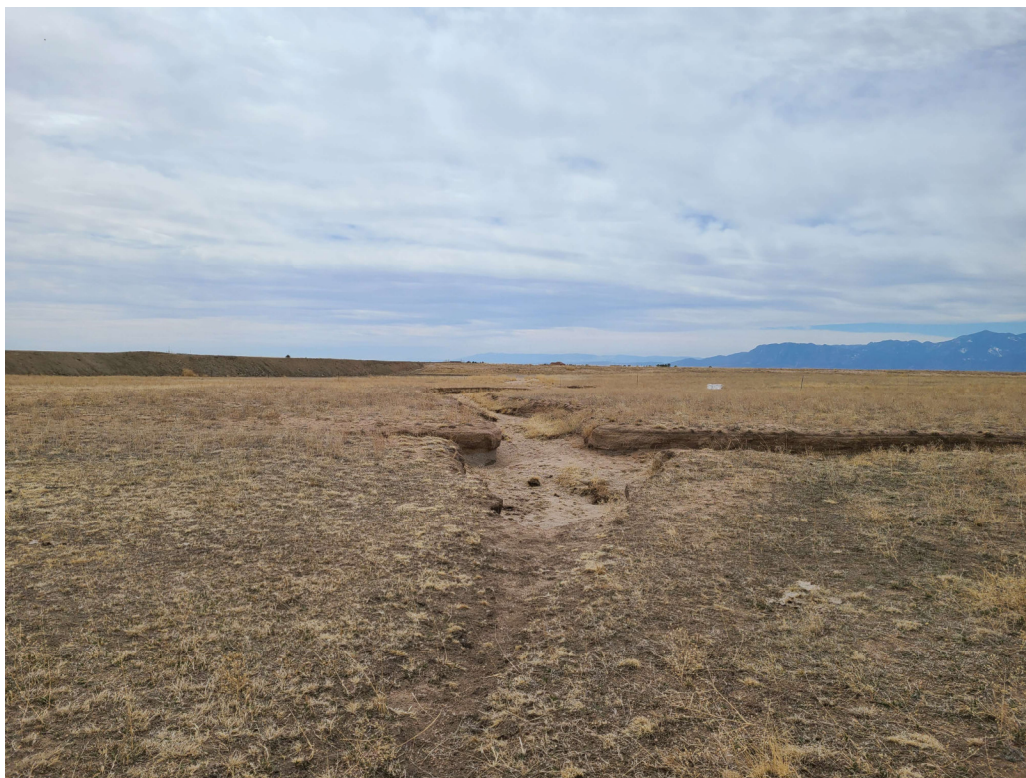
These are areas that are undergoing erosion by water and sheetwash producing gullies and rill erosion. The areas significant erosion observed on the site are located in the former borrow areas where most of the vegetation had been removed.

**Looking southwest
towards erosion
feature in the central
portion of the site west
of future Sterling
Ranch Road.**

Mitigation: Due to the nature of the soils on this site, virtually all the soils are subject to erosion by wind and water. Other minor areas of erosion were observed on site other than those mapped, particularly where some rill erosion has occurred. Areas of erosion can occur across the entire site, particularly if the soils are disturbed during construction. Vegetation reduces the potential for erosion. The areas identified where erosion is actually taking place may require check dams, regrading and revegetation using channel lining mats to anchor vegetation. Further recommendations for erosion control are discussed under Section 8.0 "Erosion Control" of this report. Recommendations pertaining to revegetation may require input from a qualified landscape architect and/or the Natural Resource Conservation Service (previously Soil Conservation Service).

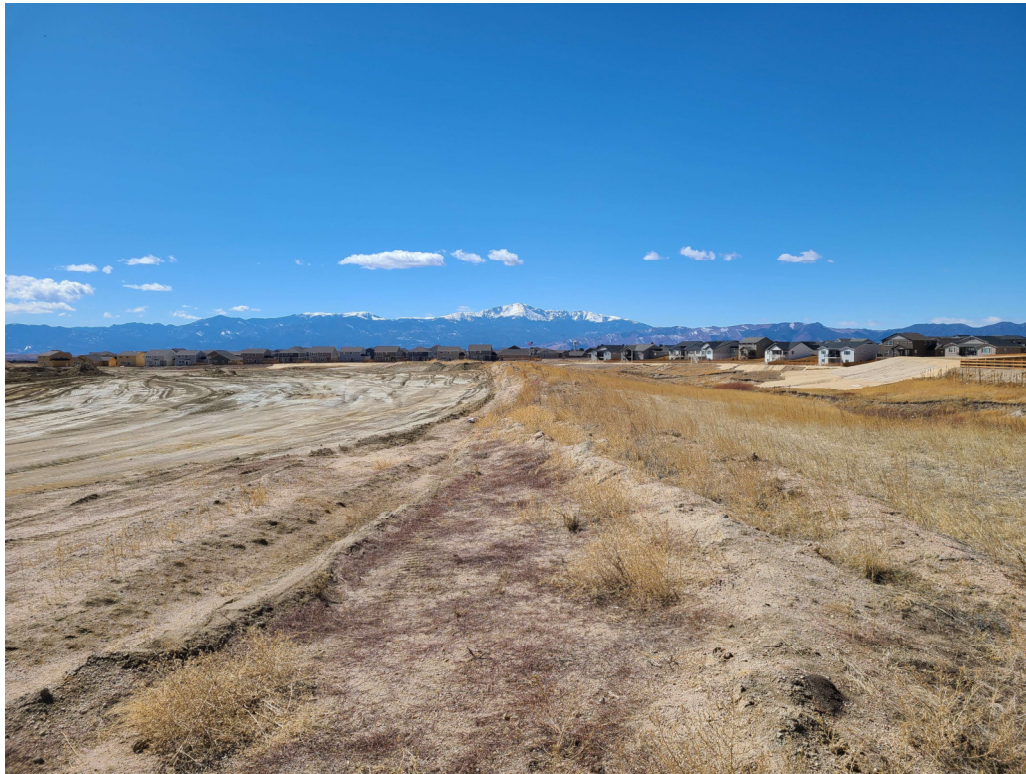
**Looking southwest
along Sand Creek from
the west central
portion of the site.**

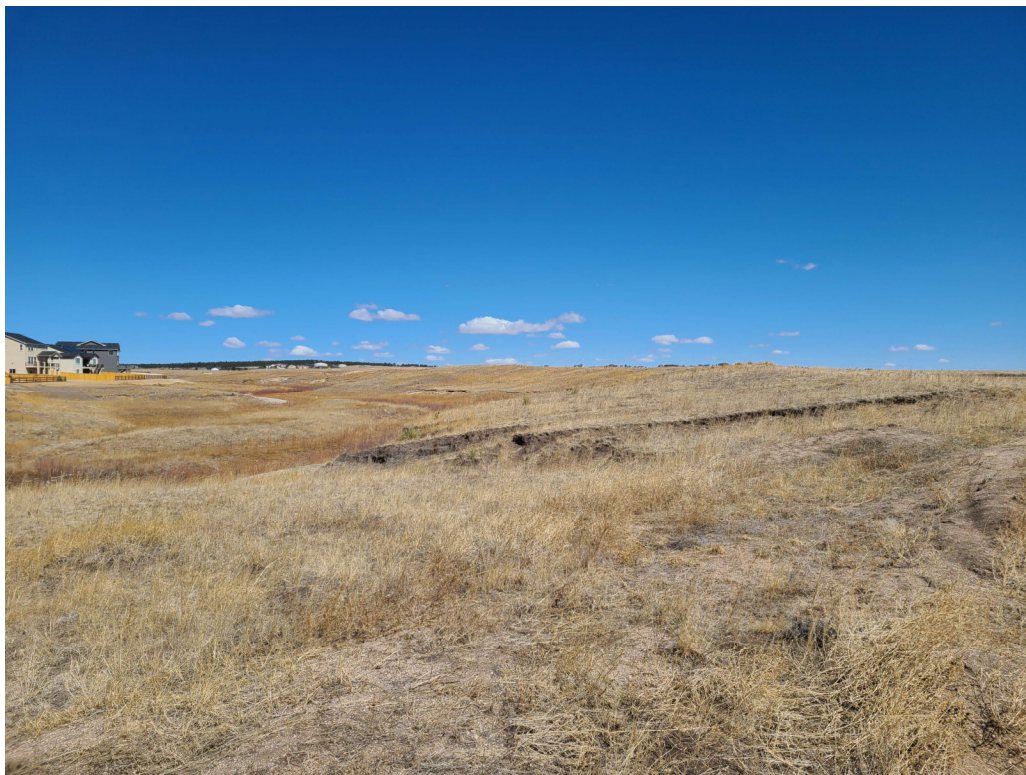
**Looking north along
Sand Creek Drainage
along the west central
portion of the site.**

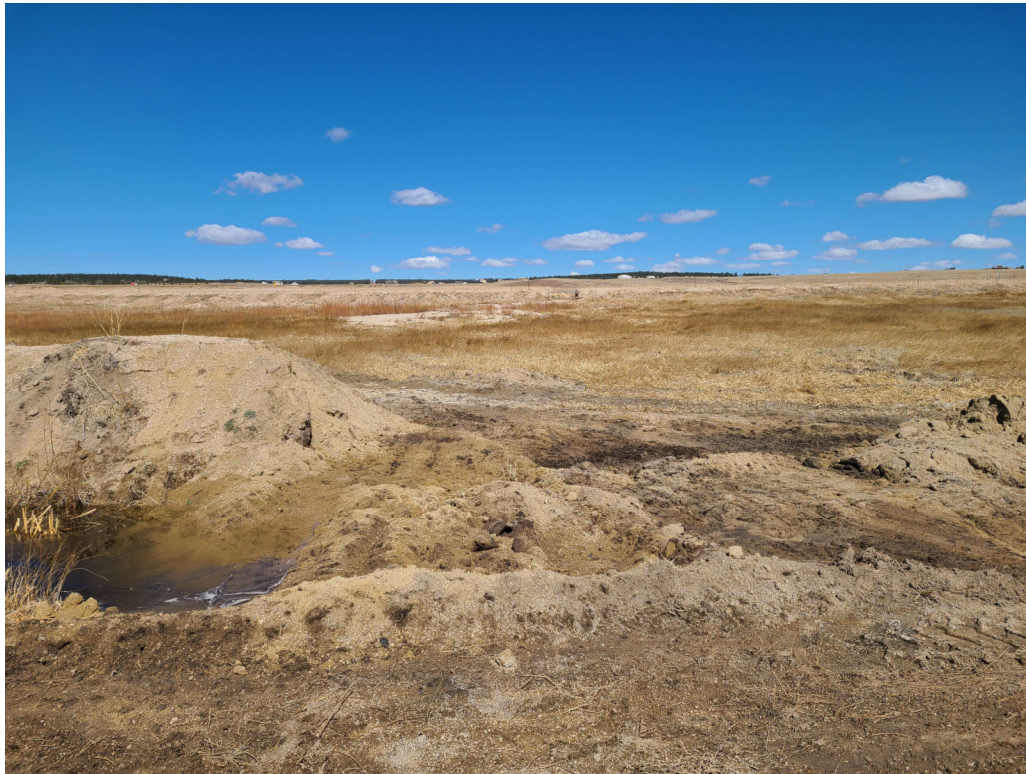
**Looking north at area
of standing water on
the south side of
future Briargate
Parkway.**
