Wyoming Estates Preliminary Plan

Filings #1 and #2

Compilation of Soils, Geology, and OWTS

Soils and Geology
And Wastewater Treatment System
Evaluation

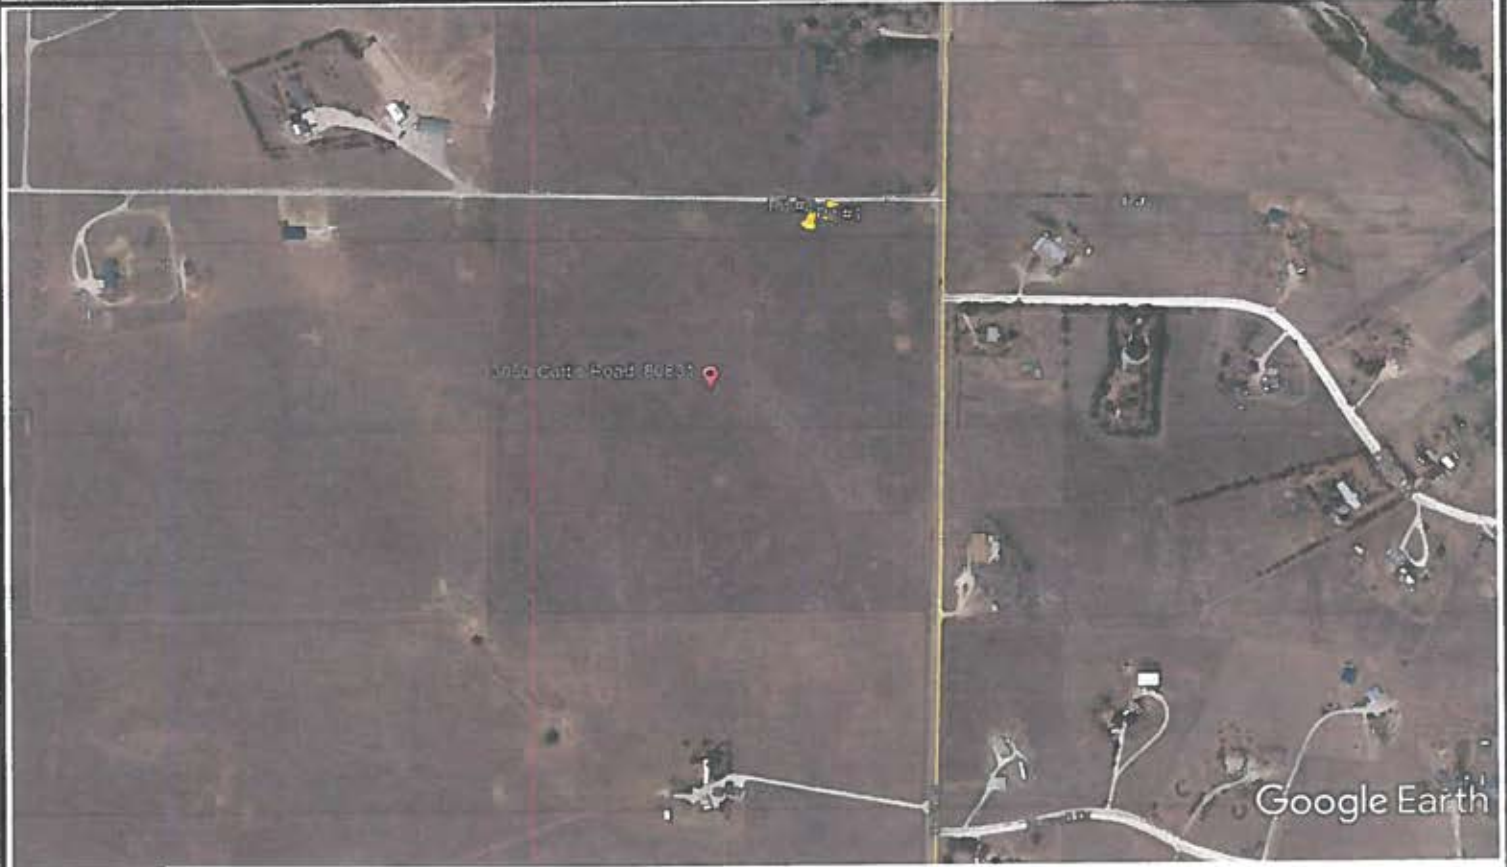
Google Site Map

Recommendations: (1) A conventional, non-engineered On-Site Wastewater Treatment system (OWTS) is acceptable for this site.
