Subject: Geologic Hazard Evaluation
Citizen on Constitution
El Paso County, Colorado
CTL|T Project No. CS19460-105

GEOLOGIC HAZARD EVALUATION

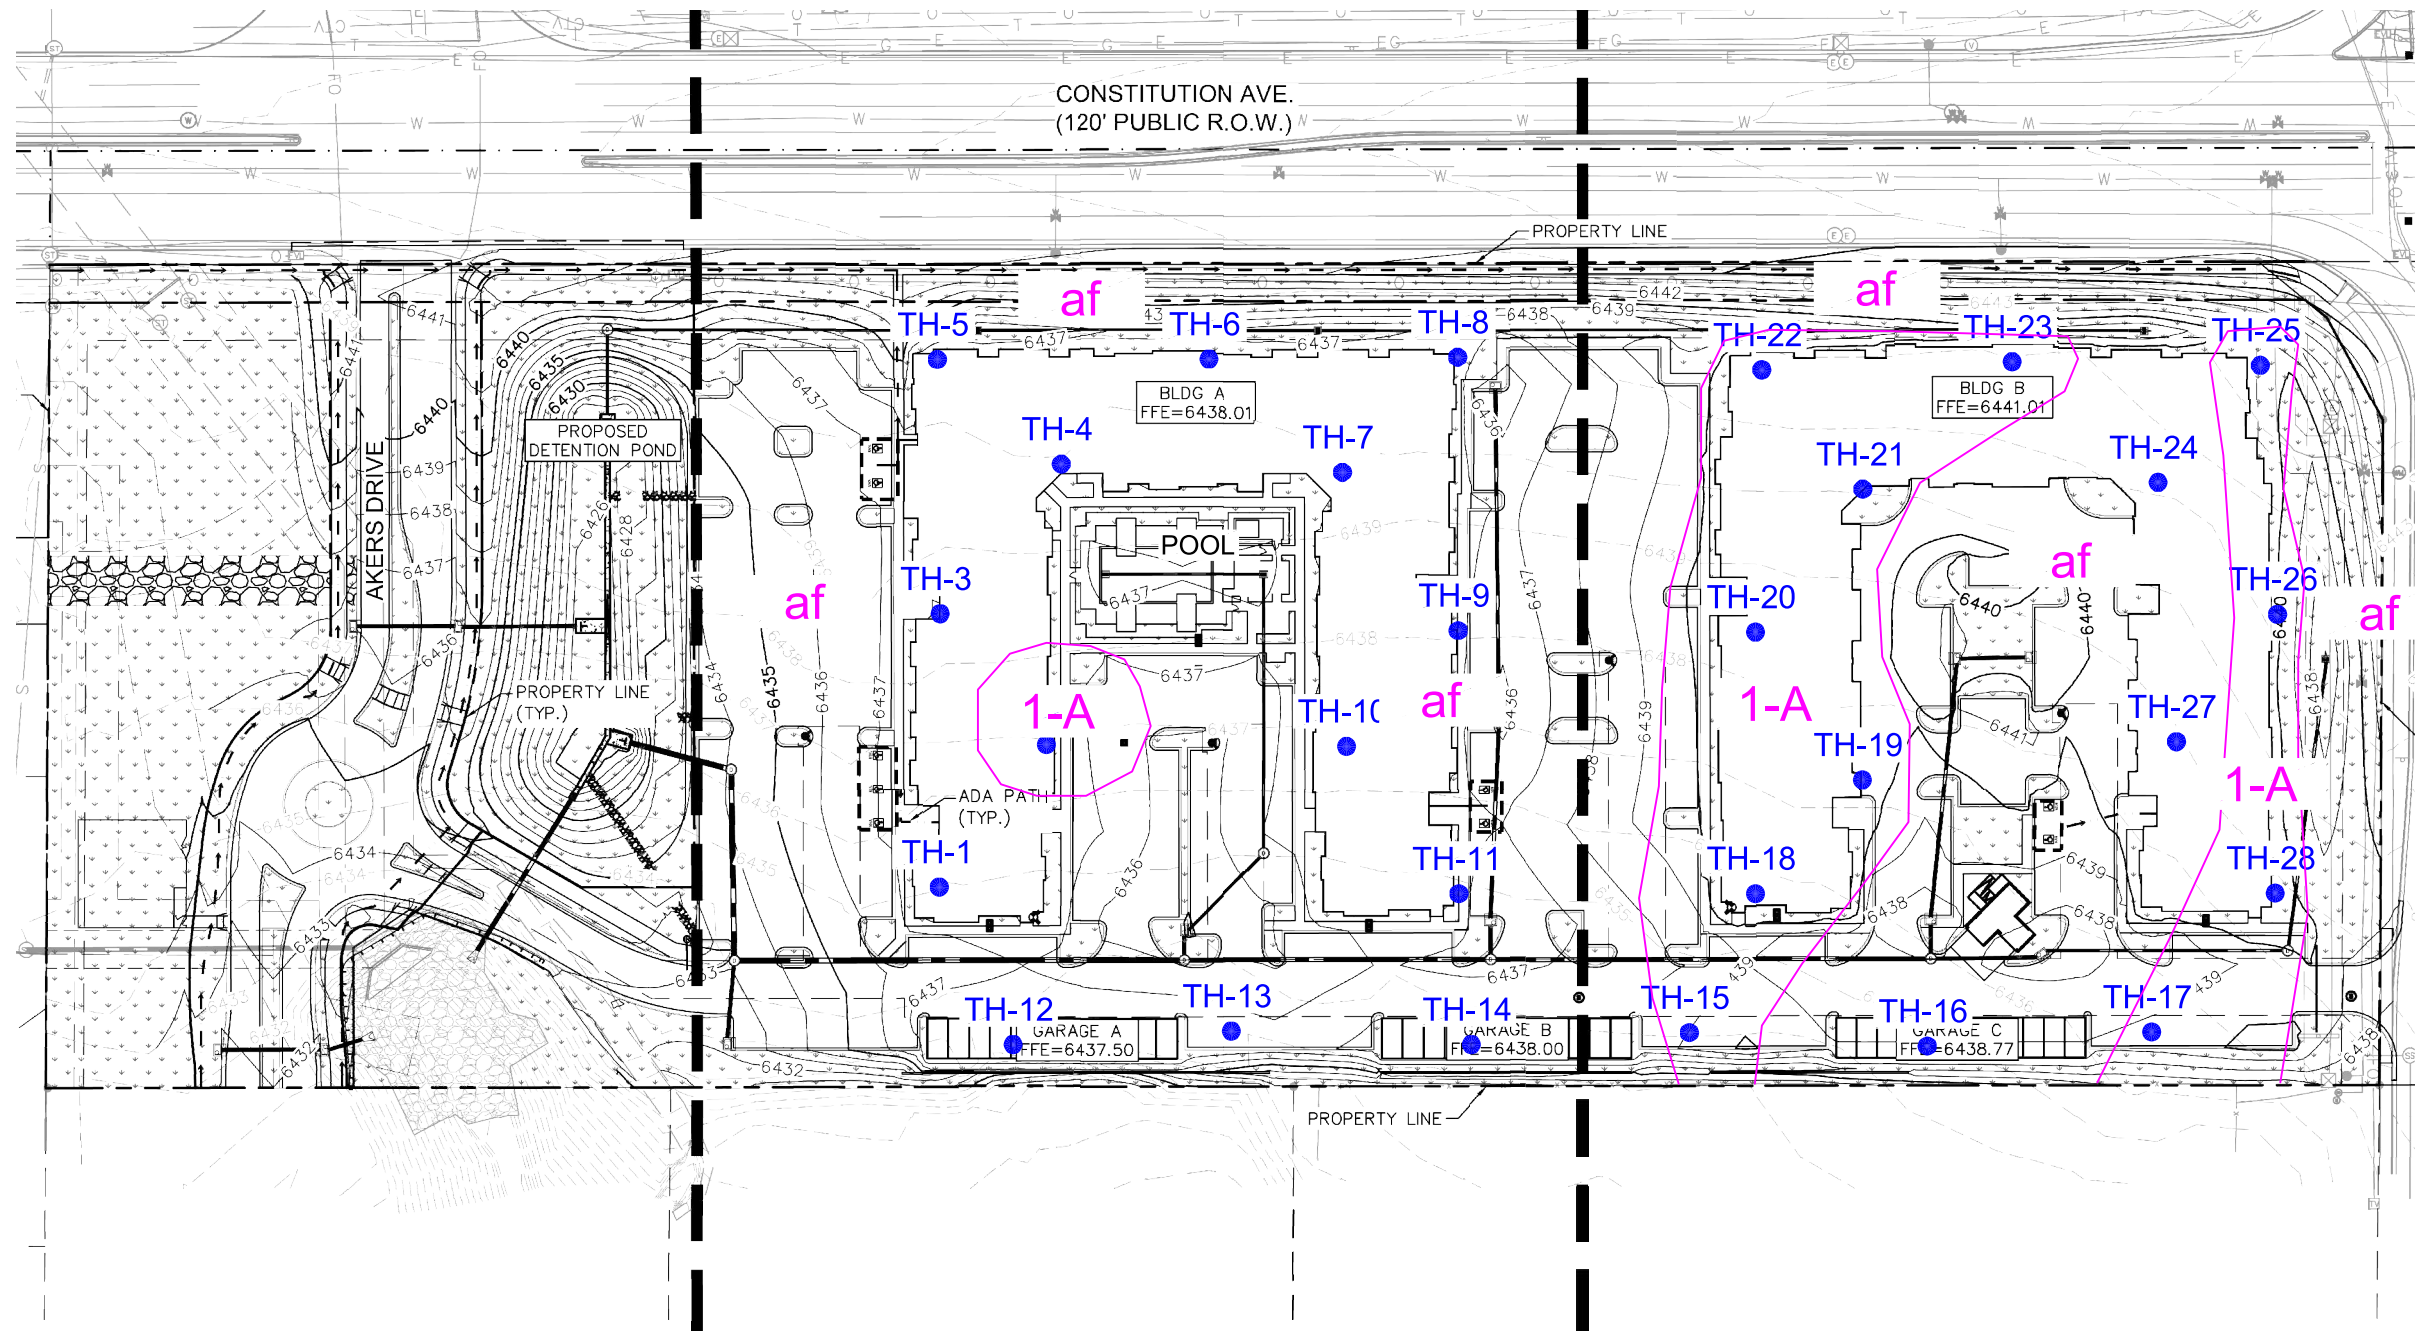
The site is mapped as late Pleistocene-age eolian sand (wind-deposited sediment) consisting of very pale-brown, pale-brown, and light yellowish-brown sand with silt deposited as sand sheets, overlying the Dawson Formation. The Dawson Formation typically consists of sandstone interbedded with claystone in this area. Our subsurface investigation and observations generally confirm the mapping, although the site has been disturbed though prior use. A map of the site specific surficial geologic conditions is shown on Figure 2.

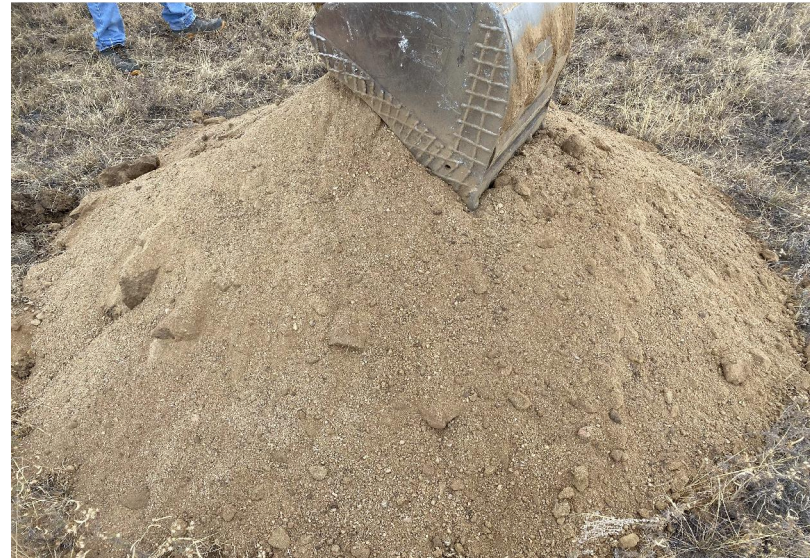
2. Material from Test Pit 1

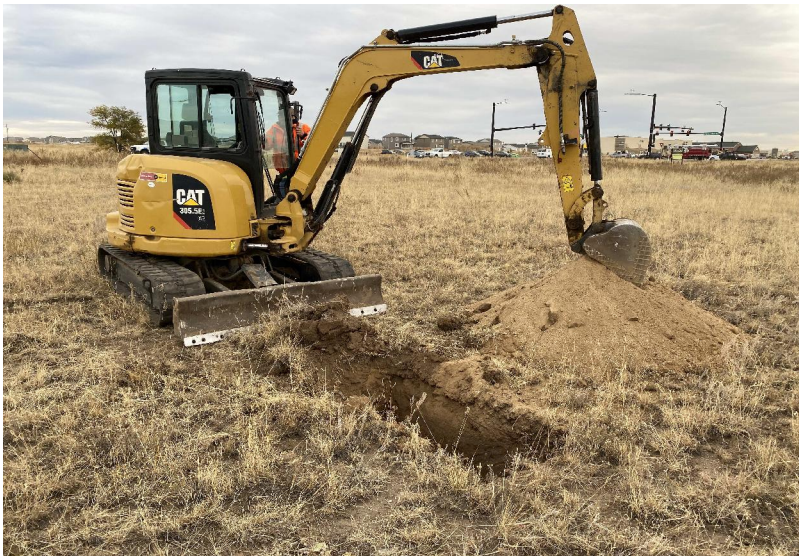
3. Overall view of excavation for Test Pit 1

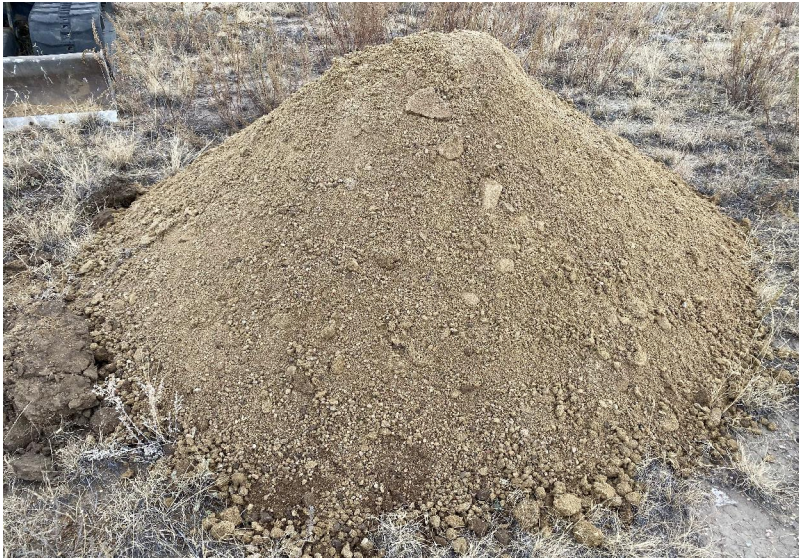
5. Material from Test Pit 2

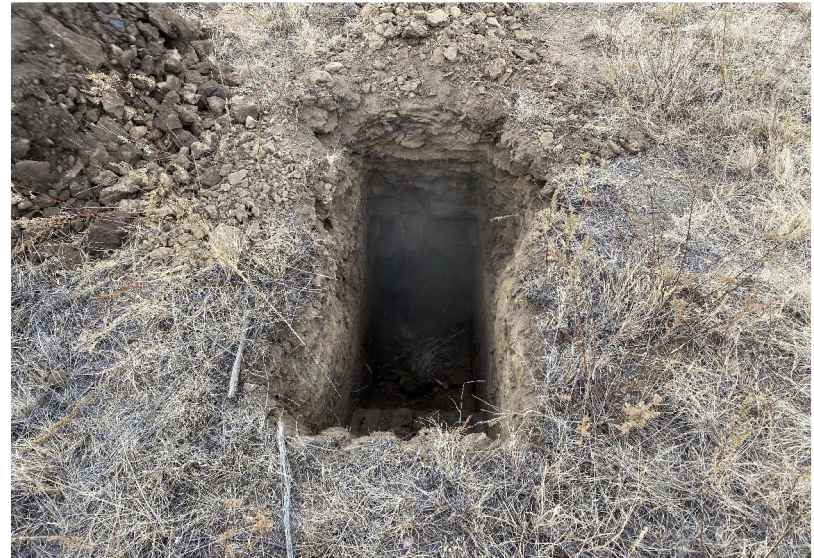
6. Test Pit 3

- Suspect solid waste materials were not observed in the test pits.
- We do not believe that further investigation is warranted at this time. If potentially solid waste materials are encountered during the development of the Site, we should be contacted for further guidance.
- A very limited amount of debris was encountered in Test Pit 3.

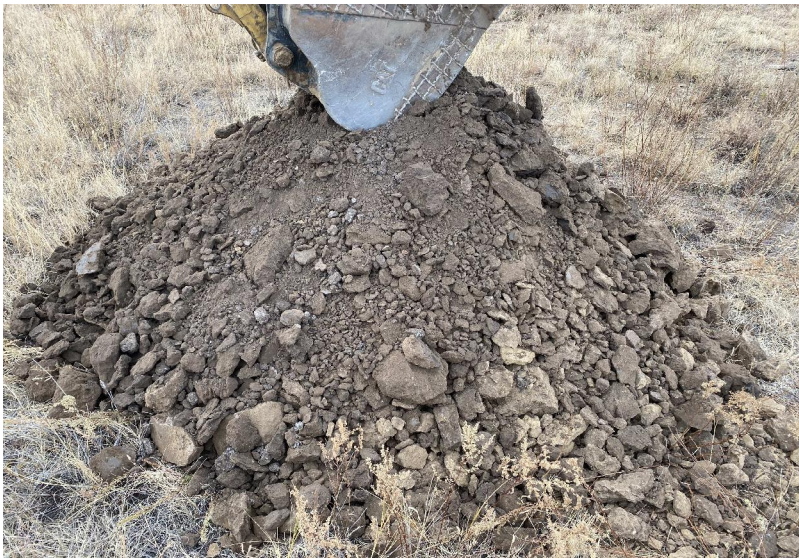
7. Material from Test Pit 3

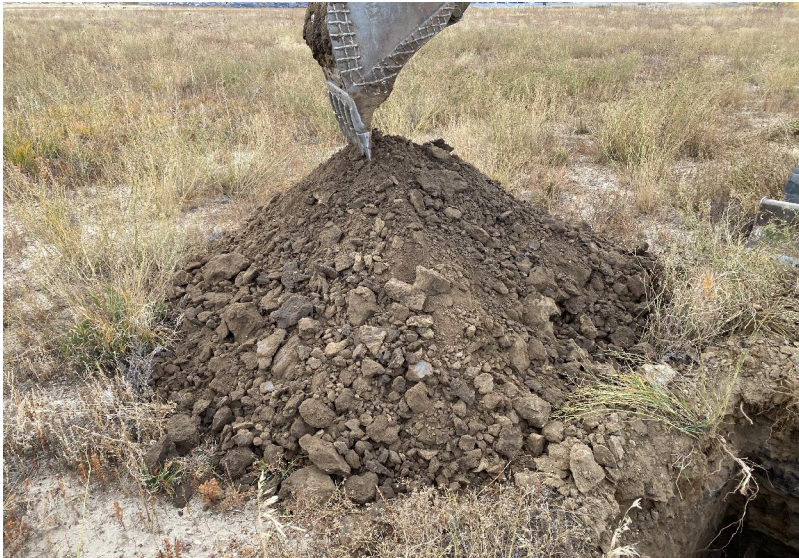
9. Material from Test Pit 4

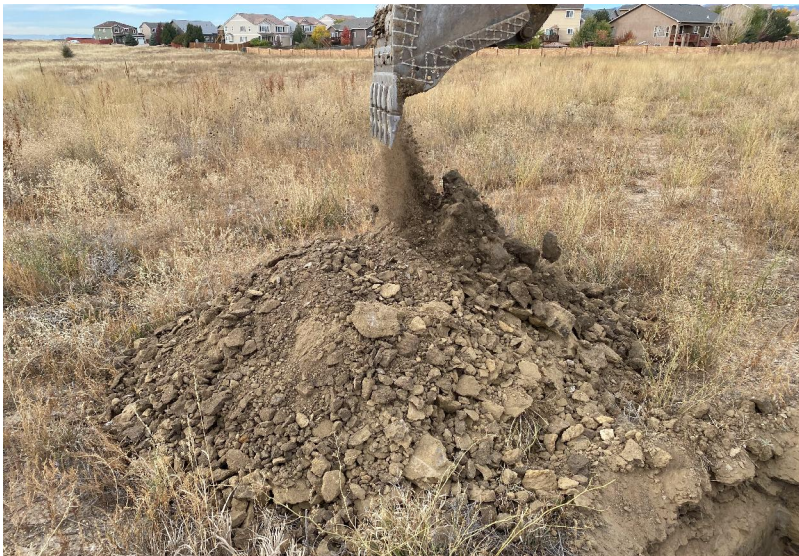
11. Material from Test Pit 5
