**SOIL, GEOLOGY AND
GEOLOGIC HAZARD STUDY
CLOVERLEAF DEVELOPMENT
EL PASO COUNTY, COLORADO**

PT Cloverleaf, LLC
1864 Woodmoor Drive, Suite 100
Monument, Colorado 80132

April 7, 2020
Revised November 9, 2020

Entech Job No. 200100
AAProjects/2020/200100 soil ge

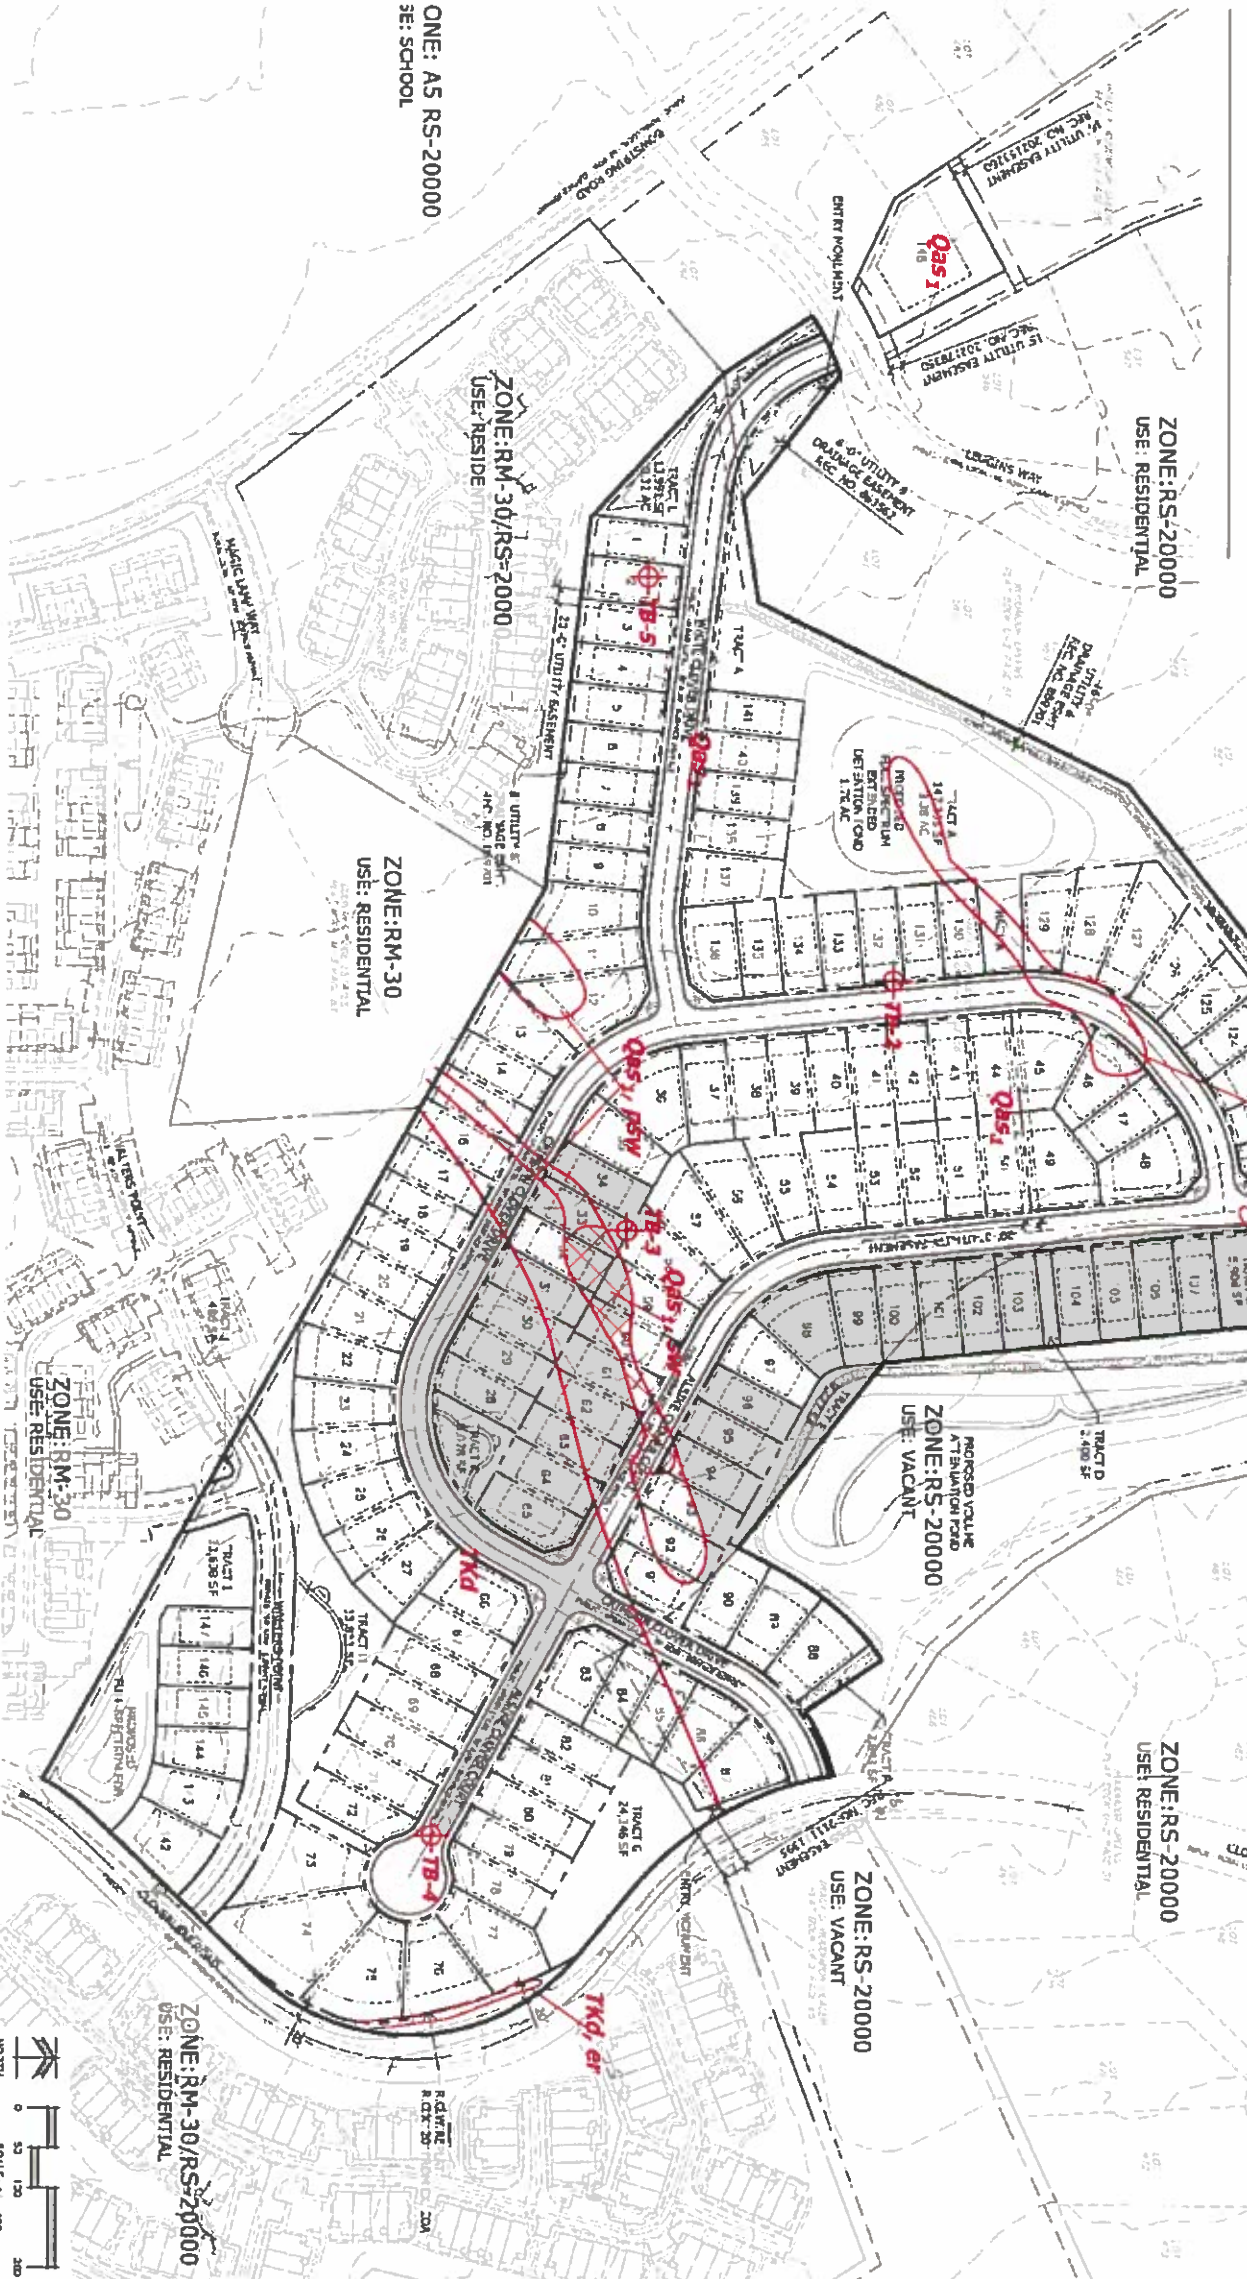
ENGINEERING GEOLOGY MAP
CLOVERLEAF DEVELOPMENT
HIGBY ROAD & CLOVERLEAF ROAD
MONUMENT, CO
FOR: PT CLOVERLEAF, LLC

As mentioned previously, detailed mapping has been performed on this site to produce an Engineering Geology Map (Figure 6). This map shows the location of various geologic conditions of which the developers and planners should be cognizant during the planning, design and construction stages of the project. The hazards identified on this site include loose soils, erosion, potentially seasonal shallow groundwater, and seasonal shallow groundwater areas. The following hazards have been addressed as a part of this investigation:

These are areas that are undergoing erosion by water and sheetwash producing gullies and rill erosion. Areas of erosion were observed in the Teachout Creek drainage in the northern portion of the site, and an area along eastern side of the site along Cloverleaf Road.

In these areas, we would anticipate the potential for periodically high subsurface moisture conditions and possible frost heave potential, depending on the soil conditions. Areas within the drainages on-site have been identified as potentially seasonal shallow groundwater, and the seasonal shallow groundwater area is located in a minor drainage area in the south-central portion of the site, and is also identified as a wetland in the National Wetland Inventory. In this wetland area we would anticipate the potential for surface and near surface groundwater conditions depending on seasonal changes in precipitation and runoff. This area had saturated surface conditions and minor areas of standing water during our field mapping. The areas identified as potentially seasonal and seasonal shallow groundwater lie within drainages and low-lying areas that will be regraded during overlot grading. Where structures or utility trenches encroach on, or lie within these areas, the following mitigation is recommended:

Mitigation: In these locations, foundations in areas subject to severe frost heave potential should penetrate sufficient depth so as to discourage the formation of ice lenses beneath foundations. Preliminary grading plans indicate the seasonally wet area will be filled. At this location and elevation, a foundation depth for frost protection of 30 inches is recommended.

In areas where high subsurface moisture conditions are anticipated periodically, a subsurface perimeter drain will be necessary to help prevent the intrusion of water into areas located below grade. A typical perimeter drain detail is presented in Figure 8. Where shallow groundwater is encountered, additional drains, such as capillary breaks and/or interceptor drains may be necessary typical drain details are presented in Figures 9 and 10. Unstable conditions should be expected where excavations approach the groundwater level. The use of rock, shotcrete, or geo-grids may be necessary to stabilize excavations. Additionally, swales should be created to intercept surface runoff and carry it safely around and away from structures. The drainages will be filled during site grading mitigating the seasonal shallow and potentially seasonally shallow groundwater hazards. The water table may be of sufficient depth to minimize the effects on buildings; however, groundwater may be encountered during utility trenches during site development. All soft and organic soils should be removed prior to fill placement. Stabilization of the subgrade with rock and fabric prior to placing fill may be necessary if saturated unstable conditions are encountered.

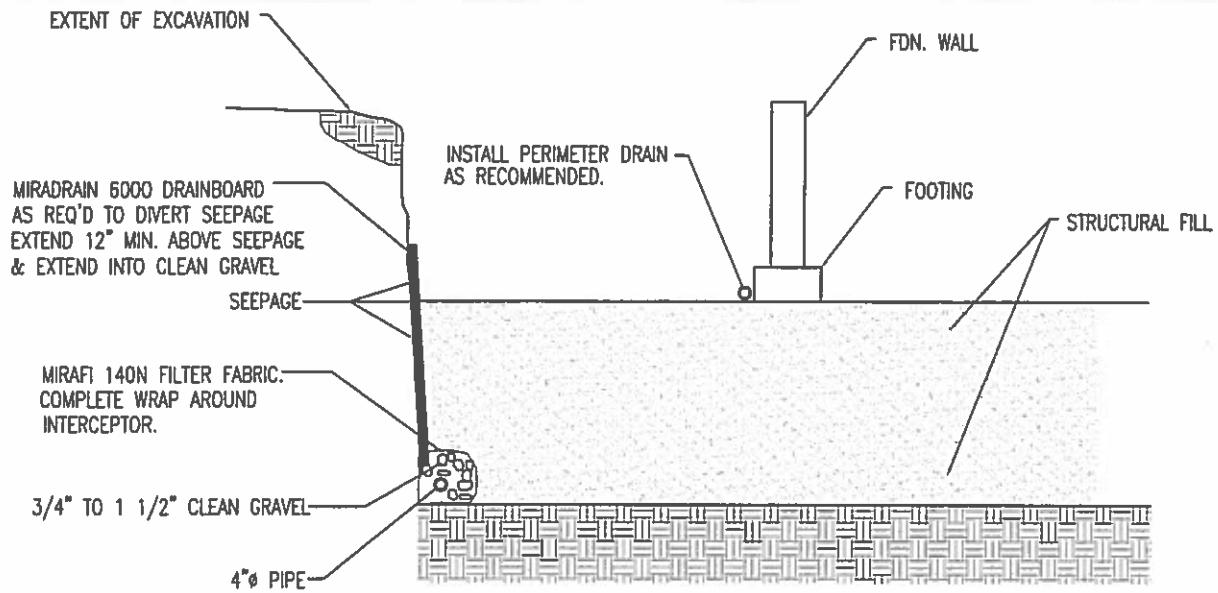
INTERCEPTOR DRAIN DETAIL
N.T.S.

NOTE:
EXTEND INTERCEPTOR DRAIN TO DAYLIGHT

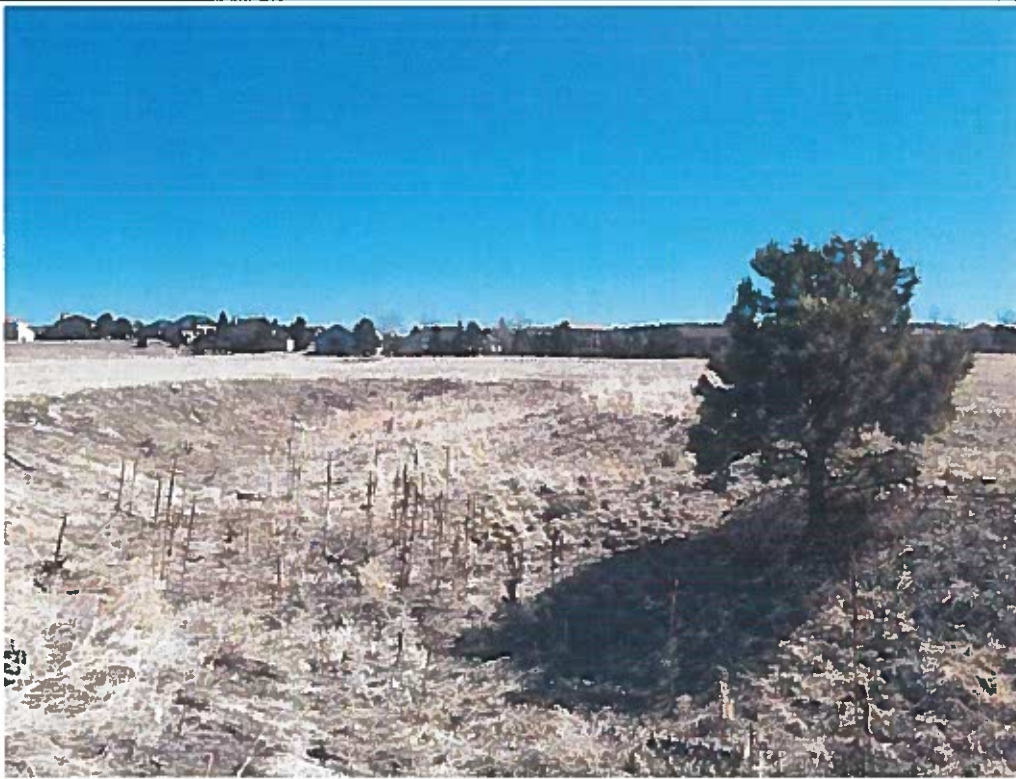
**Looking northeast
along Teachout Creek
in the northwestern
portion of the site.**

Mitigation: Due to the nature of the soils on this site, virtually all the soils are subject to erosion by wind and water. Other minor areas of erosion were observed on site other than those mapped, particularly where some rill erosion has occurred. Areas of erosion can occur across the entire site, particularly if the soils are disturbed during construction. Vegetation reduces the potential for erosion. The areas identified where erosion is actually taking place may require check dams, regrading and revegetation using channel lining mats to anchor vegetation. Further recommendations for erosion control are discussed under Section 9.0 "Erosion Control" of this report. Recommendations pertaining to revegetation may require input from a qualified landscape architect and/or the Natural Resource Conservation Service (previously Soil Conservation Service).

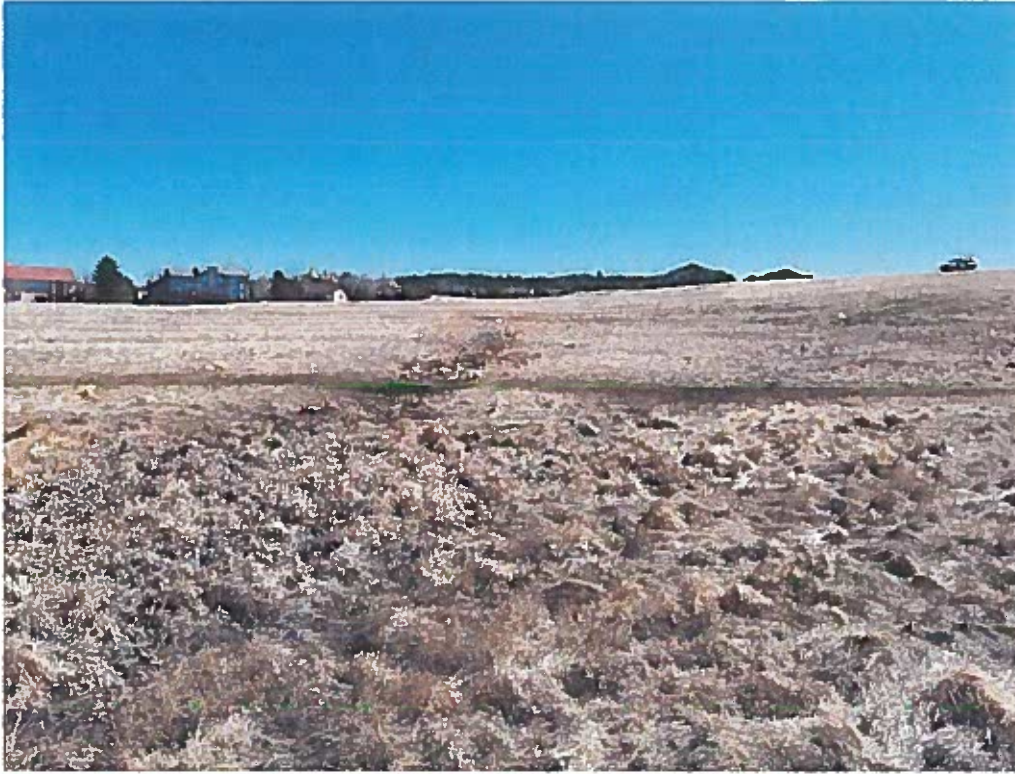
**Looking east along
seasonally wet area in
the central portion of
the site.**

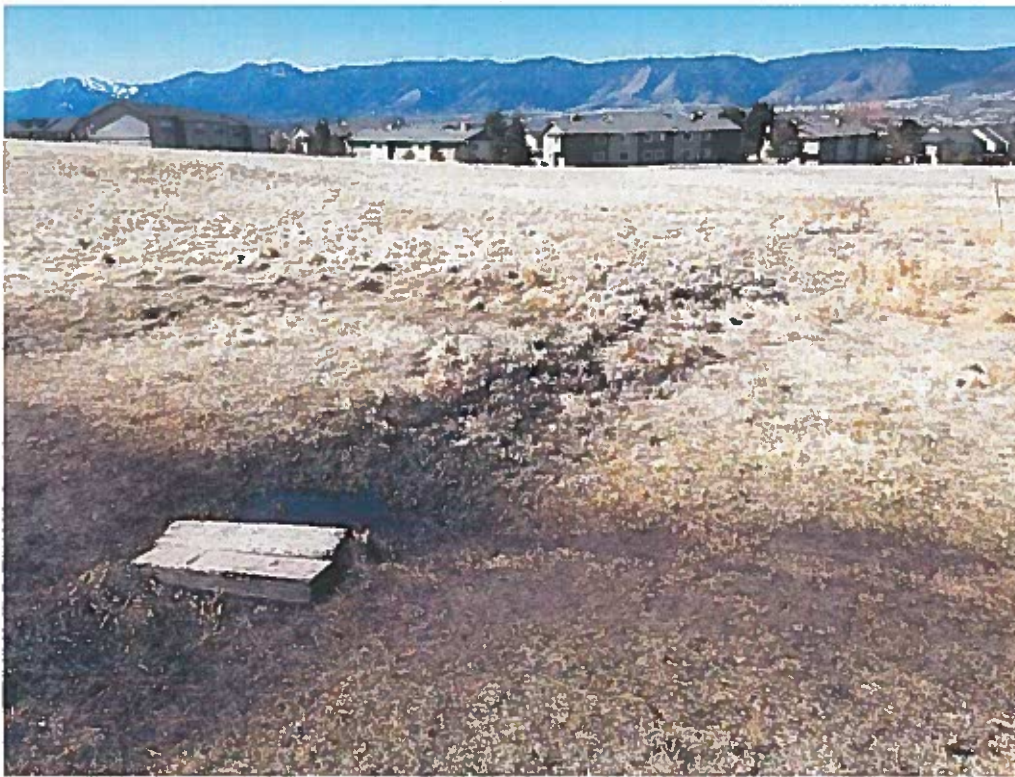
**Looking west along
seasonally wet area in
the central portion of
the site.**
