**ENTECH**  
ENGINEERING, INC.

**SOIL, GEOLOGY, AND GEOLOGIC HAZARD STUDY  
PARCEL NOS. 43070-00-001 AND 430720-00-015  
WOODMEN ROAD AND HIGHWAY 24  
EL PASO COUNTY, COLORADO**

January 20, 2021

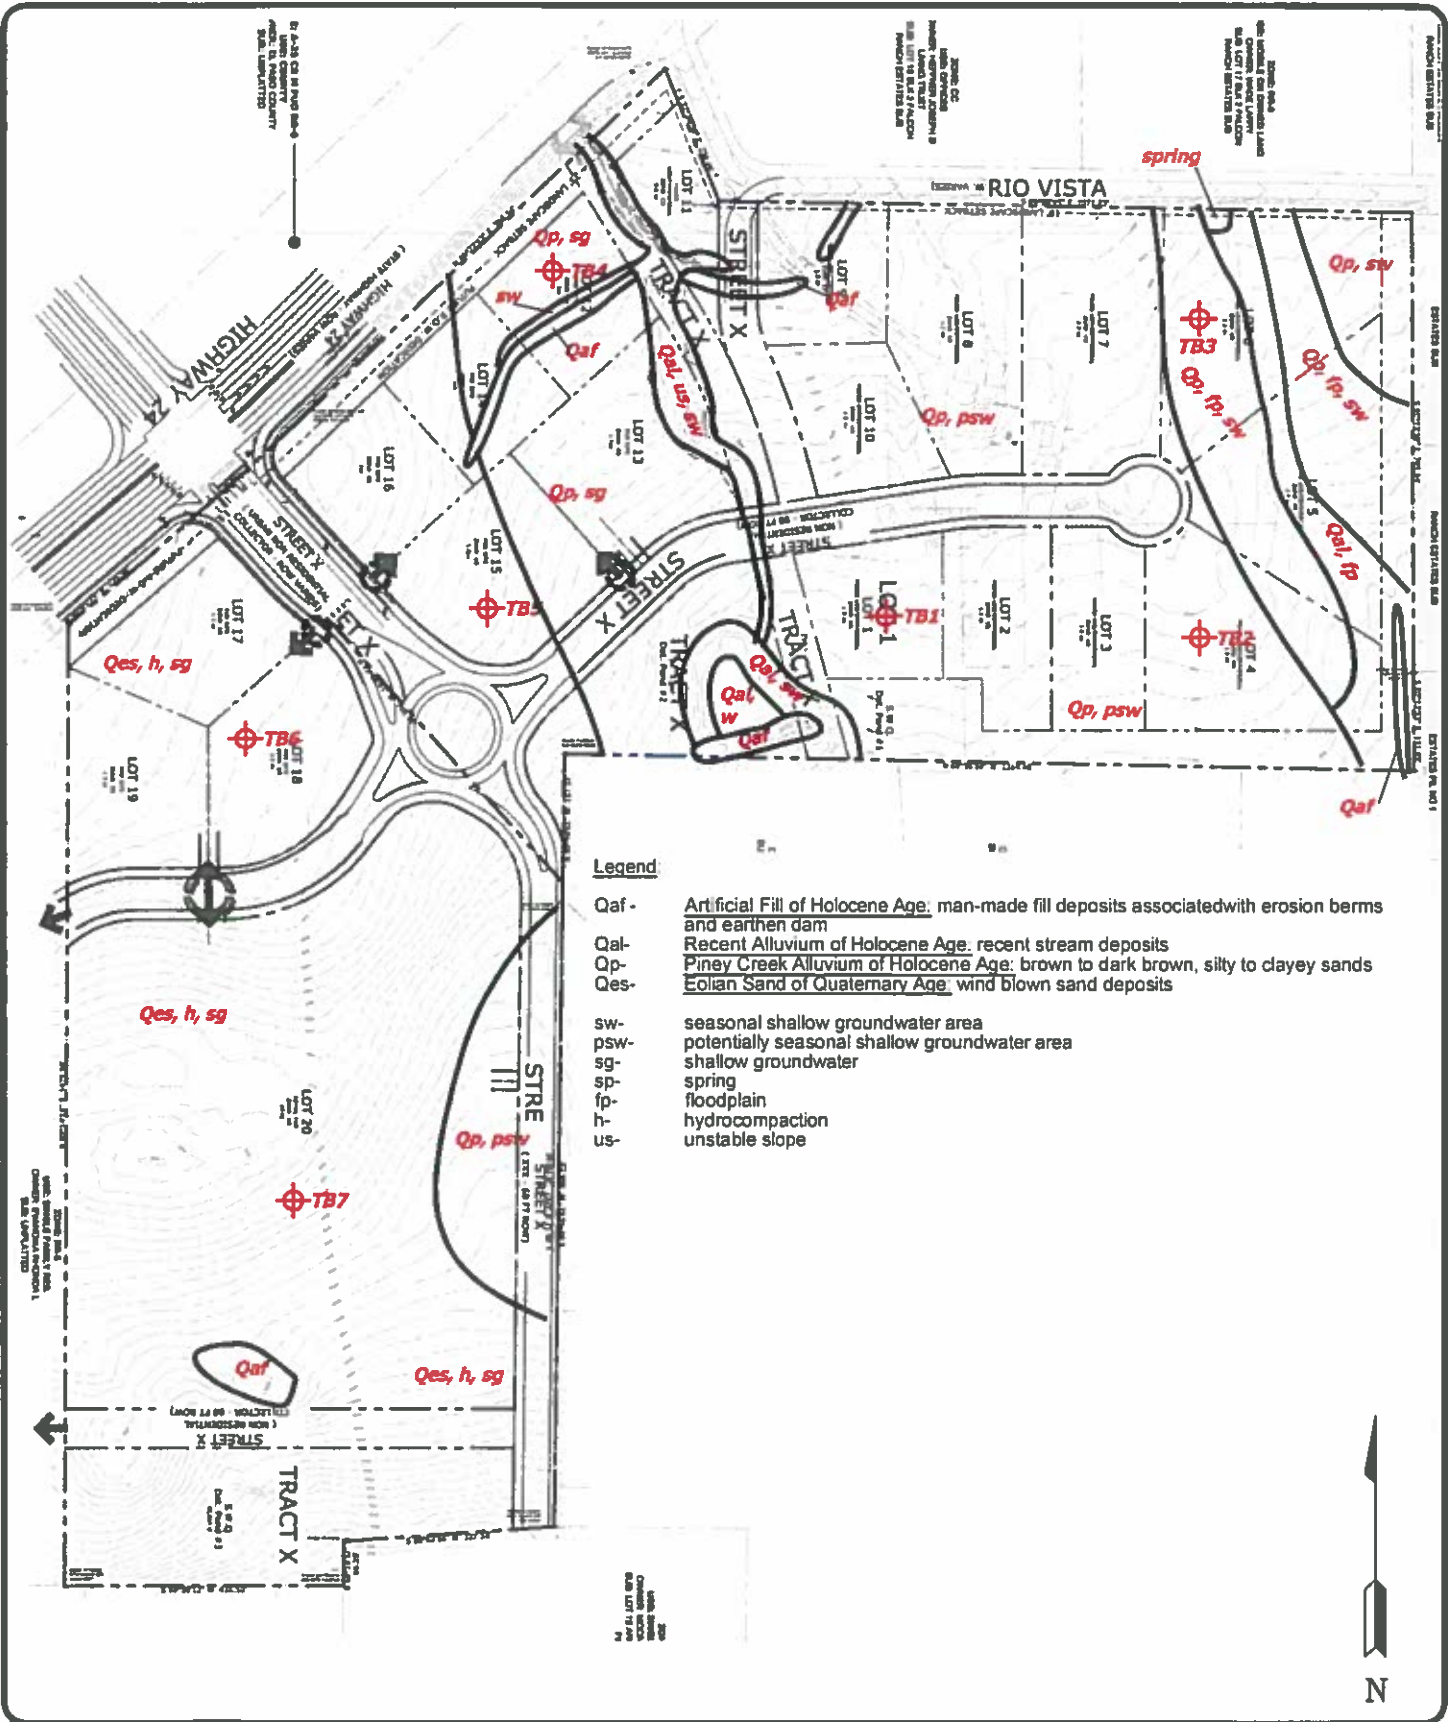
FIG NO.:  
6

Detailed mapping has been performed on this site to produce an Engineering Geology Map (Figure 6). This map shows the location of various geologic conditions of which the developers and planners should be cognizant during the planning, design and construction stages of the project. The hazards identified on this site include artificial fill, hydrocompaction, potentially expansive soils, seasonal and potentially seasonal shallow groundwater areas, areas of ponded water, springs, unstable slopes and floodplains. These geologic conditions and the recommended mitigation techniques are as follows.

The majority of the slopes on-site are gently sloping and do not exhibit any past or potential unstable slopes or landslides. Some of the steeper slopes along a drainage in the central portion of the site have been identified as unstable slopes. The mitigation recommendation for these areas is as follows:

Mitigation: Based on the proposed development plan, the majority of the drainage is to be located in a drainage tract. It is anticipated these areas would be avoided or regraded. Building should be avoided on the unstable slopes unless stabilized. A setback of 20 feet from the crest of these slopes is recommended unless stabilized. Stabilization could involve regrading to slope angles no steeper than 3:1 or the use of engineer-designed retaining walls, tiebacks, or buttresses. Where retaining walls are not used, erosion protection may be necessary to prevent undercutting by the creek during periods of high water. Specific slope stabilization recommendations are beyond the scope of this report.

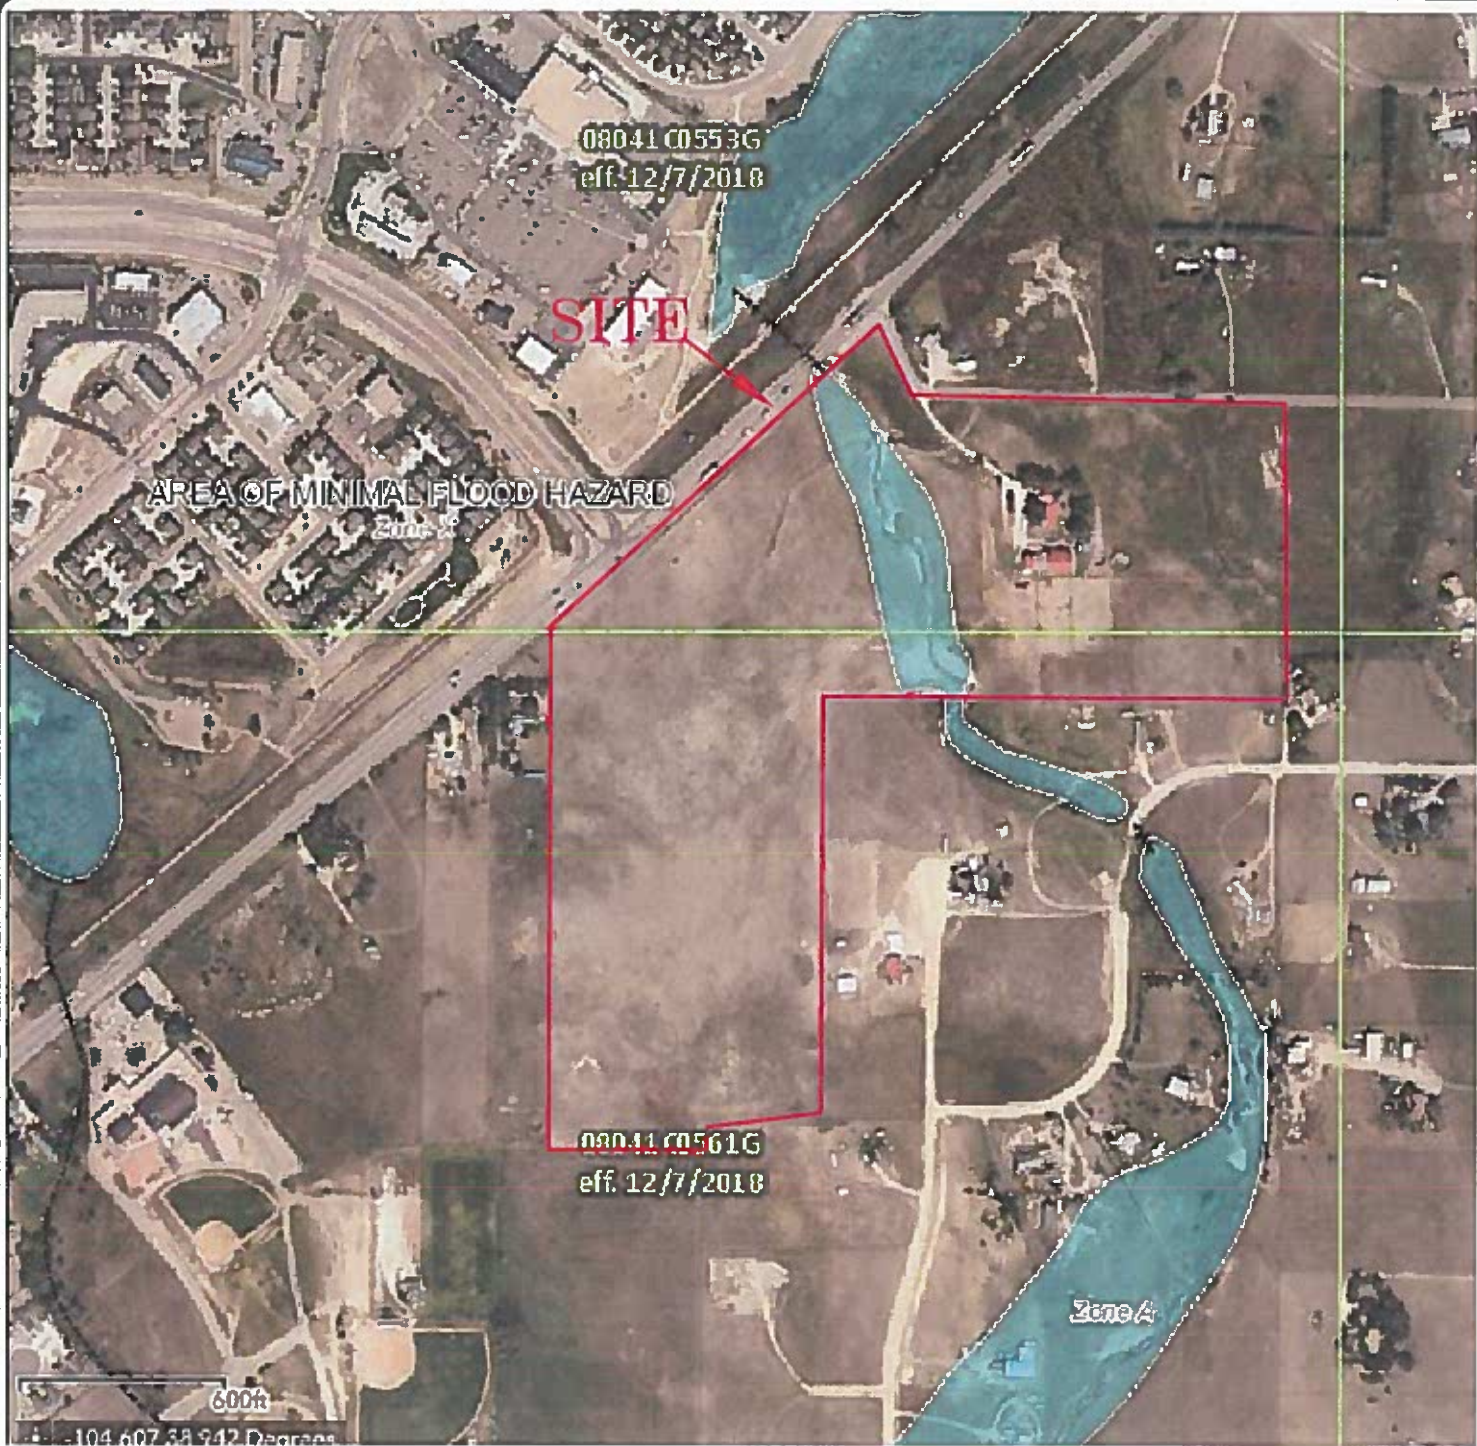
**FLOODPLAIN MAP**  
**FALCON FIELD**  
**HIGHWAY 24 & WOODMEN ROAD**  
**EL PASO COUNTY, CO.**  
**FOR: FALCON FIELD, LLC**

Floodplain: The drainage in the eastern portion of the site and has been mapped as a floodplain zone according to the FEMA Map No. 08041CO533G, Figure 8 (Reference 12). Any construction considered in a floodplain area will require approval of the drainage plan. Lots immediately adjacent to the floodplain may experience higher groundwater levels during peak flows. Subsurface perimeter drains are recommended for structures adjacent to the floodplain to help prevent the intrusion of water into areas below grade. Typical drain details are presented in Figure 8. Finished floor levels must be a minimum of one floor above the floodplain level. Exact floodplain locations by drainage studies are beyond the scope of this report.

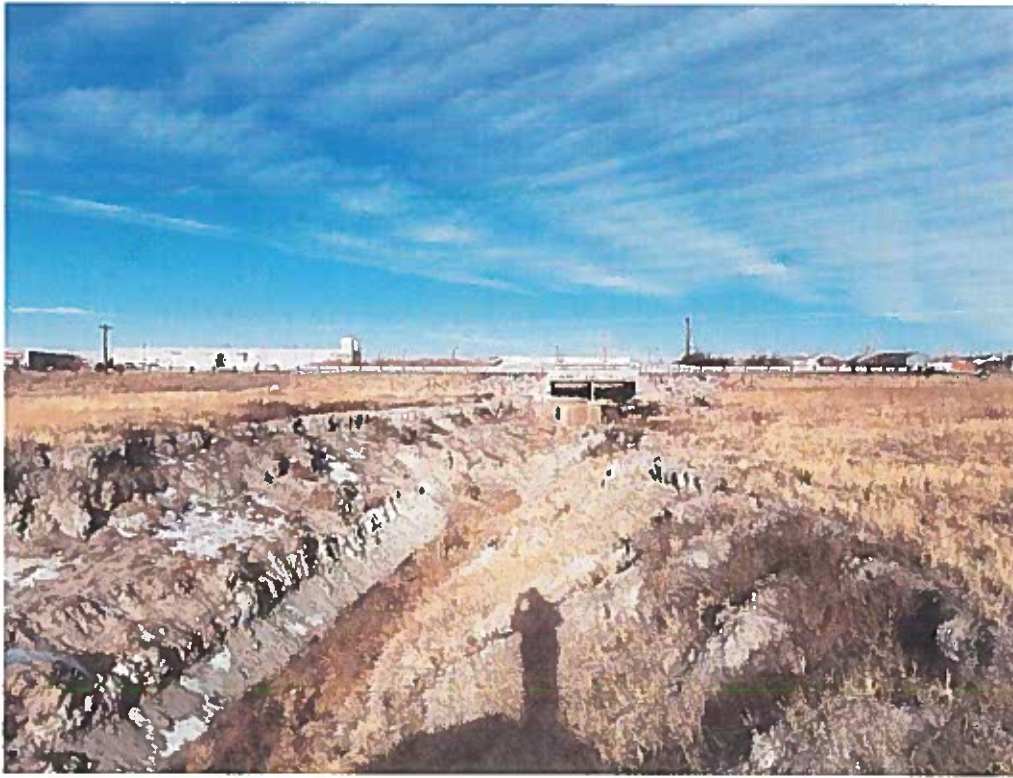
**Looking northwest  
along drainage in the  
northern portion of the  
site.**

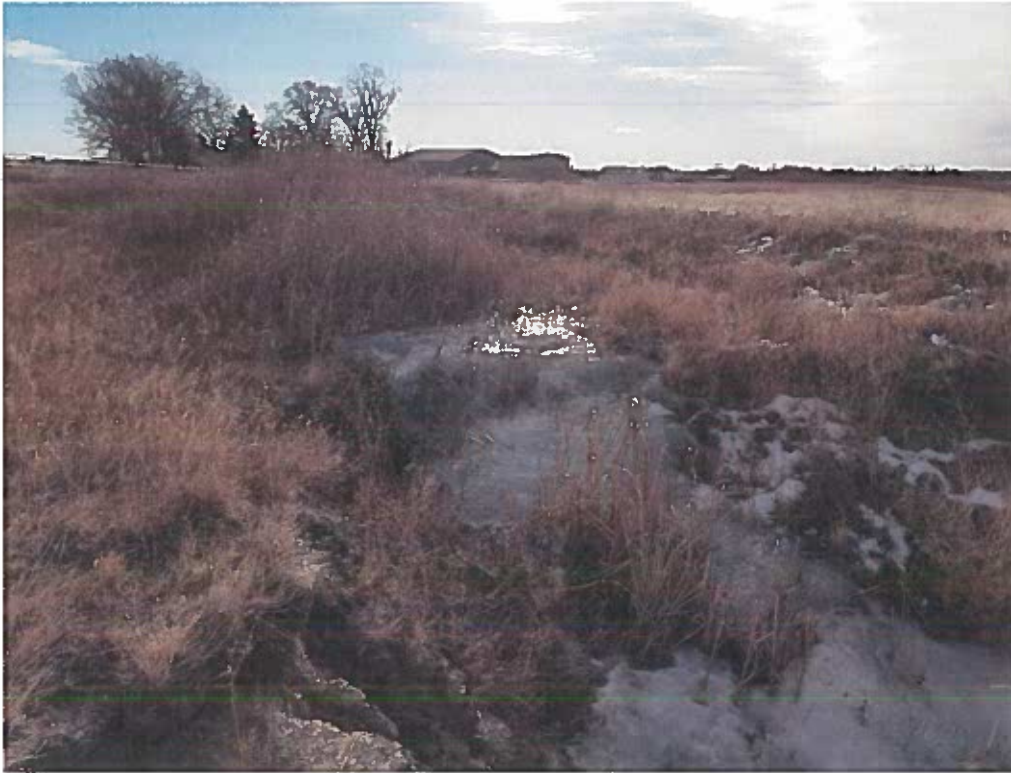
Spring: This area lies within the floodplain area on the eastern portion of the site, therefore, recommendations for the floodplain should be followed for the spring area. Additionally, should development be considered in this area, interceptor drains will be necessary to capture waters and transport them safely around structures. It is anticipated dewatering and drainage systems will be necessary for this site, particularly in the drainage area below the spring.

**Looking northeast  
towards spring in the  
northern portion of the  
site.**

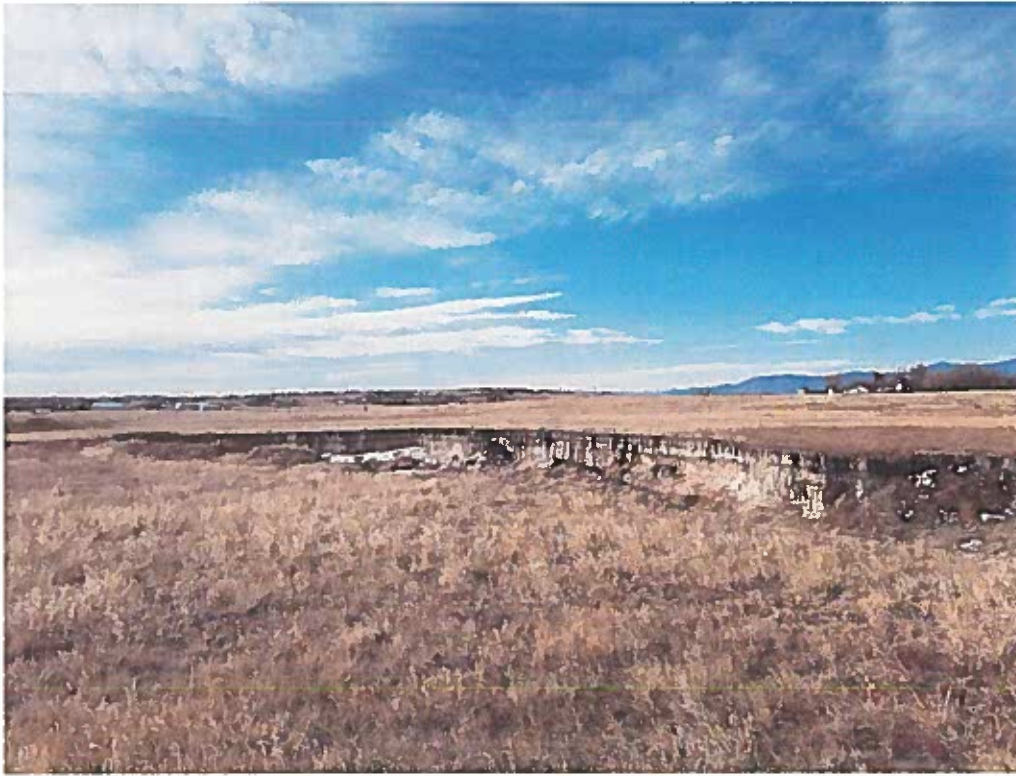
**Looking south across  
drainage in the north-  
central portion of the  
site.**
