**SOIL, GEOLOGY, & GEOLOGIC HAZARD STUDY
SADDLEHORN RANCH – FILING NO. 3
CURTIS ROAD & JUDGE ORR ROAD
EL PASO COUNTY, COLORADO**

November 15, 2022
Revised May 17, 2023

Entech Job No. 230509
AAprojects/2023/230509 countysoil/geo

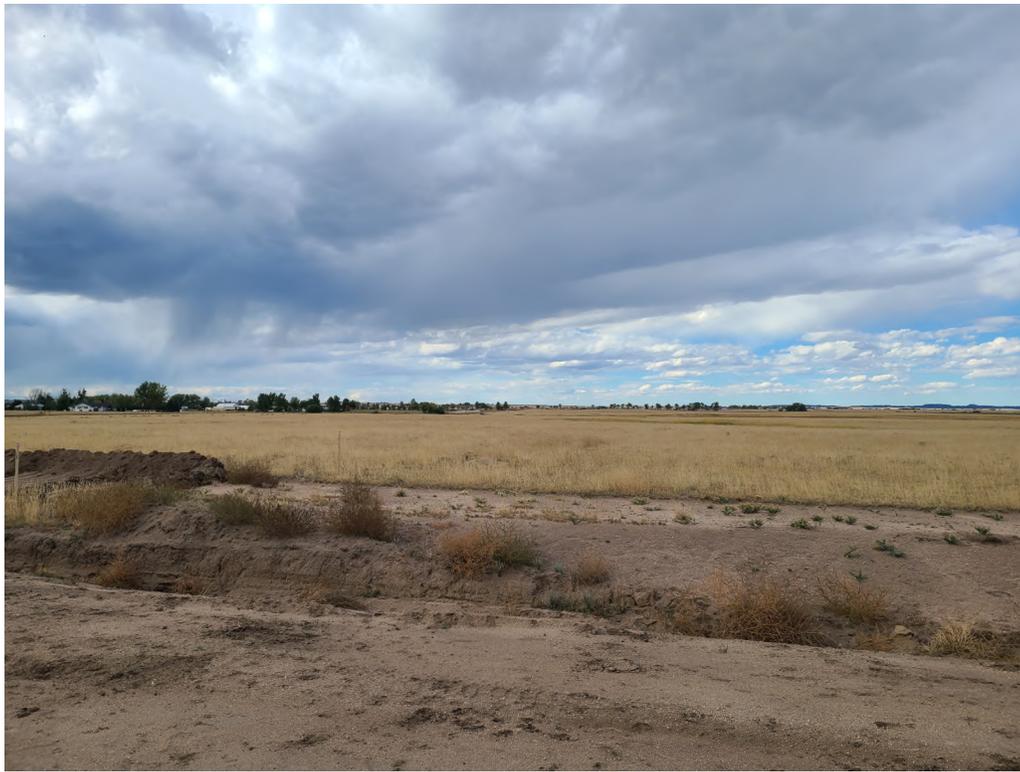
Looking north from the southwestern portion of Filing No. 3.

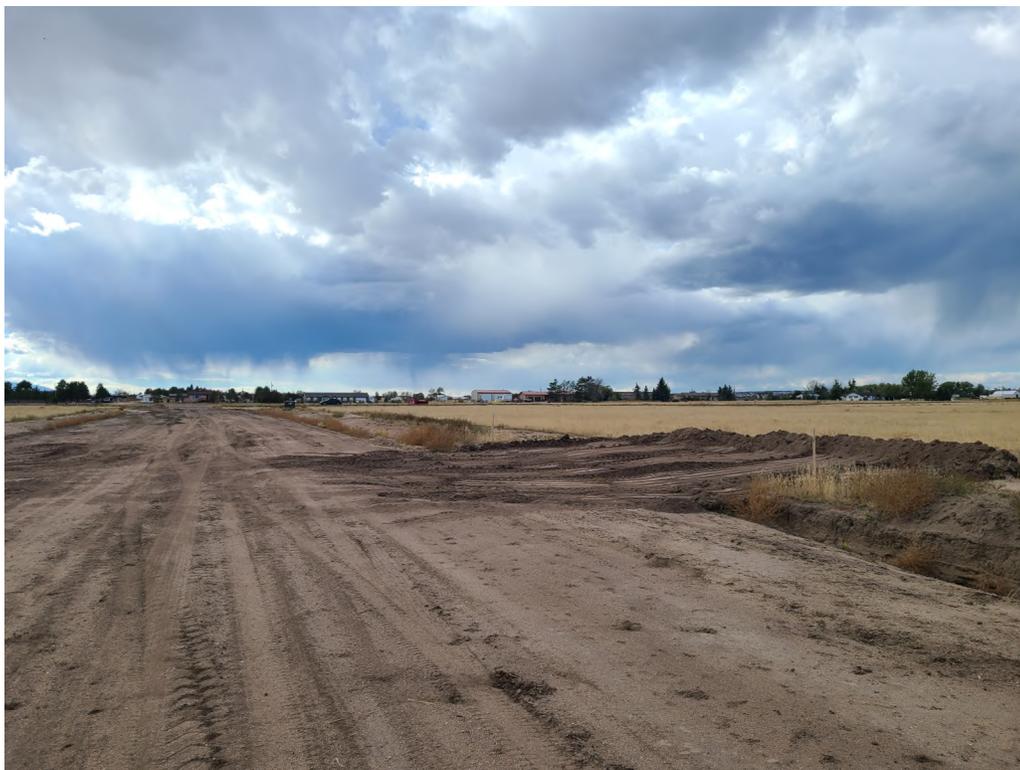
Looking west from the southeastern portion of Filing No. 3.

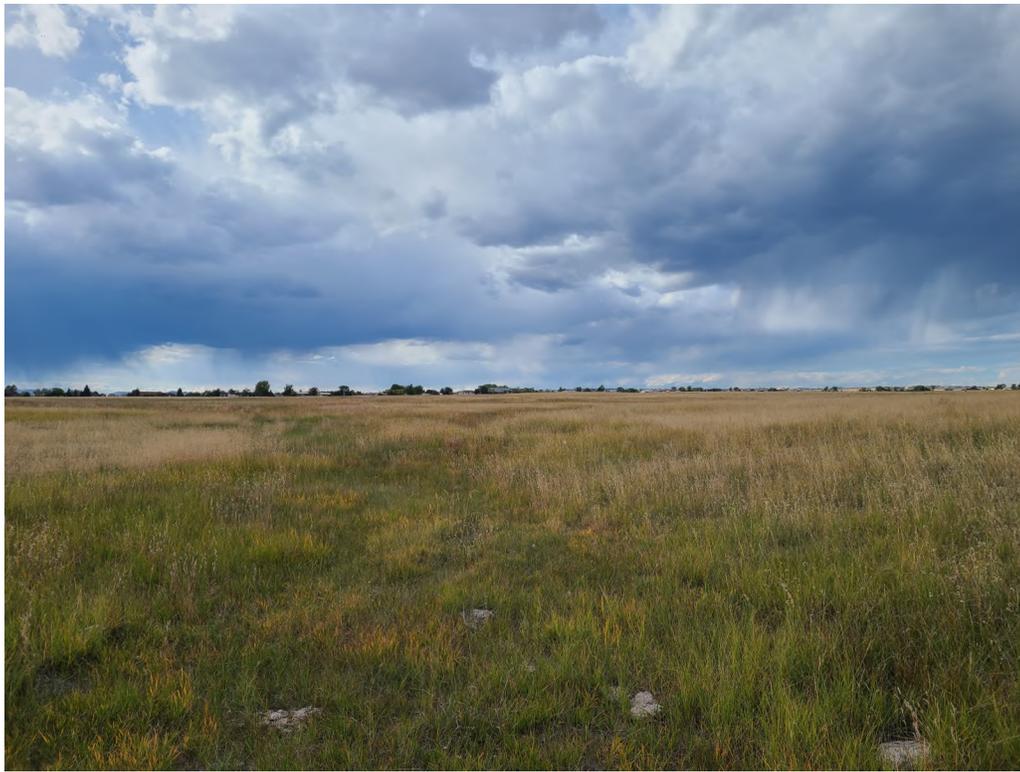
**Looking northwest
from the southeastern
portion of Filing No. 3.**

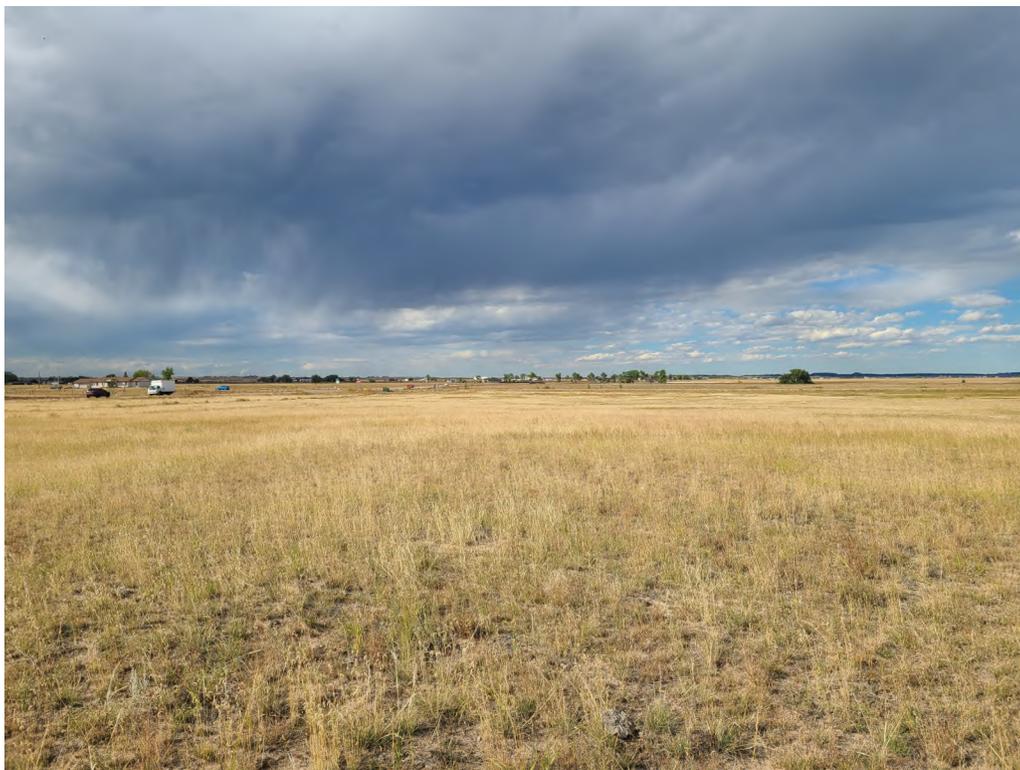
**Looking north from the
northwestern portion
of Filing No. 3.**

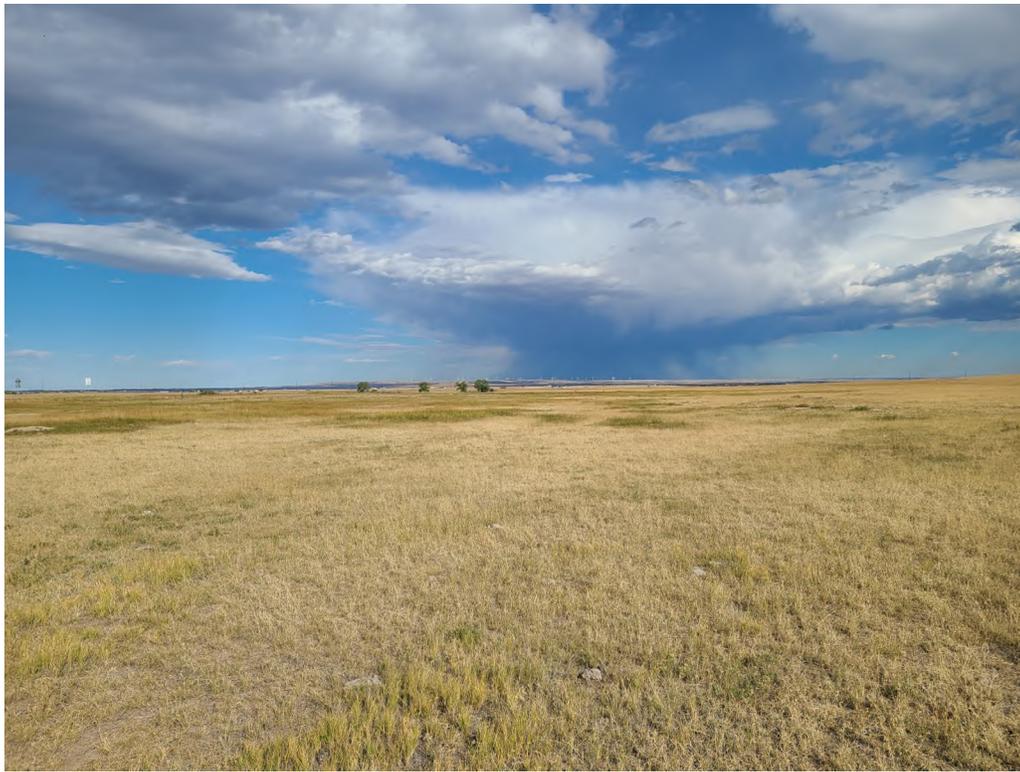
**Looking east from the
northwestern portion
of Filing No. 3.**

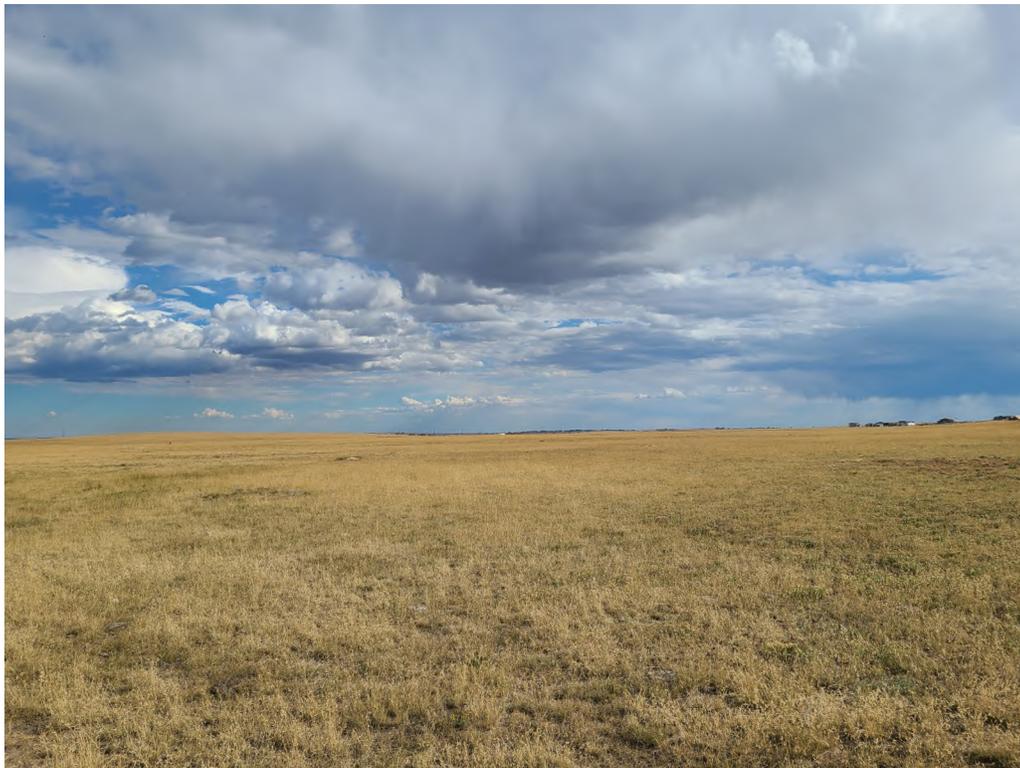
**Looking southeast
from the northwestern
portion of Filing No. 3.**

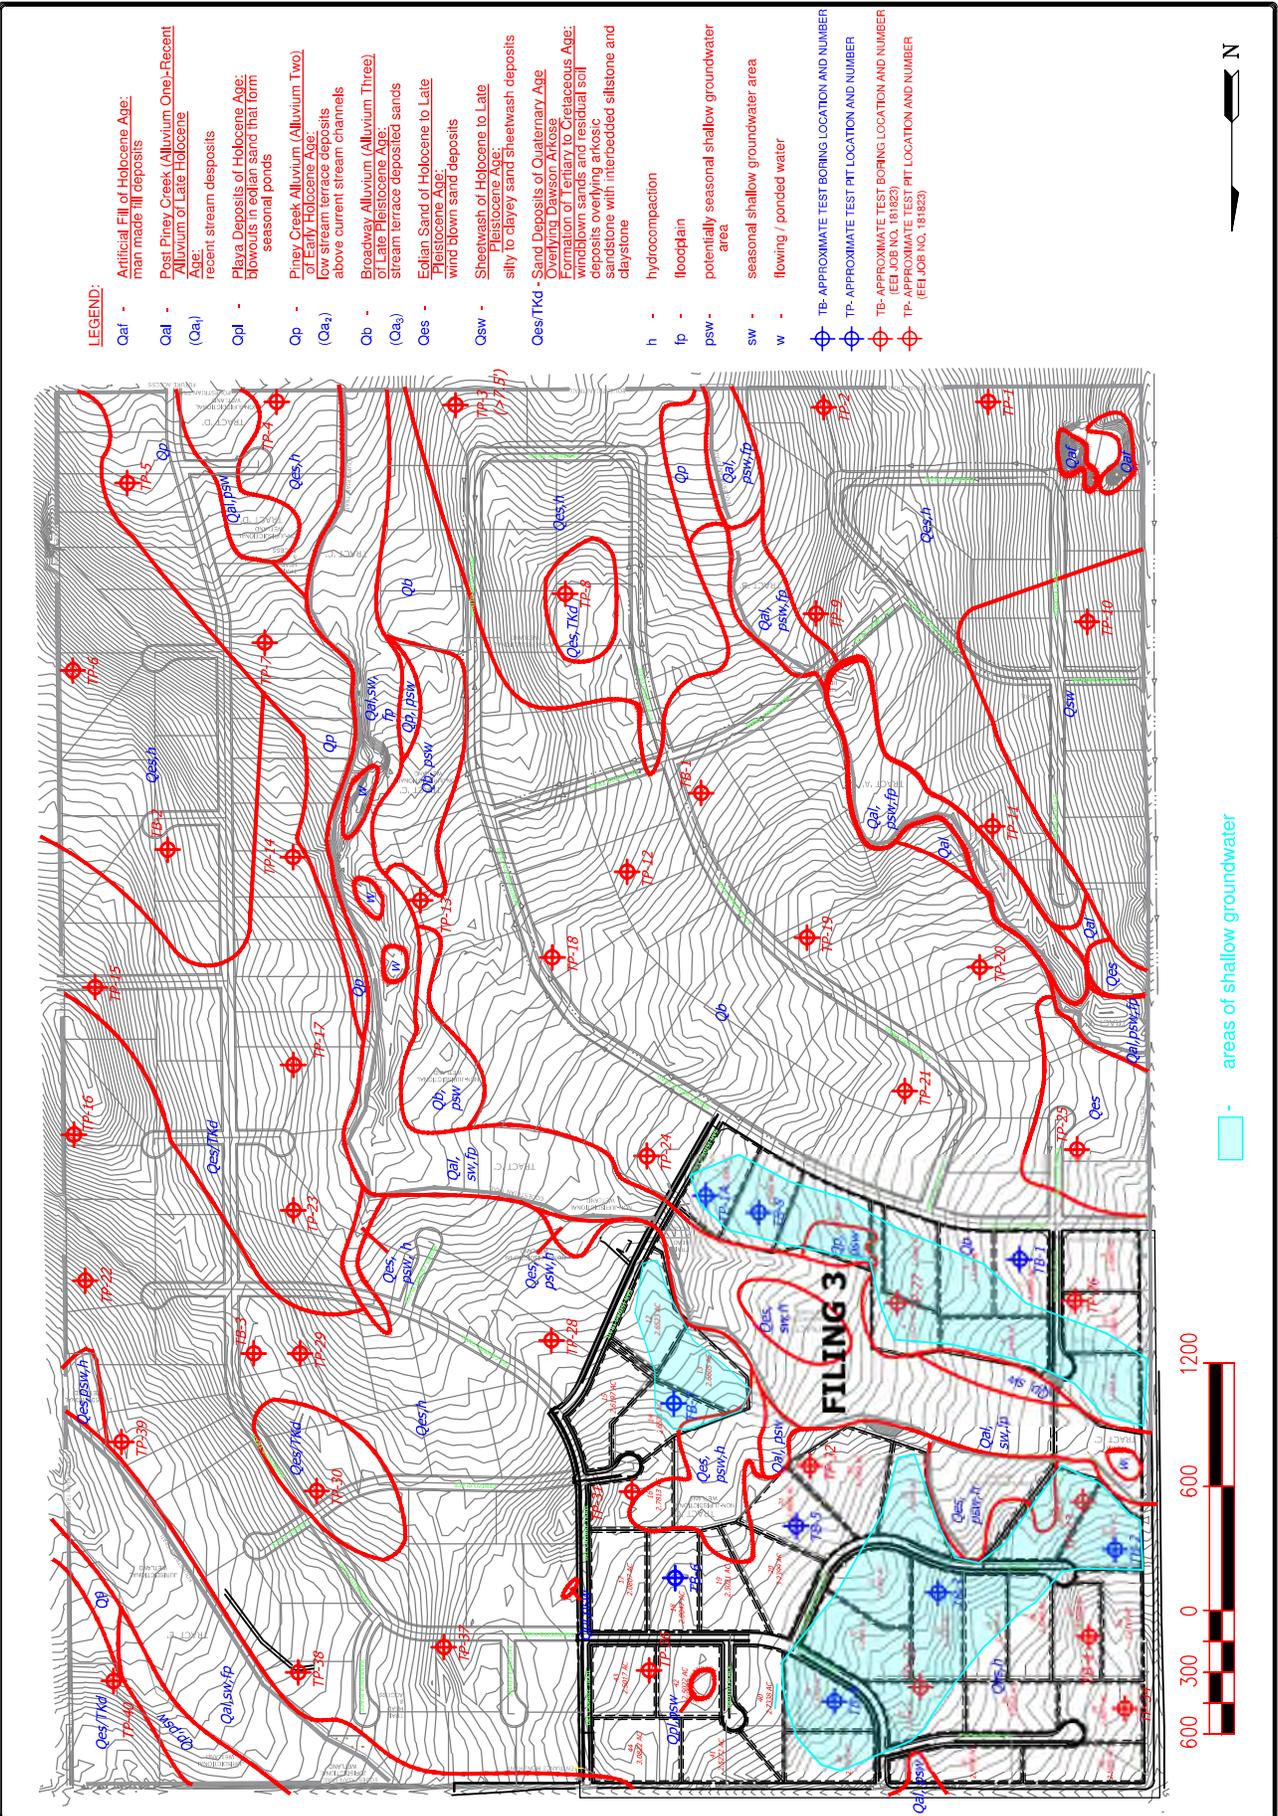
GEOLOGY/ENGINEERING GEOLOGY MAP
SADDLEHORN RANCH FILING NO. 3
CURTIS ROAD AND JUDE ORR ROAD
EL PASO COUNTY, CO.
FOR: WILLIAM GUMAN AND ASSOCIATES, LTD.

Detailed mapping has been performed on this site to produce a Geology/Engineering Geology Map (Figure 6). This map shows the location of various geologic conditions of which the developers should be cognizant during the planning, design and construction stages of the project. These hazards and the recommended mitigation techniques are as follows:

sw, psw – Seasonal and Potentially Seasonal shallow groundwater areas: In these areas, we would anticipate the potential for periodically high subsurface moisture conditions, frost heave potential, and highly organic soils. Areas where perched water conditions are encountered should also follow these recommendations. Construction proposed in or adjacent to these areas, should follow these precautions:

Shallow water (6 feet or less) was encountered in preliminary studies on lots 2,7,14,18,21,25,30 and 39 (Figure 6). Structures should be constructed a minimum of 3 feet above water levels. Lots 1, 3 to 6,8,11,23,24,28,29,31,32,33 and 38 are adjacent to the lots with shallow water. Due to the sizes of the lots, areas with deeper water which are suitable for below grade construction are likely to be available. Investigation on each lot is recommended prior to construction on all of the lots to determine soils conditions and determine depths to water.

Mitigation: In these locations, foundations are subject to severe frost heave and should penetrate to a sufficient depth so as to prevent the formation of ice lenses beneath foundations. At this location and elevation, a foundation depth for frost protection of 30-inches is recommended. In areas where high subsurface moisture conditions are anticipated periodically, a subsurface perimeter drain will be necessary to help prevent the seepage of water into areas below grade. A typical perimeter drain detail is presented in Figure 8. Any grading in these areas should be done in a manner that directs surface flow around construction to avoid areas of ponded water. Areas of organic material will require removal prior to any fill placement. Unstable soil conditions should be expected in areas of shallow groundwater. Where foundations approach the groundwater level, stabilization of the excavations utilizing shot rock may be necessary. Underslab drains or capillary breaks, and interceptor drains may be necessary to prevent intrusion of water into areas below grade. Typical drain details are presented in Figures 9 and 10.
