June 7, 2021

ENTECH
ENGINEERING, INC.

Re: Soil, Geology, and Geologic Hazard Study
Crowe Subdivision
Parcel No. 61280-00-001
15980 Roller Coaster Road
El Paso County, Colorado

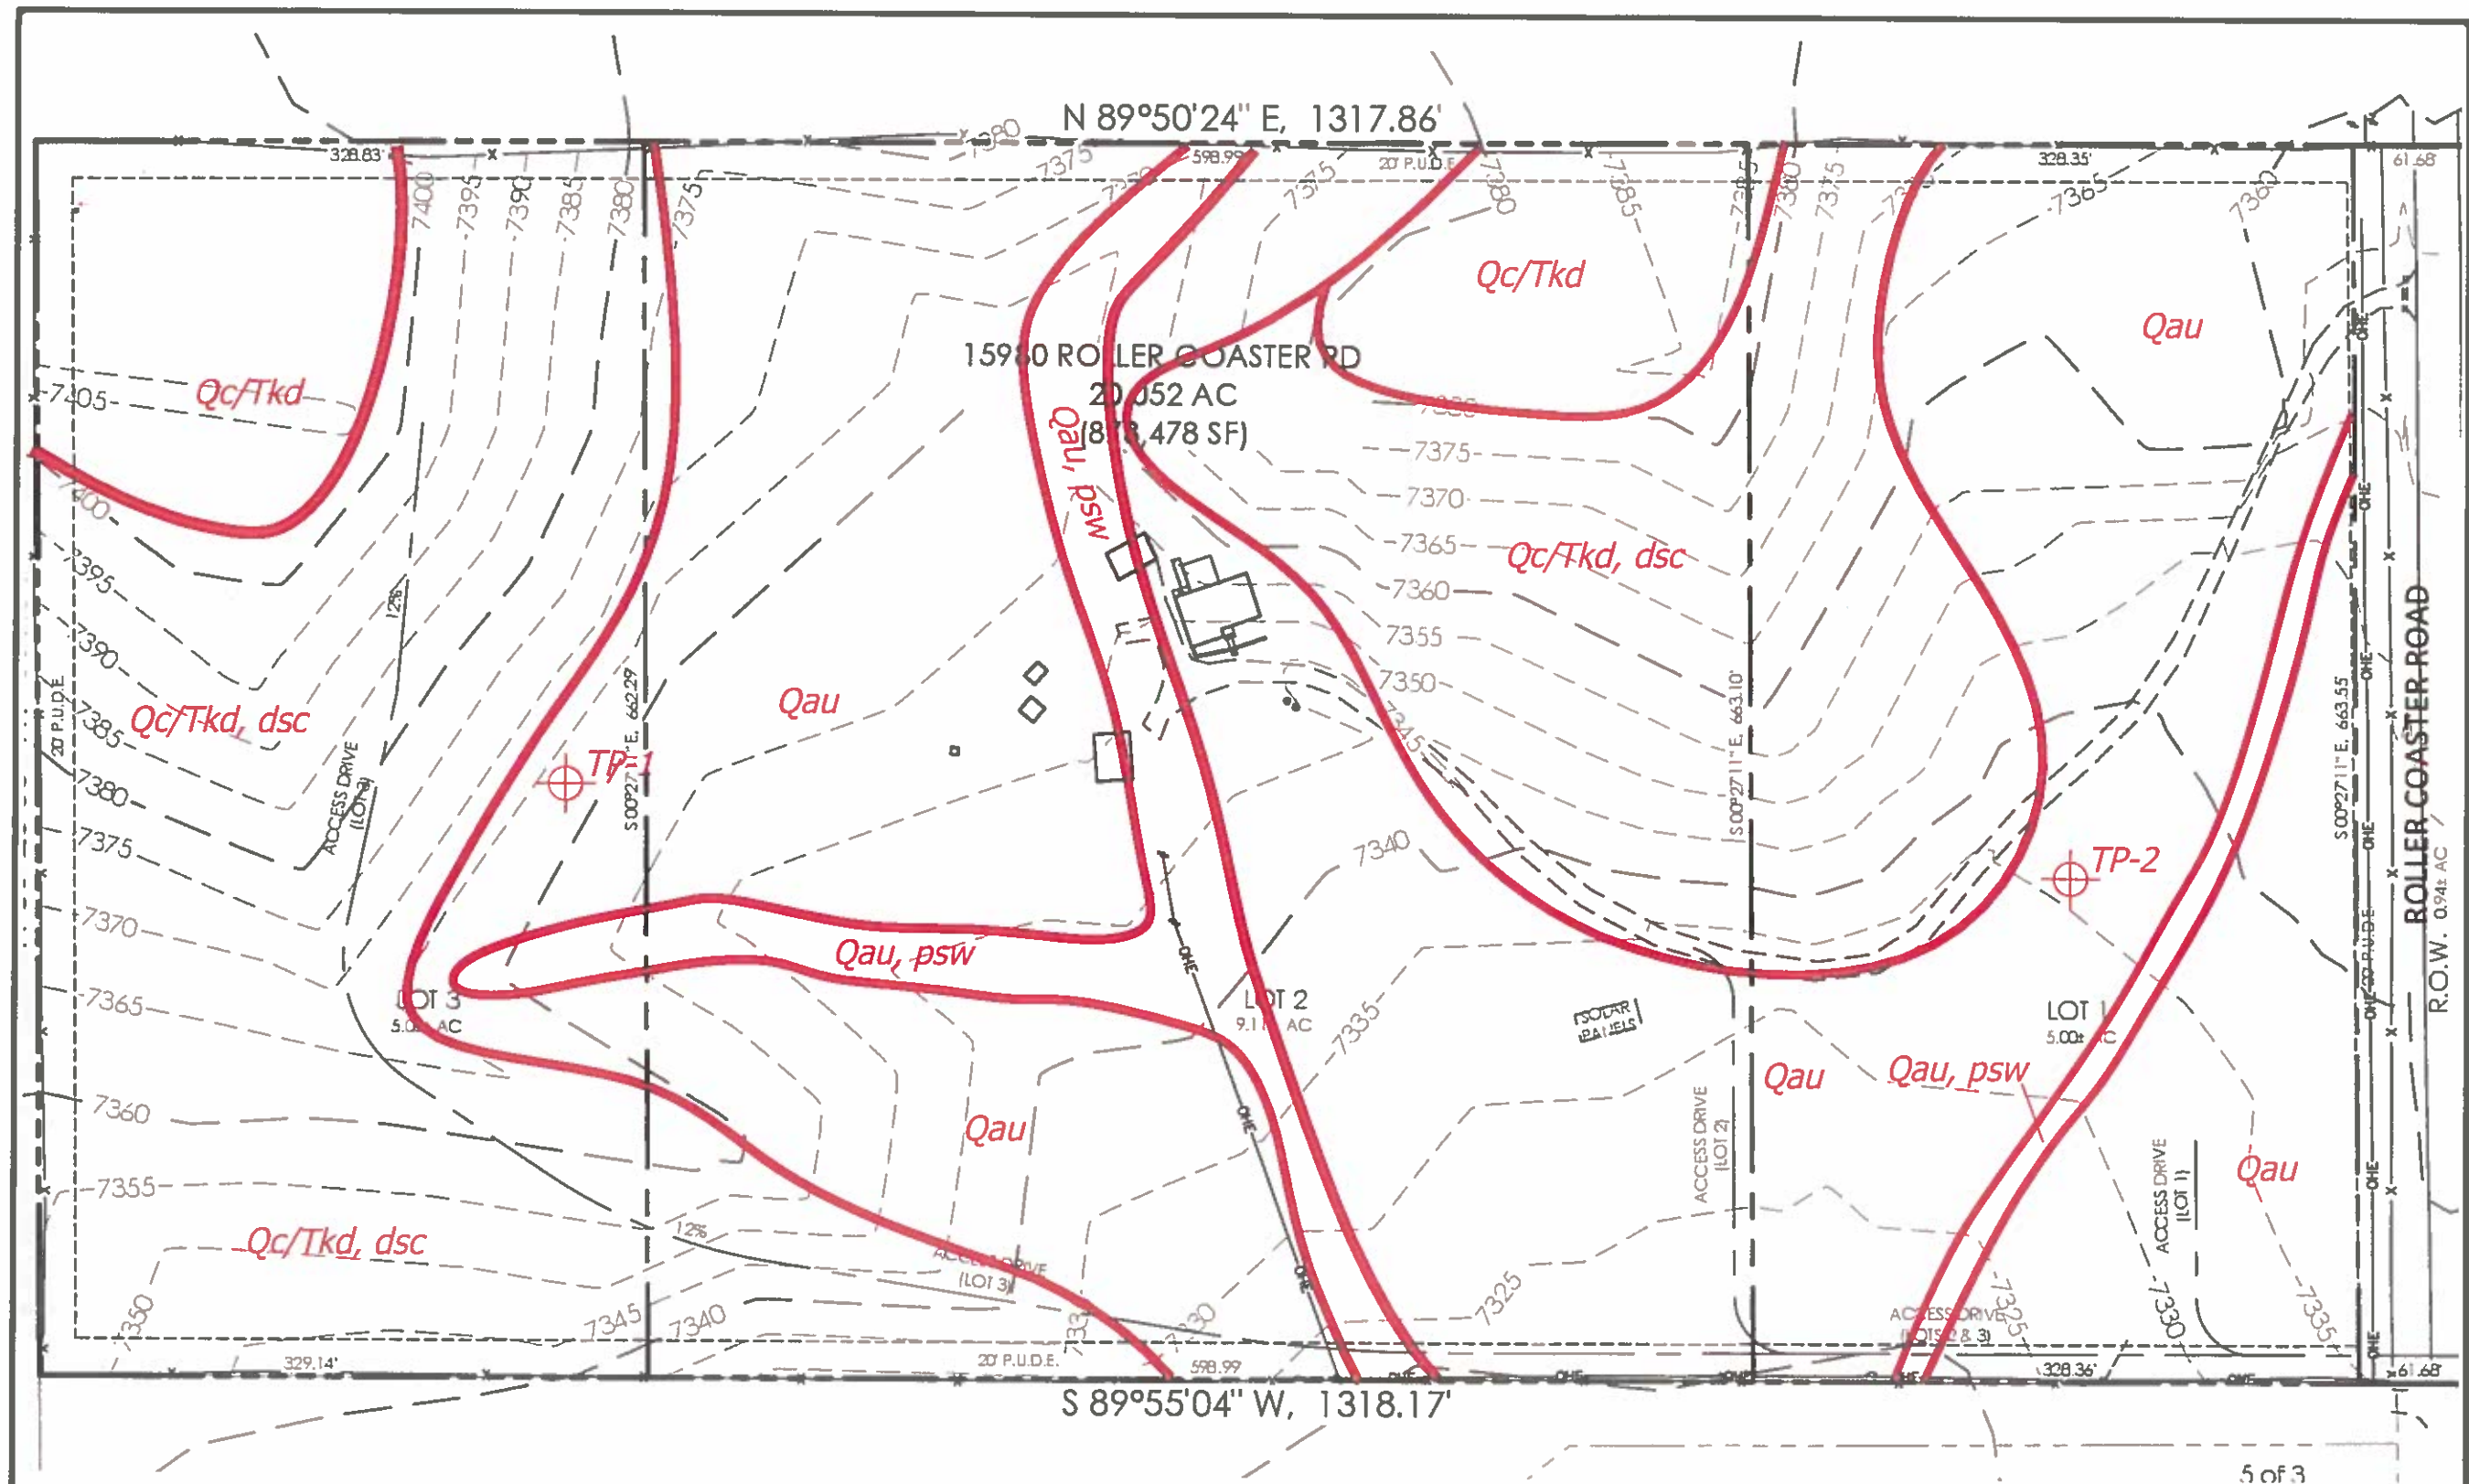
DRAWN LL
CHECKED
DATE 5/22/21
SCALE AS SHOWN
JOB NO. 210825
FIGURE NO. 6

The areas identified with this constraint includes the steeper slopes along the ridges in the western and northeastern portion of the site. In these areas we would anticipate lateral and vertical movement of the near surface soils in the downslope direction. These areas will be avoided by the proposed structures; however, they are acceptable for building sites with the following constraints on construction.

Areas of downslope creep were observed across the site, and are indicated on Figure 6. The areas identified with this hazard includes the steeper slopes along the ridges across the site. In these areas we would anticipate lateral and vertical movement of the near surface soils in the downslope direction. These areas will be avoided by the proposed structures; however, structures may encroach on these areas. In areas of downslope creep, structures should be

Mitigation: This type of movement will increase lateral pressures against foundation walls on the uphill side of structures. The design of foundations in these areas should account for this additional pressure. A lateral pressure detail is shown in Figure 10. Where possible in areas of downslope creep, structures should be designed to be as compact and rigid as possible. This will help them better tolerate the vertical and lateral movements to which the foundation system

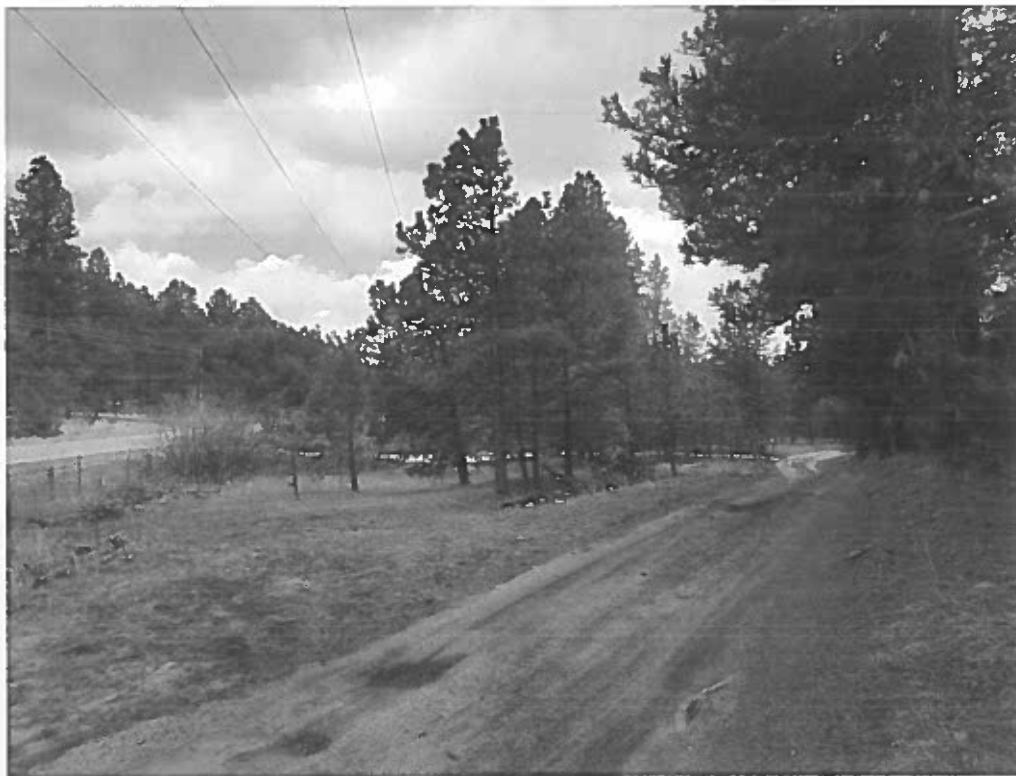
**Looking south from
the northeastern
portion of the site.**

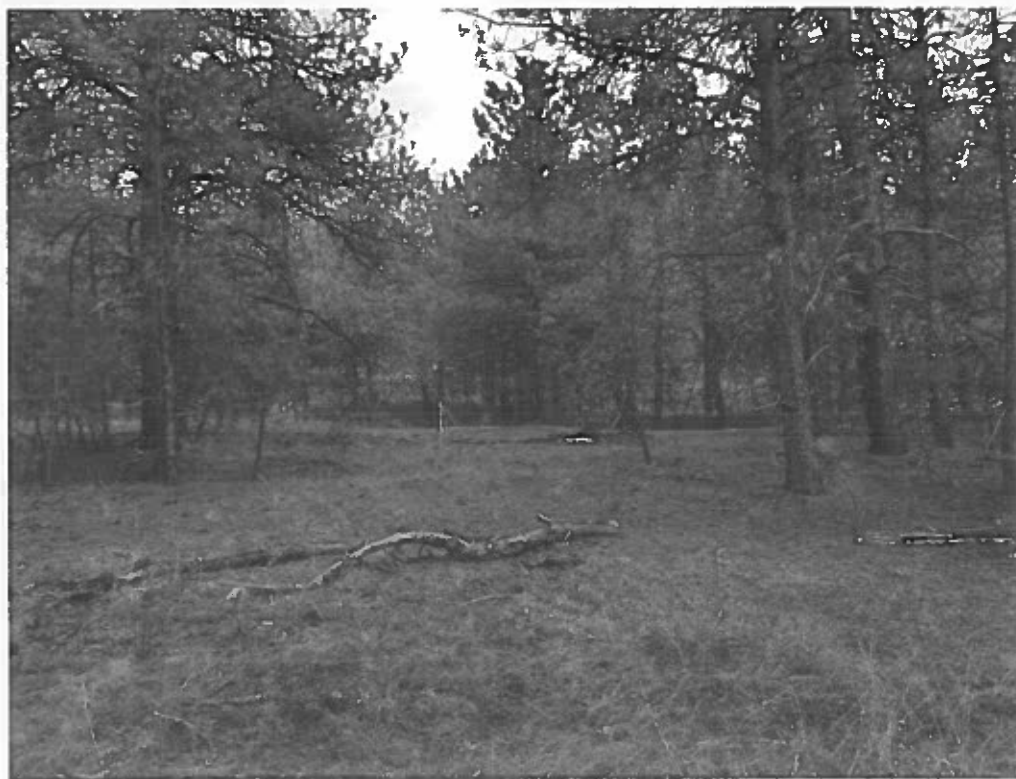
**Looking northwest
from the southeastern
side of the site.**

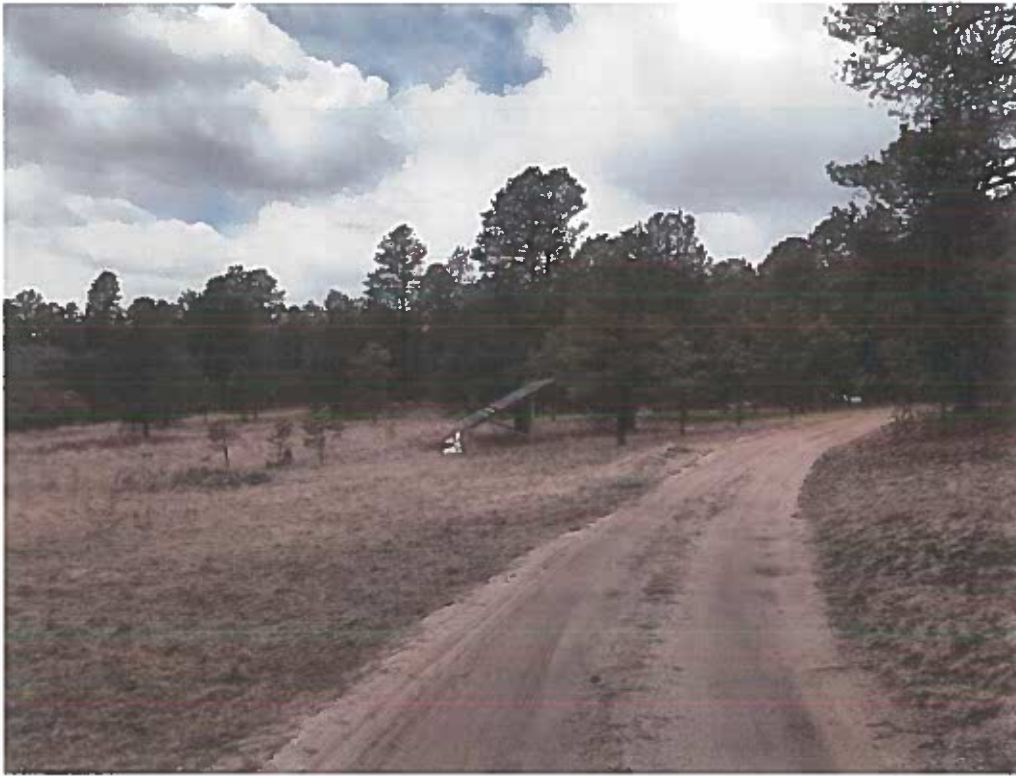
**Looking west from the
southeastern portion
of the site.**

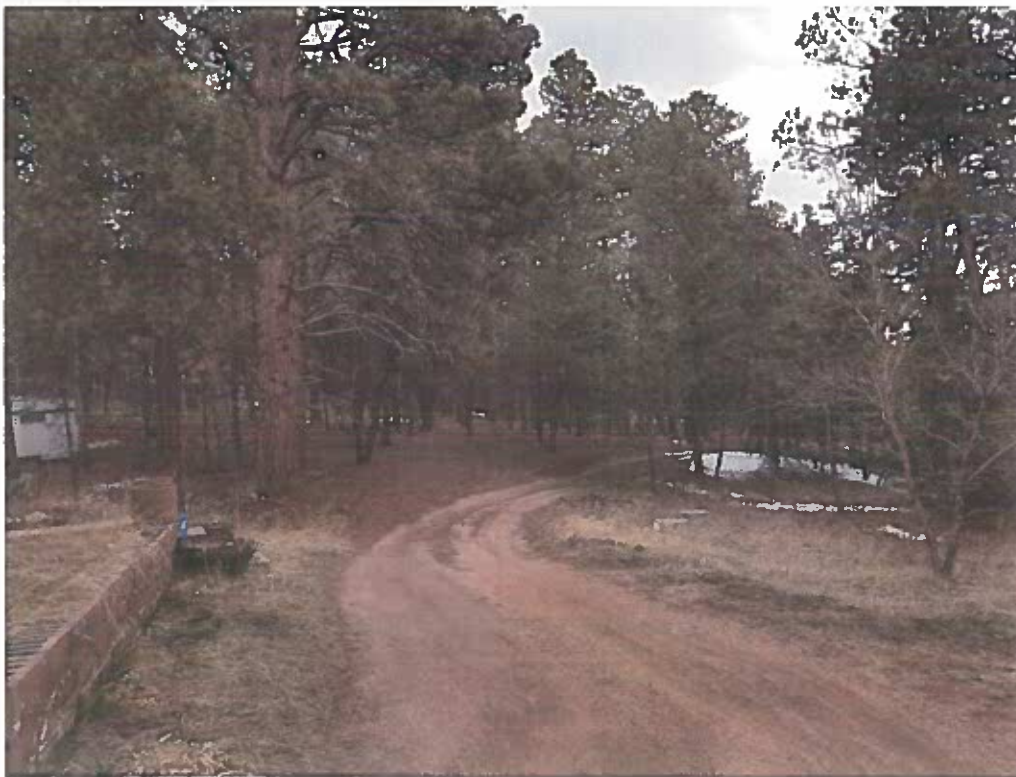
**Looking southeast
along existing
driveway from the
central portion of the
site.**

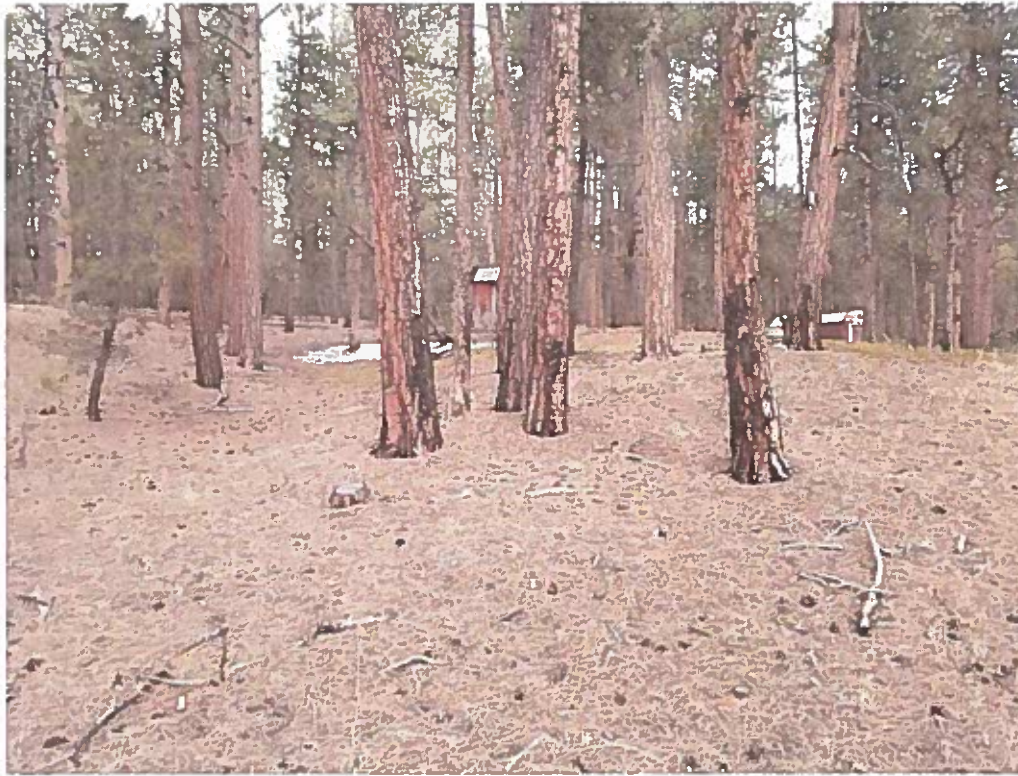
Looking northeast
from the south central
portion of the site.

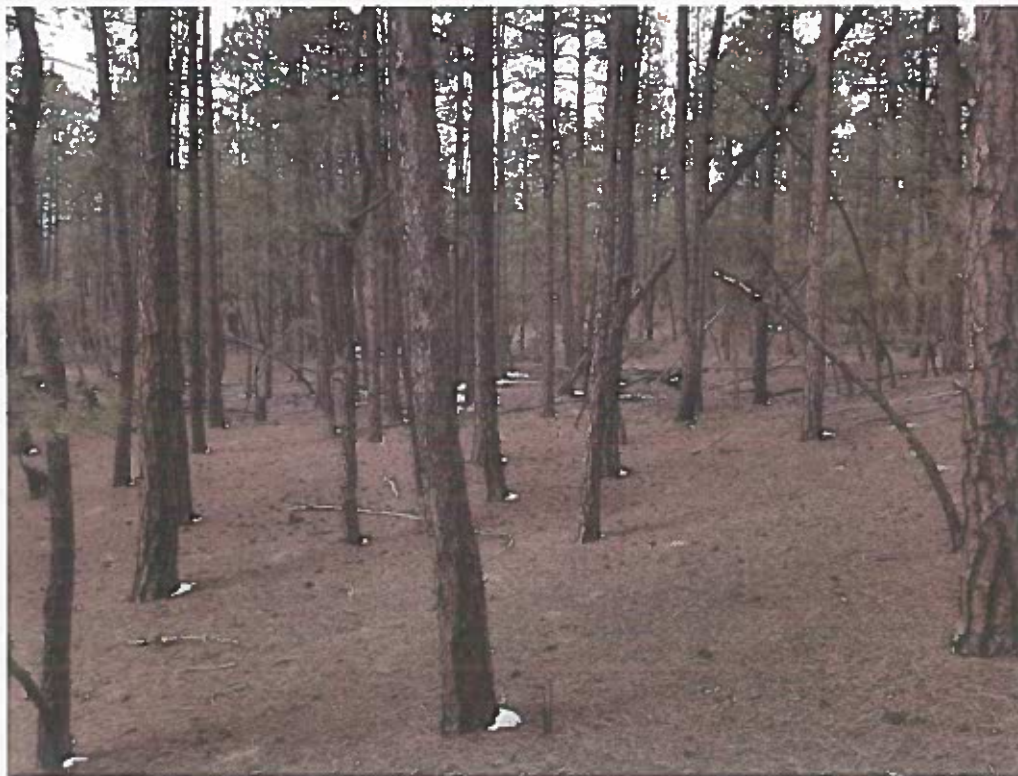
Looking northwest the
central portion of the
site.

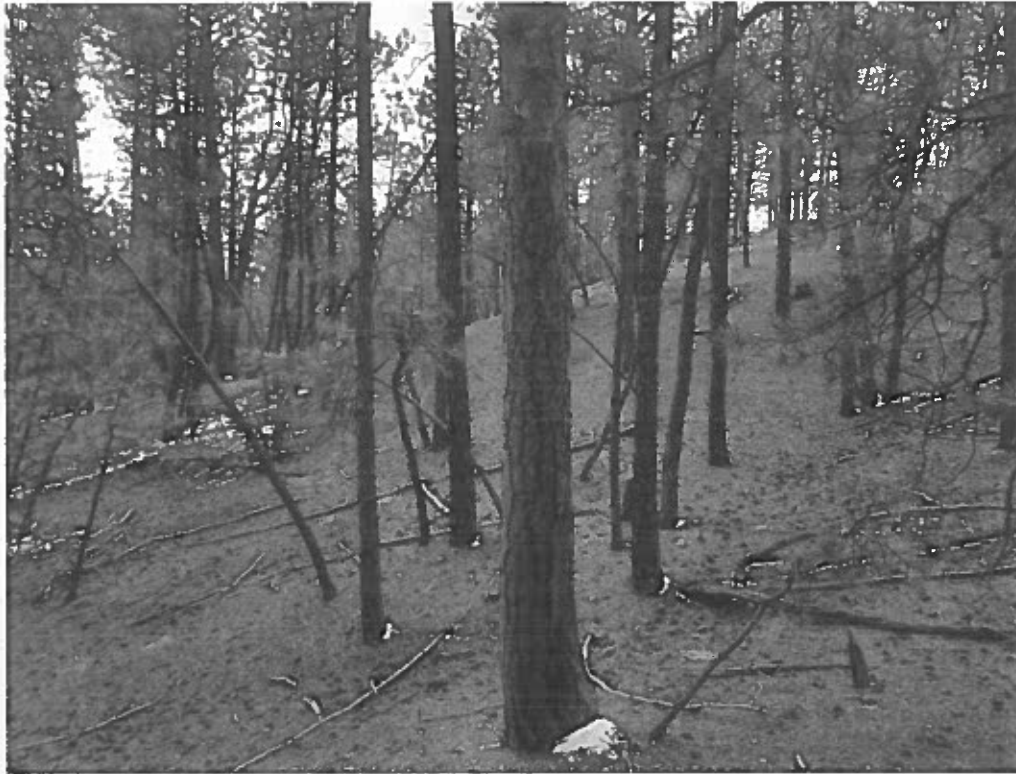
**Looking southeast
along at moderate
slope in the western
portion of the site.**

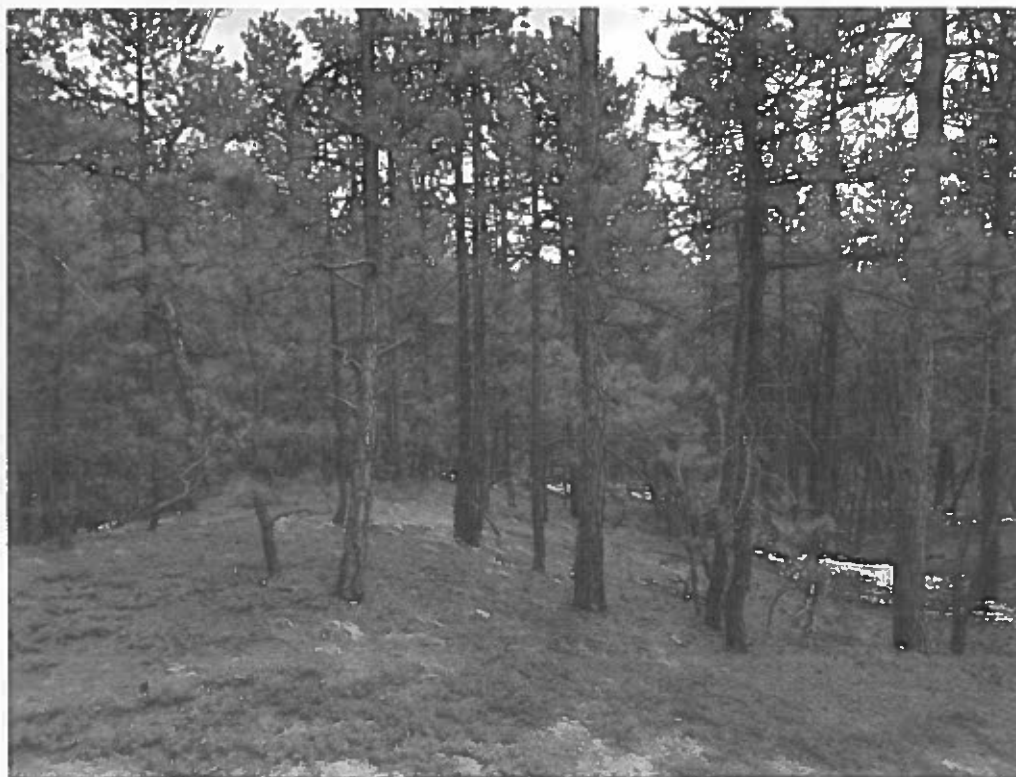
**Looking east from the
western side of the
site.**
