**SOIL, GEOLOGY, AND GEOLOGIC HAZARD STUDY  
COPPER CHASE AT STERLING RANCH  
EL PASO COUNTY, COLORADO**

March 7, 2022

Entech Job No. 191088  
F://AAPProjects/2019/191088 Geohaz 2

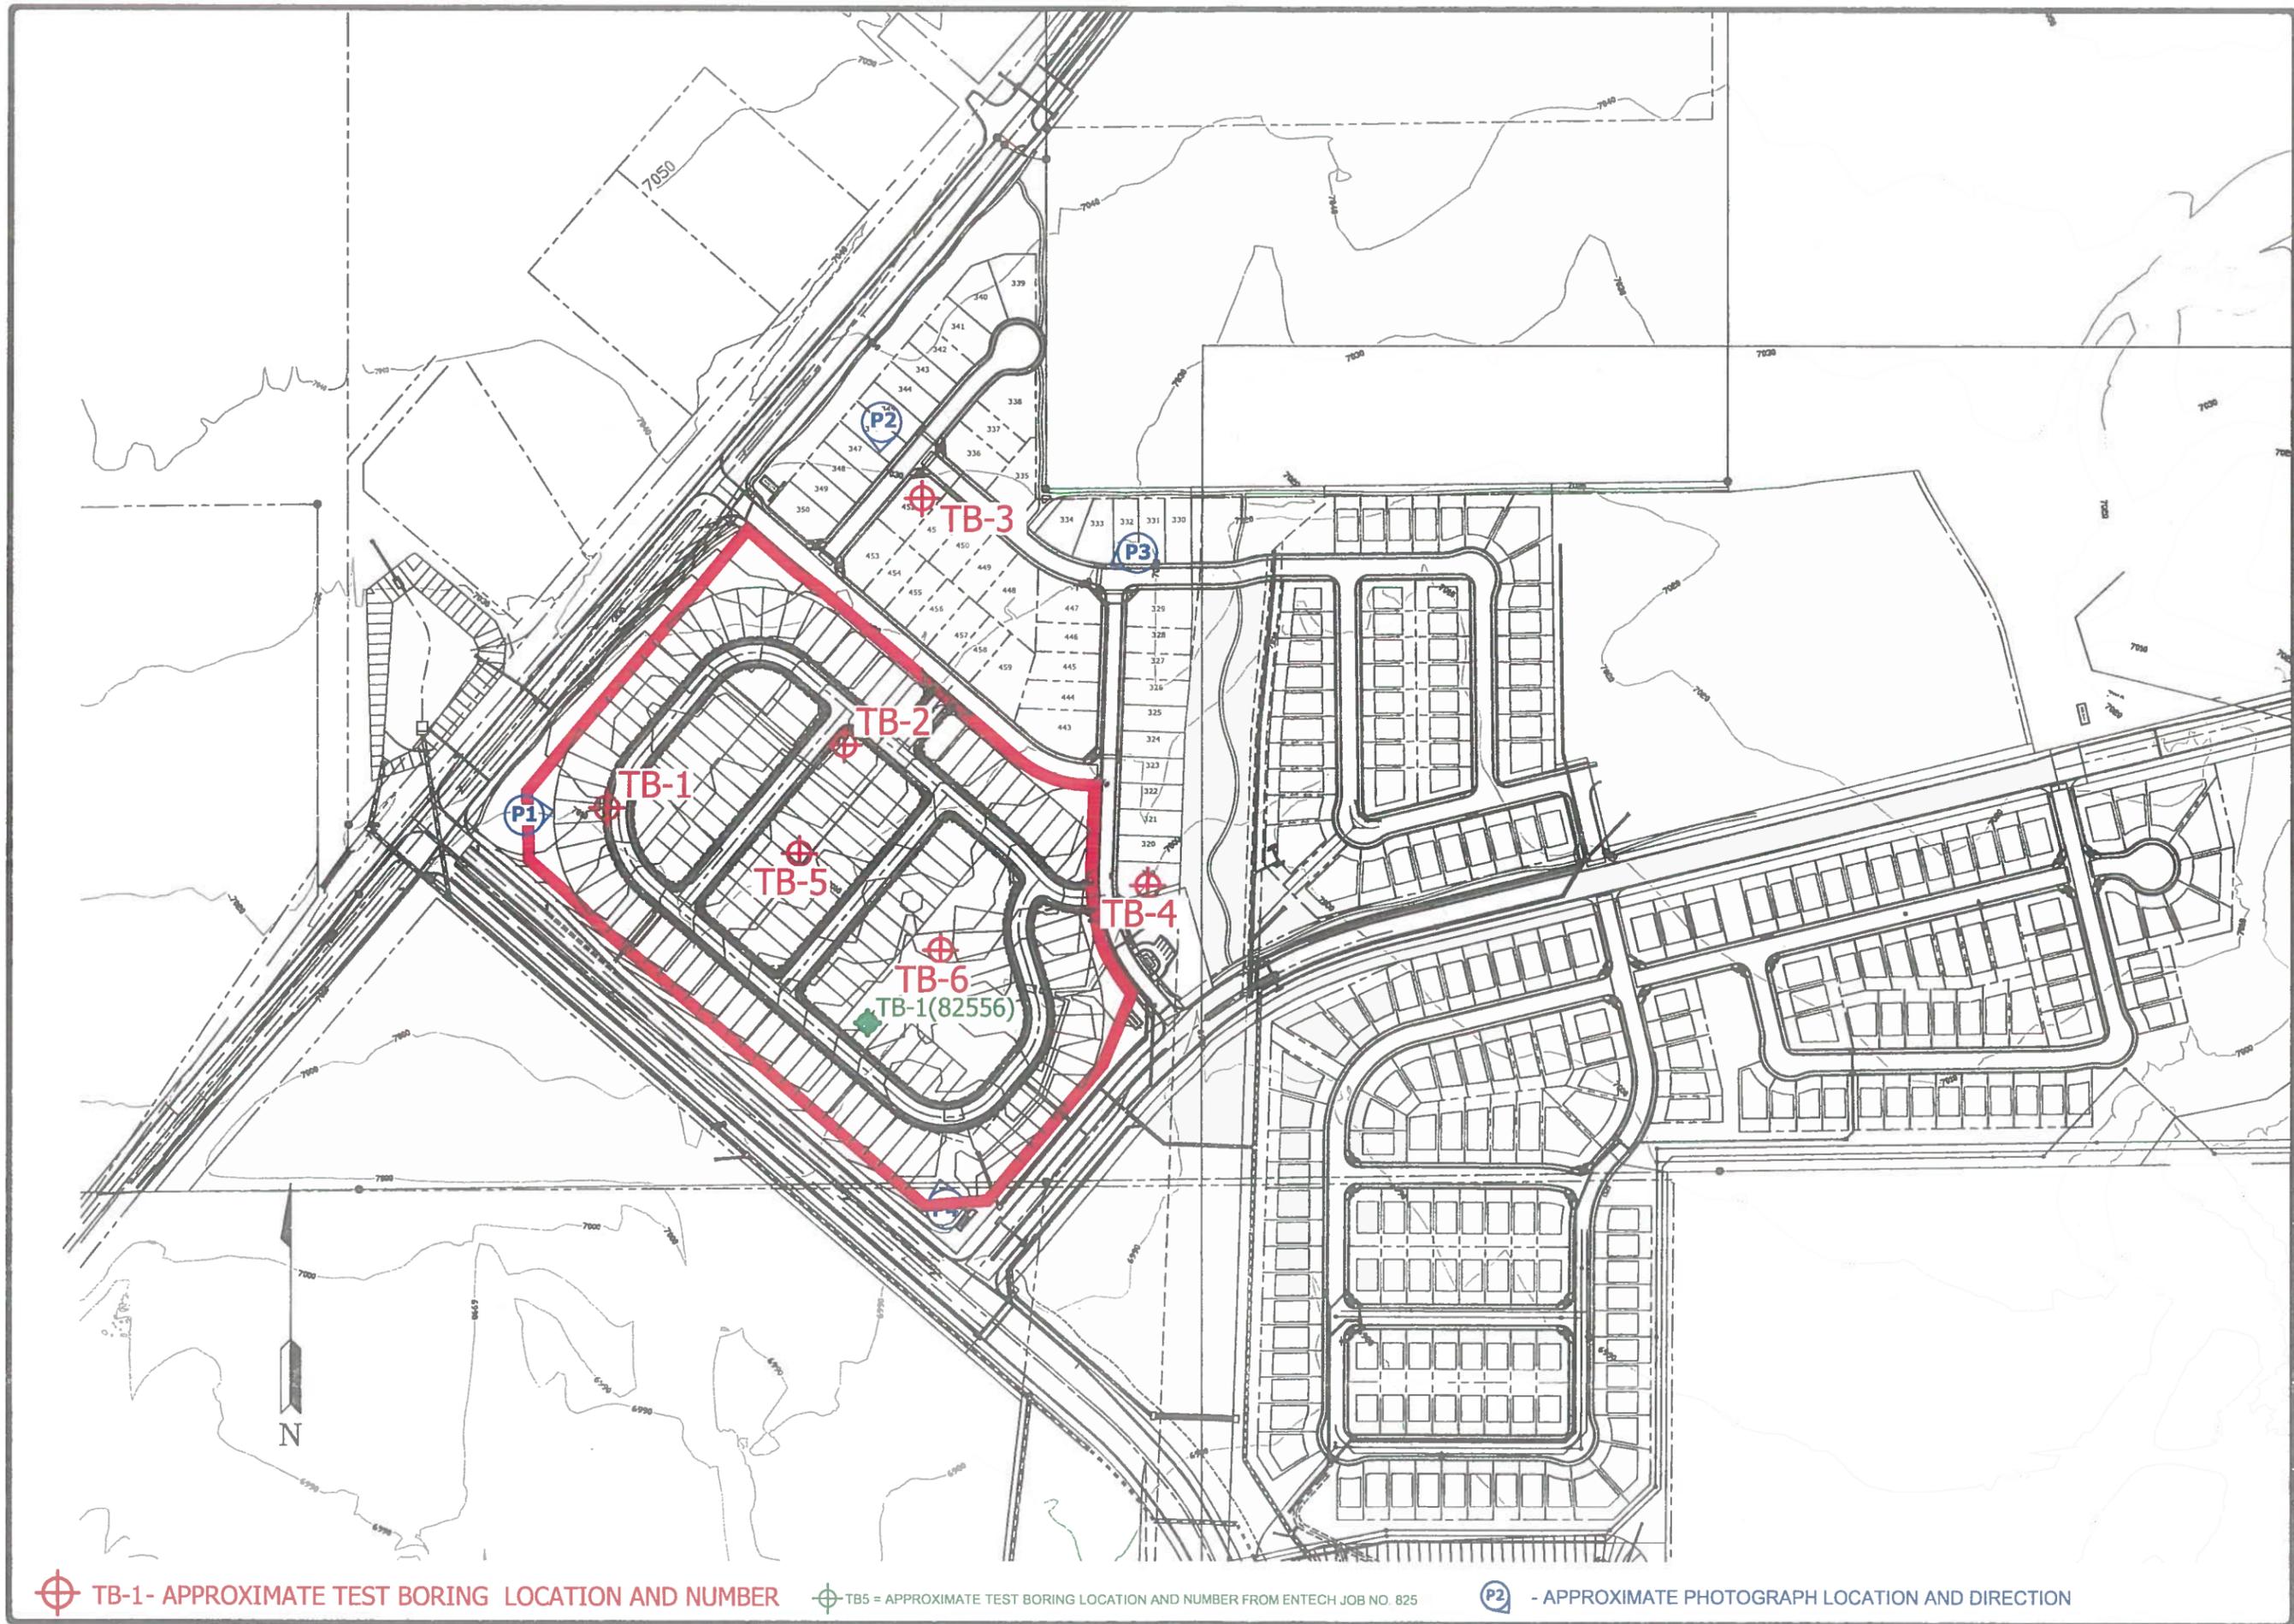
DRAWN
IA C
CHECKED
DPB
DATE
12/7/21
SCALE
1" = 300'
JOB NO.
191088
FIGURE NO.
4

Four (4) test borings were drilled by Entech Engineering, Inc. in an investigation dated February 10, 2020, Entech Job No. 191088. Two of these borings were within the project referenced above. Two additional test borings were drilled on March 1, 2022 to analyze current groundwater conditions. The borings were drilled with a power-driven continuous flight auger drill rig to 20 feet. Samples were obtained during drilling using the Standard Penetration Test, ASTM D-1586, utilizing a 2-inch O.D. Split Barrel Sampler and a California Sampler. Results of the penetration tests are shown on the drilling logs to the right of the sampling point. The location of the test borings is shown on the Test Boring Location Plan, Figure 4. The drilling logs are included in Appendix B.

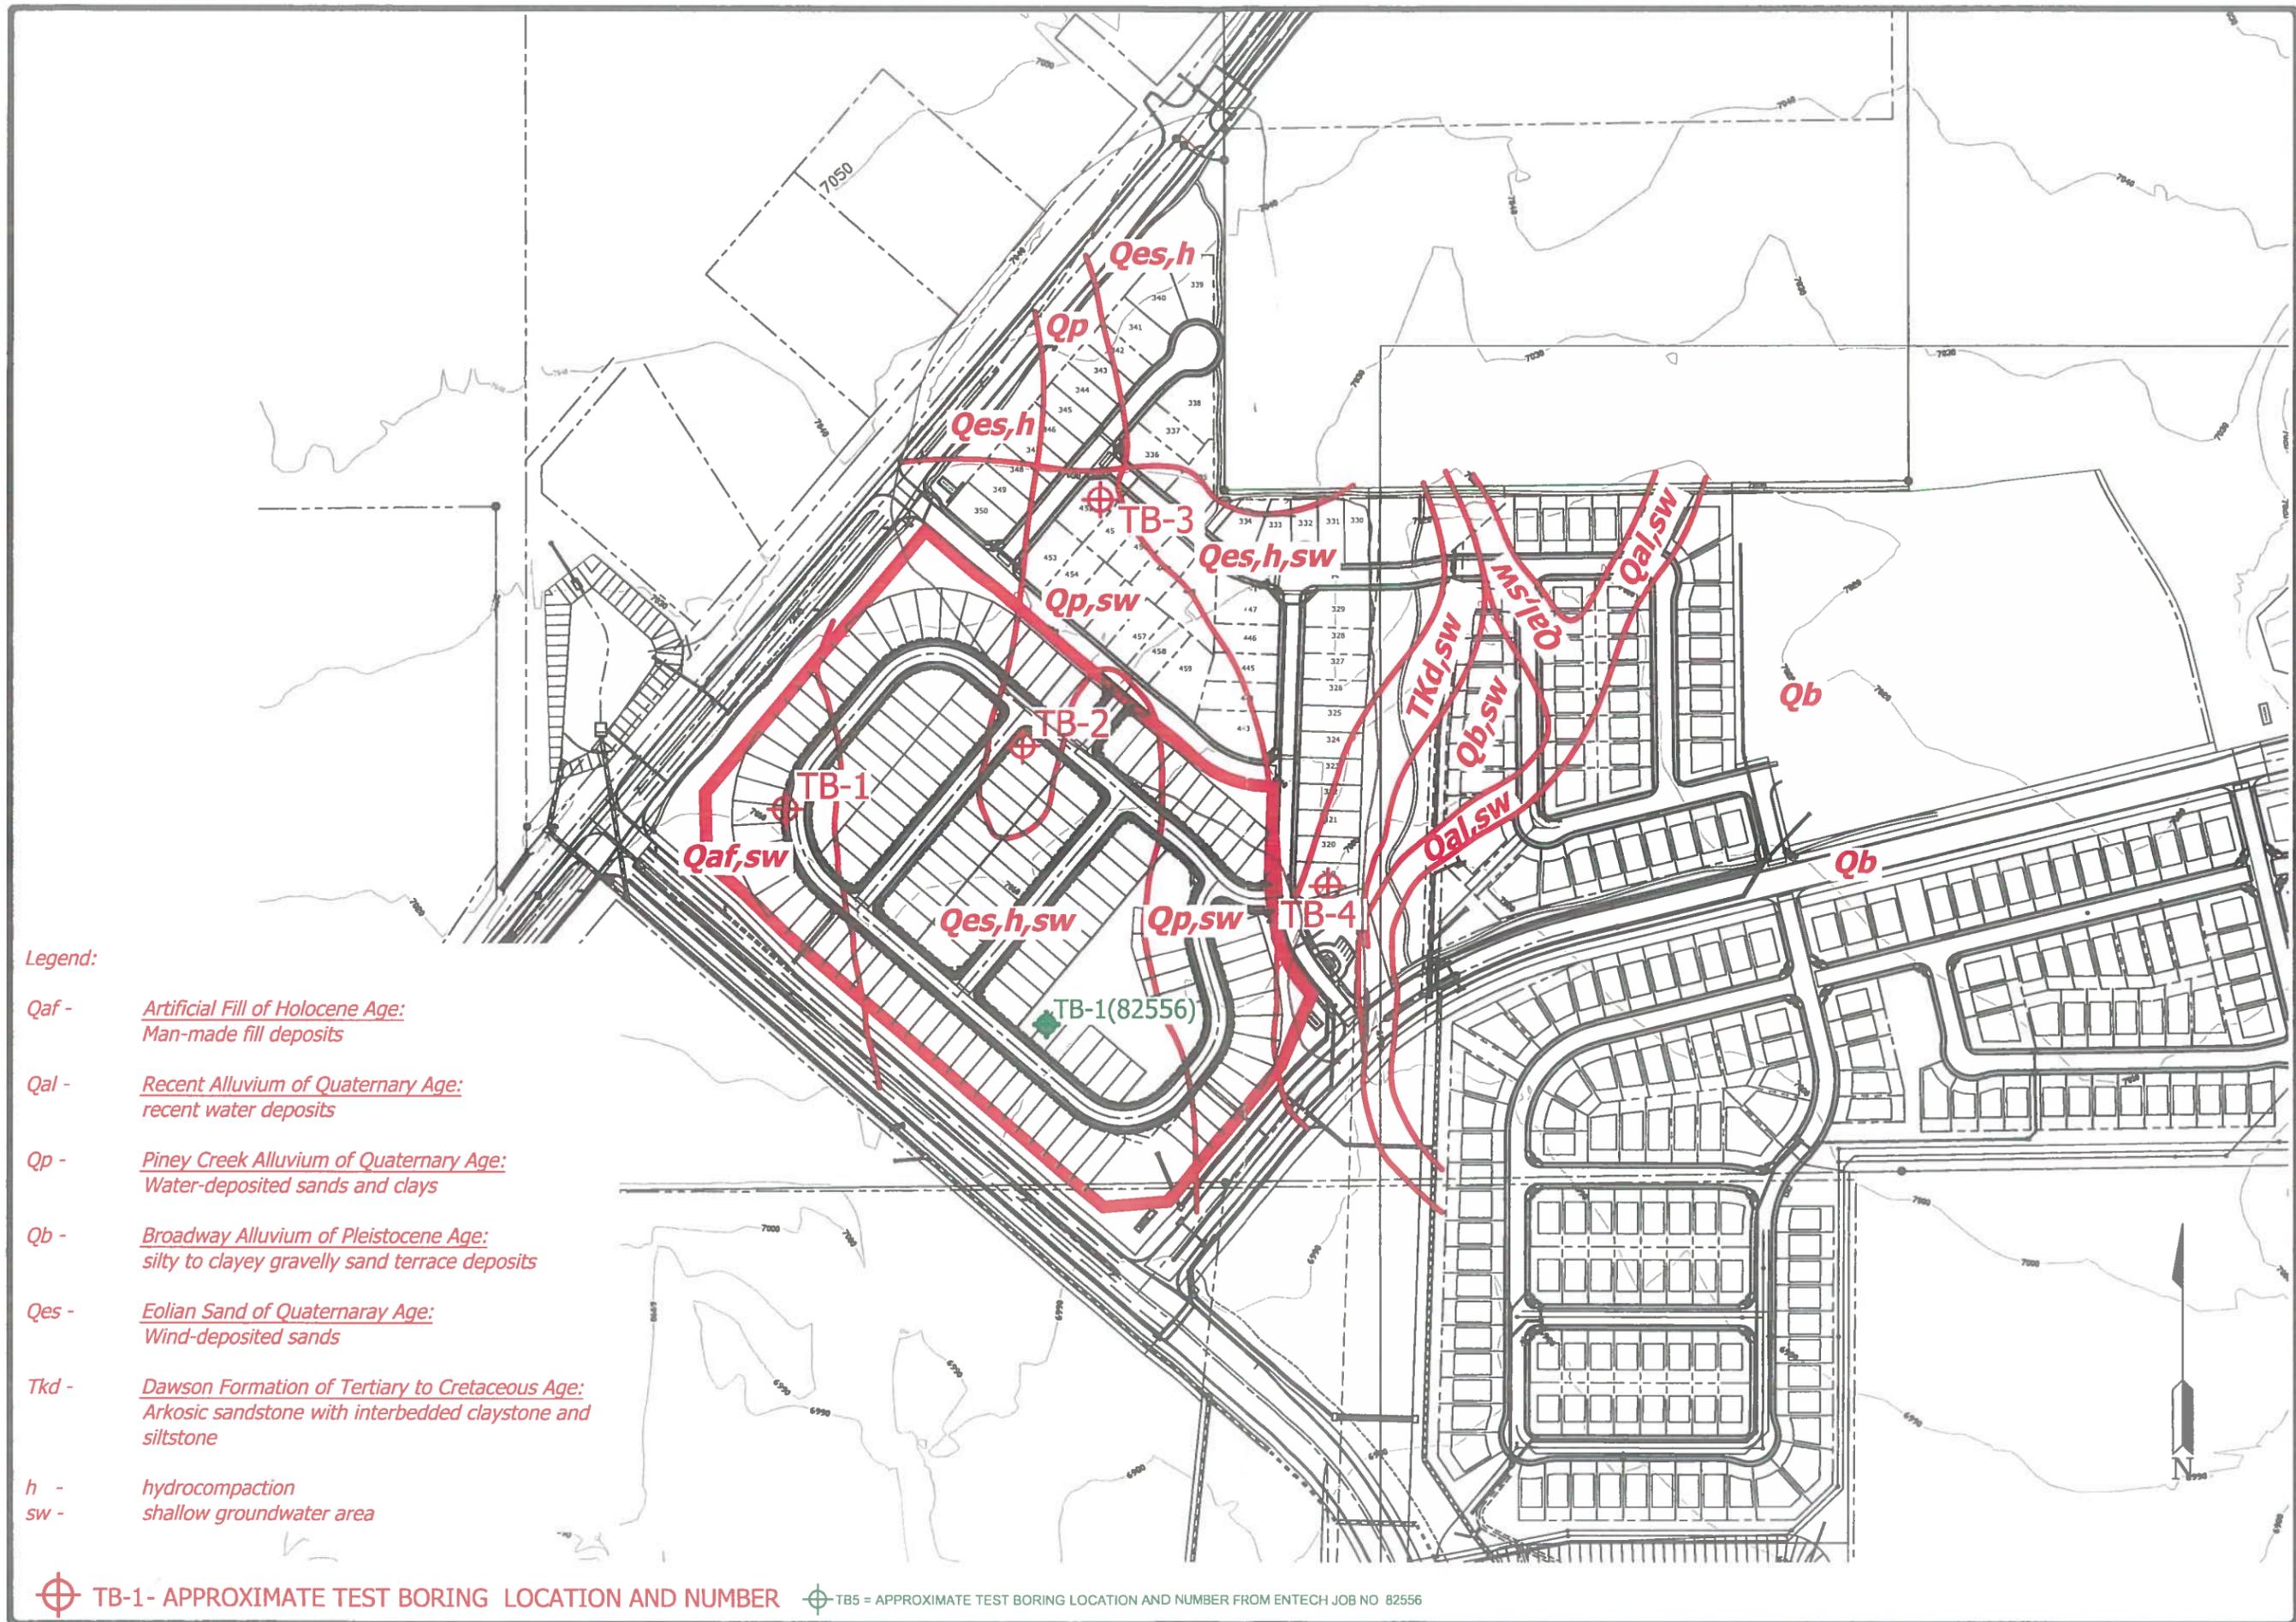
As mentioned previously, detailed mapping has been performed on this site to produce an Engineering Geology Map (Figure 7). This map shows the location of various geologic conditions of which the developers and planners should be cognizant during the planning, design and construction stages of the project. The hazards identified on this site include artificial fill, hydrocompaction, potentially expansive soils, and shallow groundwater areas. The following hazards have been addressed:
