**GEOLOGIC HAZARDS EVALUATION AND
PRELIMINARY GEOTECHNICAL INVESTIGATION
HAY CREEK DEVELOPMENT
2855 HAY CREEK ROAD
EL PASO COUNTY, COLORADO**

CTL|T Project No. CS19573-115

December 27, 2022

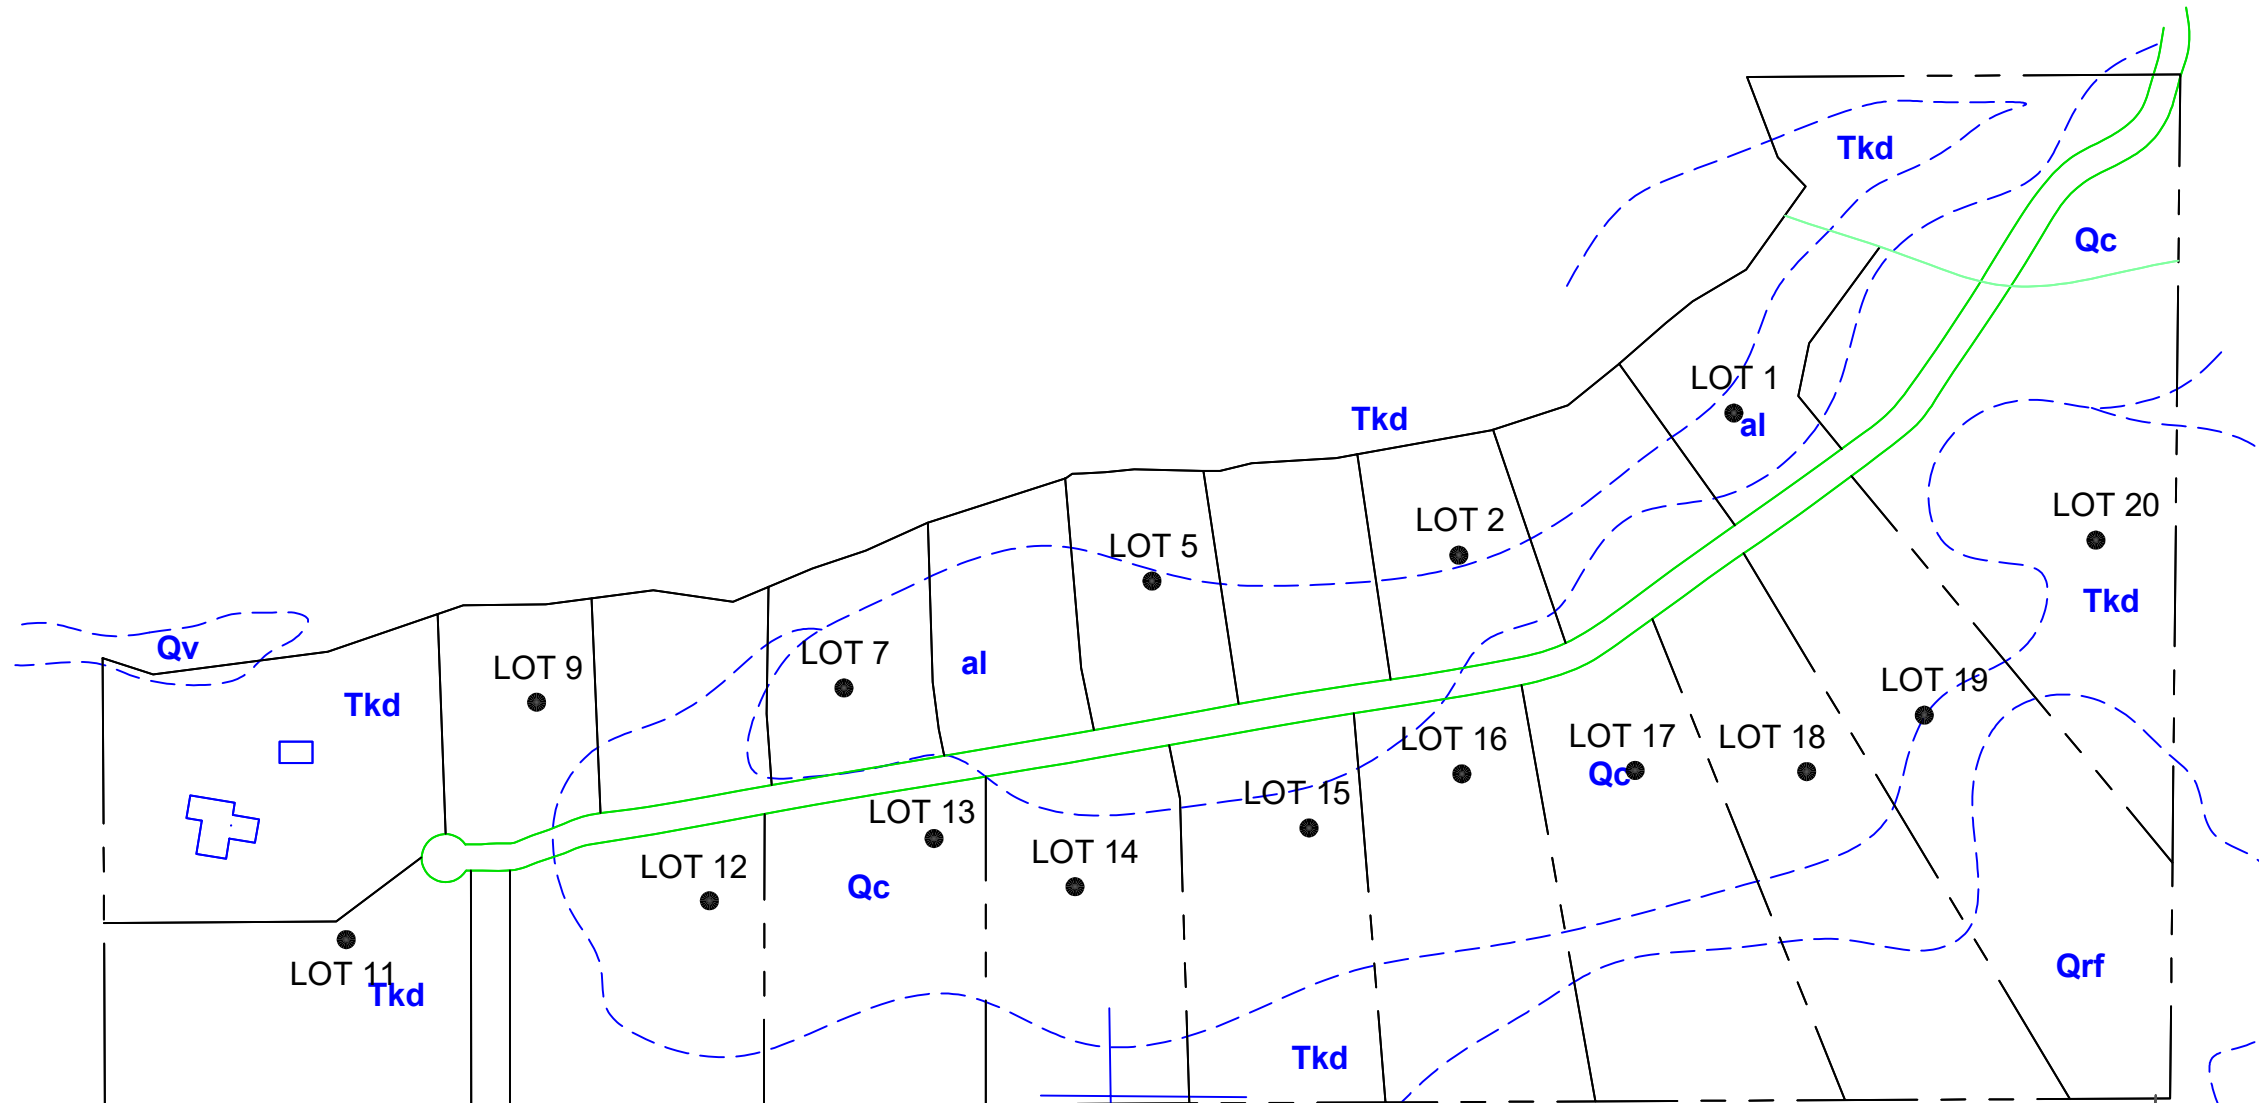
Geologic conditions at the site were evaluated through the review of published geologic maps, field reconnaissance, and exploratory borings. Information from these sources was used to produce our interpretation of site geology (Fig. 2). A list of references is included at the end of this report.

The surficial overburden soils are considered to be alluvial and colluvial deposits (Map Units: al, Qc, Qv, Qrf) and are underlain by bedrock of the Dawson formation (Tkd). The materials are geologically recent, early to late Pleistocene, Holocene, Upper Cretaceous, and Paleocene-age materials. The overburden materials are light brown to brown, red-brown, and gray to gray brown and considered the dominant stratum at the site. Alluvial and Colluvial deposits (al and Qc) are generally mapped as being found within the valley or low lying areas of the site while the bedrock (Tkd) is mapped as generally located at the higher elevations. The bedrock is overlain by Rocky Flats Alluvium (Qrf) in the vicinity of the southeastern corner. The bedrock is exposed in various areas along the north and south bluffs. Alluvium and Colluvium materials generally

- - - SURFICIAL GEOLOGIC CONTACTS
- al LATE HOLOCENE AGE, ALLUVIUM, SILT, SAND, GRAVEL, AND BOULDERS IN STREAM BEDS AND ON LOWER TERRACES ON VALLEY FLOORS.
- Qc HOLOCENE AND LATE PLEISTOCENE AGE, COLLUVIUM, CLAYEY OR SILTY SAND LOCALLY WITH BOULDERS DERIVED FROM IN-PLACE WEATHERING OF BEDROCK.
- Qv EARLY MIDDLE PLEISTOCENE AGE, VERDE ALLUVIUM, POORLY SORTED STRATIFIED GRAVEL CONTAINING LENSES OF SAND, SILT, AND CLAY.
- Qrf EARLY PLEISTOCENE, ROCKY FLATS ALLUVIUM: PEBBLY, COBBLY, AND BOULDERY GRAVEL AND CLAYEY COARSE SAND.
- Tkd COLLUVIUM, DAWSON FORMATION

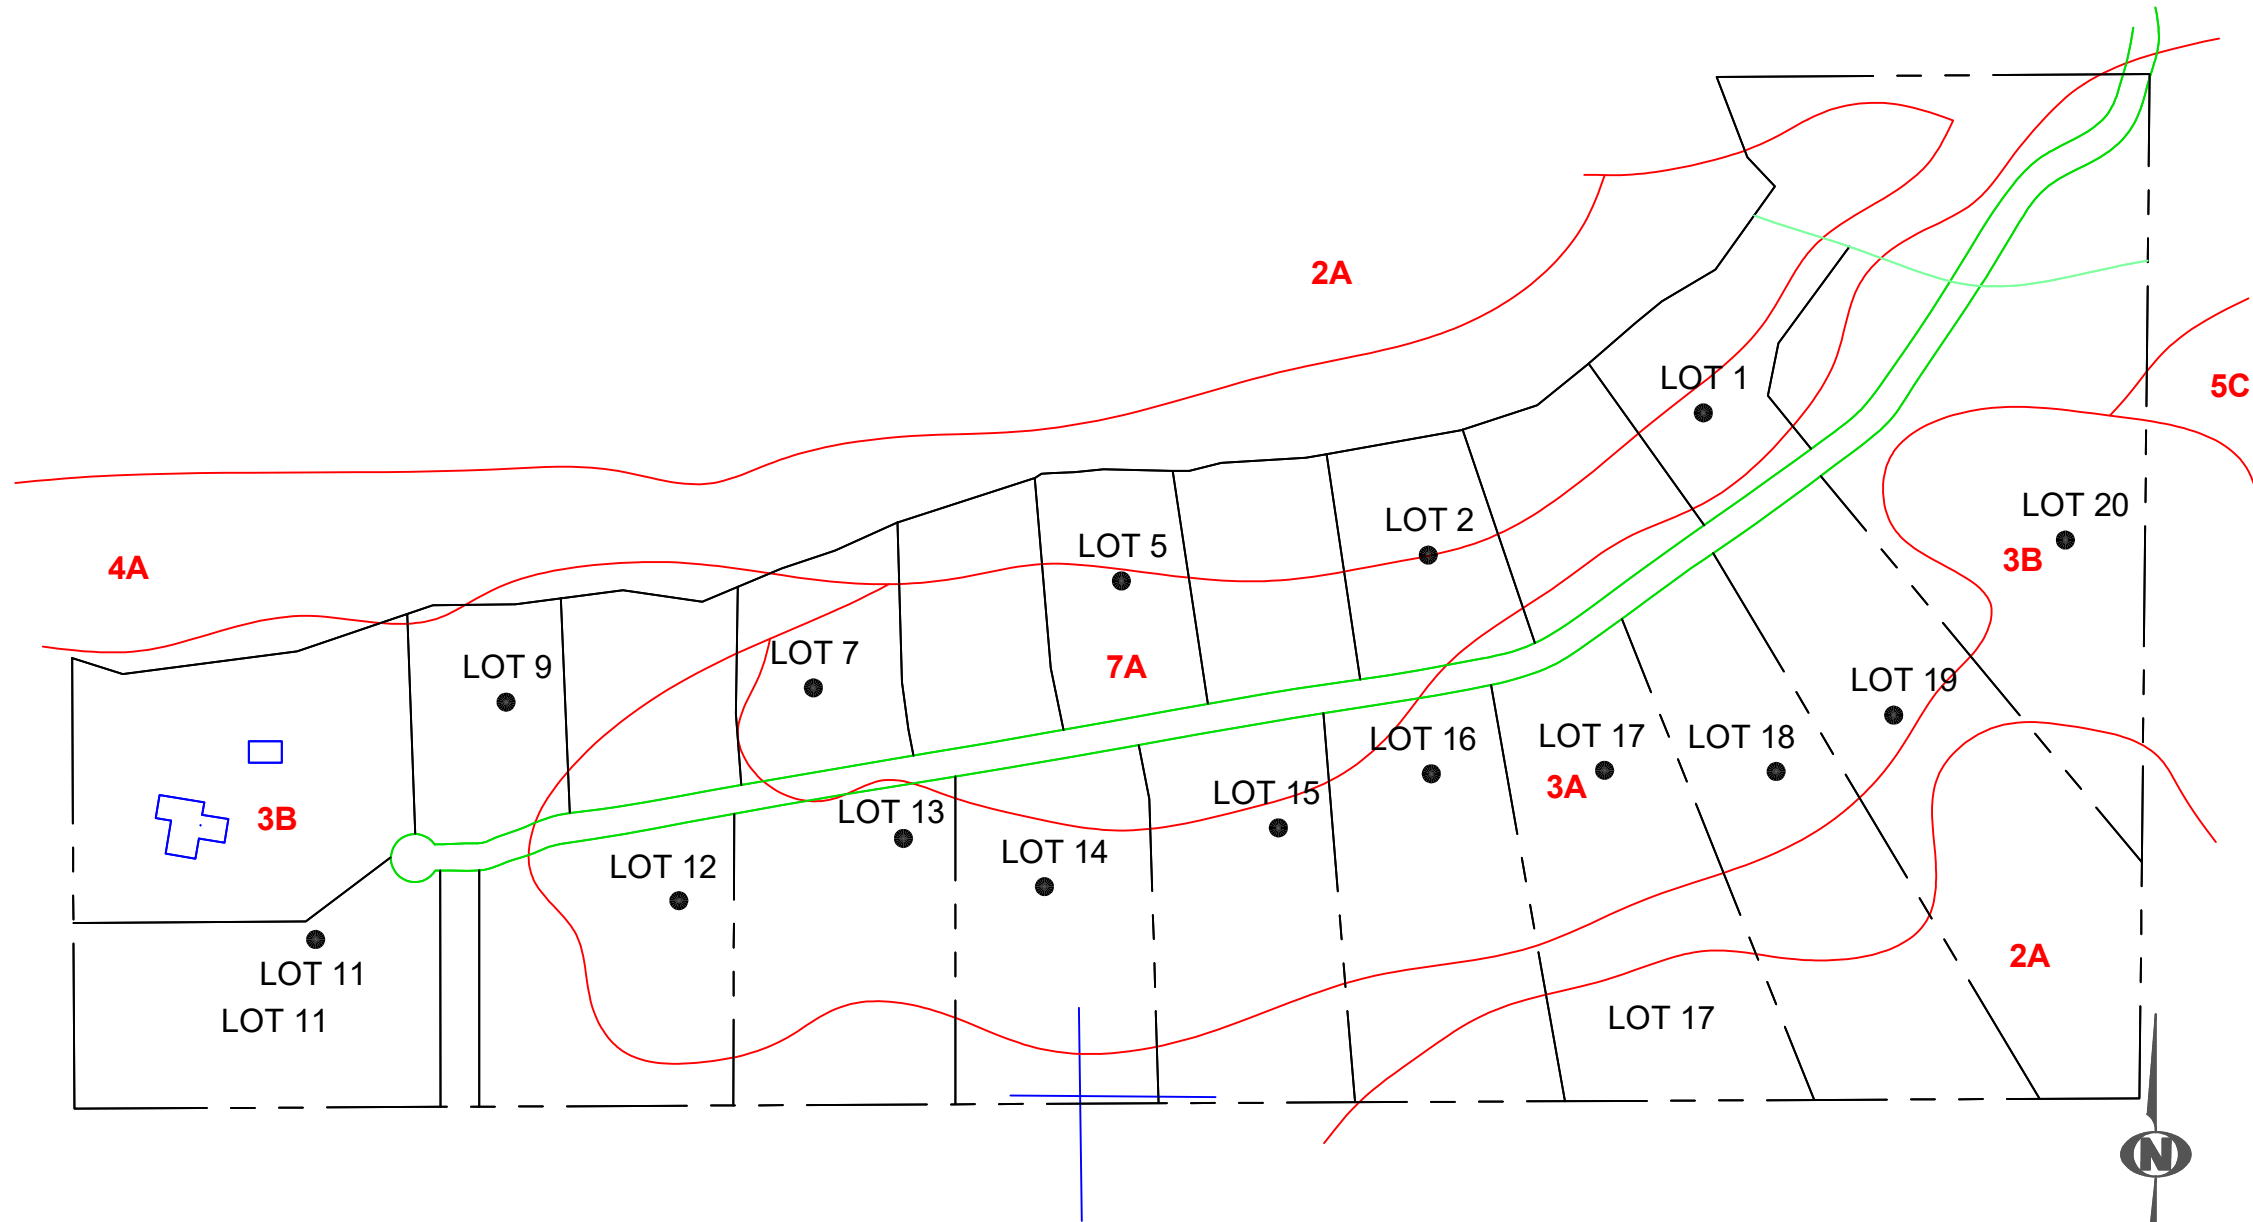
The engineering geology conditions from Robinson (1977) were considered and areas were mapped as described below and shown in Fig. 3. The other issues are site-wide concerns and are not depicted in Fig. 3.

Map Unit “3B” depicts expansive and potentially expansive soil and bedrock on flat to moderate slopes (0%-12%). Emphasis on potential for swell, depth of bedrock, design of foundation and drainage.

- 3B** EXPANSIVE AND POTENTIALLY EXPANSIVE SOIL AND BEDROCK ON FLAT TO MODERATE SLOPES (0-12%). EMPHASIS ON POTENTIAL FOR SWELL, DEPTH OF BEDROCK, DESIGN OF FOUNDATIONS AND DRAINAGE.

- 4A** POTENTIALLY UNSTABLE COLLUVIUM AND BEDROCK ON MODERATE TO STEEP SLOPES (12% - 24%). INCLUDES EXPANSIVE AND POTENTIALLY EXPANSIVE SOIL AND BEDROCK. EMPHASIS ON SLOPE STABILITY, SWELLING CHARACTERISTICS, BEDROCK STRUCTURE, AND SURFACE AND SUBSURFACE DRAINAGE.

- 5C** UNSTABLE OR POTENTIALLY UNSTABLE COLLUVIUM OR BEDROCK ON STEEP SLOPES. EMPHASIS ON SLOPE STABILITY, CONTROL OF CUTS AND SURFACE DRAINAGE.
- 7A** PHYSIOGRAPHIC FLOOD PLAIN WHERE EROSION AND DEPOSITION PRESENTLY OCCUR AND IS GENERALLY SUBJECT TO RECURRENT FLOODING. INCLUDES 100-YEAR FLOODPLAIN ALONG MAJOR STREAMS WHERE FLOODPLAIN STUDIES HAVE BEEN CONDUCTED. EMPHASIS ON FREQUENCY, DEPTH AND CONTROL.
