**SOIL, GEOLOGY, AND GEOLOGIC HAZARD STUDY
HOMESTEAD AT STERLING RANCH FILING NO. 3
EL PASO COUNTY, COLORADO**

May 26, 2022

Entech Job No. 221195
F:/AAProjects/2022/221195 Geohaz

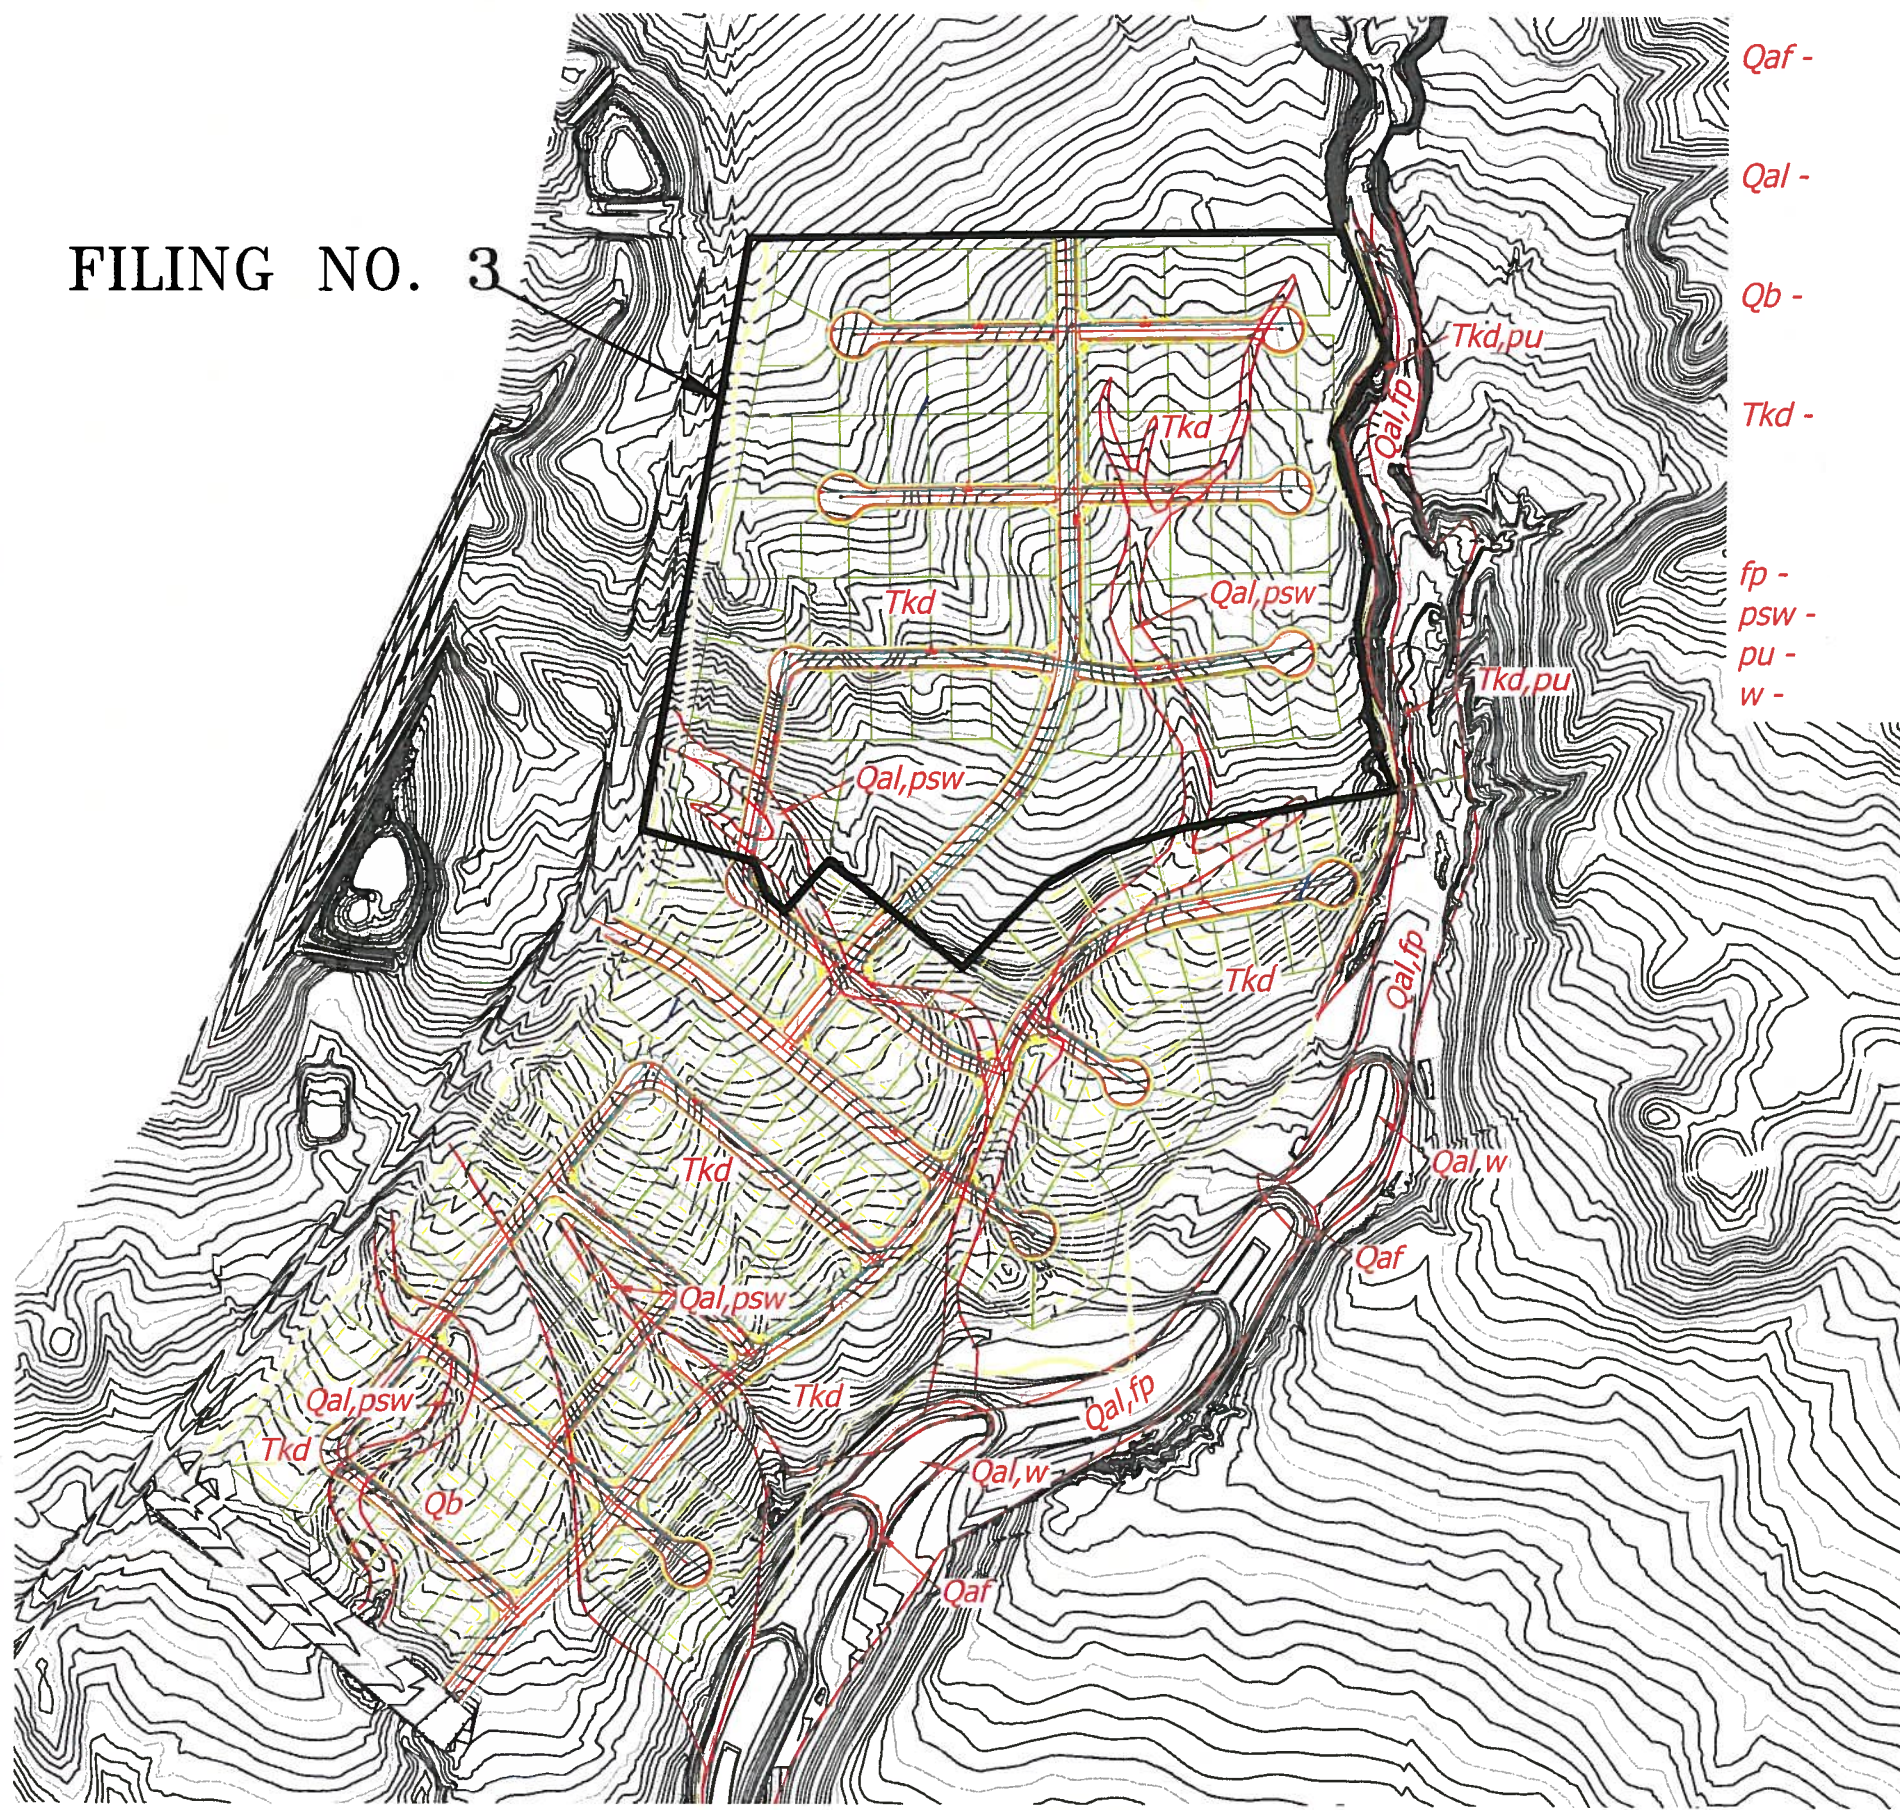
DRAWN L.L.
CHECKED
DATE 5/26/22
SCALE AS SHOWN
JOB NO. 221195
FIGURE NO. 7

Detailed mapping has been performed on this site to produce an Engineering Geology Map (Figure 7). This map shows the location of various geologic conditions of which the developers and planners should be cognizant during the planning, design and construction stages of the project. The hazards identified on this site include artificial fill, potentially unstable slopes, potentially expansive soils, floodplains, and potentially seasonal shallow groundwater areas. The following hazards have been addressed:

Some of the steep slopes along the Sand Creek drainage have been identified as potentially unstable. Considerable care must be exercised in these areas not to create a condition which would tend to activate instability.

Potentially Seasonal Shallow Groundwater: In these areas, we would anticipate the potential for periodically high subsurface moisture conditions and possible frost heave potential, depending on the soil conditions. These areas are located in areas of minor drainage swales and low areas located on the site. According to the grading plans, these areas are to be regraded and detention ponds created. Areas of shallow groundwater may exhibit unstable subgrade conditions in terms of bearing support of construction equipment during overlot grading. Lots immediately adjacent to the detention ponds or the Sand Creek drainage may also experience higher subsurface moisture conditions during periods of higher flows.

Mitigation: According to the grading plan shown on Figure 7, Much of this area is to be regraded or avoided by development. Building should be avoided on any remaining potentially unstable slopes unless stabilized. A setback of 20 feet from the crest of these slopes is recommended. Stabilization could involve regrading to slope angles no steeper than 3:1 or the use of engineer-designed retaining walls, tiebacks, or buttresses. Where retaining walls are not used, erosion protection may be necessary to prevent undercutting by the creek during periods of high water. It is our understanding the project will include drainage improvements and the construction of a regional trail along the Sand Creek drainage and stabilization of the slopes will be a part of the improvements. Specific slope stabilization recommendations are beyond the scope of this report.

Mitigation: In these locations, foundations subject to severe frost heave potential should penetrate sufficient depth so as to discourage the formation of ice lenses beneath foundations. At this location and elevation, a foundation depth for frost protection of 30 inches is recommended. In areas where high subsurface moisture conditions are anticipated periodically, subsurface perimeter drains are recommended to help prevent the intrusion of water into areas located below grade. A typical perimeter drain detail is presented in Figure 9. Structures should not block drainages. Swales should be created to intercept surface runoff and carry it safely around and away from structures. Groundwater was not encountered in the test borings drilled on the site. It is anticipated groundwater will not affect shallow foundations on the majority of the site.
