## SOIL, GEOLOGY, AND WASTEWATER STUDY

**6385 Vessey Road  
El Paso County Schedule No. 5206000065  
El Paso County, Colorado**

**JOB NO. 185099**

**January 11, 2021**

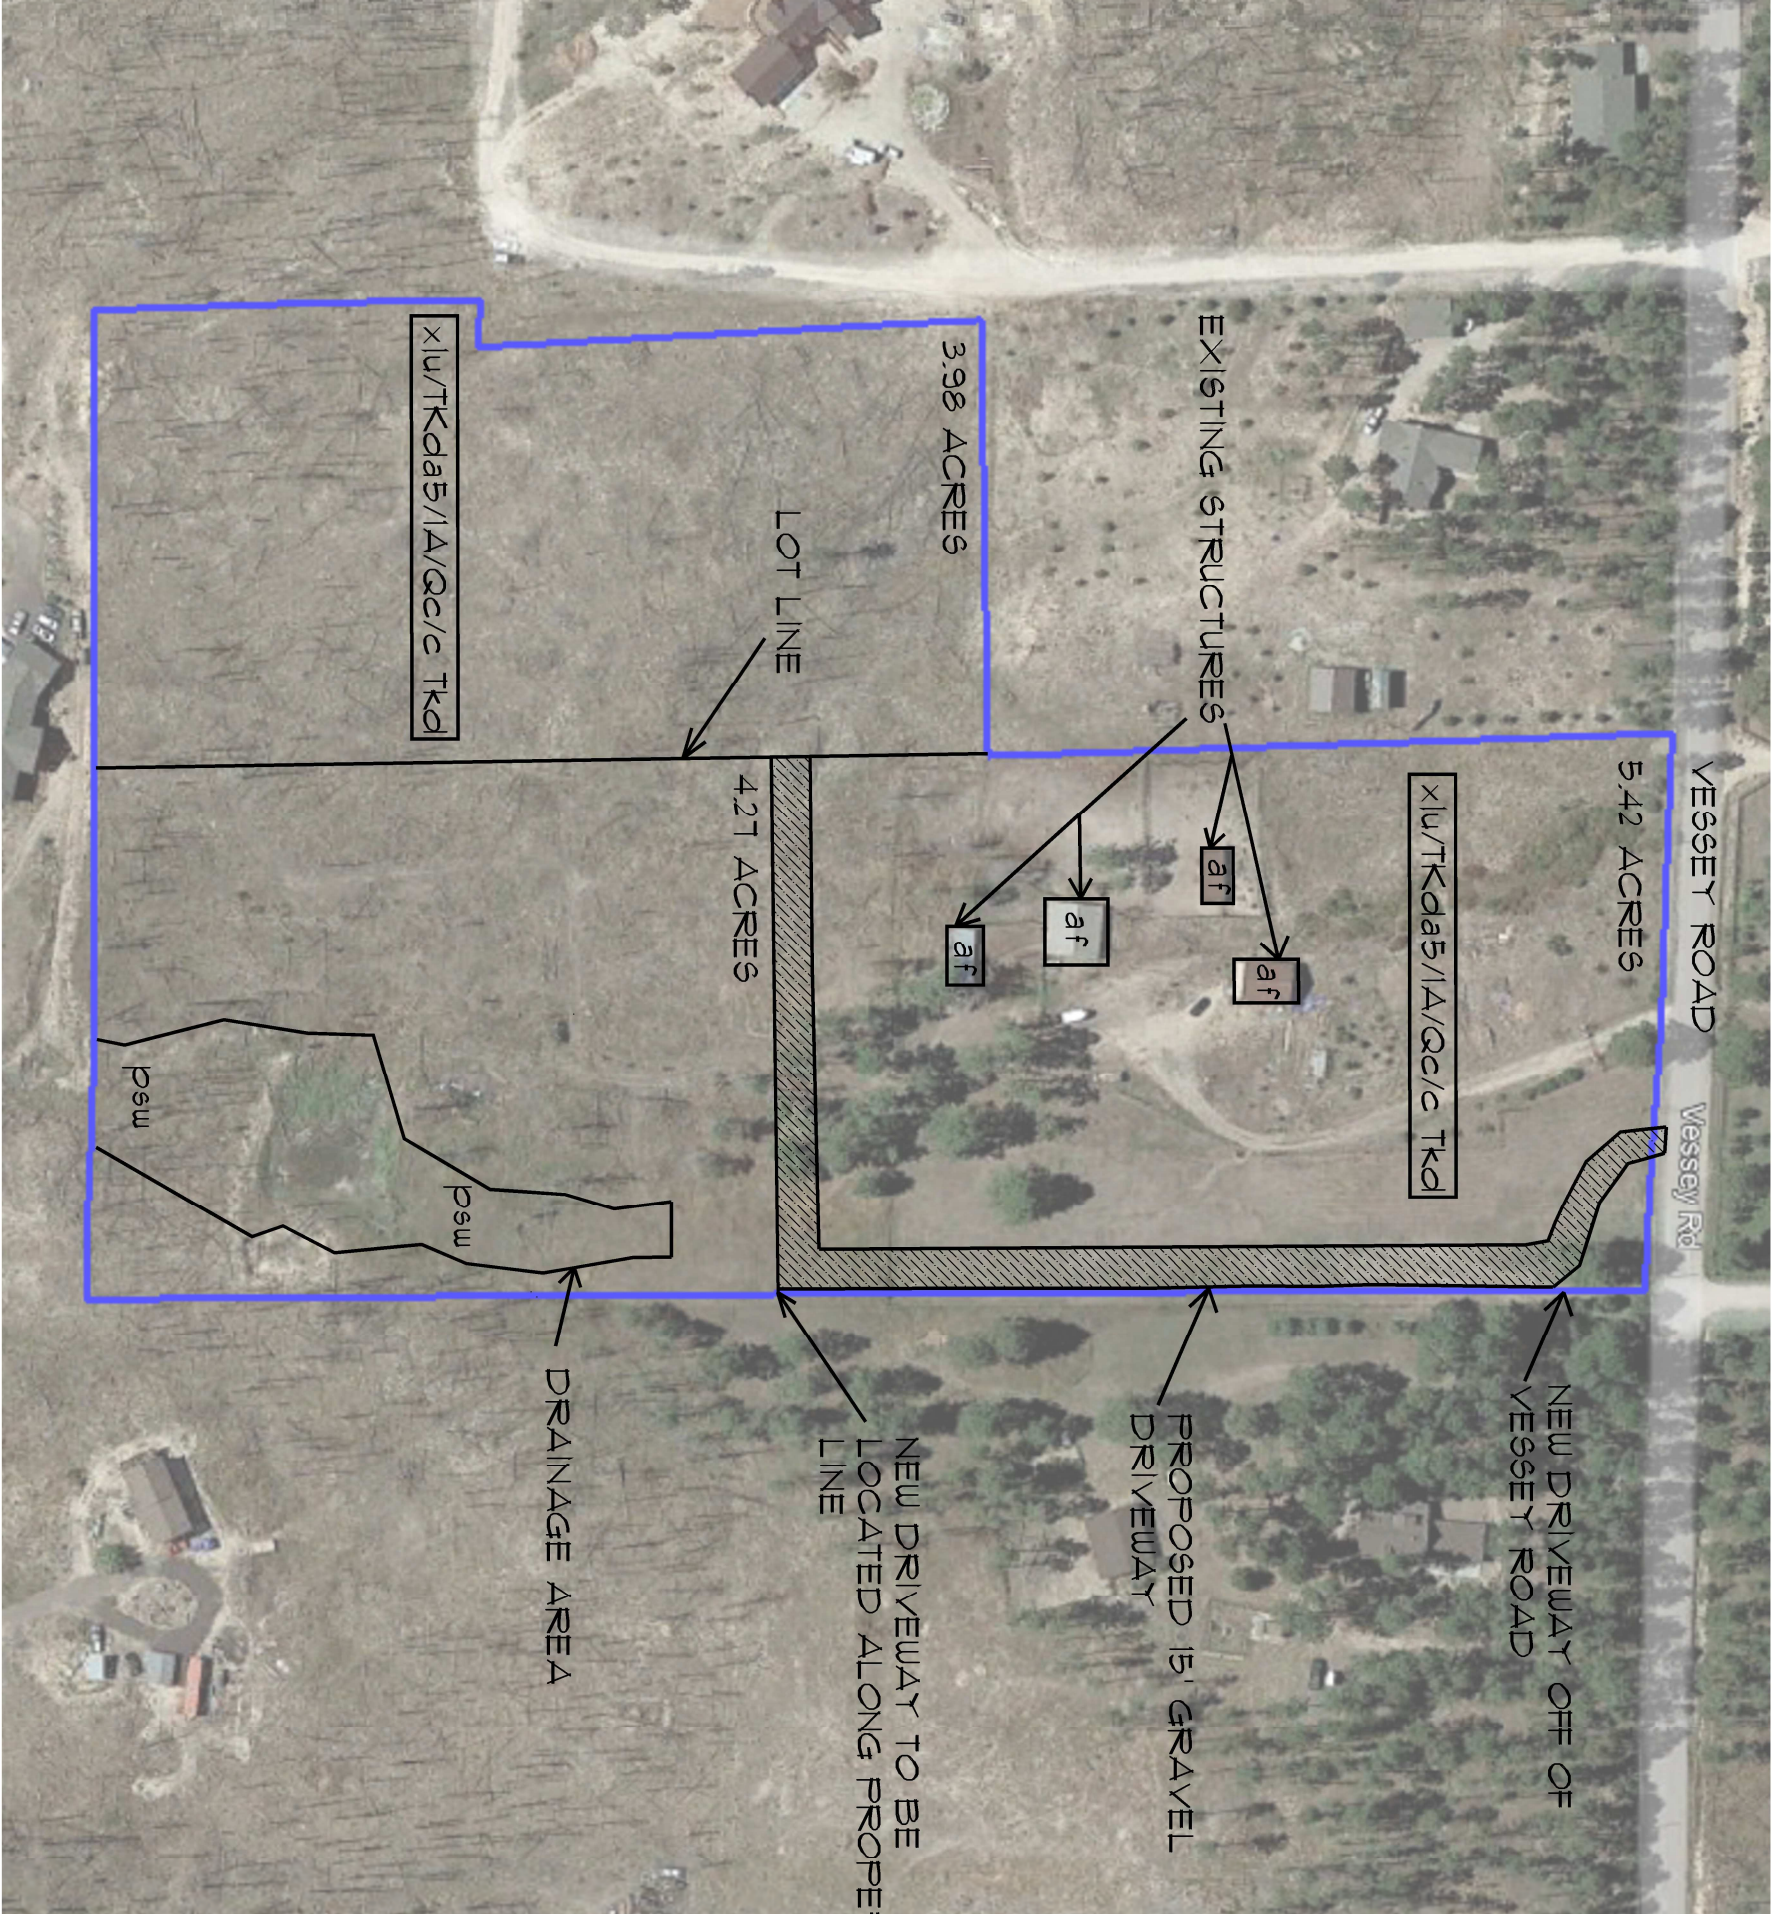
Based on our field observations and review of relevant geologic maps, a geologic map was prepared which identifies the geologic conditions affecting the development. The geologic conditions affecting the development are presented in the Engineering and Geology Map, Figure 6.

- xlu - Feldspathic loamy disintegration residuum
- TKda5 - Dawson Formation Facies Unit Five
- psw - Potentially Seasonally Wet Area
- af - Artificial Fill Area

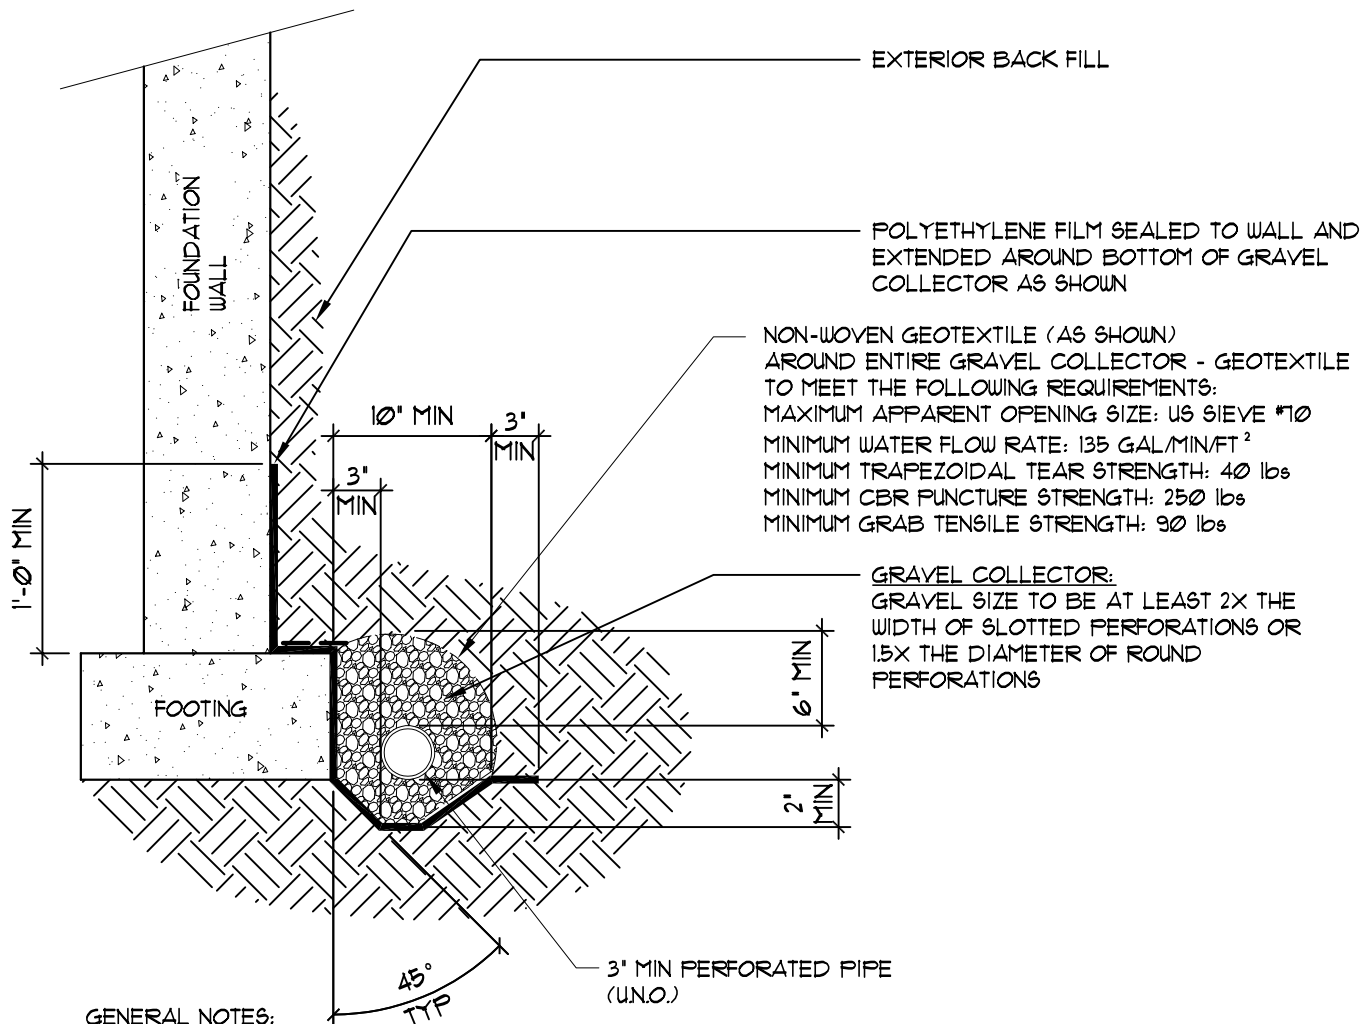
**FIG No. 10**

Foundations must have a minimum 30-inch depth for frost protection. Perimeter drains are recommended around portions of the structures which will have habitable or storage space located below the finished ground surface. This includes crawlspace areas but not the walkout trench, if applicable. Perimeter drains help reduce the likelihood of intrusion of "nuisance" water into below-grade spaces. A typical perimeter drain detail is presented in Figure 10.

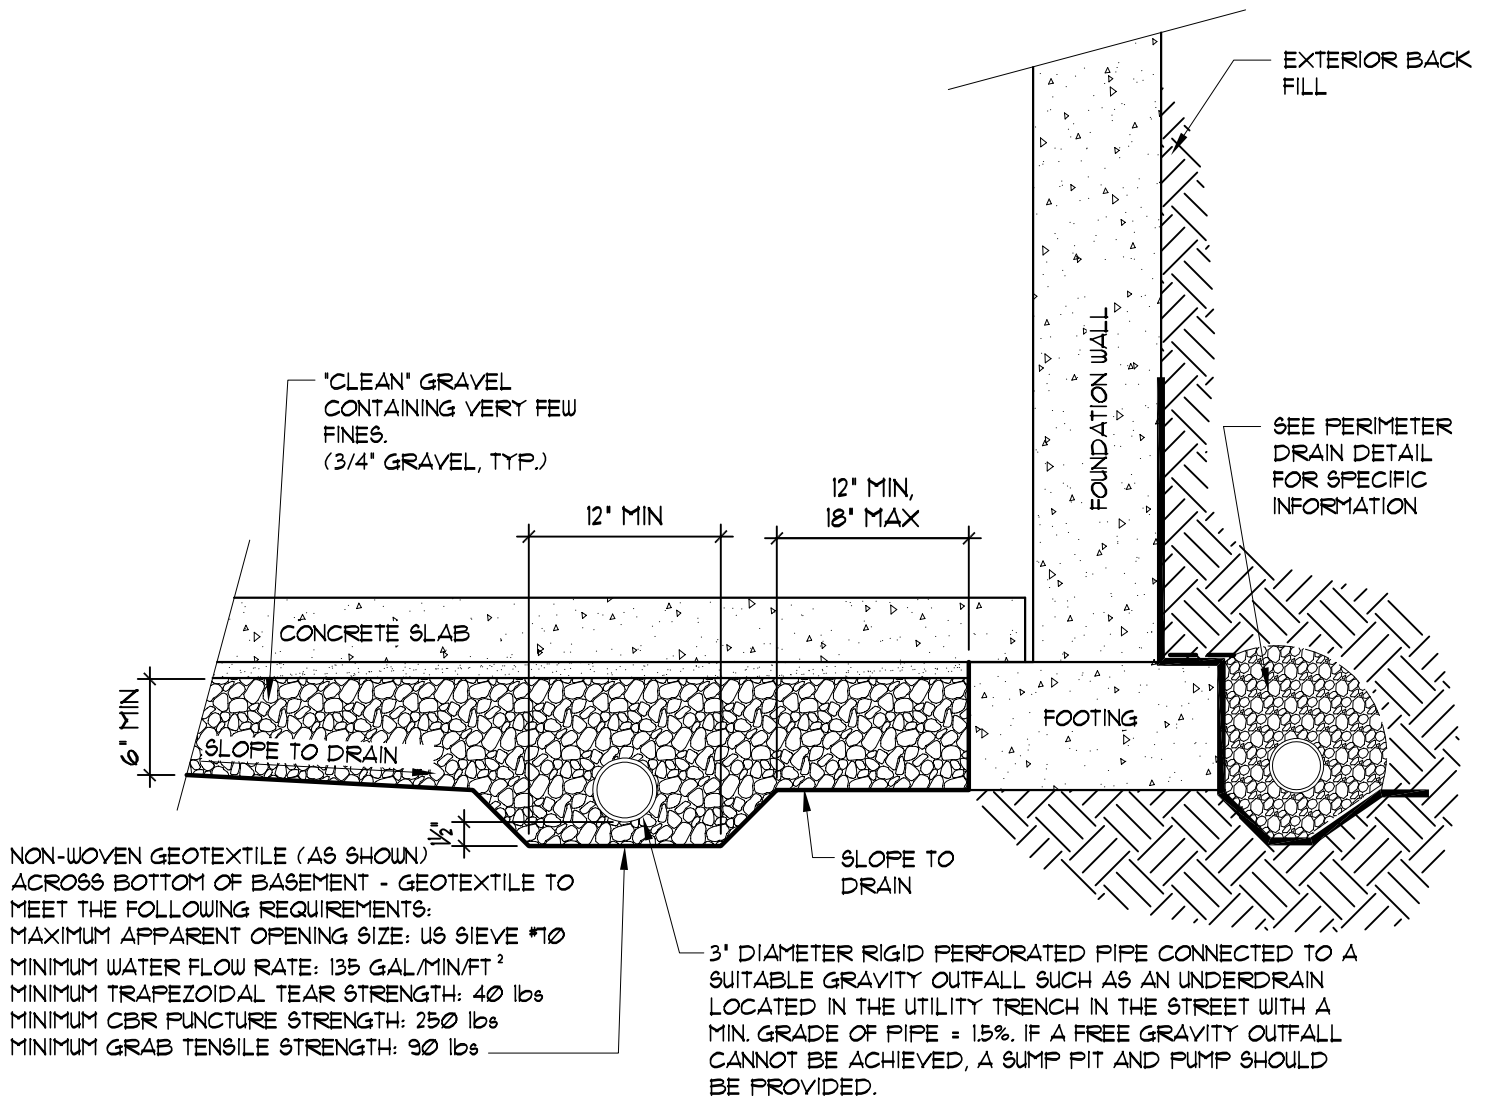
The proposed development may include both basements and crawlspaces. If groundwater is encountered at the time of the site-specific subsurface soil investigations within 4 to 6 feet of the proposed basement slab elevations, an underslab drain should be considered in conjunction with the perimeter drain. It must be understood that subsurface drains are designed to intercept some types of subsurface moisture and not others. Therefore, the drains could operate properly and not mitigate all moisture problems relating to foundation performance or moisture intrusion into the basement area. A typical underslab drain detail is presented in Figure 11.

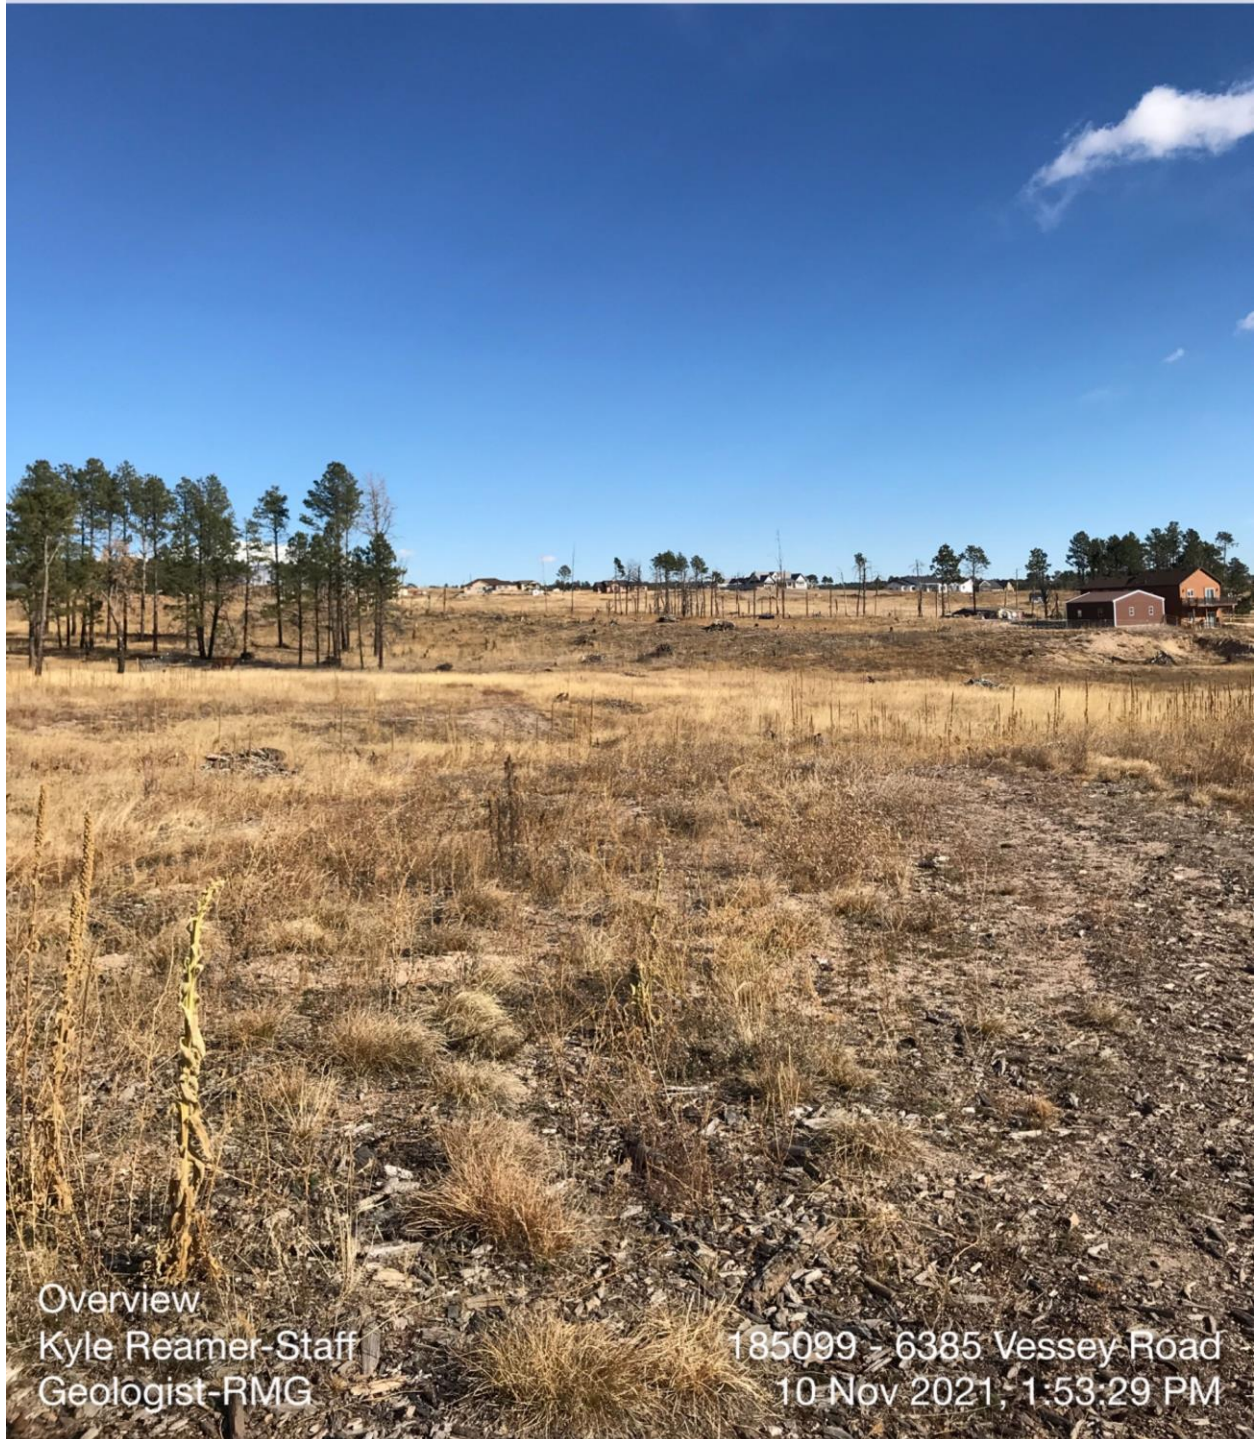
# West Elevation

Overview  
Kyle Reamer-Staff  
Geologist-RMG

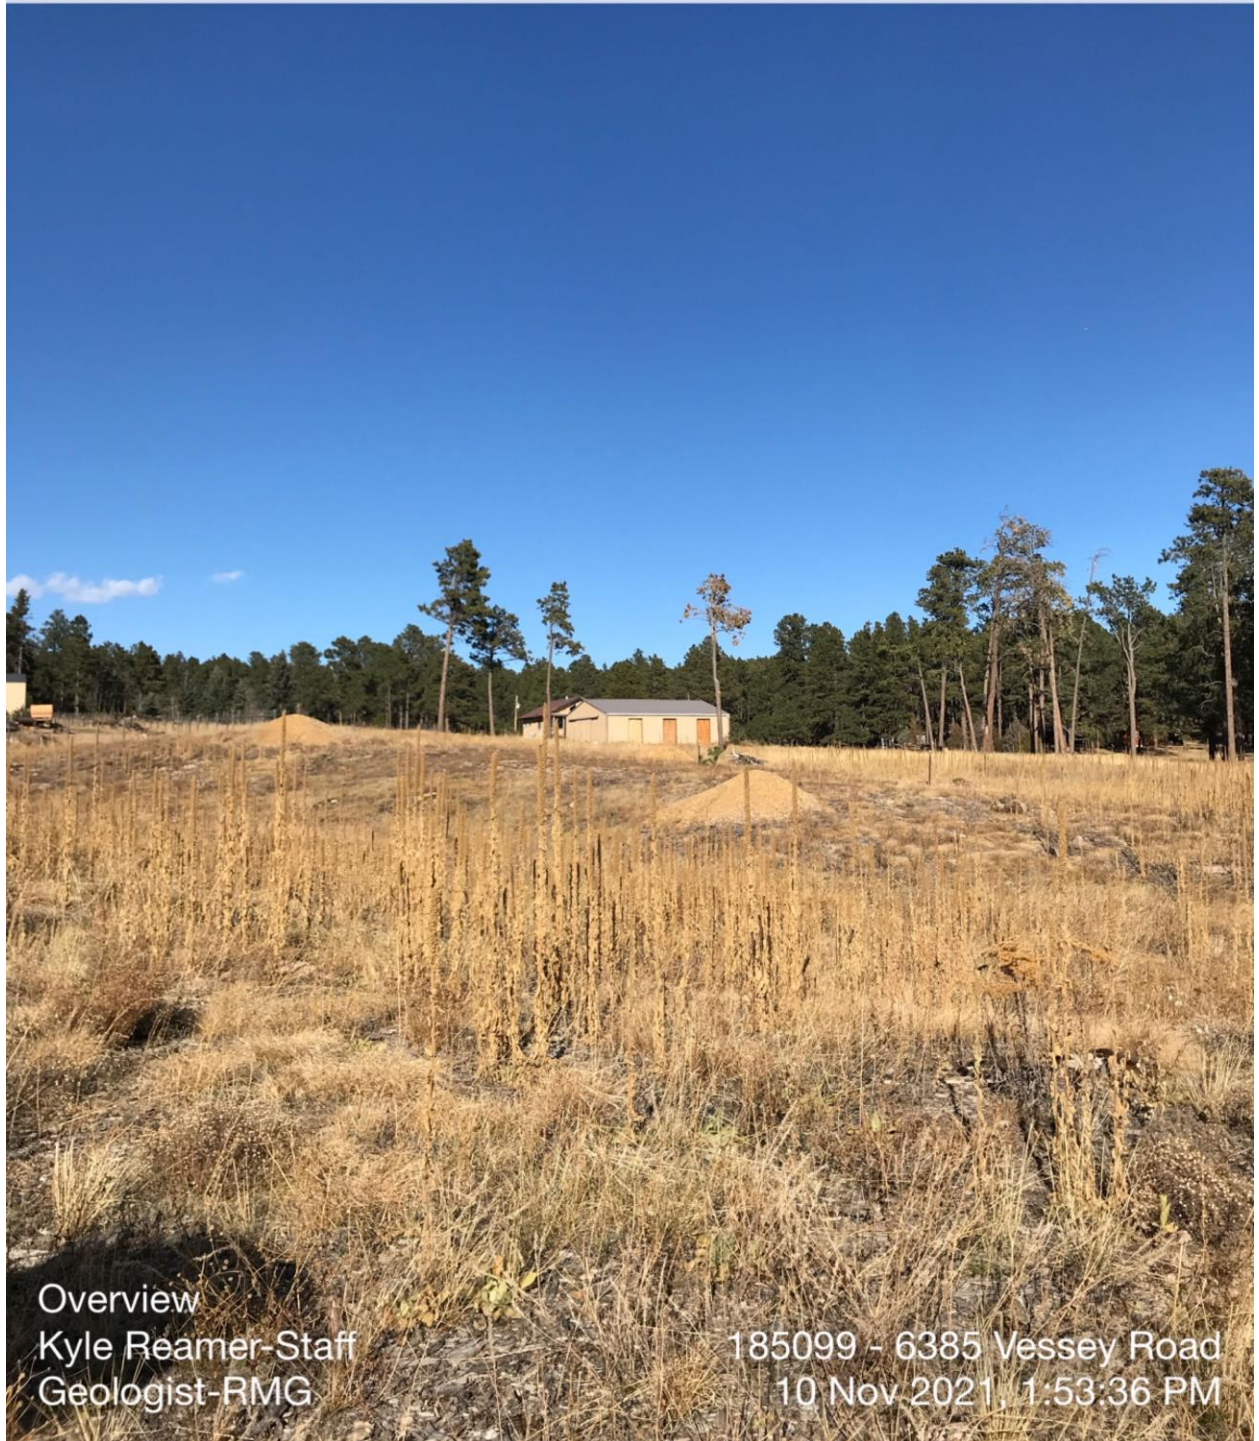
# South West Elevation

Overview  
Kyle Reamer-Staff  
Geologist-RMG
