SOIL, GEOLOGY, AND WASTEWATER STUDY

**6385 Vessey Road
El Paso County Schedule No. 5206000065
El Paso County, Colorado**

JOB NO. 185099

January 11, 2021

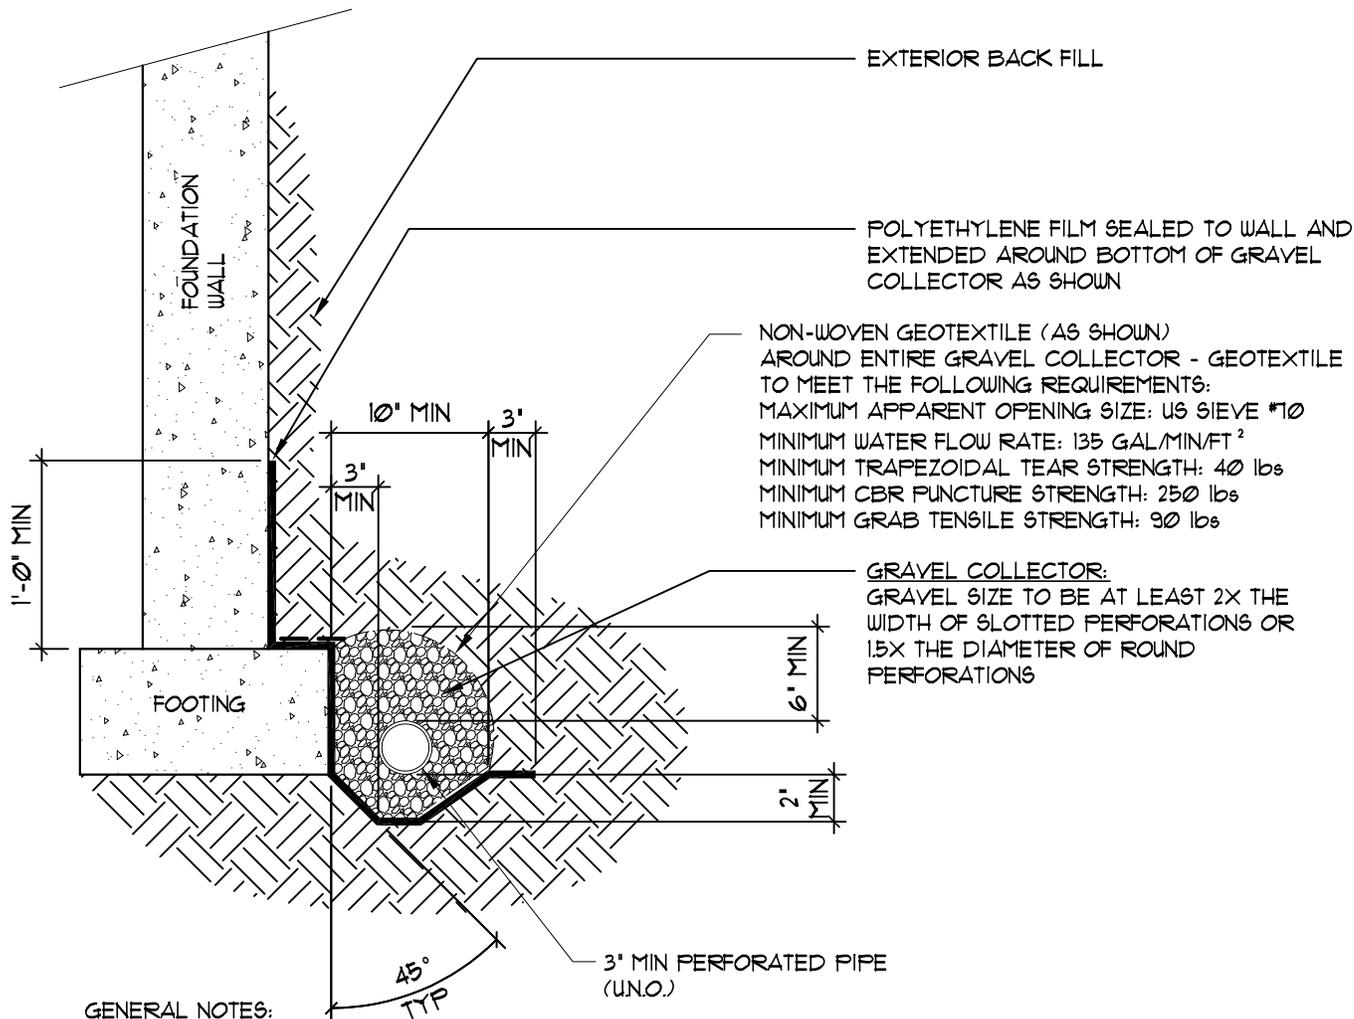
FIG No. 10

Foundations must have a minimum 30-inch depth for frost protection. Perimeter drains are recommended around portions of the structures which will have habitable or storage space located below the finished ground surface. This includes crawlspace areas but not the walkout trench, if applicable. Perimeter drains help reduce the likelihood of intrusion of "nuisance" water into below-grade spaces. A typical perimeter drain detail is presented in Figure 10.

In addition to the previously identified mitigation alternatives, surface and subsurface drainage systems should be considered. Exterior, perimeter foundation drains should be installed around below-grade habitable or storage spaces. A typical perimeter drain detail is presented in Figure 10. Surface water should be efficiently removed from the building area to prevent ponding and infiltration into the subsurface soil.

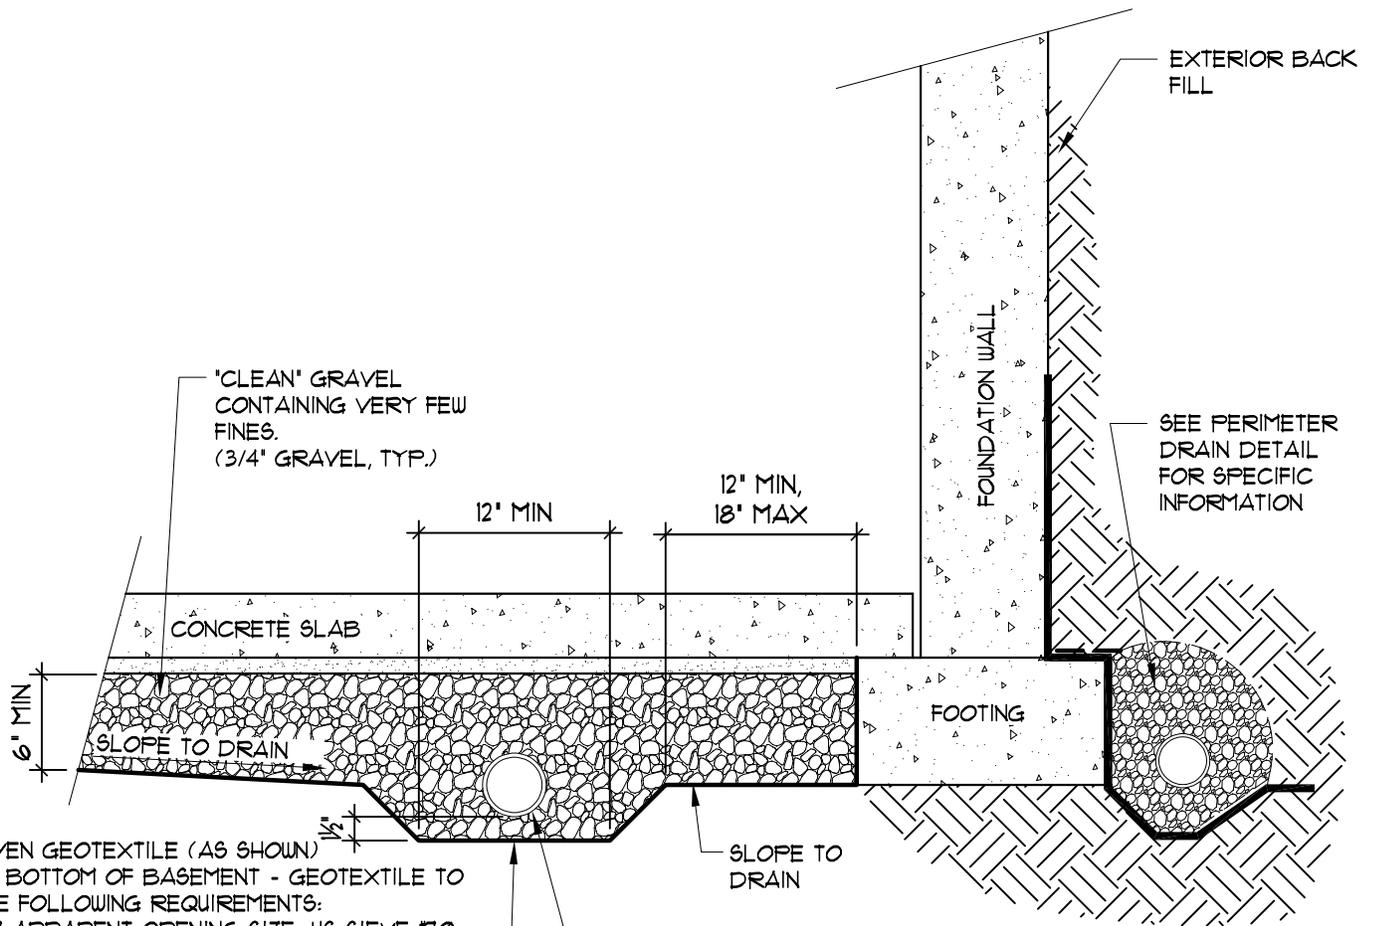
The proposed development may include both basements and crawlspaces. If groundwater is encountered at the time of the site-specific subsurface soil investigations within 4 to 6 feet of the proposed basement slab elevations, an underslab drain should be considered in conjunction with the perimeter drain. It must be understood that subsurface drains are designed to intercept some types of subsurface moisture and not others. Therefore, the drains could operate properly and not mitigate all moisture problems relating to foundation performance or moisture intrusion into the basement area. A typical underslab drain detail is presented in Figure 11.
