SOIL, GEOLOGY, AND WASTEWATER STUDY

**6385 Vessey Road
El Paso County Schedule No. 5206000065
El Paso County, Colorado
PCD File #MS-22-08**

JOB NO. 185099

**January 11, 2021
Amended December 7, 2022**

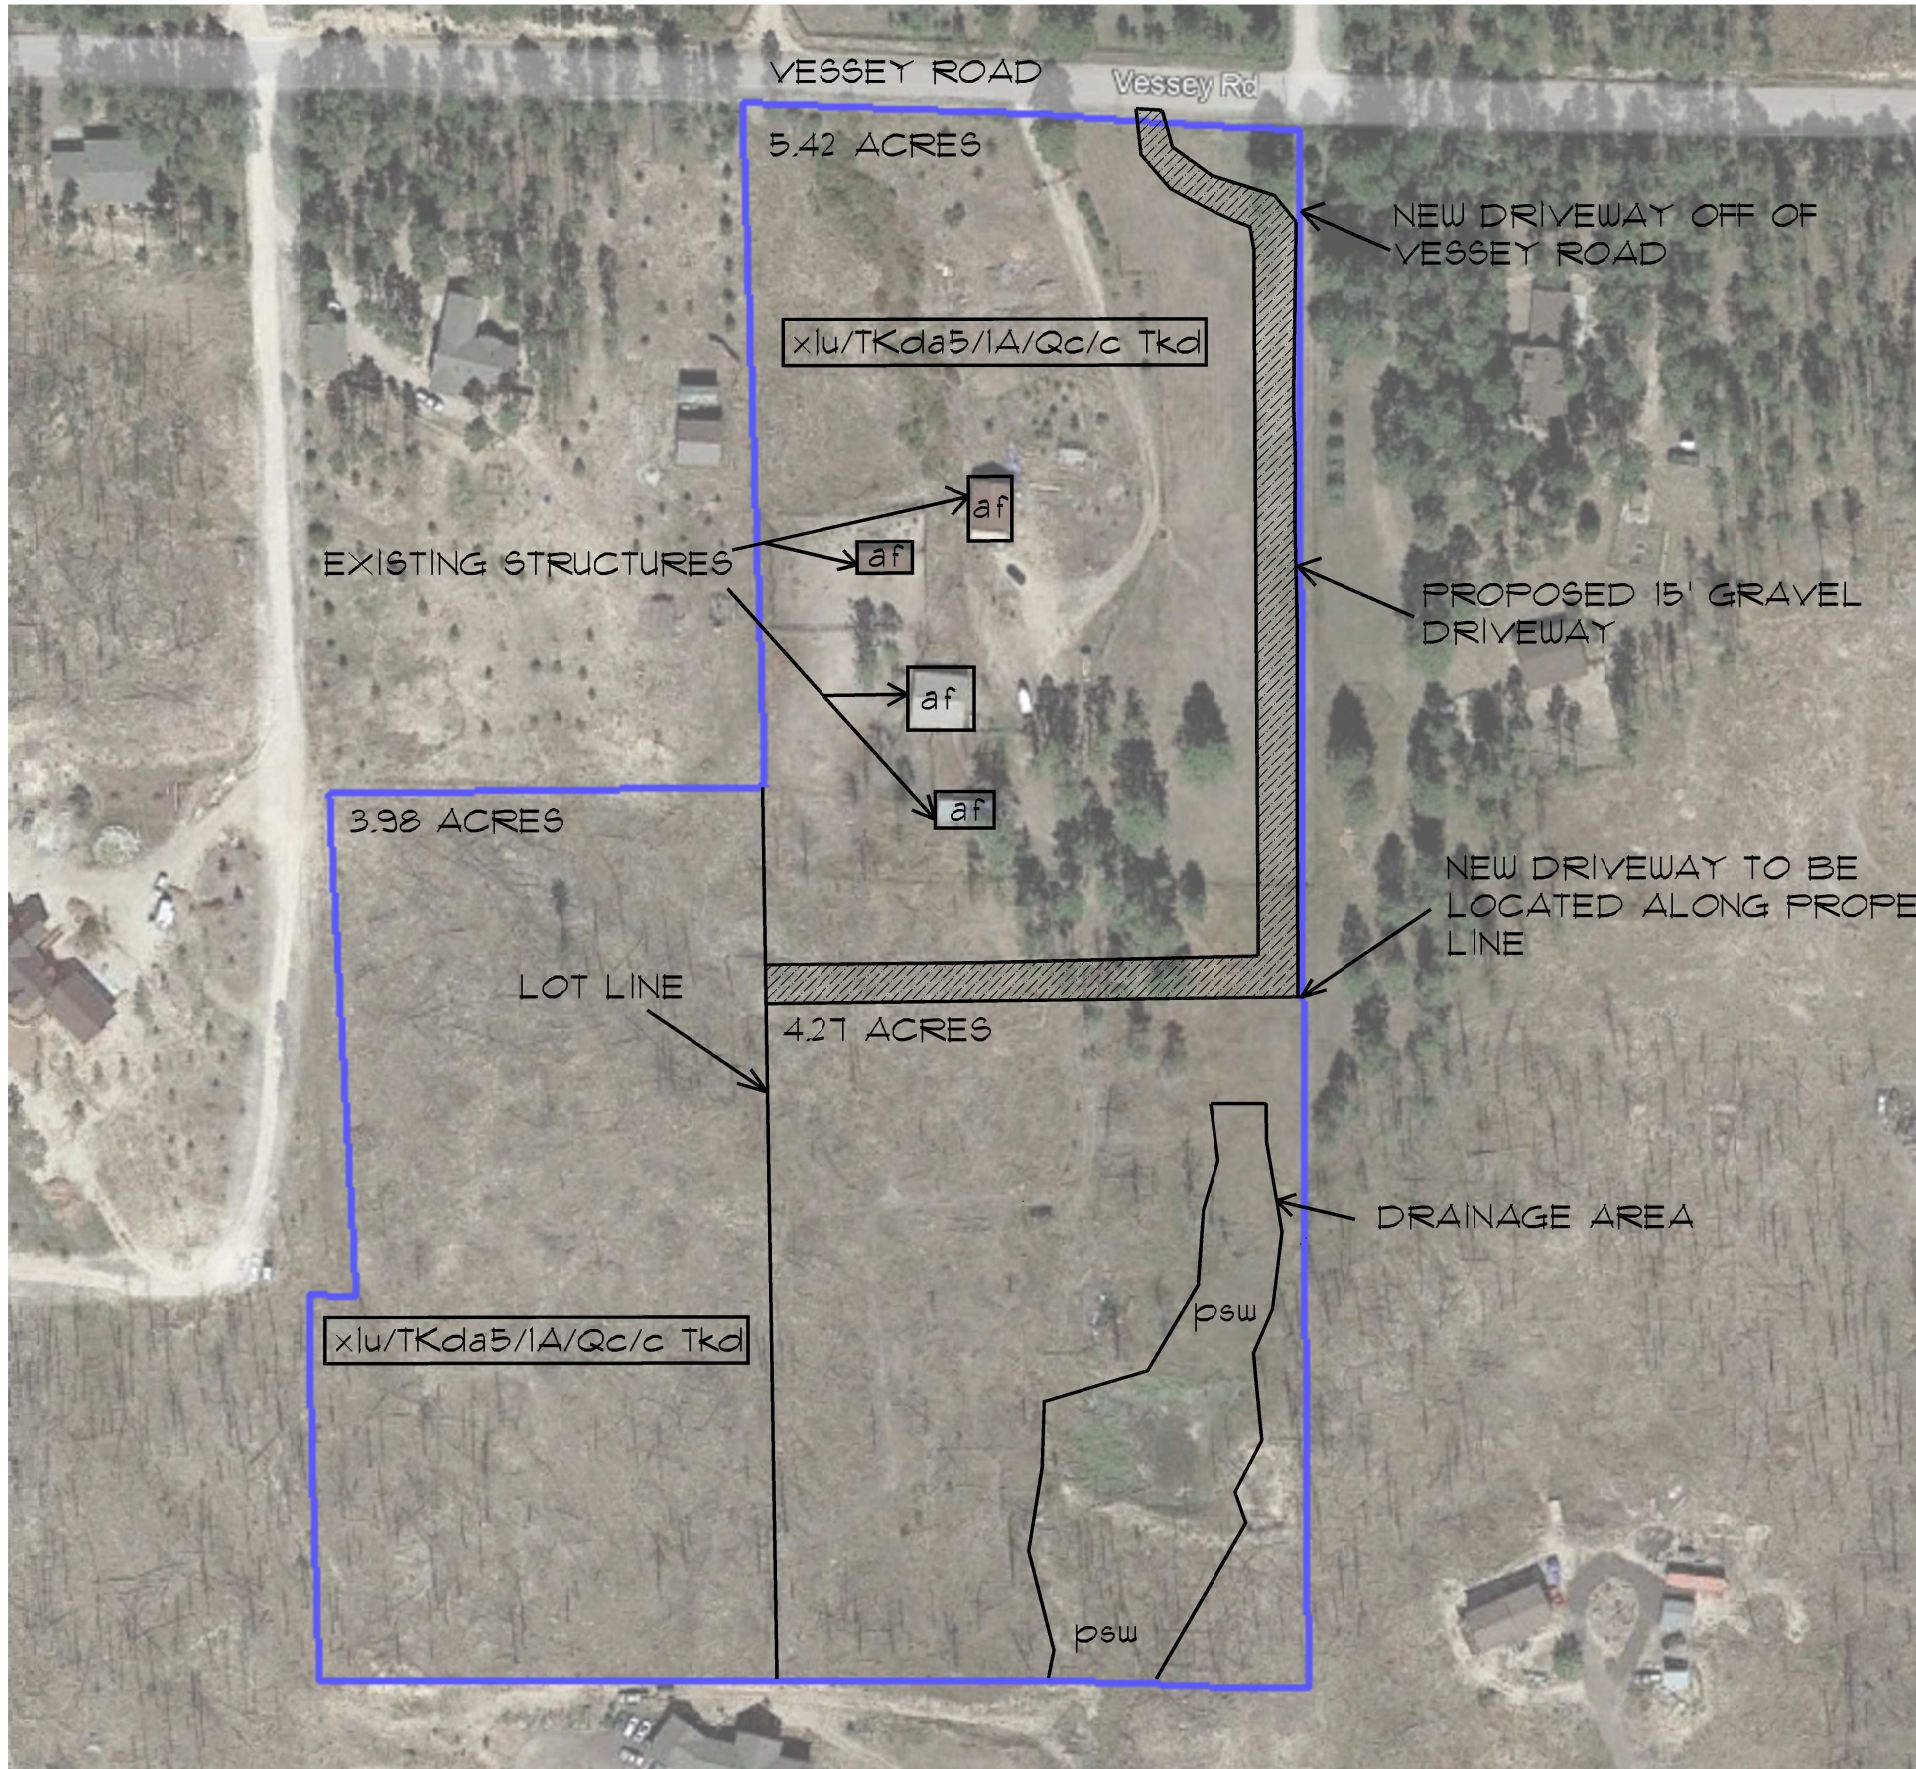
Based on our field observations and review of relevant geologic maps, a geologic map was prepared which identifies the geologic conditions affecting the development. The geologic conditions affecting the development are presented in the Engineering and Geology Map, Figure 6.

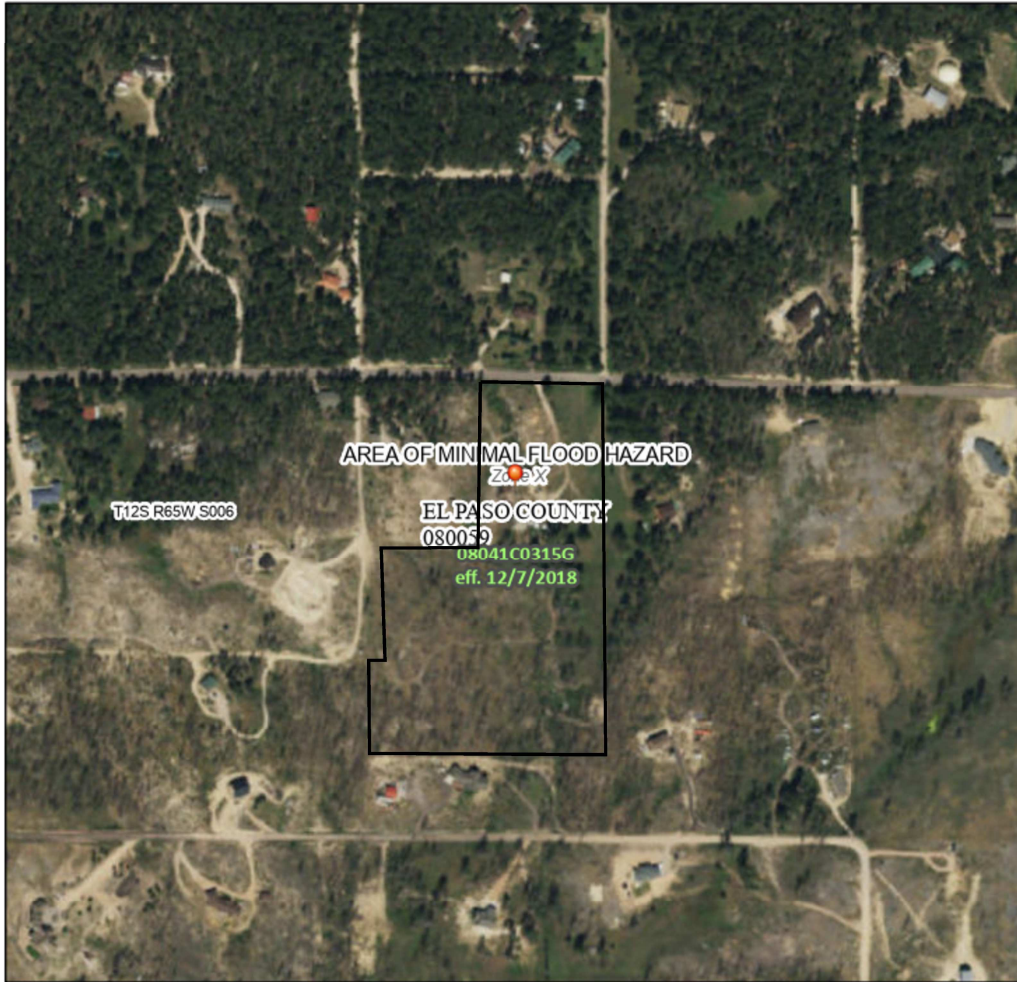
FIG No. 7

Based on our review of the Federal Emergency Management Agency (FEMA) Community Panel No. 08041C0315G and the online ArcGIS El Paso County Risk Map, the entire site lies outside of identified regulatory floodway and 100 or 500-year floodplains. The site lies in Zone X. Zone X is defined by FEMA as an area of minimal flood hazard that is determined to be outside the Special Flood Hazard Area and higher than the elevation of the 0.2-percent-annual-chance (or 500-year) flood. The FEMA Map is presented in Figure 7.
