## SOIL, GEOLOGY, AND WASTEWATER STUDY

**6385 Vessey Road  
El Paso County Schedule No. 5206000065  
El Paso County, Colorado**

**JOB NO. 185099**

**January 11, 2021**

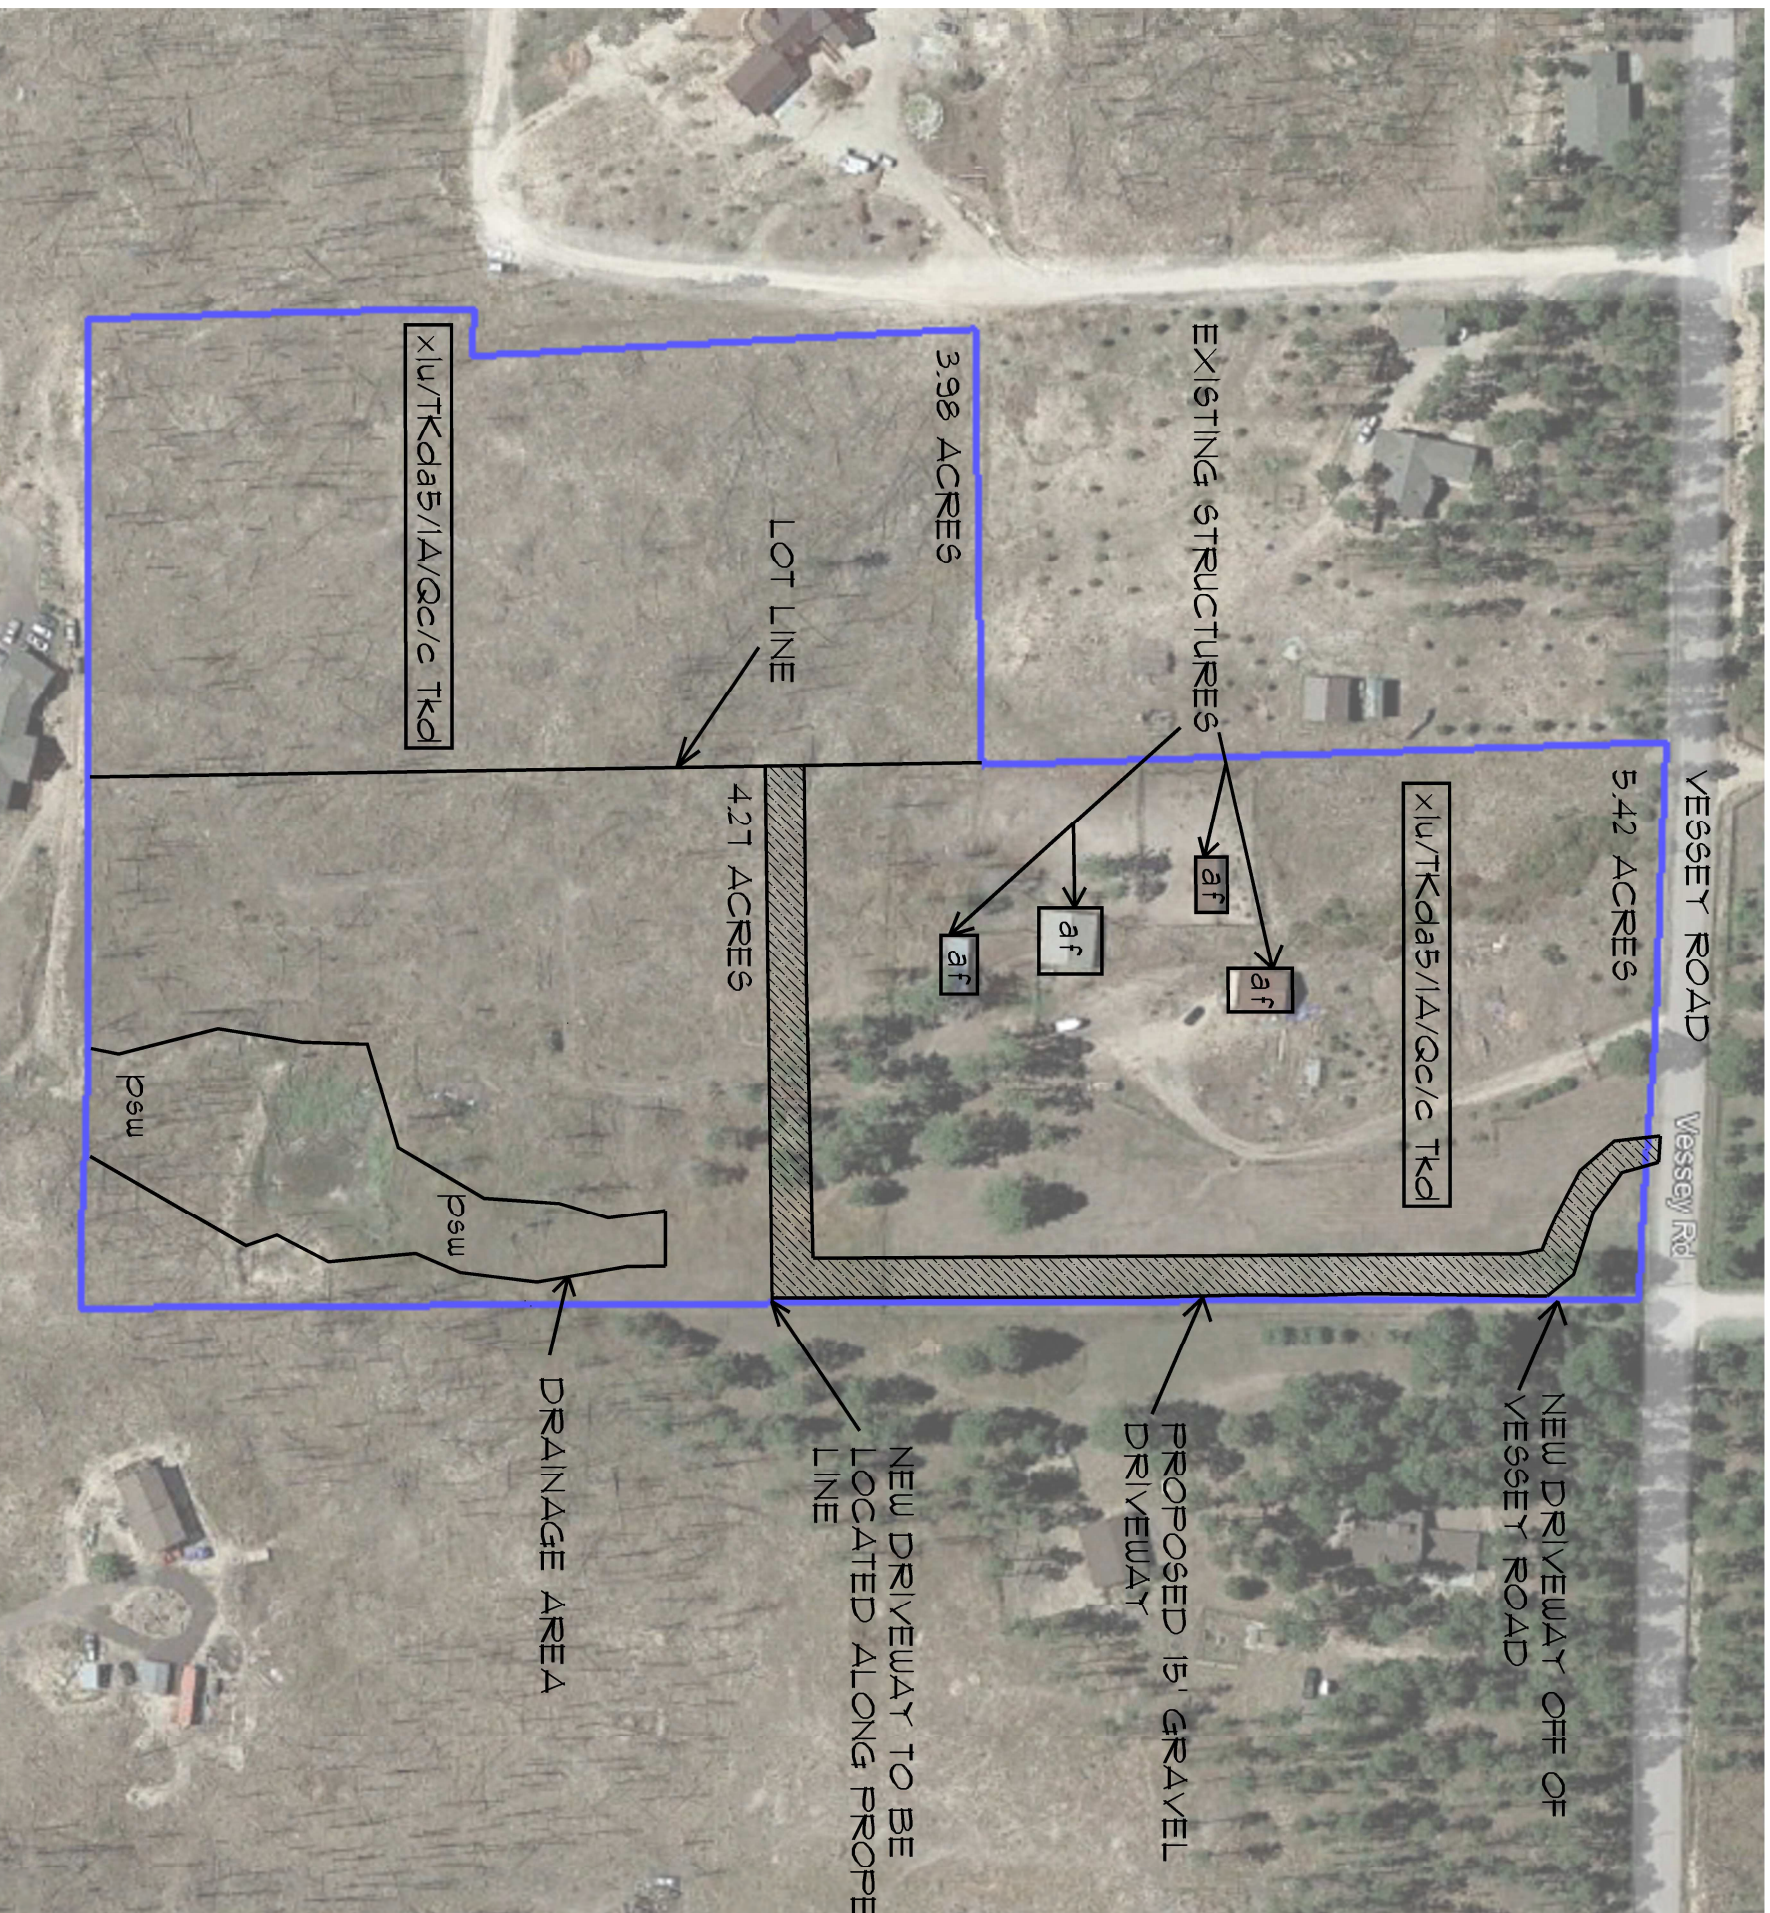
Based on our field observations and review of relevant geologic maps, a geologic map was prepared which identifies the geologic conditions affecting the development. The geologic conditions affecting the development are presented in the Engineering and Geology Map, Figure 6.

A potentially seasonally wet area in the form of a low-lying pond-like depression was encountered during our investigation. In this area, we would anticipate the potential for periodically high subsurface moisture conditions and frost heave potential. This area lies within a low-lying area in the southeast portion of the property.

It is our opinion that the EPCHDE physical setback requirements are met for each lot. It is recommended that the placement of individual On-Site Wastewater Treatment Systems be located outside of the potentially seasonally wet low-lying pond-like area in the southeastern portion of the property.
