**GEOLOGIC HAZARD EVALUATION AND  
PRELIMINARY GEOTECHNICAL INVESTIGATION  
GRANDVIEW RESERVE, PHASE 2  
EASTONVILLE ROAD AND U.S. HIGHWAY 24  
FALCON, COLORADO**

Project No. CS19345-115-R3

December 20, 2023  
Revised February 27, 2024

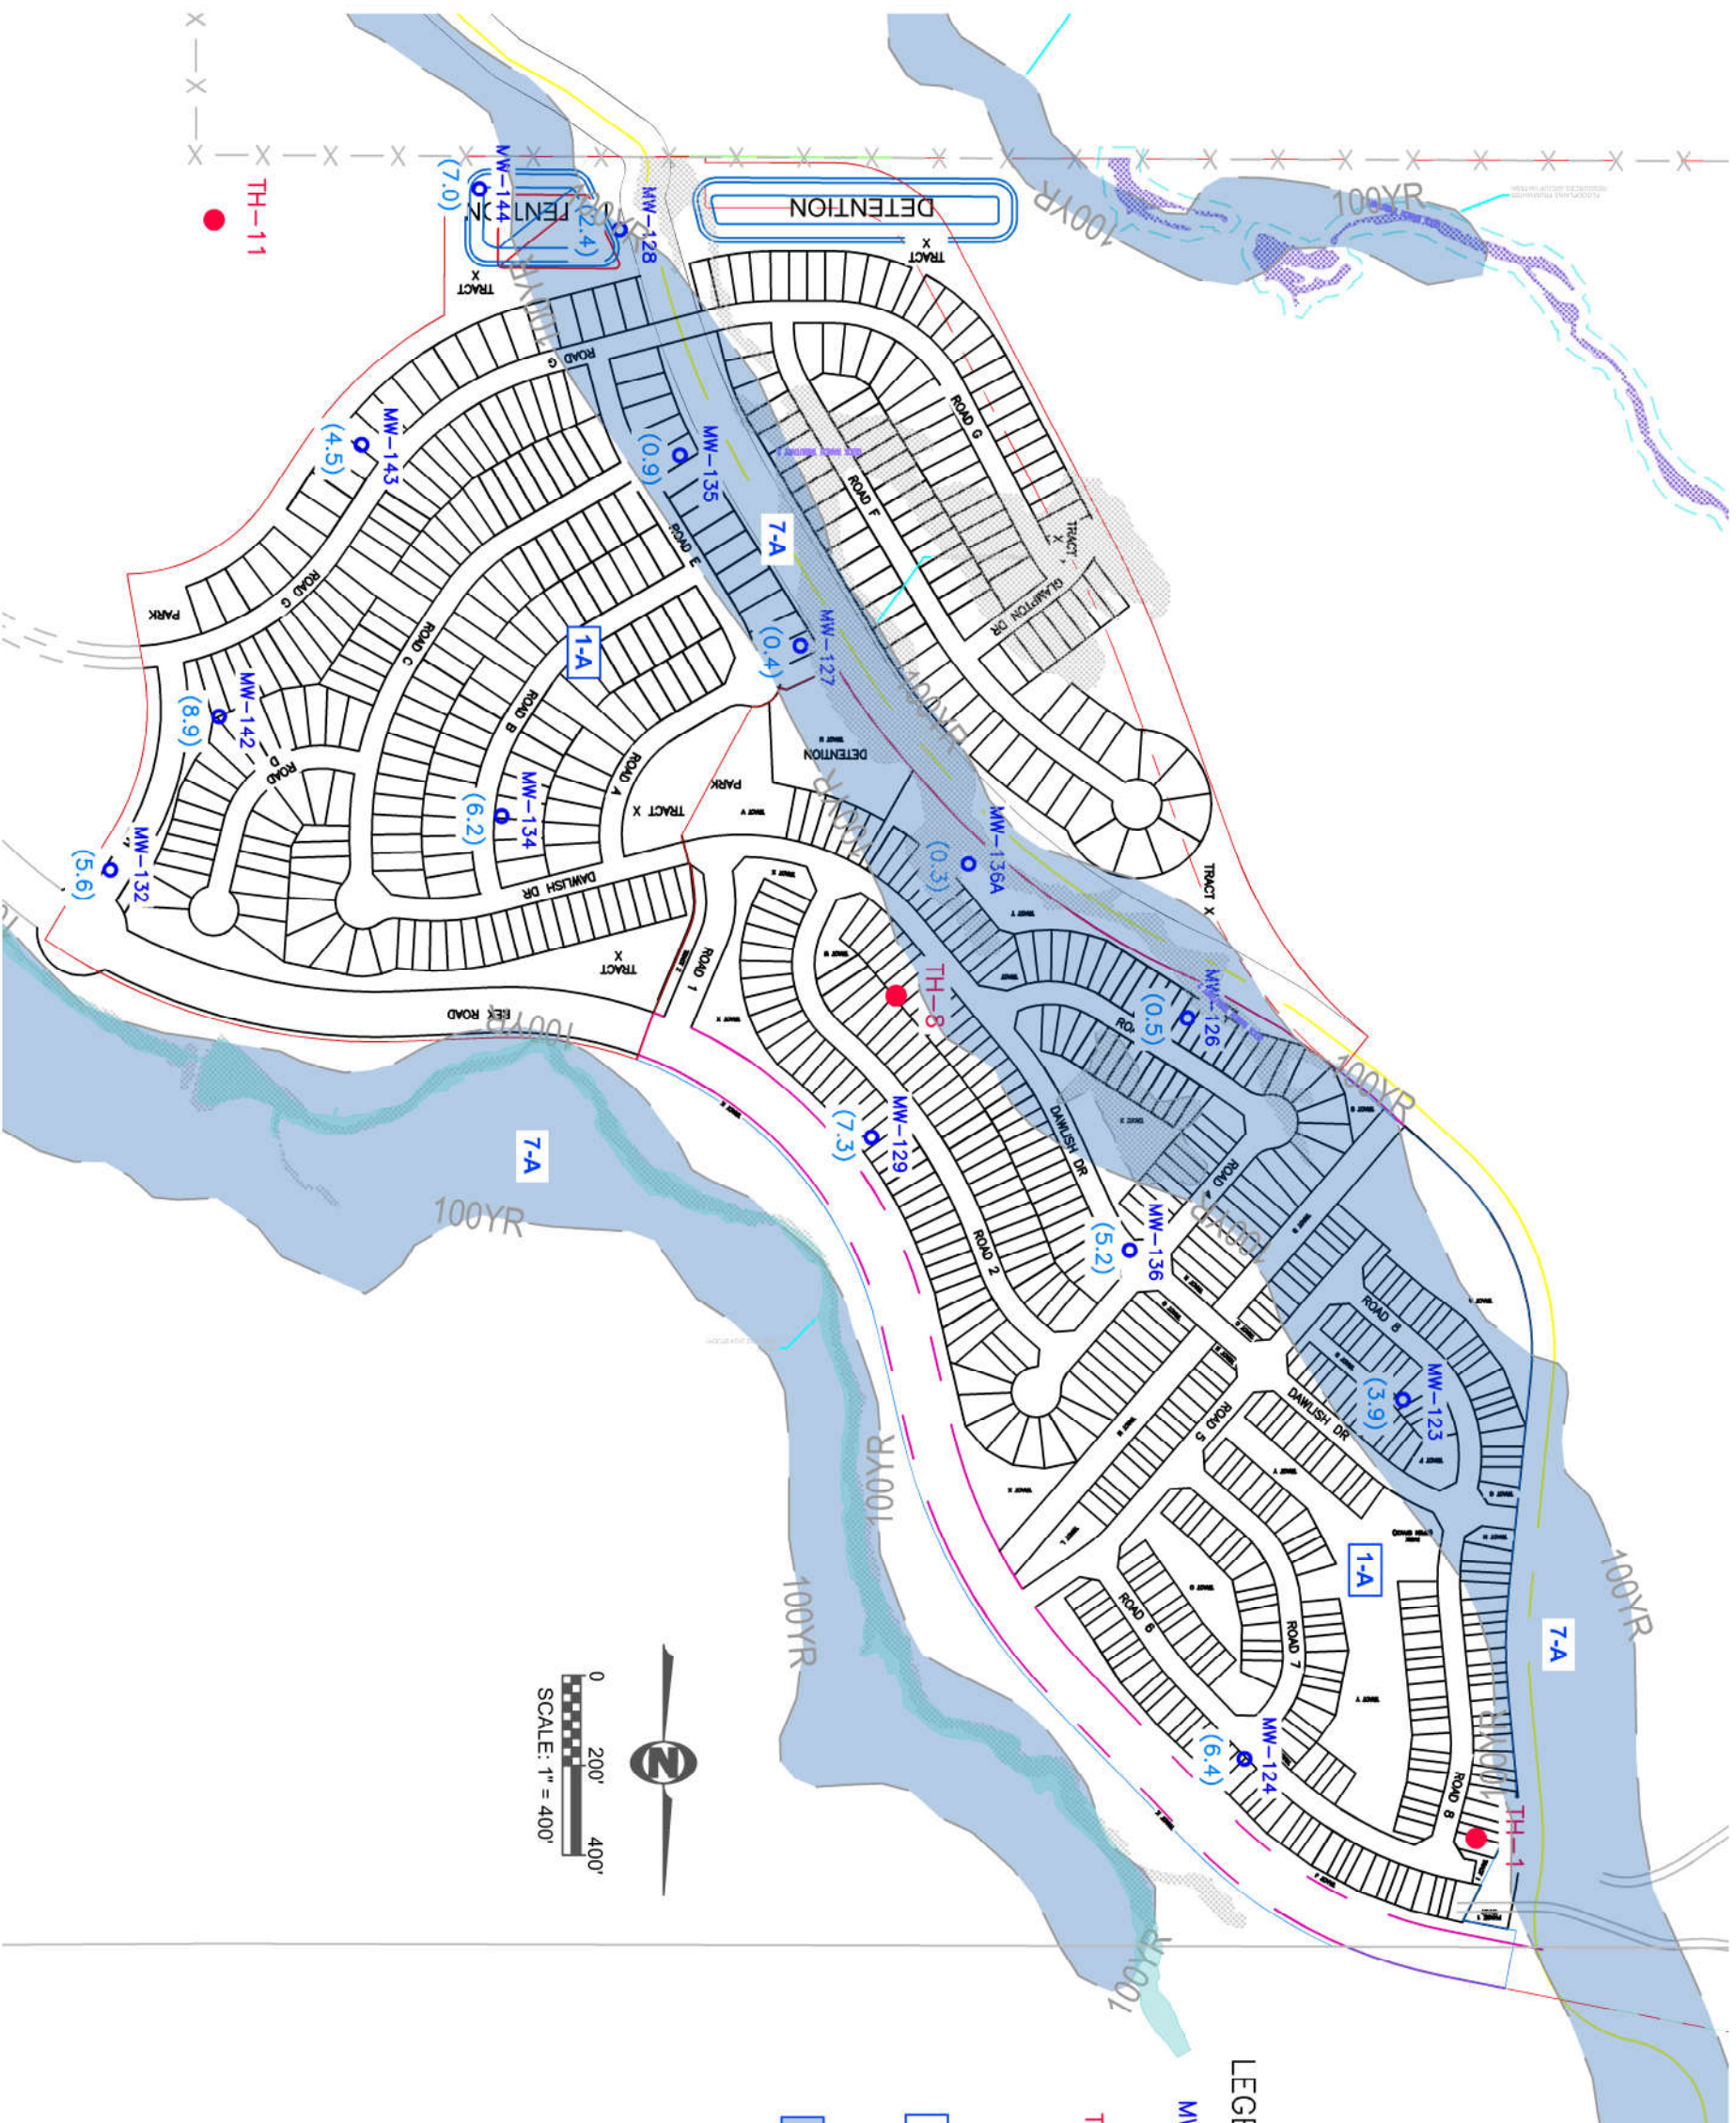
**NOTE:** EXPANSIVE SOILS/BEDROCK WERE FOUND SPORADICALLY ACROSS THE SITE. ALL LOTS MAY BE IMPACTED BY GROUND HEAVE. TOTAL CALCULATED GROUND HEAVE RANGED FROM LESS THAN 0.5 INCHES TO 1 INCH. DEPTH TO GROUNDWATER ARE PEAK LEVELS MEASURED IN MONITORING WELLS BETWEEN SEPTEMBER AND NOVEMBER 2023.

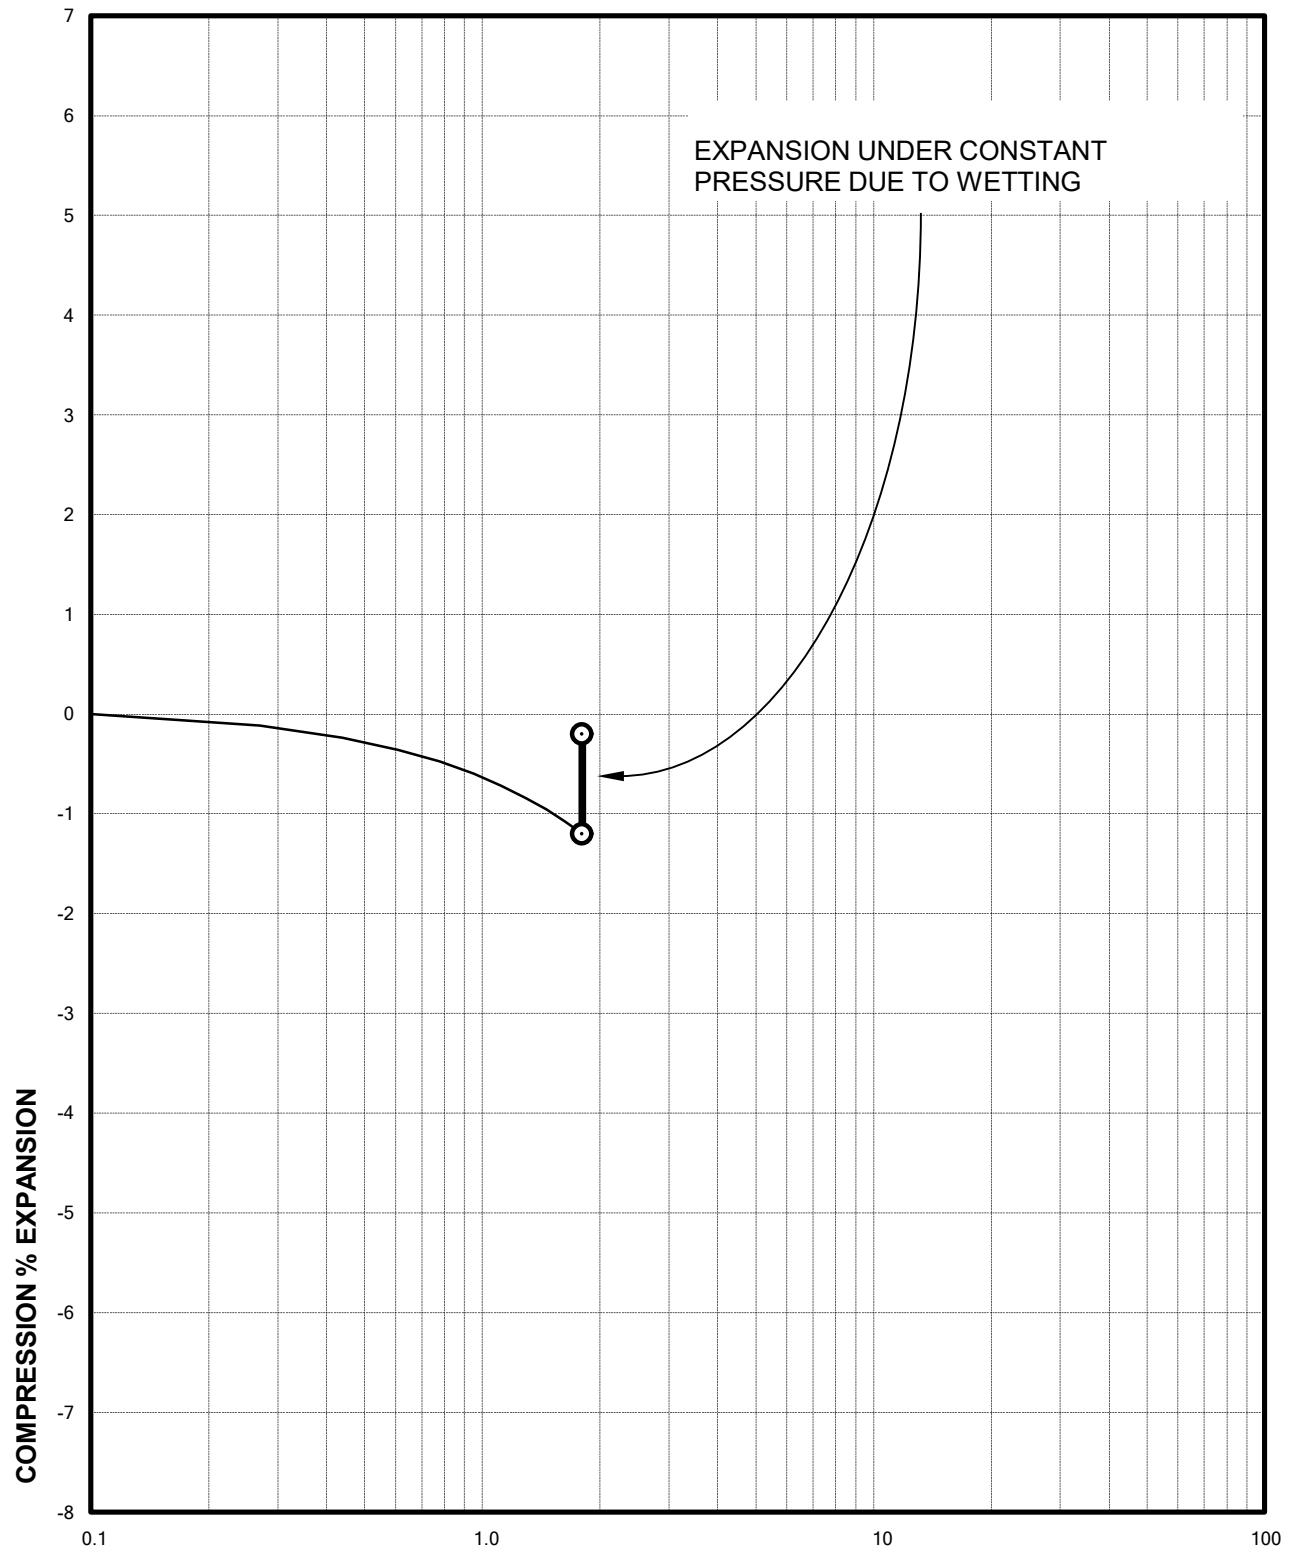
**APPLIED PRESSURE - KSF**  
Sample of SANDSTONE, VERY CLAYEY  
From TH-8 AT 14 FEET

DRY UNIT WEIGHT= 114 PCF  
MOISTURE CONTENT= 13.2 %
