**Williams Creek Generating Station**

**SOILS AND GEOLOGY STUDY  
CSU – WILLIAMS CREEK PLANT  
EL PASO COUNTY, COLORADO**

September 23, 2026

Entech Job No. 261095

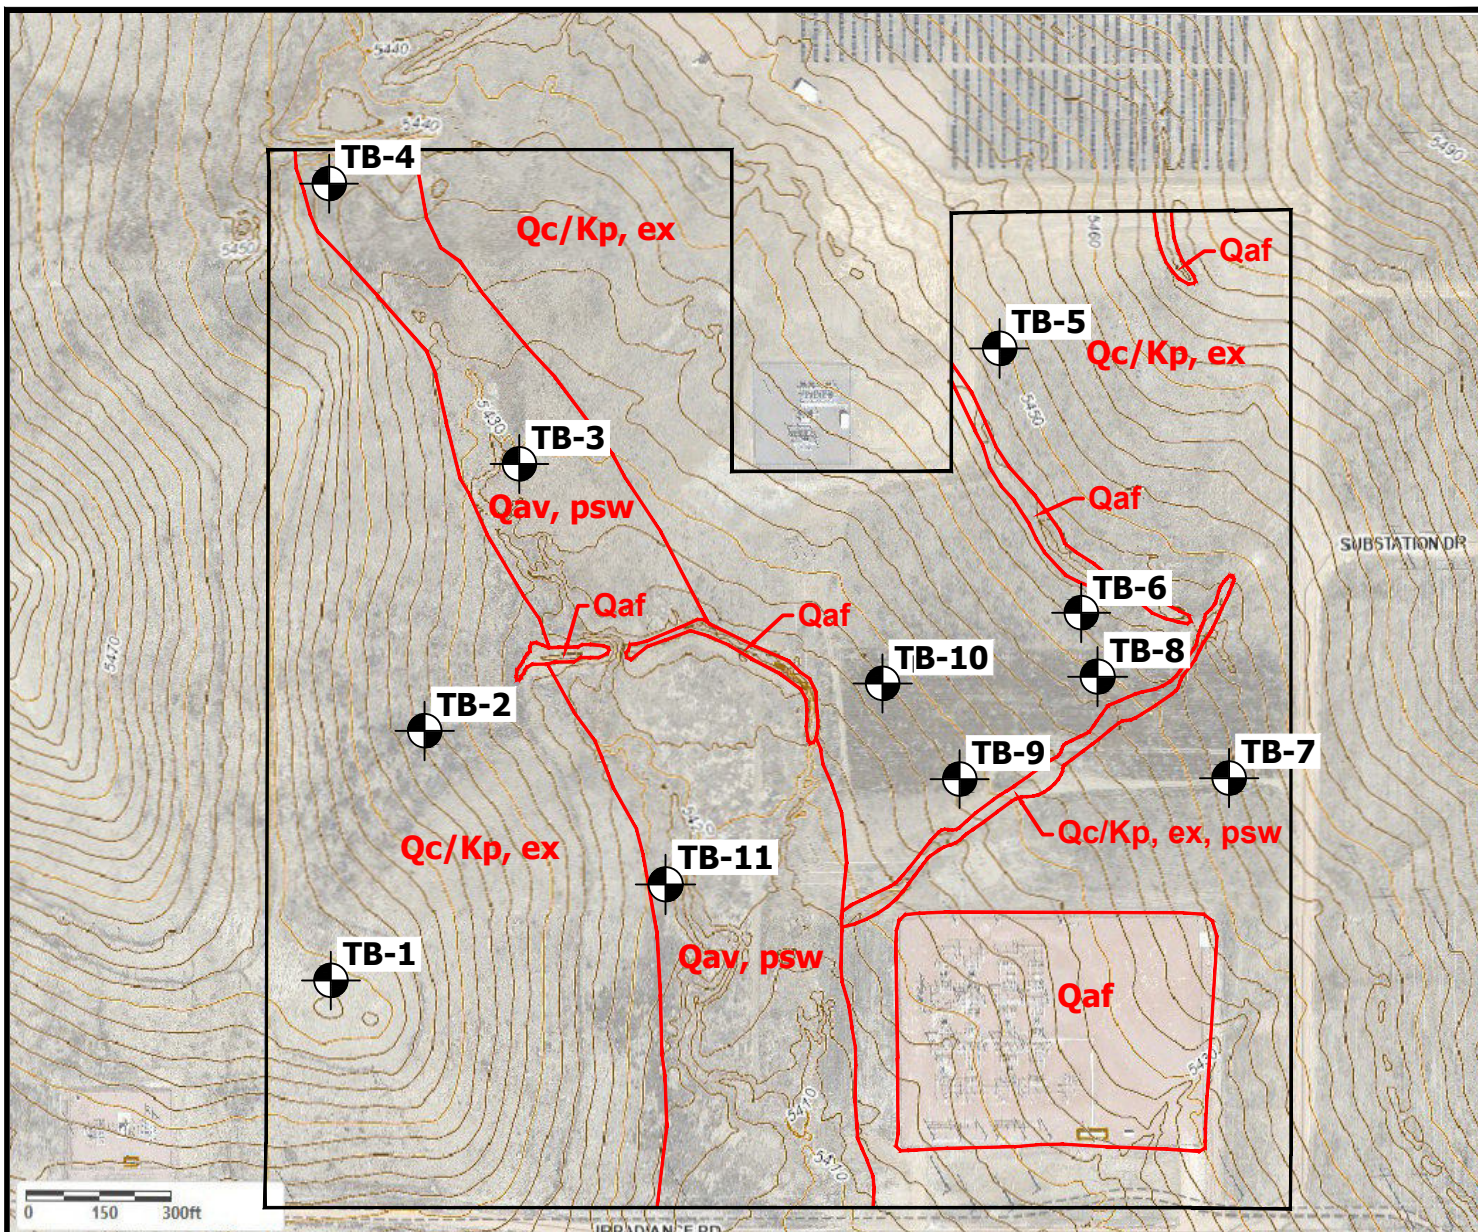
JOB NO.  
261095  
FIG. 3

Detailed mapping has been performed on this site to produce the Engineering Geology Map, Figure 3. This map shows the location of various geologic conditions the land developer should consider during the planning, design, and construction stages of the project. These hazards and the recommended mitigation techniques are as follows:

The site is classified in an area of high swell potential according to the *Map of Potentially Swelling Soil and Rock in the Front Range Urban Corridor, Colorado* by Hart, 1974 (Reference 10). Expansive soils were encountered in the test borings drilled on-site with swells ranging from 0.1% to 5%, indicating low to very high swell potentials. Expansive clays and claystone, encountered at foundation grade, can cause differential movement in structures. These occurrences should be identified and mitigated on an individual basis.

These are areas that are undergoing erosion by water and sheetwash, producing gullies and rill erosion. The areas of erosion observed on the site are primarily located along the drainage in the central portion of the site and along minor drainage swales across the site.

A tributary of Williams Creek bisects the central portion of the site. This drainage and minor drainage swales across the site have been identified as areas of potentially seasonal shallow groundwater. The site is not mapped within any floodplains according to FEMA Map No. 08041CO706G, Exhibit 5 (Reference 11). The existing topography generally slopes towards a drainage running north-to-south through the center of the site. Groundwater was encountered in TB-4 at a depth of 17.5 feet bgs. A minimum separation of 3 feet between foundation components and groundwater levels is recommended. Groundwater is not expected to affect the site development.

Mitigation: Should expansive soils be encountered beneath foundations, mitigation will be necessary. Mitigation of expansive soils will require special foundation design. Overexcavation of 4 to 10 feet and replacement with nonexpansive soils, moisture conditioning, or a combination are suitable mitigations that are common in the area. Floor slabs on expansive soils should be expected to experience movement. Overexcavation and replacement has been successful in minimizing slab movements. The use of structural floors should be considered if movement cannot be tolerated. Final recommendations should be determined after additional investigation of each structure.

Mitigation: Due to the nature of the soils on this site, virtually all the soils are subject to erosion by wind and water. Other minor areas of erosion were observed on-site other than those mapped, particularly where some rill erosion has occurred. Areas of erosion can occur across the entire site, particularly if the soils are disturbed during construction. Vegetation reduces the potential for erosion. The areas identified where erosion is actually taking place may require check dams, regrading, and revegetation using channel lining mats to anchor vegetation. Further recommendations for erosion control are discussed under Section 8.0, Erosion Control, of this report. Recommendations pertaining to

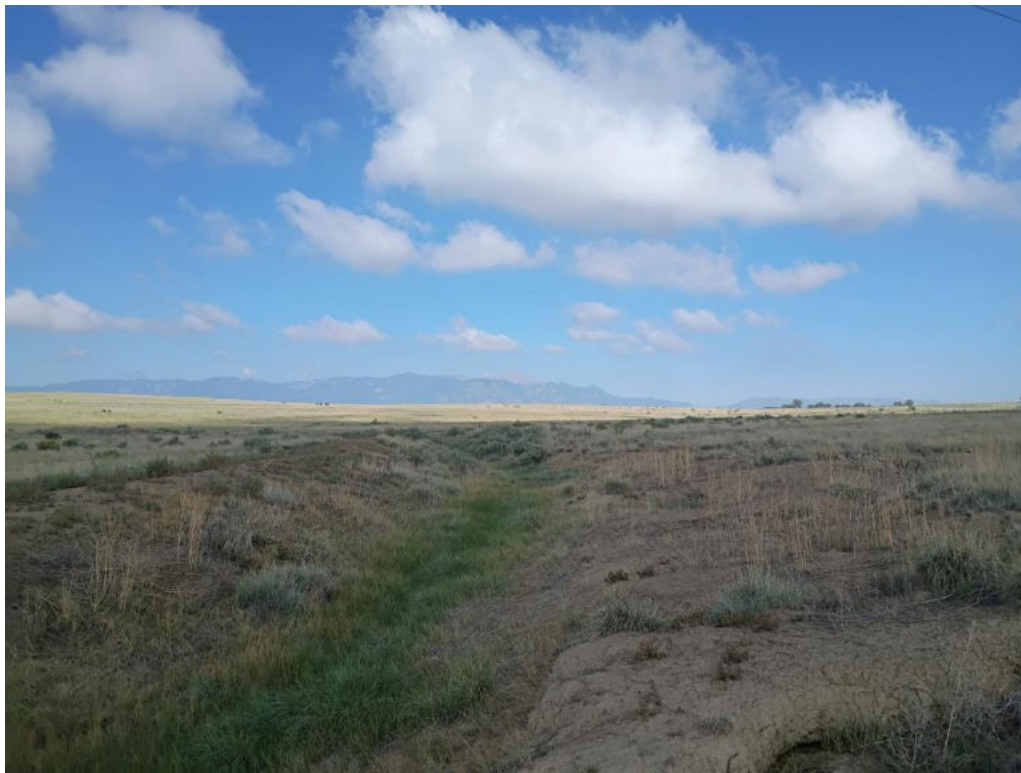
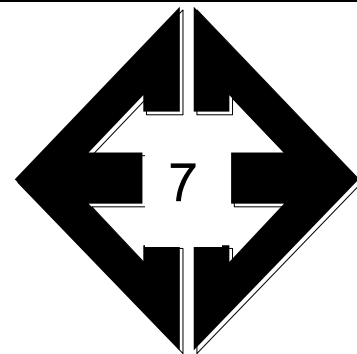
**Looking northwest  
along dry drainage  
central portion of the  
site.**

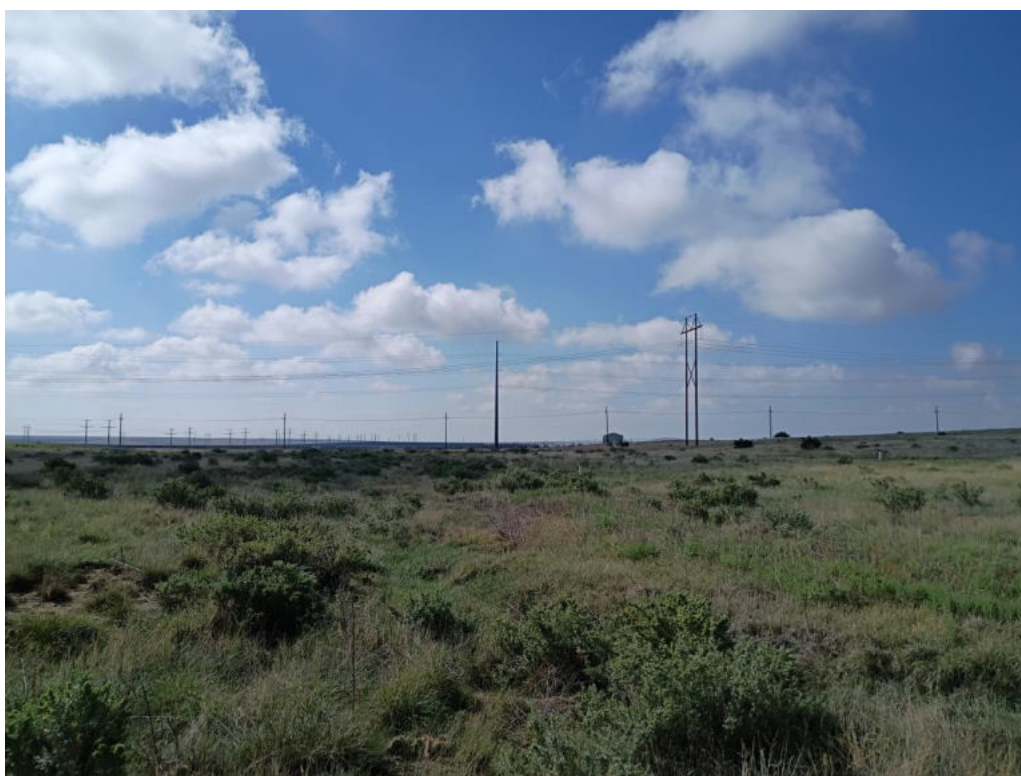
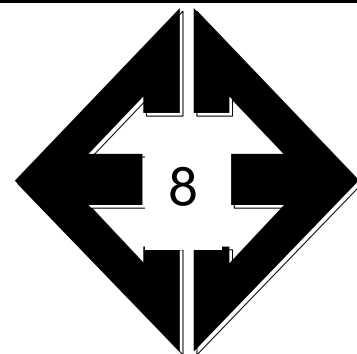
**Looking south along  
dry drainage central  
portion of the site.**
