**SOIL, GEOLOGY, AND GEOLOGIC HAZARD STUDY
STERLING RANCH PHASE 2
AND STERLING RANCH FILING NO. 3
EL PASO COUNTY, COLORADO**

Morley-Bentley Investments, LLC
20 Boulder Crescent Street, Suite 200
Colorado Springs, Colorado 80903

June 25, 2020
Revised March 3, 2021

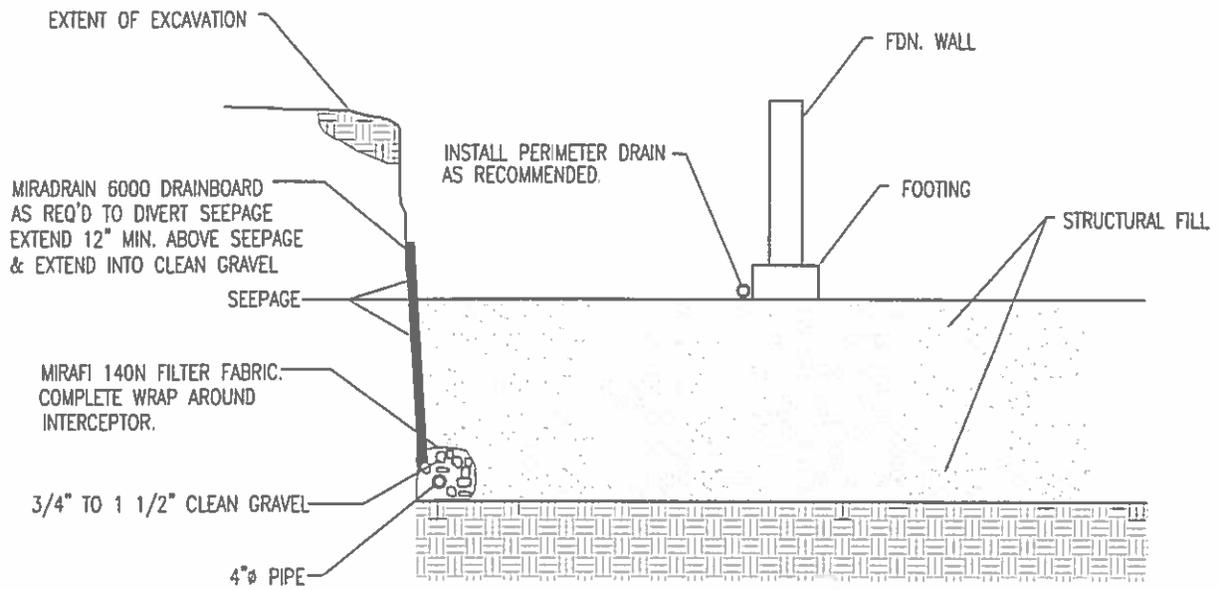
JOB NO.:
 191089
 FIG. NO.:
 11

INTERCEPTOR DRAIN DETAIL
 N.T.S.

NOTE:
 EXTEND INTERCEPTOR DRAIN TO DAYLIGHT

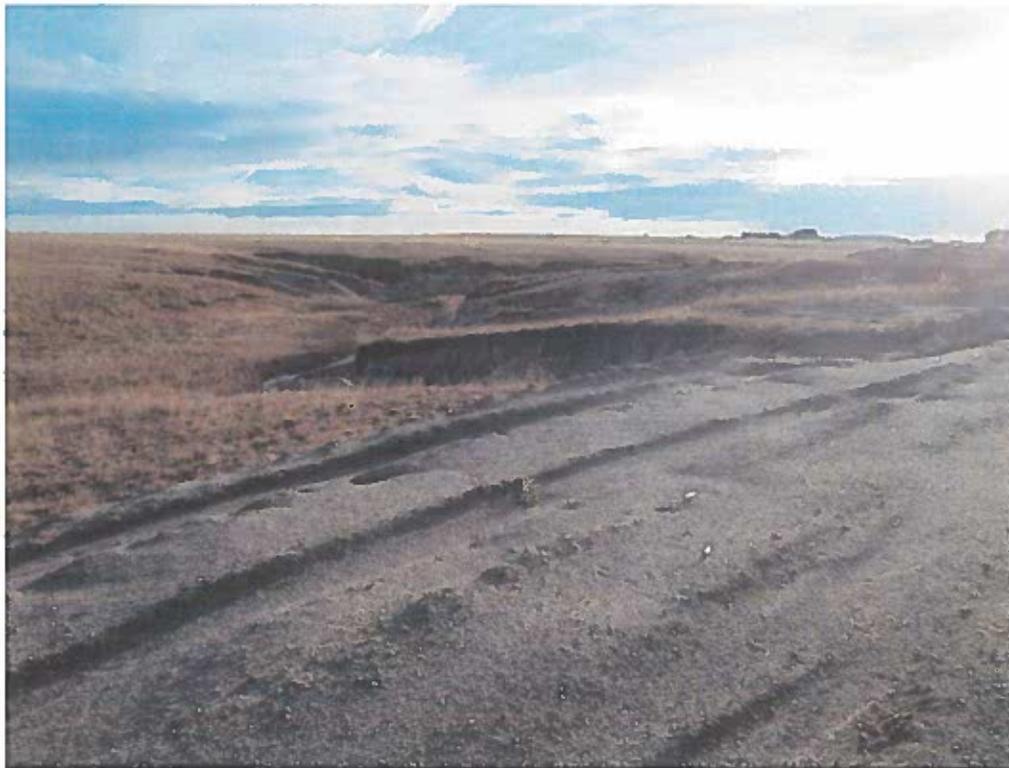
**Looking south along
Sand Creek from the
northeastern portion of
the site.**

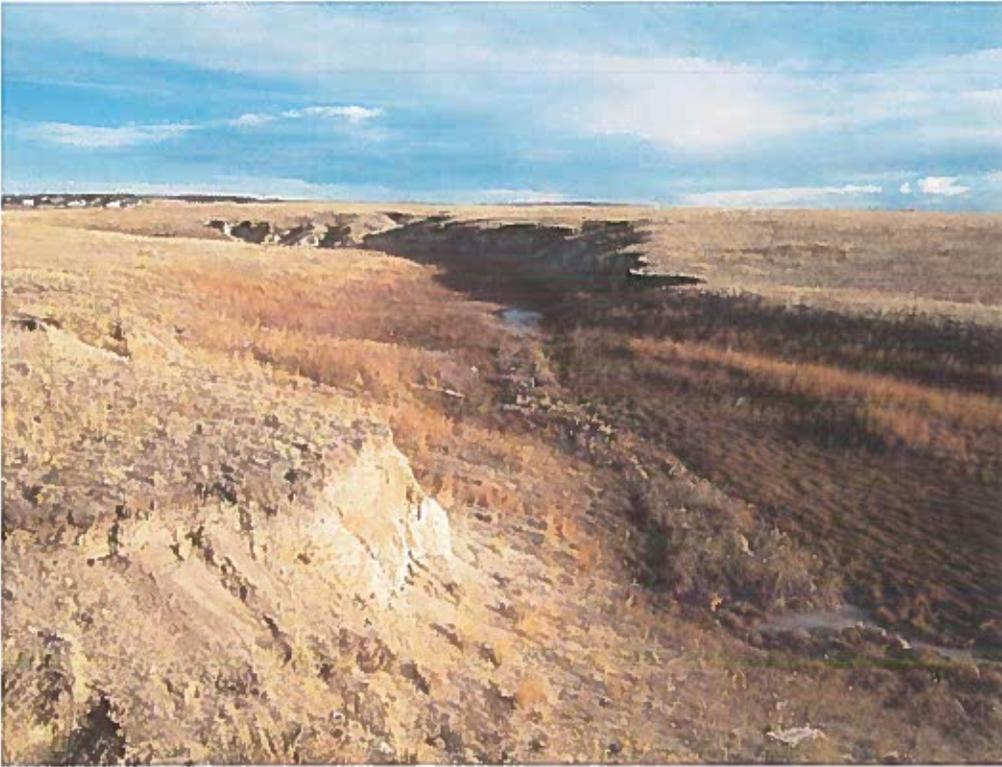
**Looking northeast
along Sand Creek from
the southeast portion
of the site.**

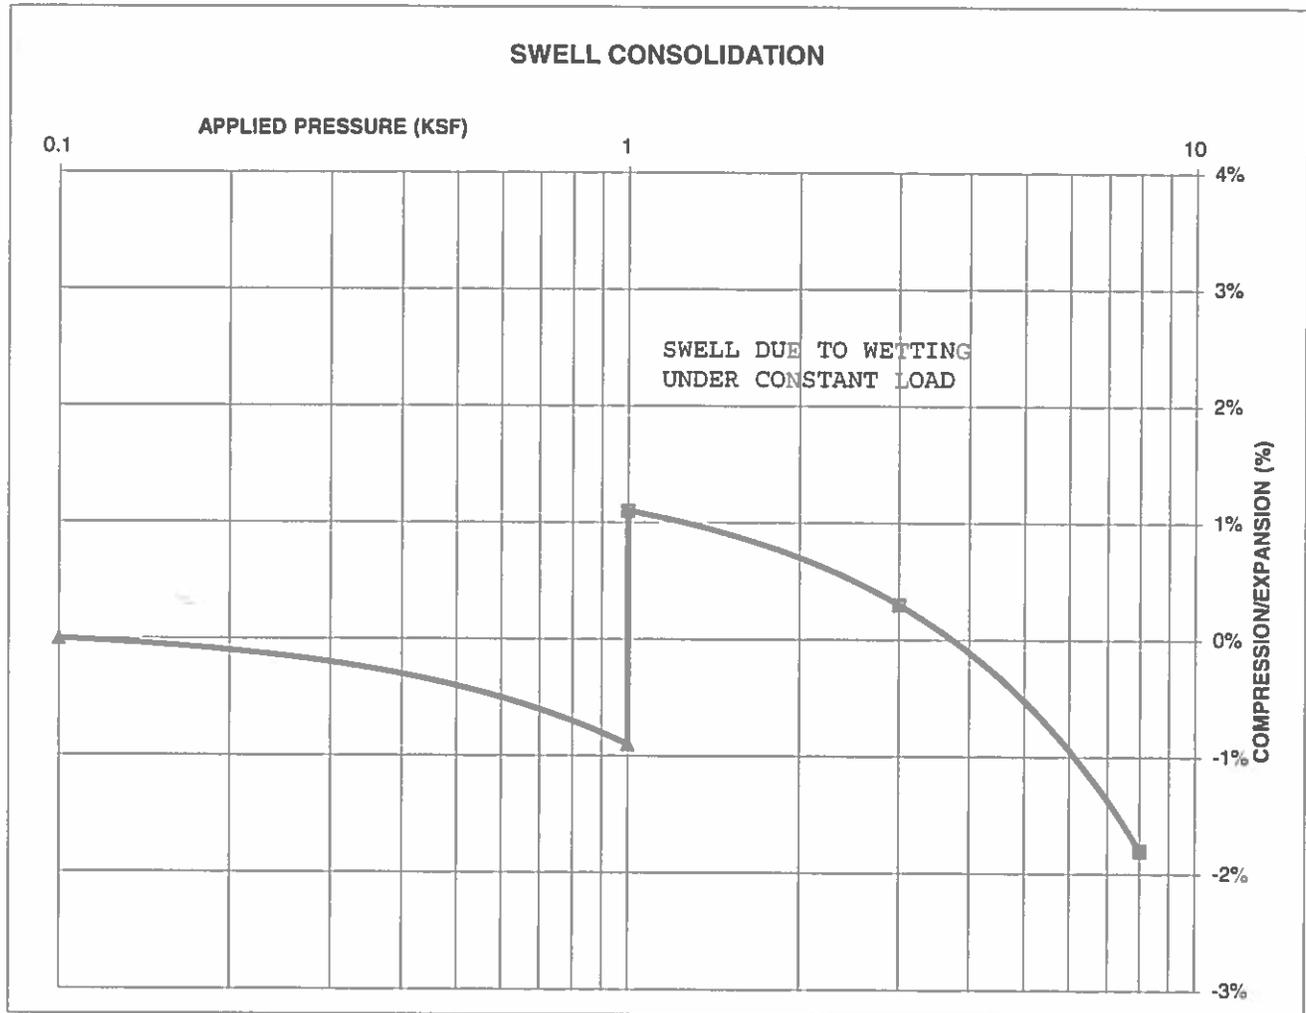
TEST BORING #	4	DEPTH(ft)	5
DESCRIPTION	CL	SOIL TYPE	2
NATURAL UNIT DRY WEIGHT (PCF)			113
NATURAL MOISTURE CONTENT			12.5%
SWELL/CONSOLIDATION (%)			2.0%
