ENTECH
ENGINEERING, INC.

**SOIL, GEOLOGY, AND GEOLOGIC HAZARD STUDY
STERLING RANCH PHASE 2
AND STERLING RANCH FILING NO. 3
EL PASO COUNTY, COLORADO**

June 25, 2020

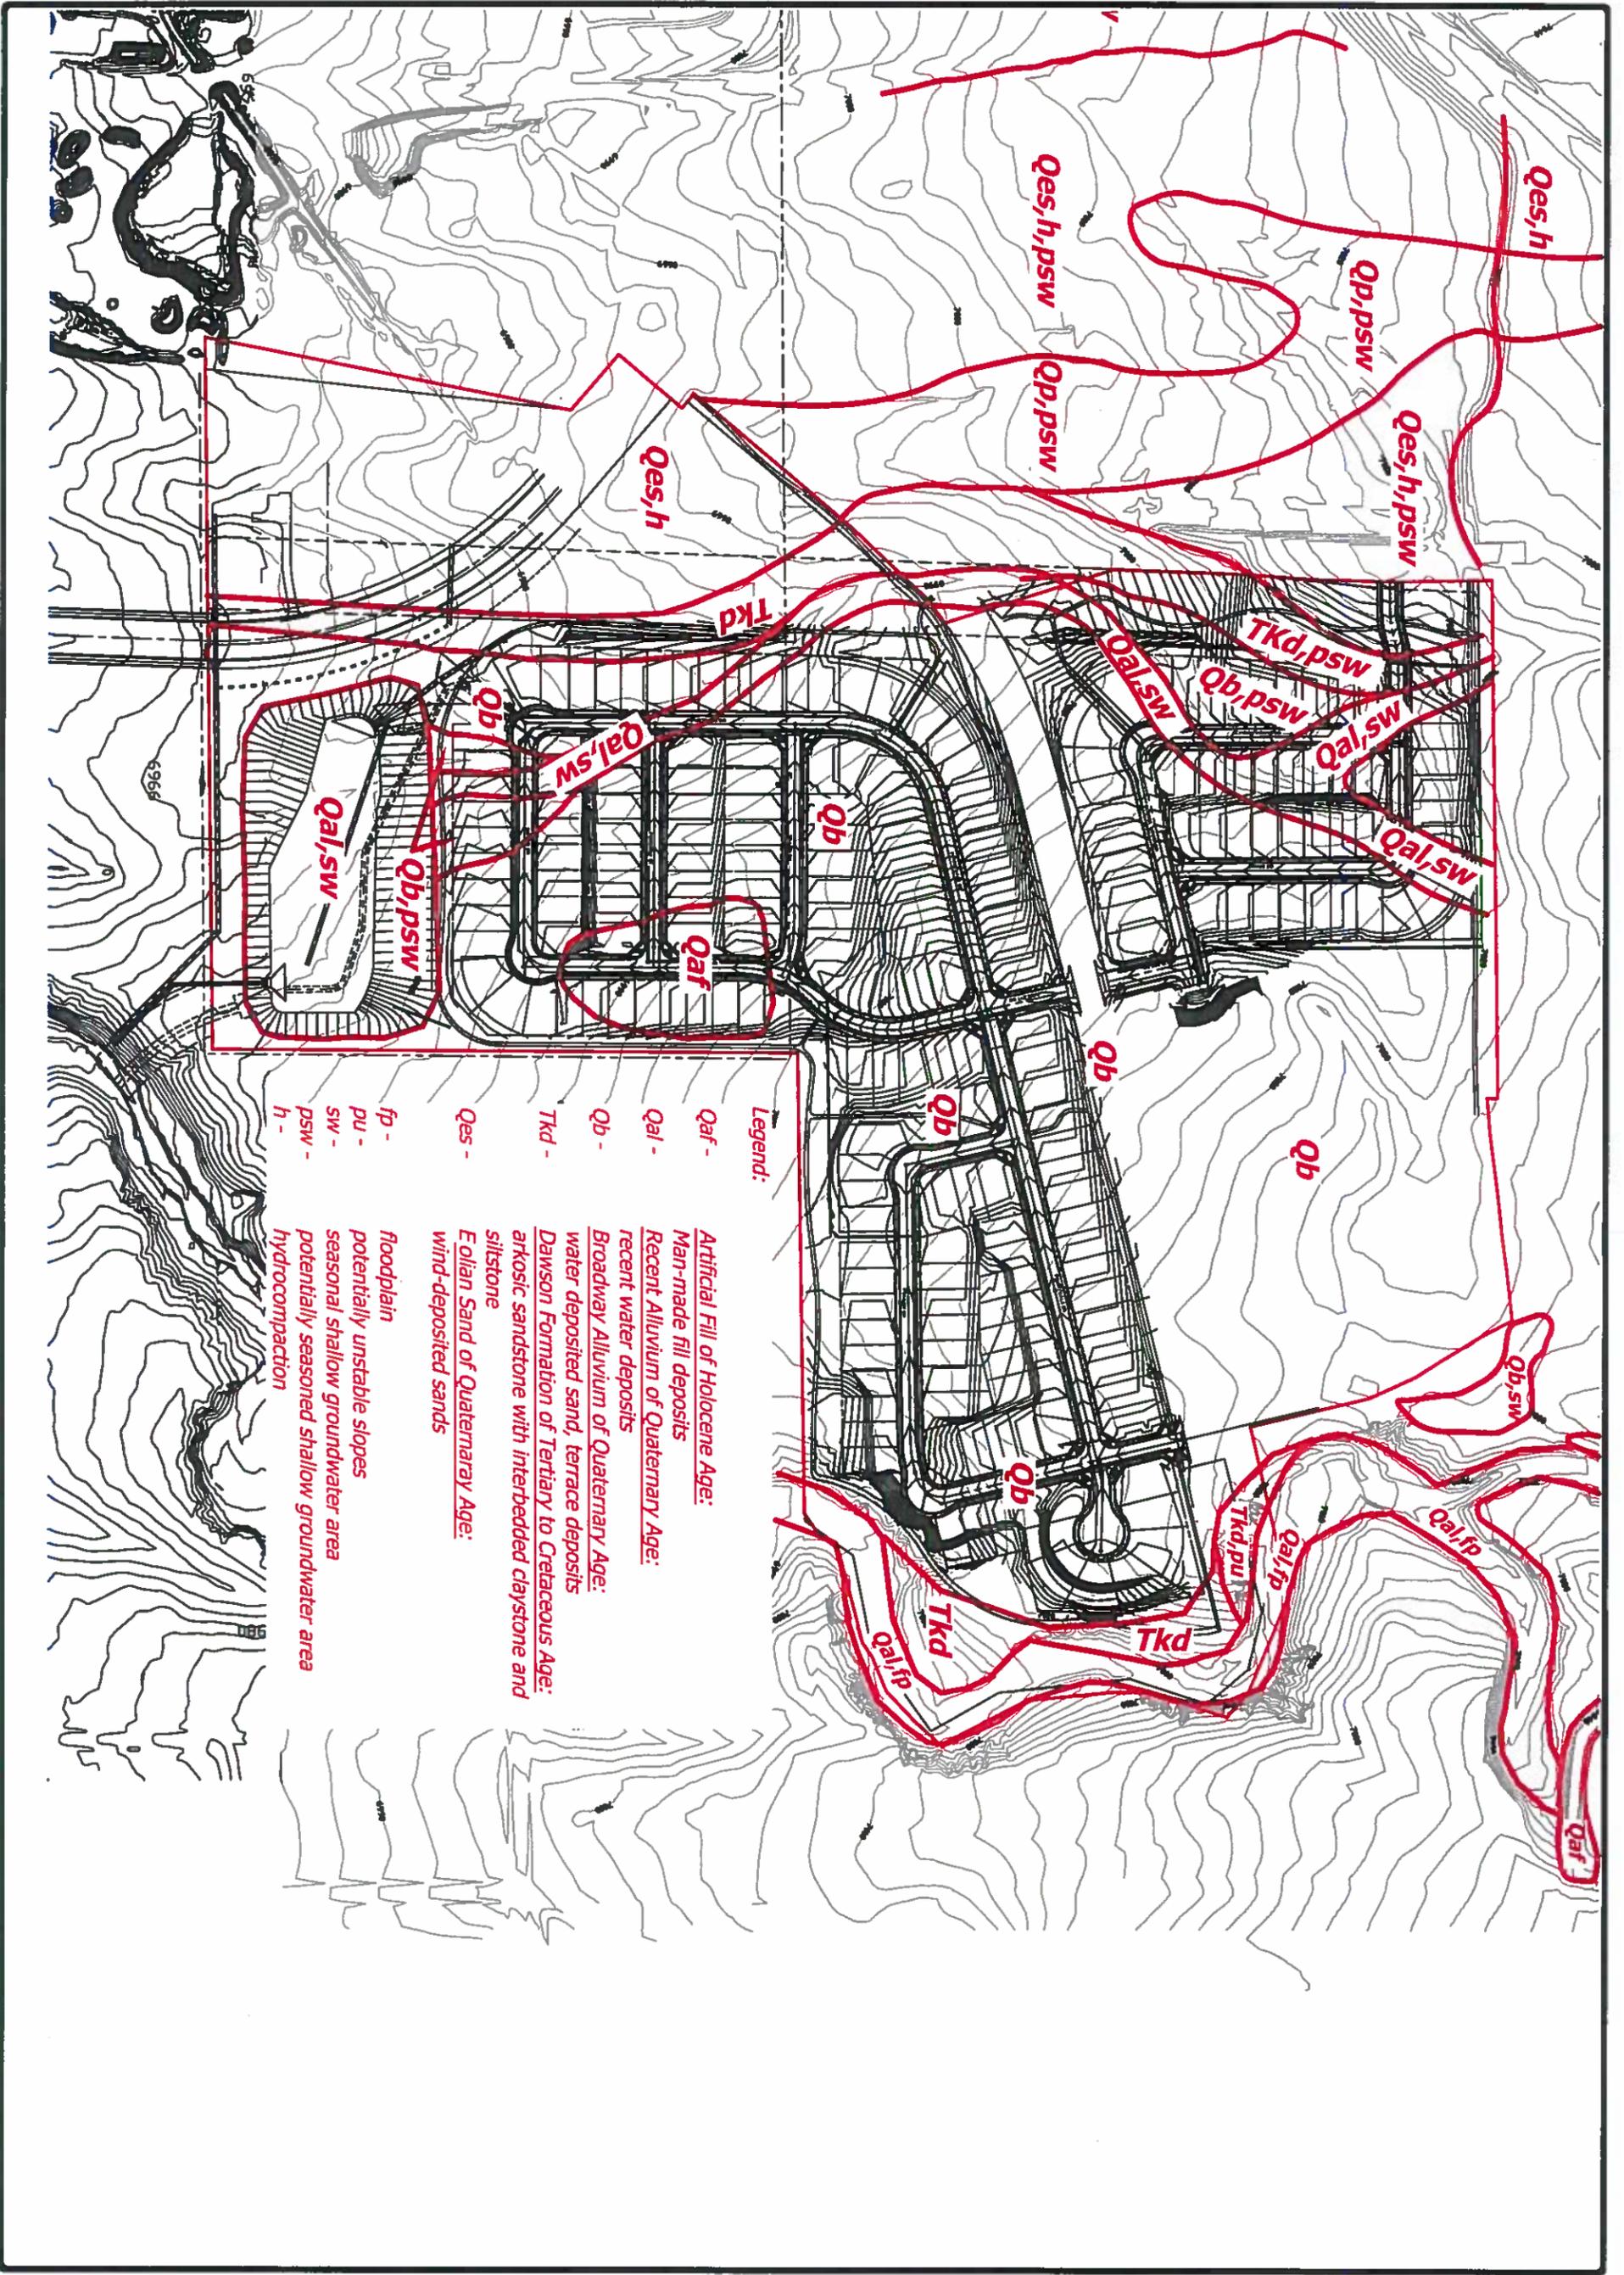
As mentioned previously, detailed mapping has been performed on this site to produce an Engineering Geology Map (Figure 7). This map shows the location of various geologic conditions of which the developers and planners should be cognizant during the planning, design and construction stages of the project. The hazards identified on this site include artificial fill, hydrocompaction, potentially expansive soils, and seasonal and potentially seasonal shallow groundwater areas and a floodplain east of the site. The following hazards have been addressed:

Some of the steep slopes along the Sand Creek drainage have been identified as potentially unstable. Considerable care must be exercised in these areas not to create a condition which would tend to activate instability.

Mitigation: According to the grading plan shown on Figure 7, the majority of these areas are to be regraded. Building should be avoided on any remaining potentially unstable slopes unless stabilized. A setback of 20 feet from the crest of these slopes is recommended unless stabilized. Stabilization could involve regrading to slope angles no steeper than 3:1 or the use of engineer-designed retaining walls, tiebacks, or buttresses. Where retaining walls are not used, erosion protection may be necessary to prevent undercutting by the creek during periods of high water. It is our understanding the project will include drainage improvements and the construction of a regional trail along the Sand Creek drainage and stabilization of the slopes will be a part of the improvements. Specific slope stabilization recommendations are beyond the scope of this report.
