February 3, 2022  
Revised March 4, 2022

Re: Soil, Geology, and Geologic Hazard Study - Addendum  
Midtown at Hannah Ridge, Filing No. 3  
Akers Drive and Constitution Avenue  
El Paso County, Colorado

**SOIL, GEOLOGY, AND GEOLOGIC HAZARD STUDY  
MIDTOWN AT HANNAH RIDGE, FILING NO. 3  
AKERS DRIVE AND CONSTITUTION AVENUE  
EL PASO COUNTY, COLORADO**

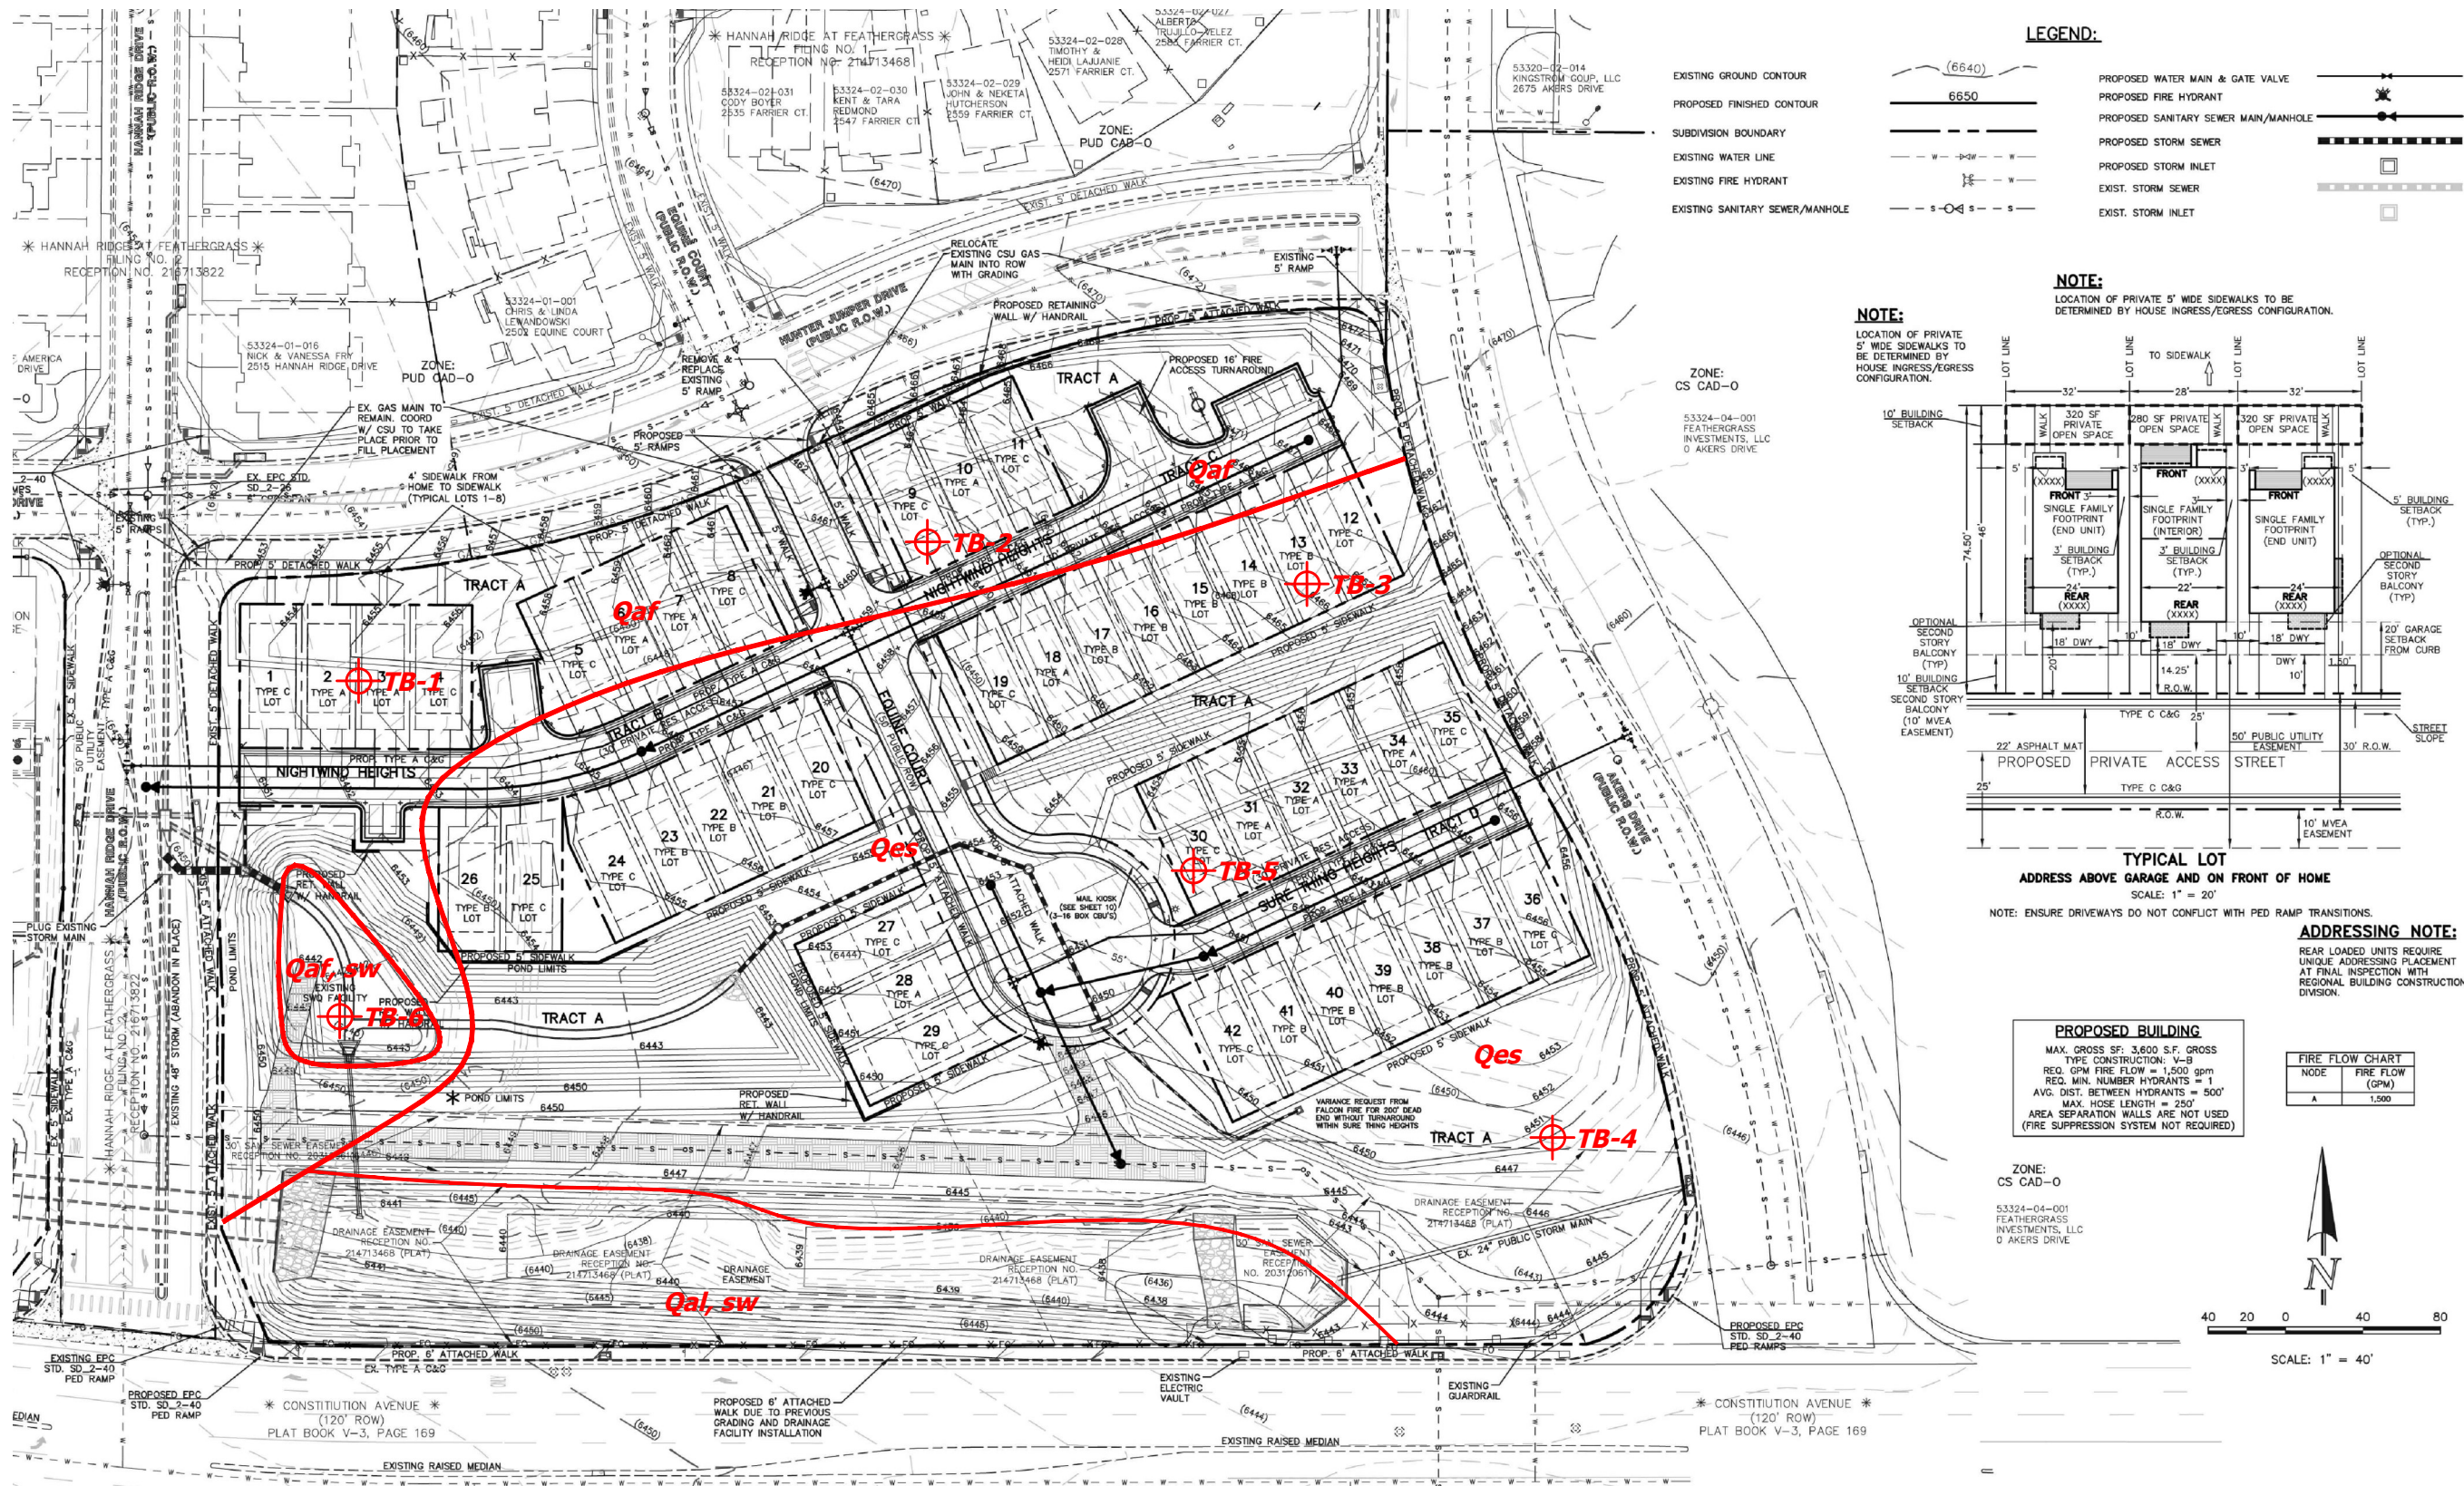
DRAWN  
L.L.L.  
CHECKED  
DATE  
2/3/22  
SCALE  
AS SHOWN  
JOB NO.  
2000006  
FIGURE NO.  
1

**Entech Response:** The proposed development does not have basements or crawlspaces, and will utilize shallow spread footings with slab on grade construction. Entech has updated the Geology/Engineering Geology Map (Figure 1), with the lasted site plan with proposed grading. The areas mapped with the potential for seasonal shallow groundwater are located in the existing detention pond, and the drainage along the southern side of the site. Groundwater was encountered in four of the six test borings drilled on the site at depths of 5 to 18 feet. The proposed structures are not located in the areas of mapped as seasonally wet areas.

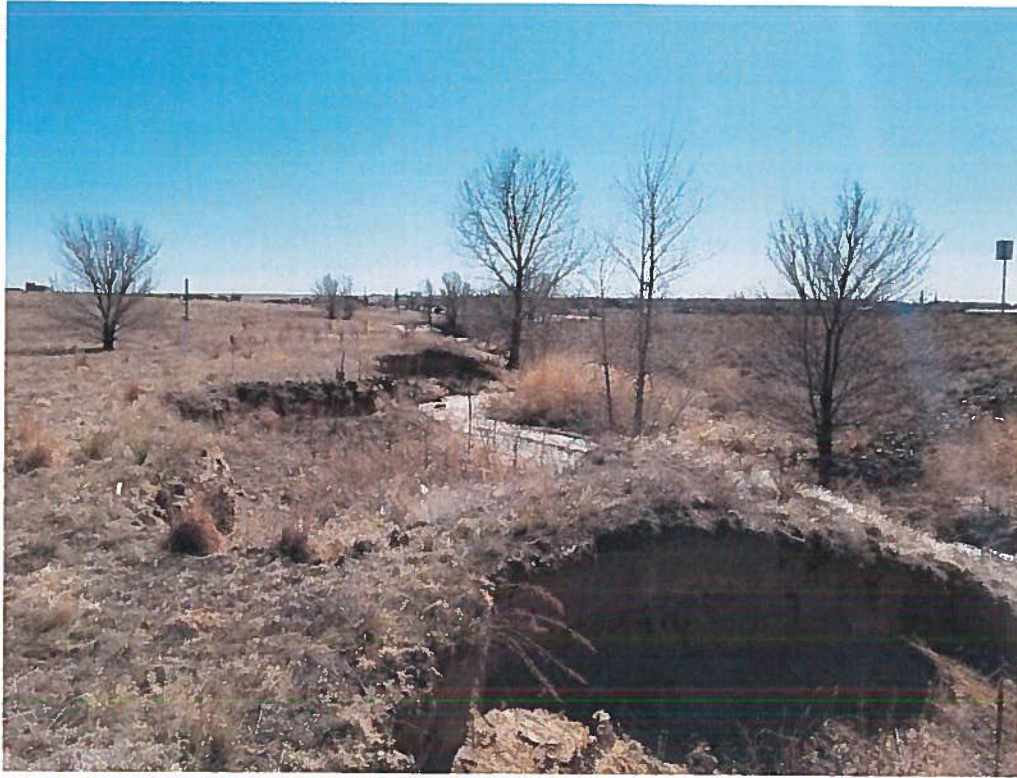
In these areas, we would anticipate the potential for periodically high subsurface moisture conditions and possible frost heave potential, depending on the soil conditions. Water was observed in portions of the drainage along the southern side of the site at the time of our field mapping. The areas mapped with this hazard are located in the drainage easement and will be avoided by the proposed residential structures.

**Looking east at  
drainage along the  
southern side of the  
site.**

Mitigation In these locations, foundations in areas subject to severe frost heave potential should penetrate sufficient depth so as to discourage the formation of ice lenses beneath foundations. At this location and elevation, a foundation depth for frost protection of 2.5 feet is recommended. In areas where high subsurface moisture conditions are anticipated periodically, a subsurface perimeter drain will be necessary to help prevent the intrusion of water into areas located below grade. Additionally, swales should be created to intercept surface runoff and carry it safely around and away from structures. It is anticipated that the site grading will likely mitigate the drainages on site.
