**SOIL, GEOLOGY, AND GEOLOGIC HAZARD STUDY
MIDTOWN AT HANNAH RIDGE, FILING NO. 3
AKERS DRIVE AND CONSTITUTION AVENUE
EL PASO COUNTY, COLORADO**

April 20, 2020

Entech Job No. 200006
AAprojects/2020/200006 countysoil/geo

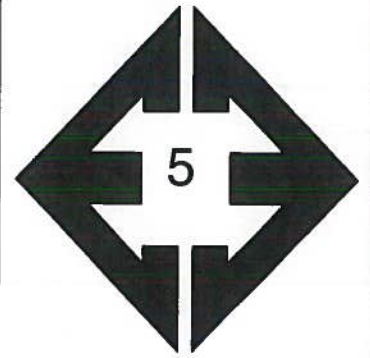
**Looking east at
drainage along the
southern side of the
site.**
