SOILS AND GEOLOGY STUDY

**Peerless Farms
El Paso County, Colorado**

JOB NO. 180213

April 14, 2021

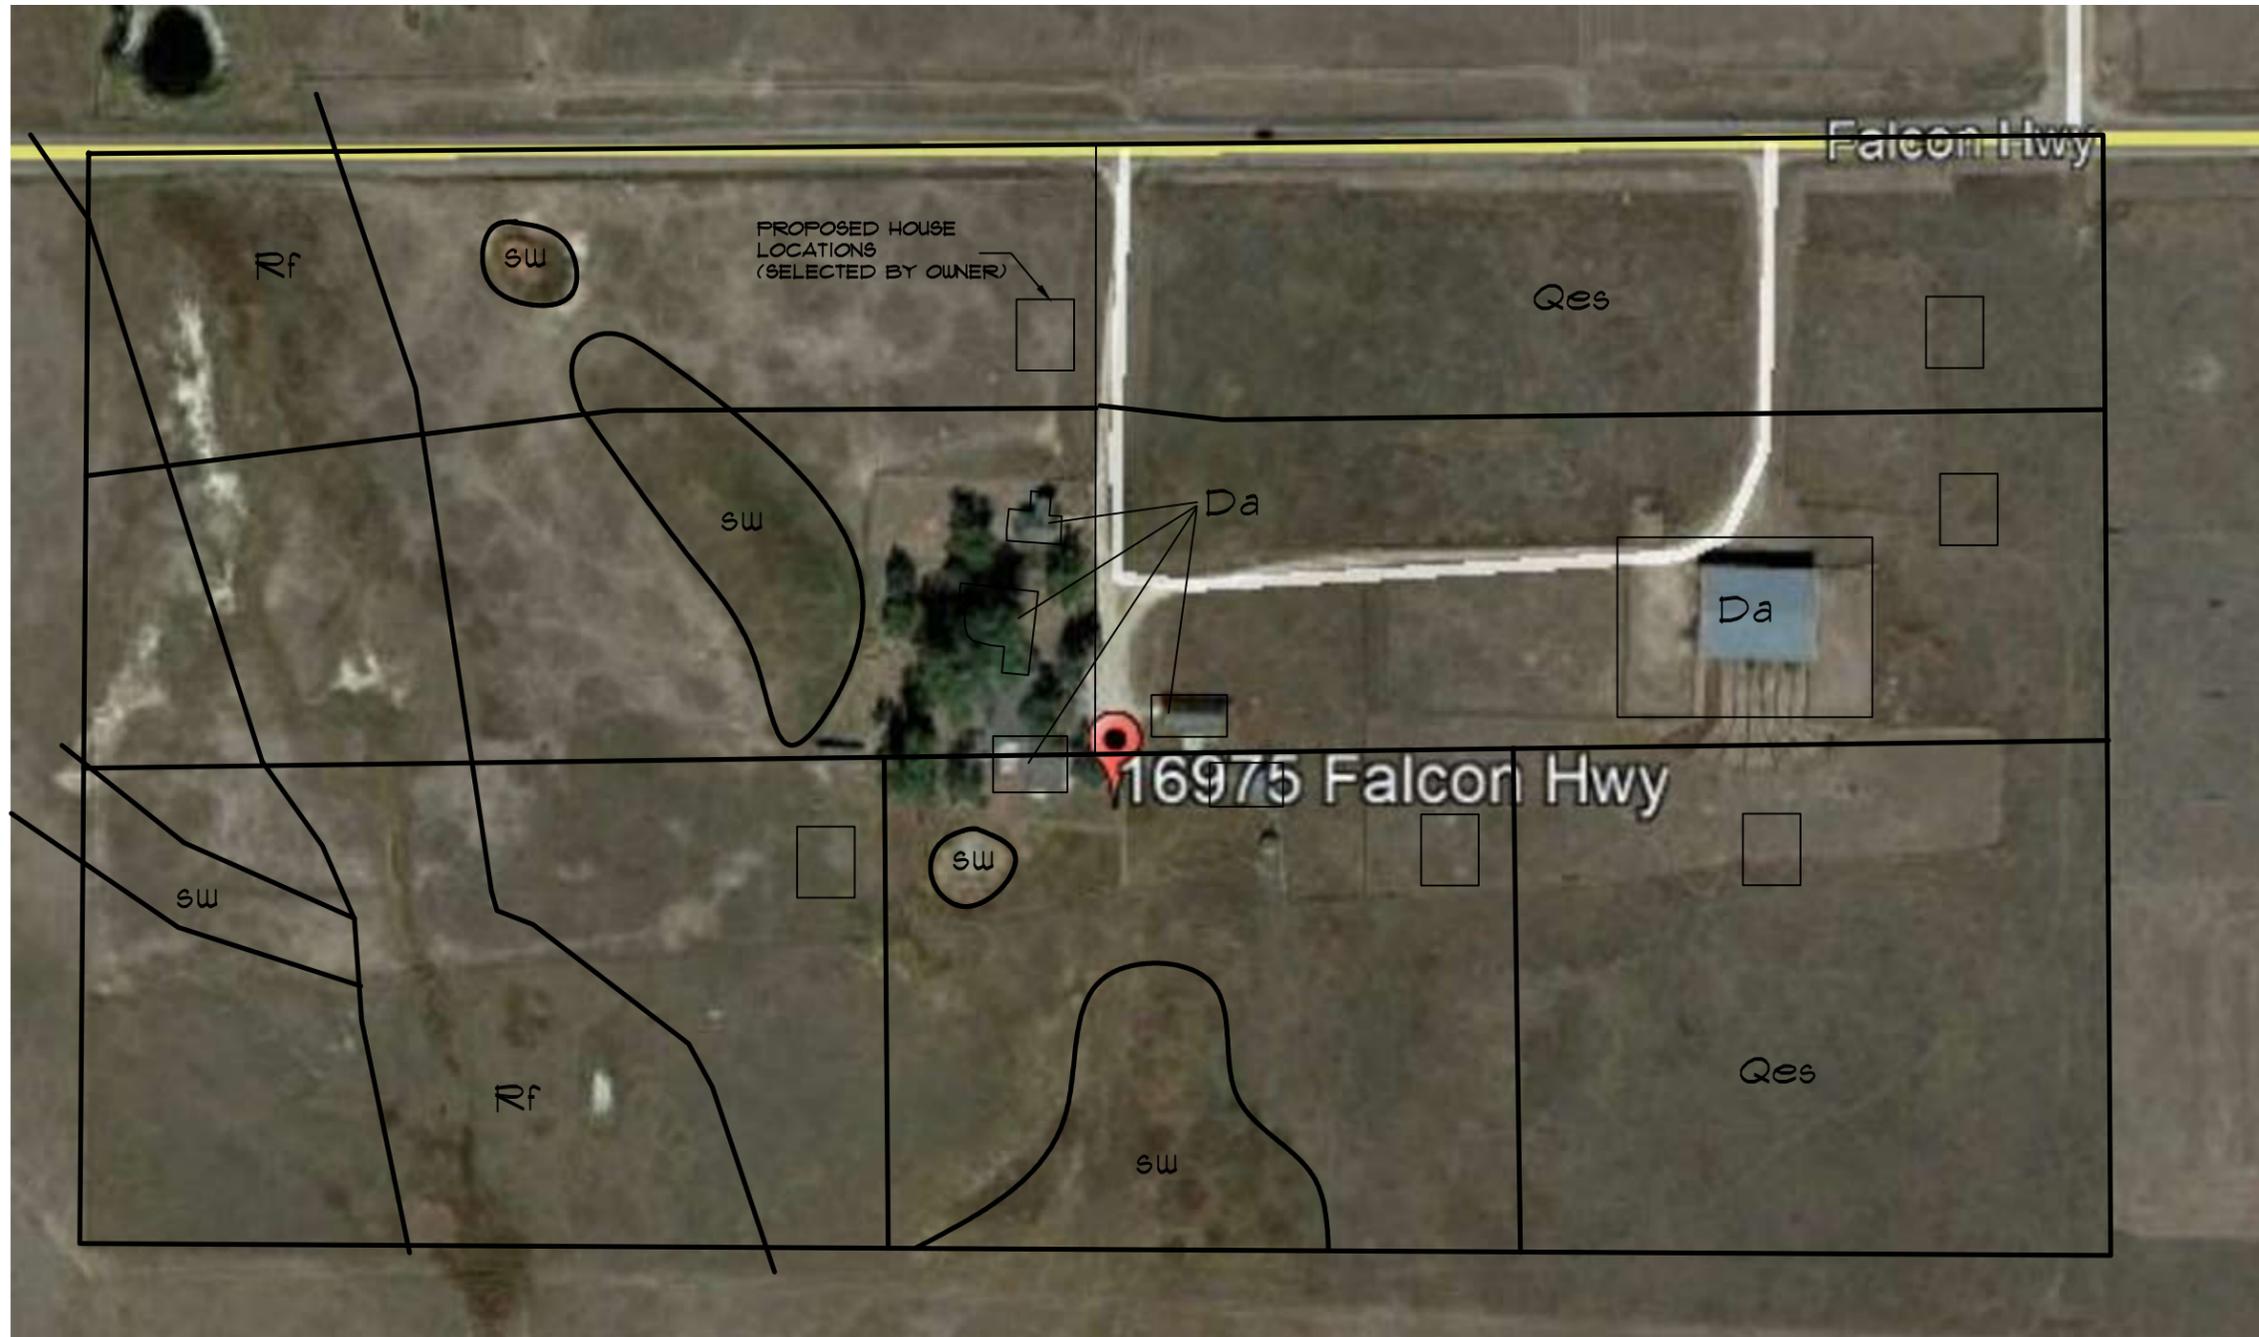
FIG-11

Based on our field observations and review of relevant geologic maps, a geologic map was prepared which identifies the geologic conditions affecting the development. The geologic units present on the site are presented in the Engineering and Geology Map, Figure 11.

- *Qes – eolian sand (Holocene to upper Pleistocene)* – as mapped on the Falcon Quadrangle, the sand is generally yellowish-brown to tan, fine to course grained, frosted sand and silt deposited by wind. Typically, this unit is faintly stratified and noncohesive; dune forms are not present. The unit is likely deposited as a sandsheet by winds capable of moving very fine gravel-sized clasts. Eolian sand is moderately compacted, easily excavated, and drains well. Eolian sand was encountered in all three test borings to depth of approximately 20 feet.

- *Da – disturbed areas* – areas that are no longer in their native state, soils have been removed and/or replaced for the existing driveway, existing residence, existing OWTS, and utility easements.

- *Rf* - Regulatory Floodway - intermittent creek, drainageway that exists along the western portion of the site. This area lies in a designated floodway zoned AE.
- *sw* - seasonally wet areas, in these areas we would anticipated the potential for periodically high surface moisture conditions. These areas lie outside the defined regulatory floodway and can likely be avoided by the proposed development.

All construction should remain outside the floodway. It is recommended the unnamed drainageway be identified as a "No Build Area" unless additional studies are performed, in conjunction with the drainage engineer, prior to any new construction. The drainageway is fairly shallow and does not contain banks that would scour and eroded away. This area is shown on the Engineering and Geology Map, Figure 10.

All construction should remain outside the unnamed creek drainageway. It is recommended the unnamed creek drainageway be identified as a “No Build Area” unless additional studies are performed, in conjunction with the drainage engineer, prior to any new construction. This area is shown on Figure 11.

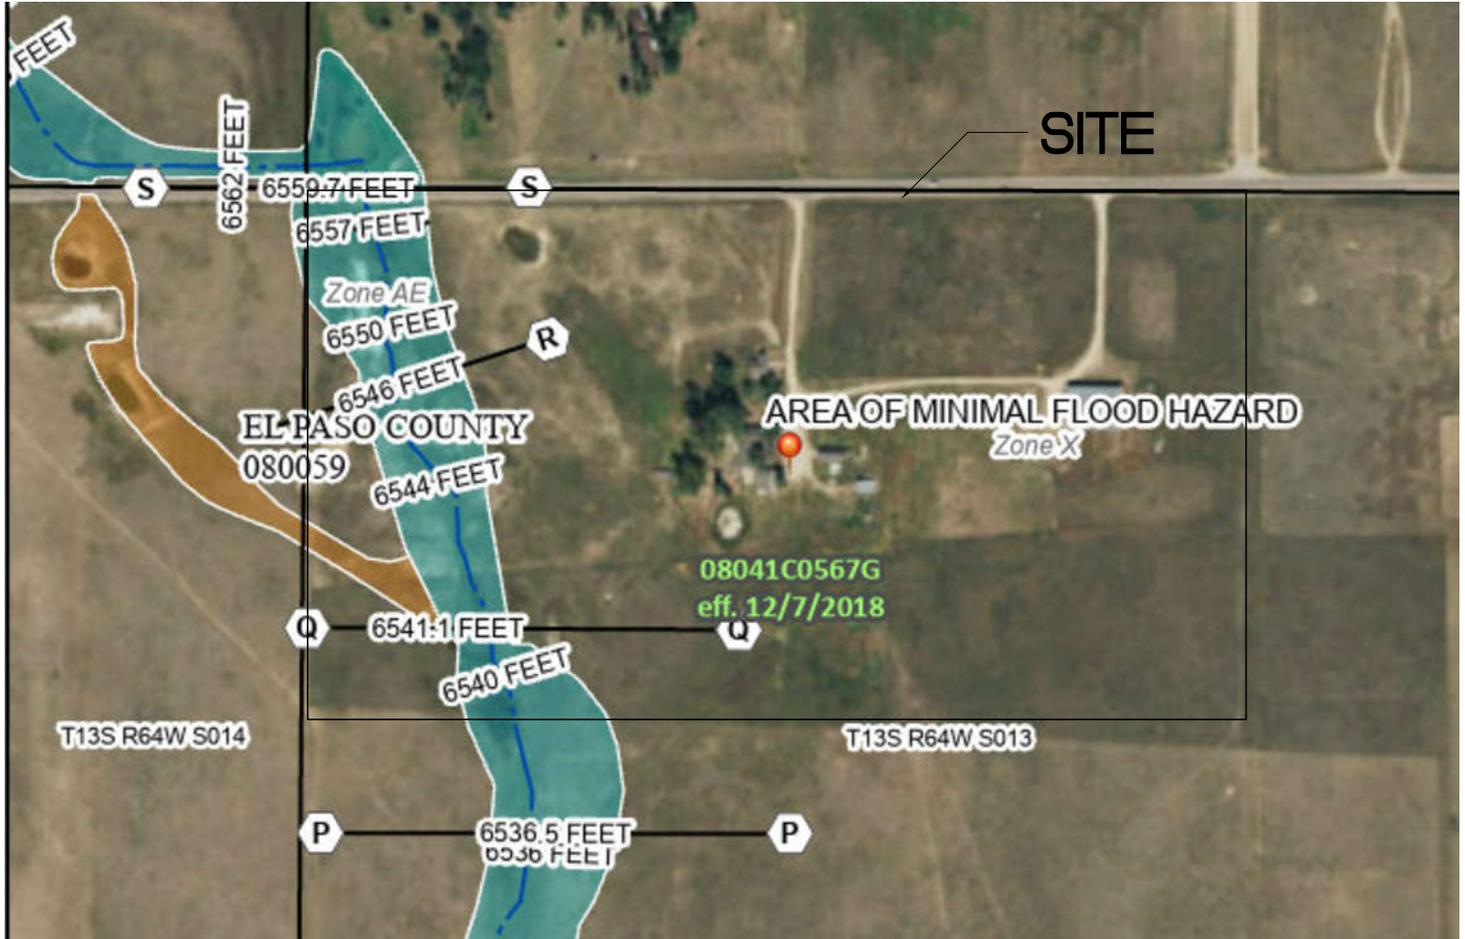
FIG No. 12

Per the latest approved edition of the Pikes Peak Regional Building Code, the lowest finished floor elevation (including basement together with attendant utility and sanitary facilities) shall be elevated one-foot or more above the BFE. This presence of the floodplain is not believed to pose a higher risk to this structure than to several currently existing structures in the surrounding area. Provided that the recommendations presented herein, as well as any requirements stipulated by the governing regulatory agencies, are followed, the presence of the floodplain is not anticipated to preclude the proposed development on Lots 1 and 5 or the development as a whole.
