RE: Wetlands Assessment

18955 Beacon Lite Road Monument, El Paso County, Colorado Project No. 22.159.06

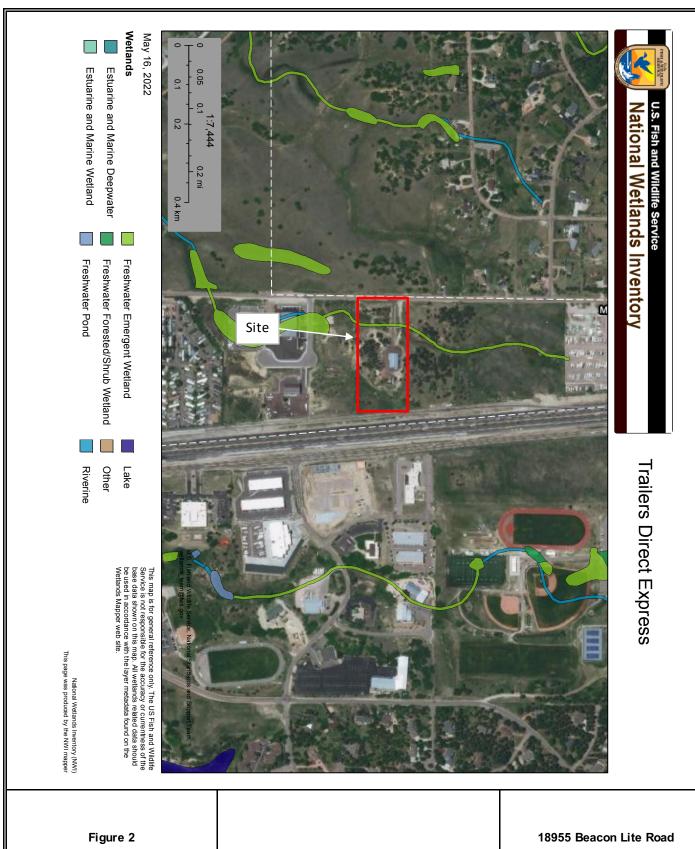
National Wetlands Inventory Map

Based on a review of appropriate National Wetland Inventory (NWI) maps, wetlands designated as a freshwater emergent wetland were noted to cross the site from north to south in the area of the existing drainage. This area is at a lower elevation than the proposed construction disturbance area and is not proposed for disturbance as part of the current project (Figure 3). The proposed project is not anticipated to impact wetlands areas.
