**GEOLOGIC HAZARDS STUDY  
PROPOSED CORVALLIS AT FOUNTAIN  
MIXED USE DEVELOPMENT  
SOUTH OF FONTAINE BOULEVARD  
WEST OF MARKSHEFFEL ROAD  
FOUNTAIN, COLORADO**

**PROJECT NO. 20-2-163.A**

**SEPTEMBER 1, 2020**

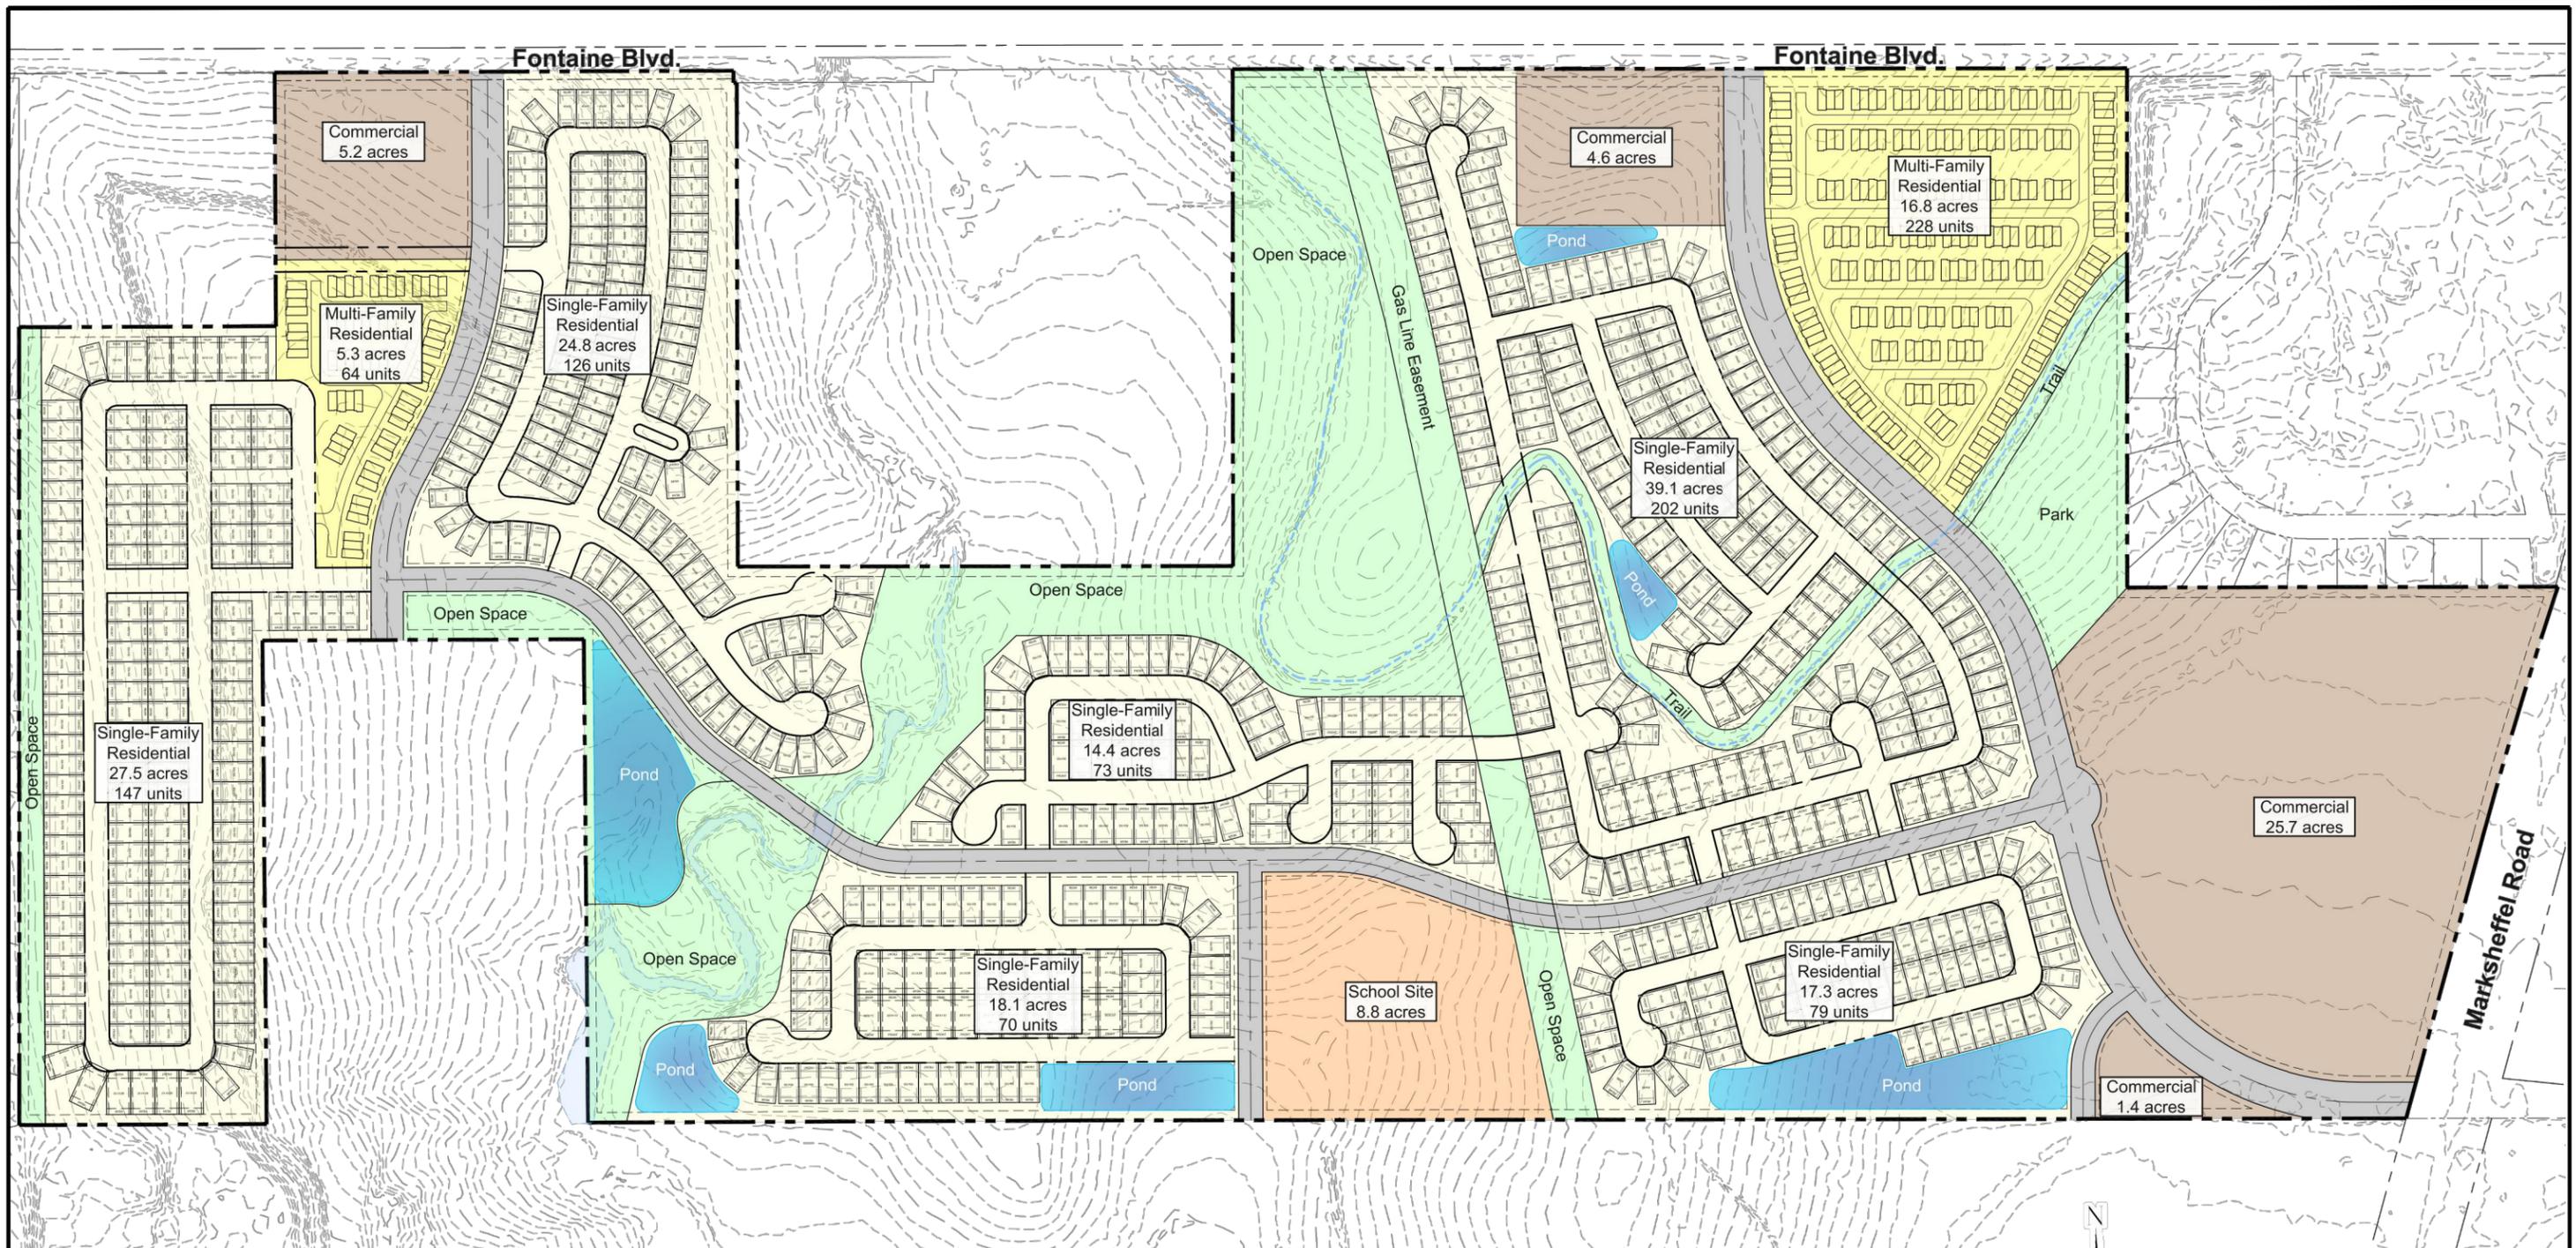
FIGURE 1 – PROPOSED DEVELOPMENT AND EXISTING TOPOGRAPHY

This report presents the results of a Geologic Hazards Study for the proposed Corvallis at Fountain Mixed Use development to be located to the south of Fontaine Boulevard and west of Marksheffel Road in Fountain, Colorado. The project site is shown on Figure 1. The purpose of the study was to evaluate the geologic conditions and their potential impact on the project. The study was conducted in accordance with our proposal for engineering geology services to Matrix Design Group, Inc., dated May 29, 2020, Proposal No. C20-189.

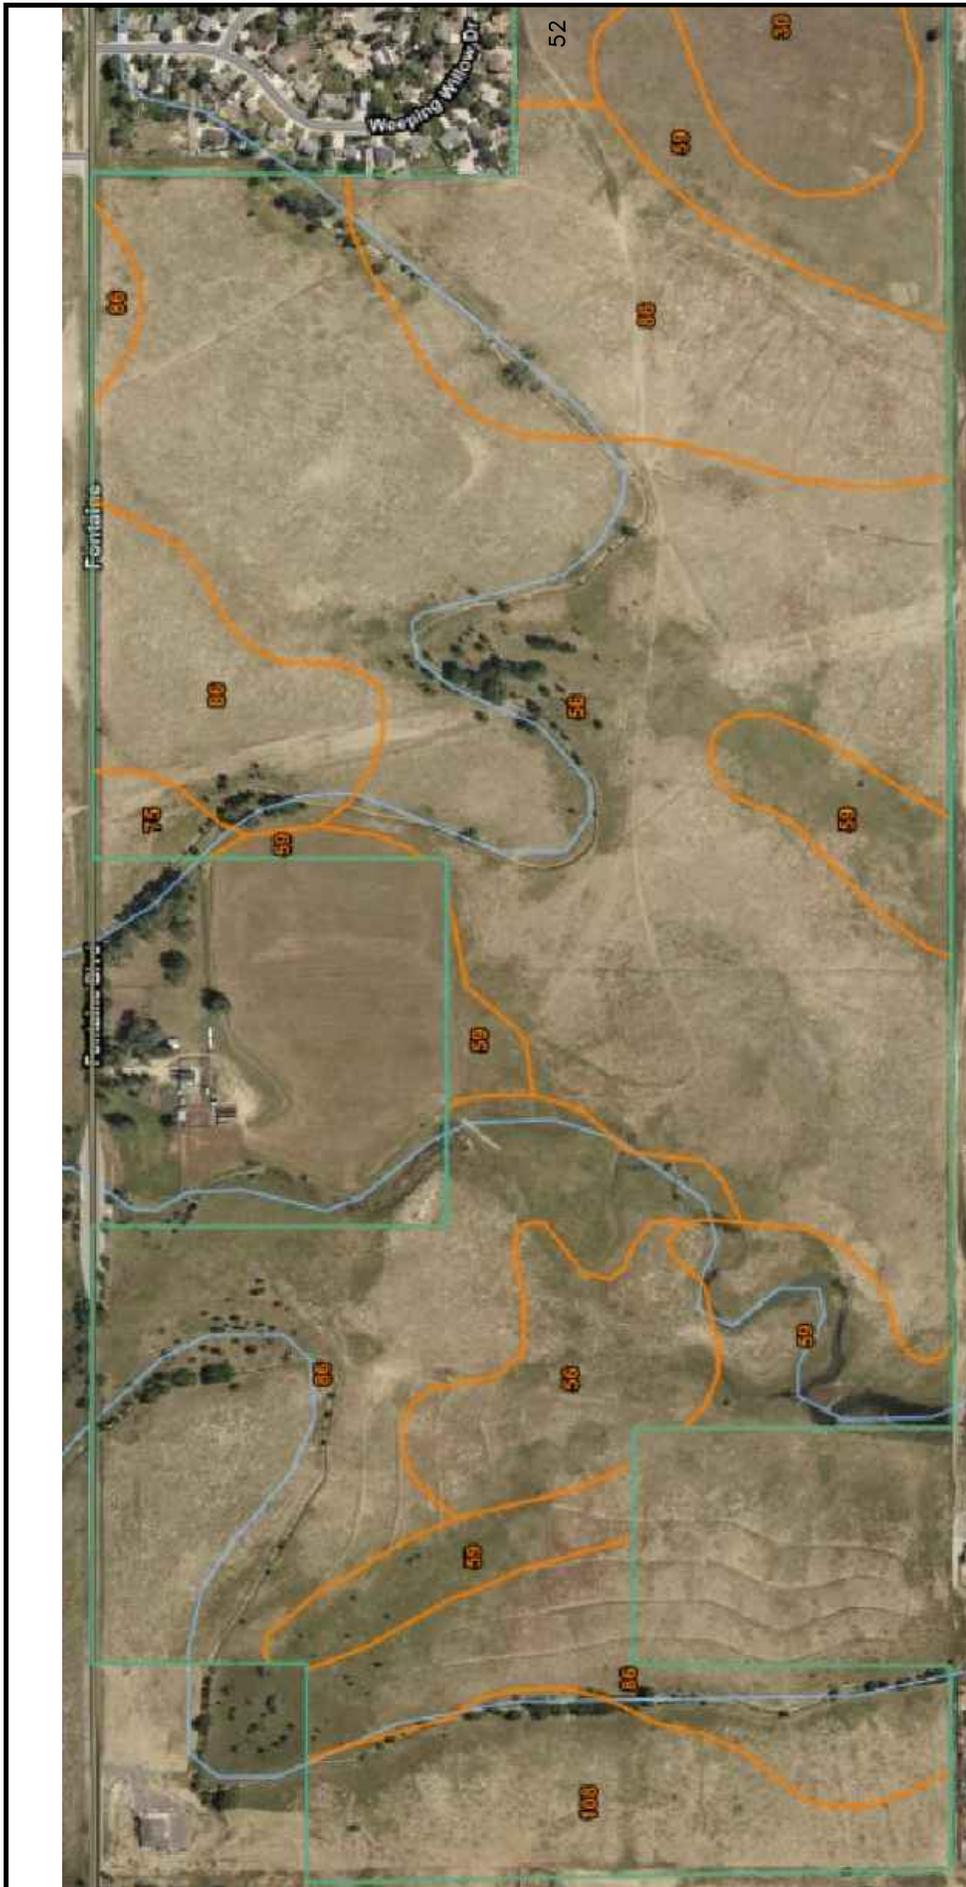
FIGURE 3 – NRCS SOIL SURVEY MAP

According to the “El Paso County- Aggregate Resource Evaluation Maps, El Paso County – Master Plan for Mineral Extraction” (1996), the site is designated as ‘Municipalities’ and no aggregate resources are indicated. The United States Department of Agriculture Natural Resource Conservation Service (NRCS) Web Soil Survey shows the site overlain with the Fort Collins loam, the Manzanst clay loam, the Nelson-Tassel fine sandy loams, the Nunn clay loam, the Razor-Midway complex, the Stoneham sandy loam, and the Wiley silt loam, see Figure 3. The NRCS classifies all of the soil types as Poor suitability as a gravel source. The NRCS classifies all the soil types as Poor suitability as a sand source except the Nelson-Tassel fine sandy loams which are classified as Fair suitability. The NRCS classifies the Ft. Collins loam, the Nunn clay loam, and the Stoneham sandy loam as Fair suitability as a road fill source and the other soil types as Poor suitability. The Ft. Collins loam, the Nunn clay loam, and the Stoneham sandy loam will likely be acceptable for use as fill material required for site grading and construction but should be evaluated for suitability during the geotechnical study portion of the development. Evaluation of commercial feasibility of gravel, sand, or roadfill mining on the subject site is beyond the scope of this study.
