ENTECH
ENGINEERING, INC.

**SOIL, GEOLOGY AND
GEOLOGIC HAZARD STUDY
LINCOLN PLAZA DRIVE AND BRADLEY ROAD
SOUTHEAST CORNER
EL PASO COUNTY, COLORADO**

April 12, 2005

Entech Job No. 37545
2MSW/rep/2005/37545sgws

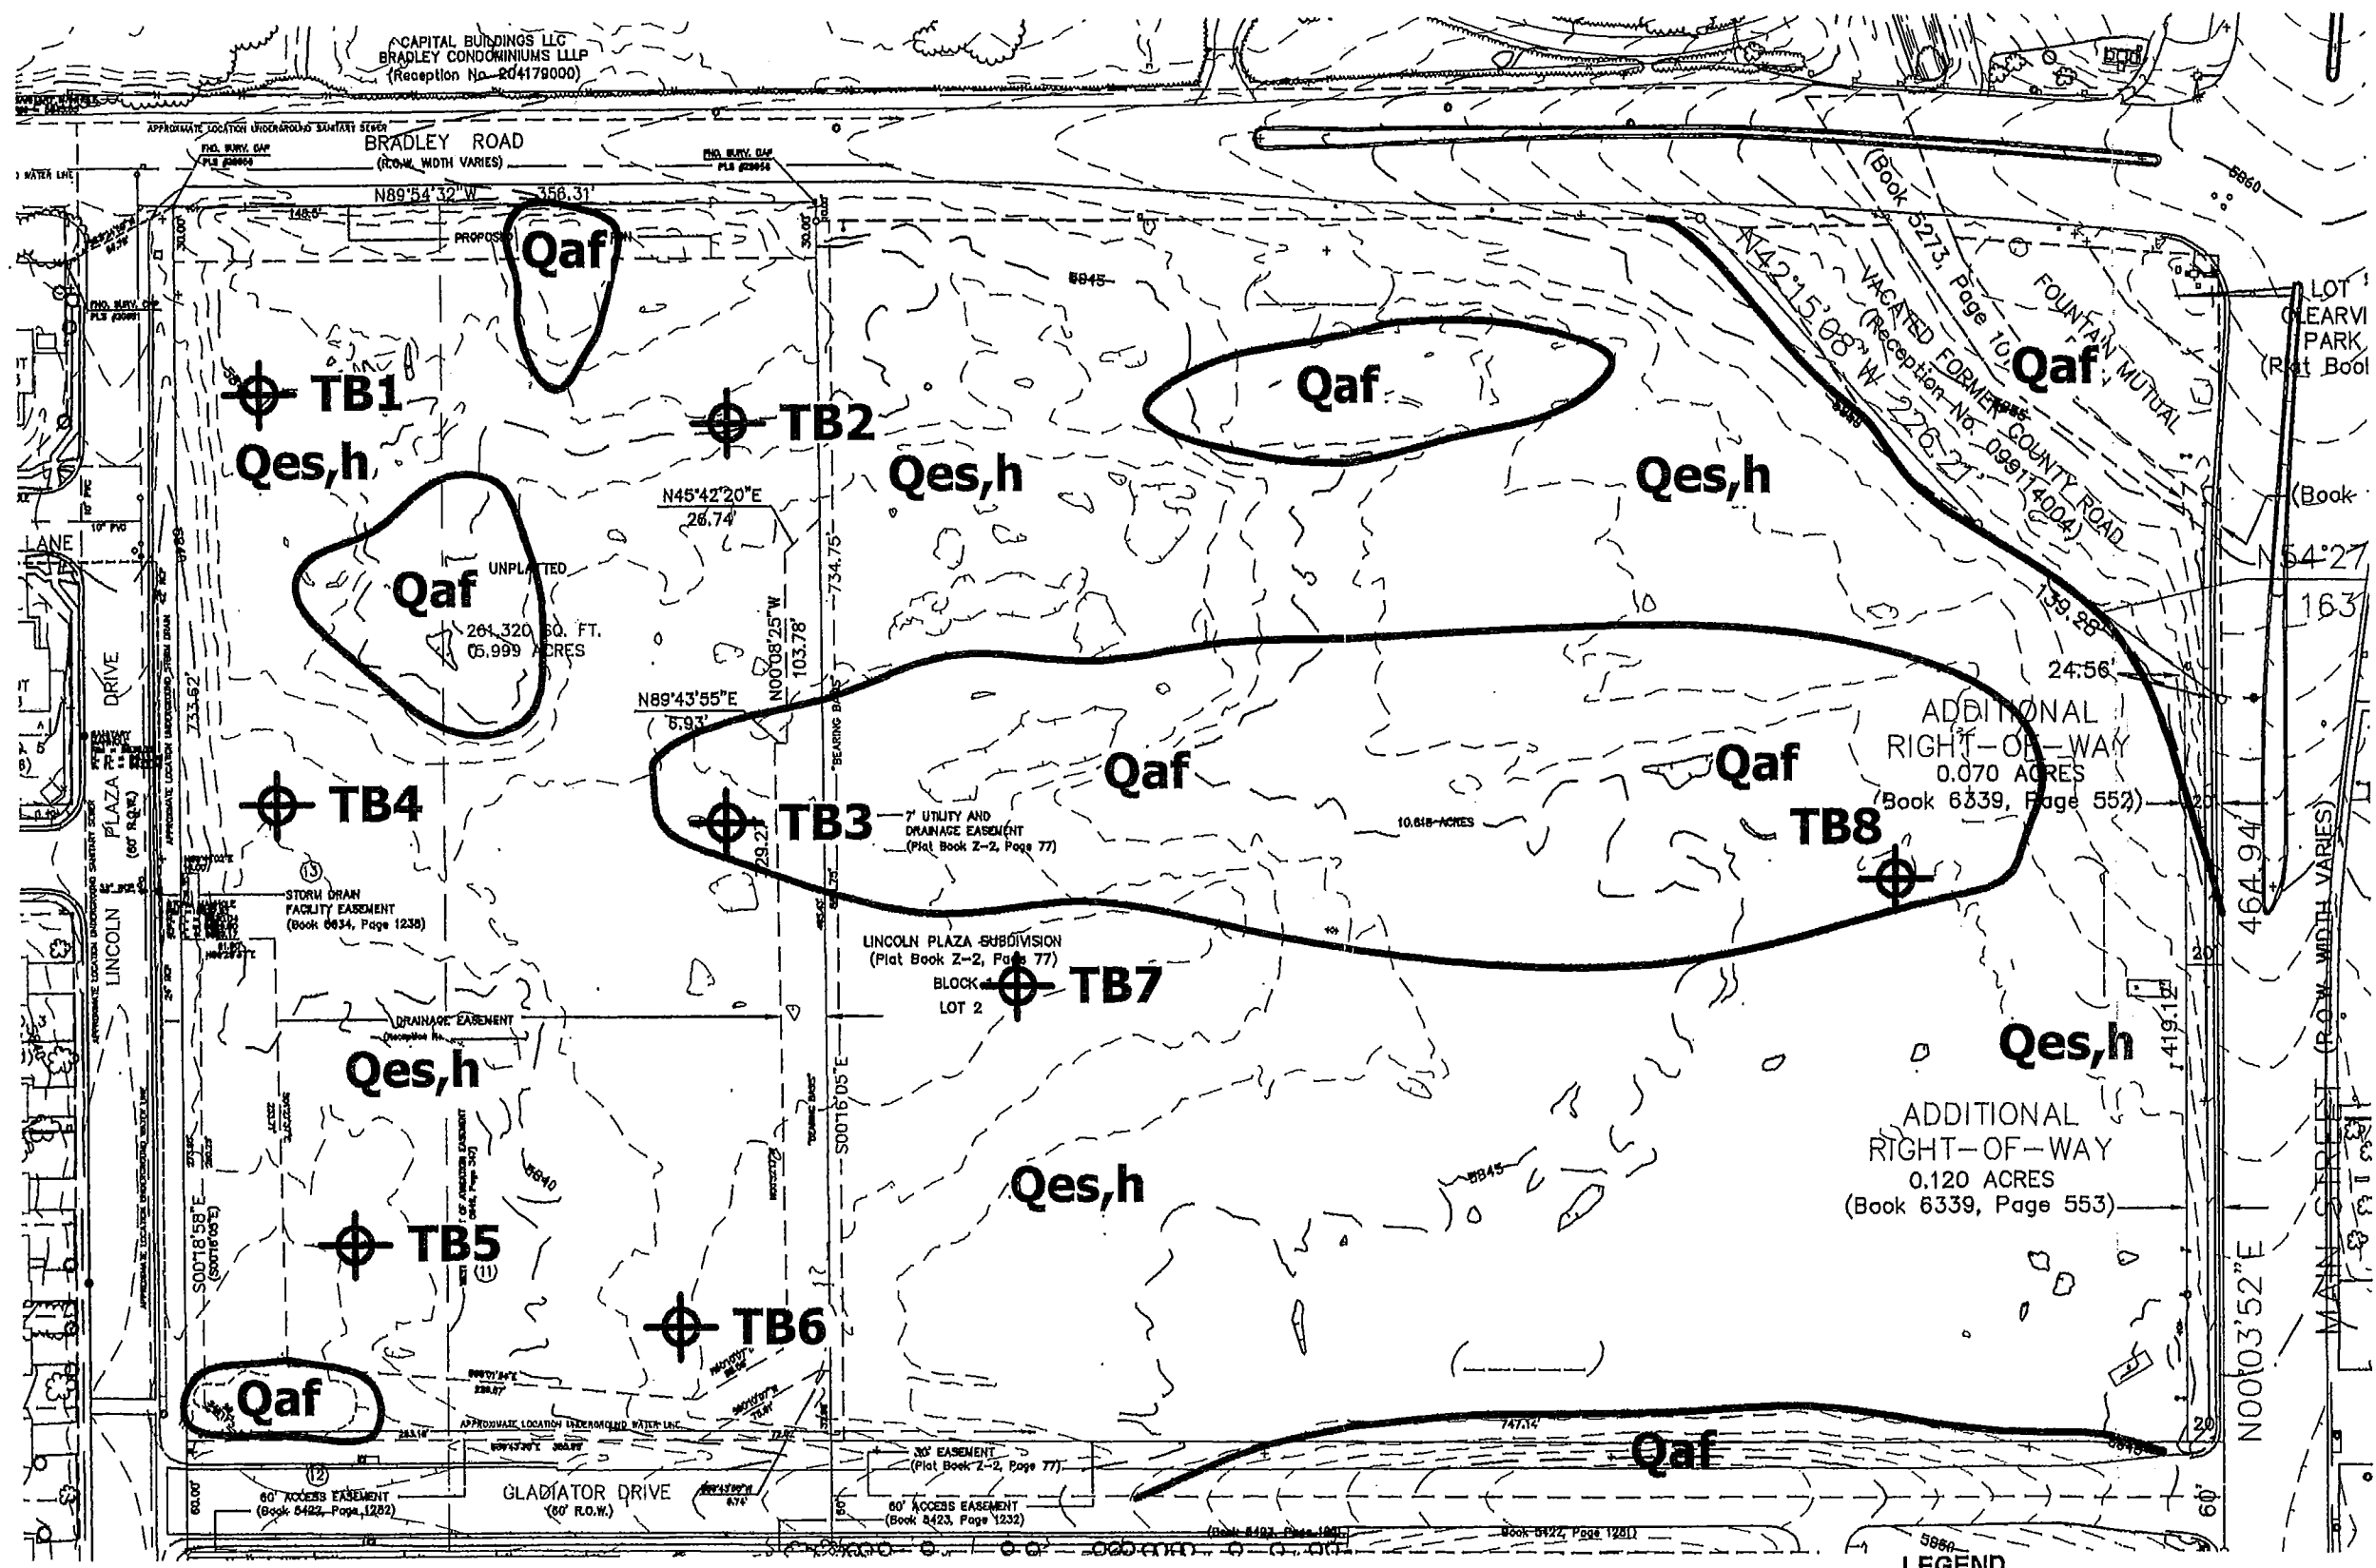
As mentioned previously, detailed mapping has been performed on this site to produce an Engineering Geology Map (Figure 8). This map shows the location of various geologic conditions of which the developers should be cognizant during the planning, design and construction stages of the project. These hazards and the recommended mitigation techniques are as follows:

h Hydrocompaction: Areas in which this hazard has been identified are acceptable as building sites. However, in areas identified for this hazard classification, we anticipate a potential for settlement movements upon saturation of these surficial soils. The low density, uniform grain sized, windblown sand deposits are particularly susceptible to this type of phenomenon.

Mitigation: It is anticipated that the fill piles would be removed during site grading. Any uncontrolled fill be encountered beneath foundations will require removal and recompaction at 90% of Modified Proctor Dry Density, ASTM D-1557.

Mitigation: The potential for settlement movement is directly related to saturation of the soils below the foundation areas. Therefore, good surface and subsurface drainage is extremely critical in these areas in order to minimize the potential for saturation of these soils. The ground surface around all permanent structures should be positively sloped away from the structure to all points, and water must not be allowed to stand or pond anywhere on the site. We recommend that the ground surface within 10 feet of the structures be sloped away with a minimum gradient of ten percent. If this is not possible on the upslope side of the structures, then a well-defined swale should be created to intercept the surface water and carry it quickly and safely around and away from the structures. Roof drains should be made to discharge well away from the structures and into areas of positive drainage. Where several structures are involved, the overall

Additionally, loose or collapsible soils may be encountered on the site. Should loose or collapsible soils be encountered beneath foundations, removal and recompaction of the upper 2 to 3 feet with thorough moisture conditioning at 90% of Modified Proctor Dry Density, ASTM D-1557 will be necessary. Specific recommendations should be made after additional investigation of each building site.

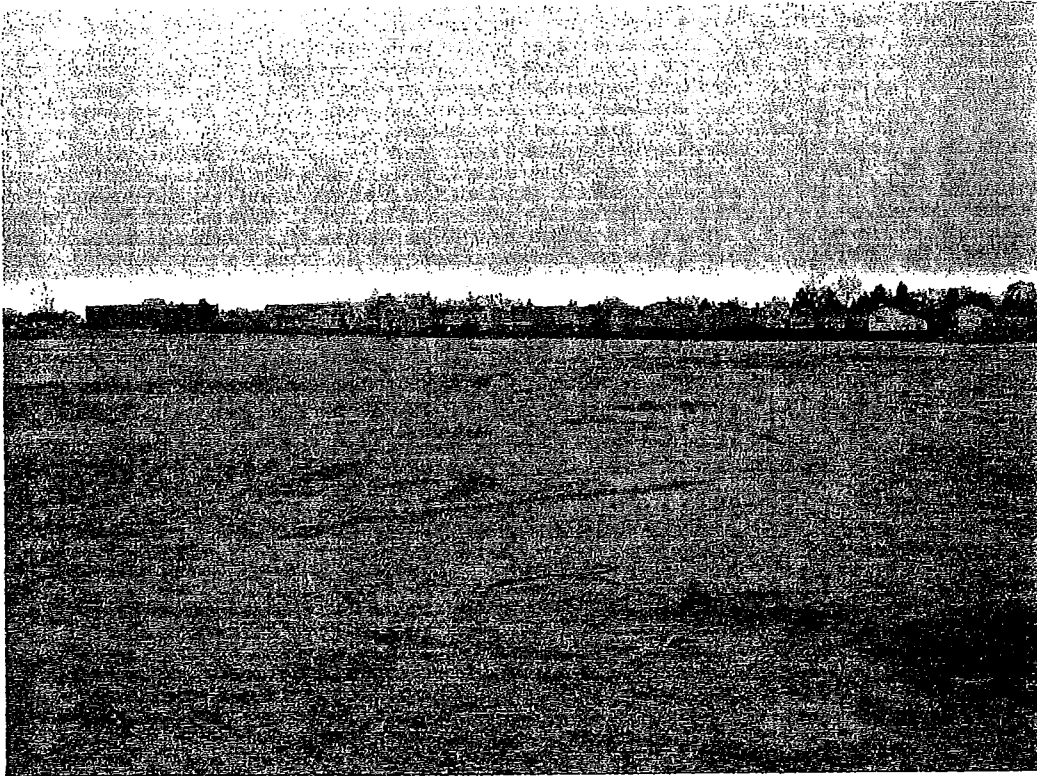
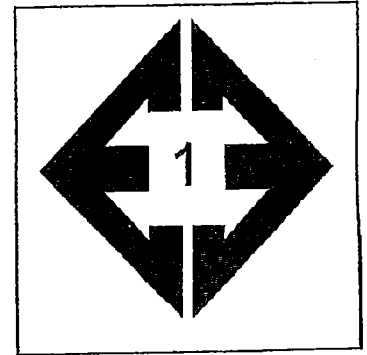
**From northwest
corner of site,
looking
southeast.**

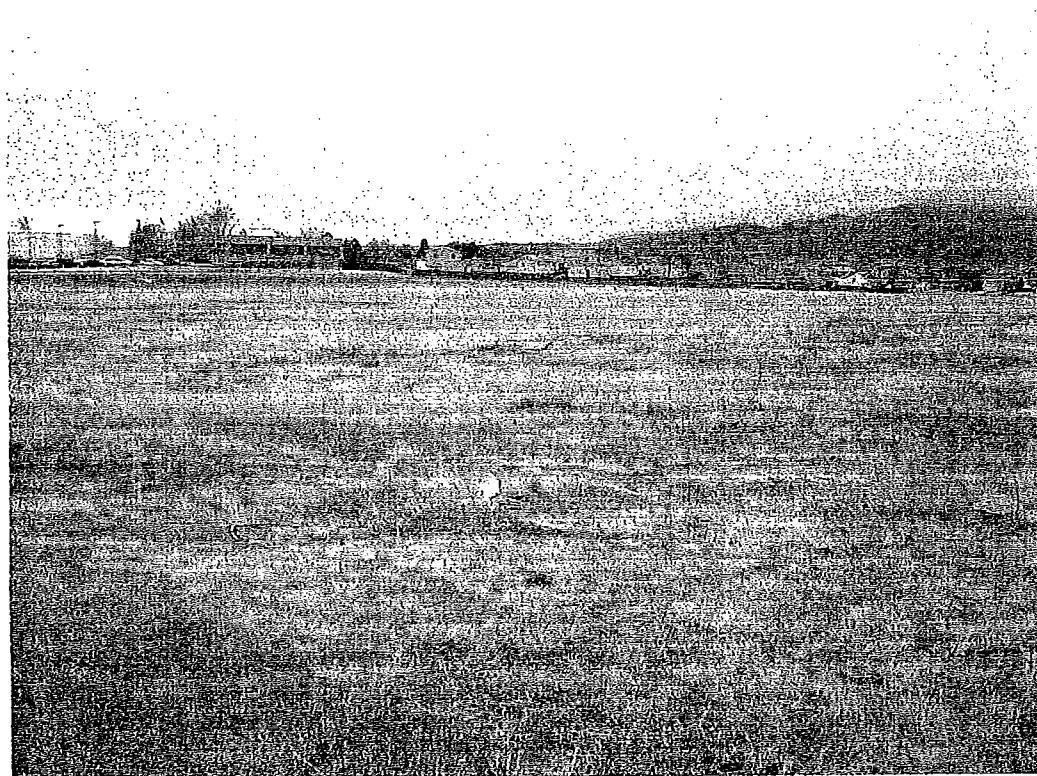
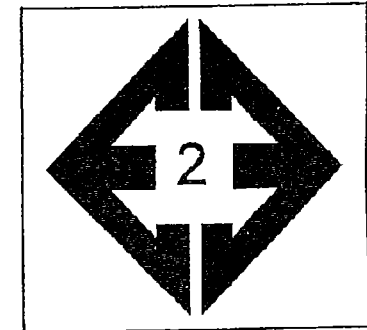
**From northeast
corner of site,
looking
southwest.**

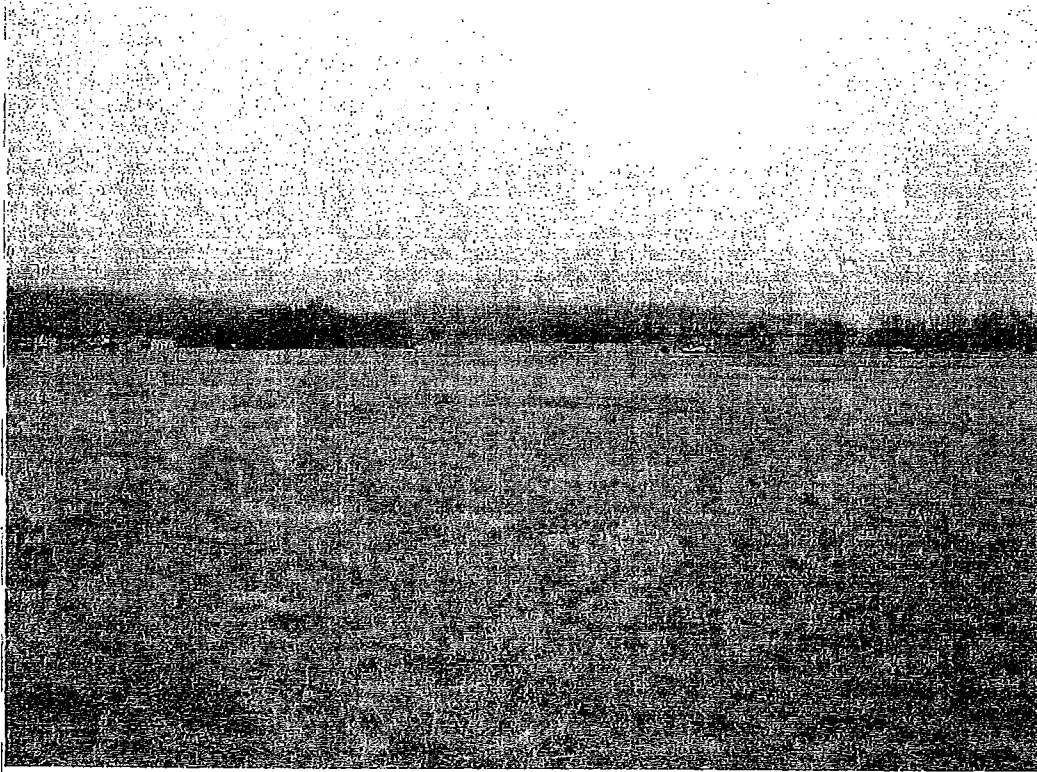
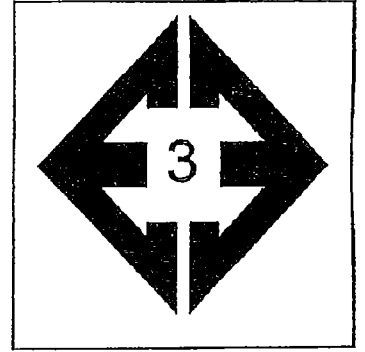
**From southeast
corner of site,
looking
northwest.**

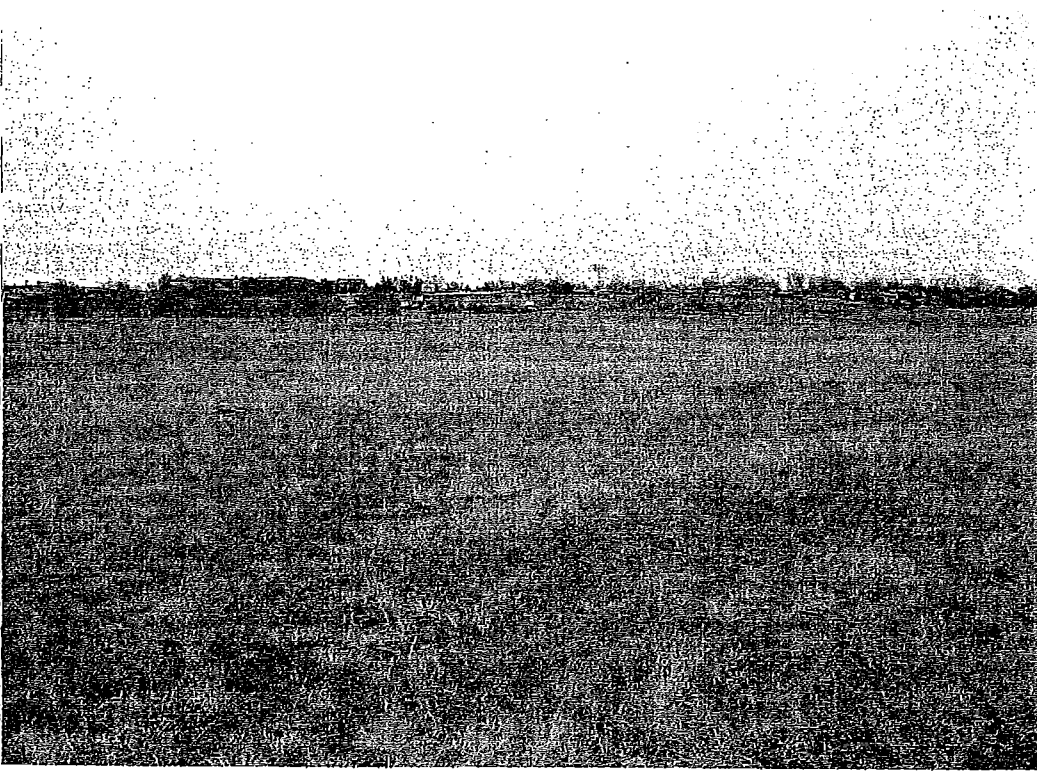
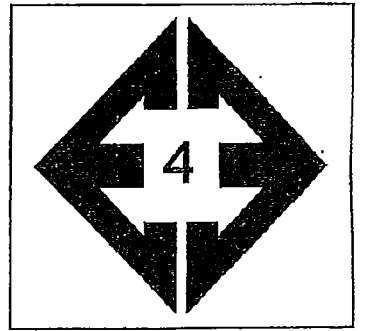
**From southwest
corner of site,
looking
northeast.**
