**ENTECH**  
ENGINEERING, INC.

**SOILS AND GEOLOGY STUDY  
VILLAS AT ASPEN TRAILS  
PARCEL NO. 55092-00-002  
SEC OF BRADLEY ROAD AND LEGACY HILL ROAD  
EL PASO COUNTY, COLORADO**

June 20, 2023

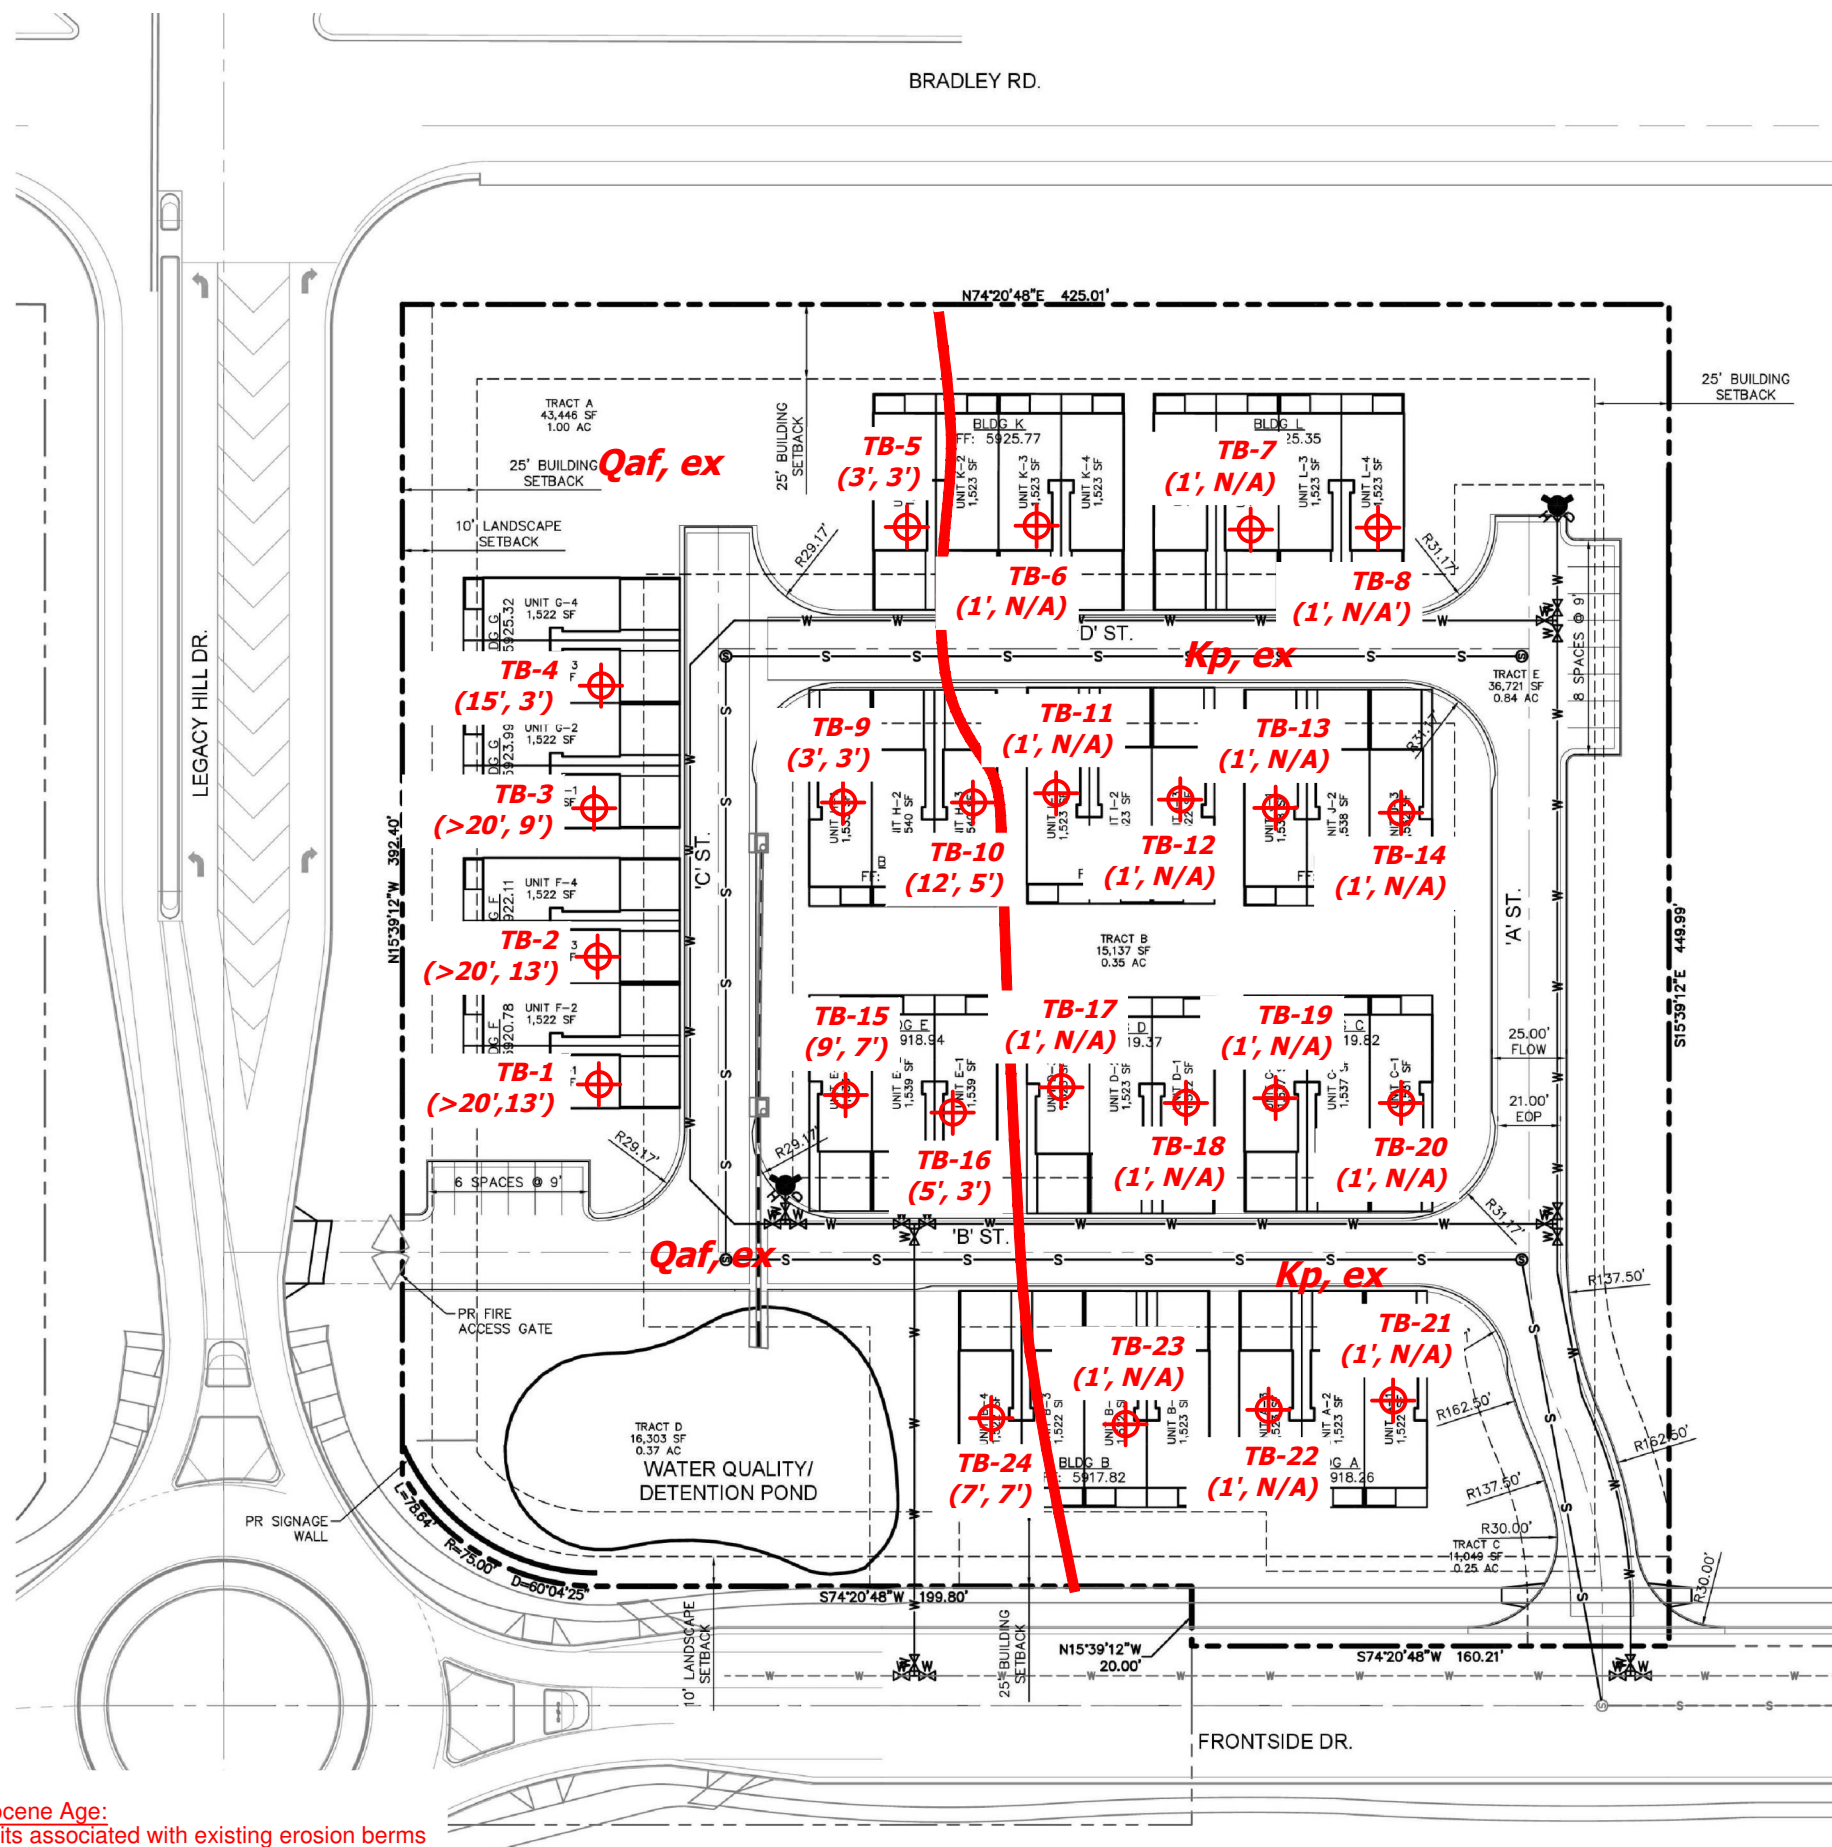
Detailed mapping has been performed on this site to produce an Engineering Geology Map Figure 6. This map shows the location of various geologic conditions of which the developers should be cognizant during the planning, design and construction stages of the project. These hazards and the recommended mitigation techniques are as follows:

**Legend:**  
Qaf - Artificial Fill of Holocene Age:  
man-made fill deposits associated with existing erosion berms  
Kp - The Pierre Shale of Cretaceous Age:  
marine deposited claystone and shale  
ex - expansive soils

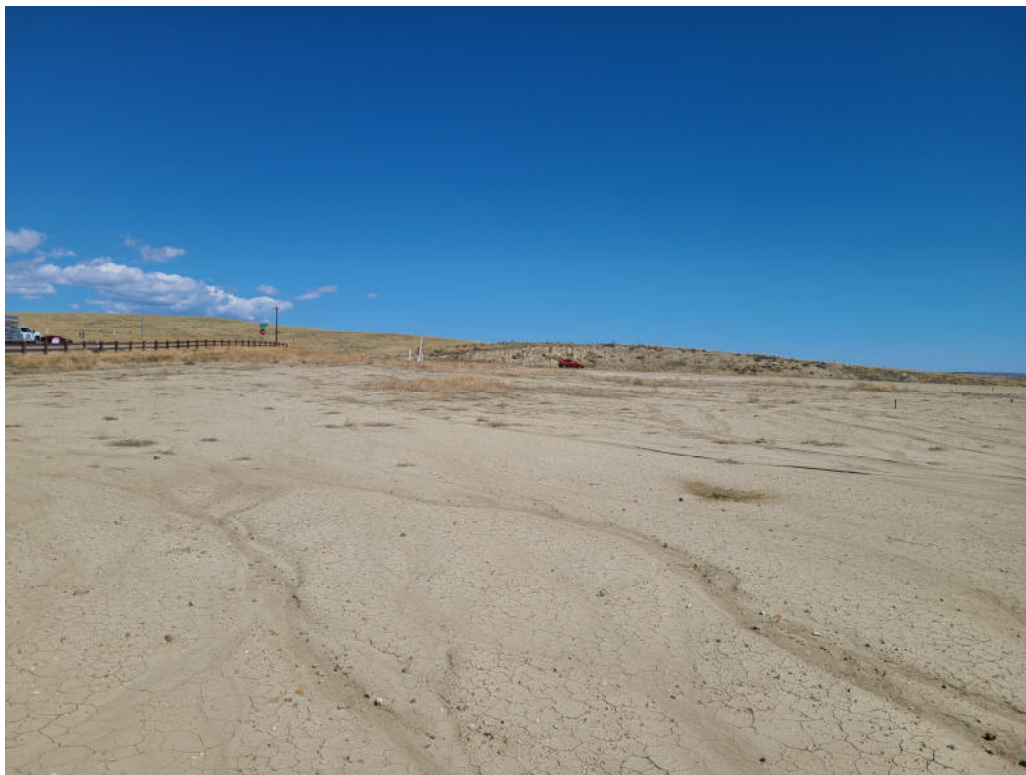
**Looking north from the  
southwest side of the  
site.**

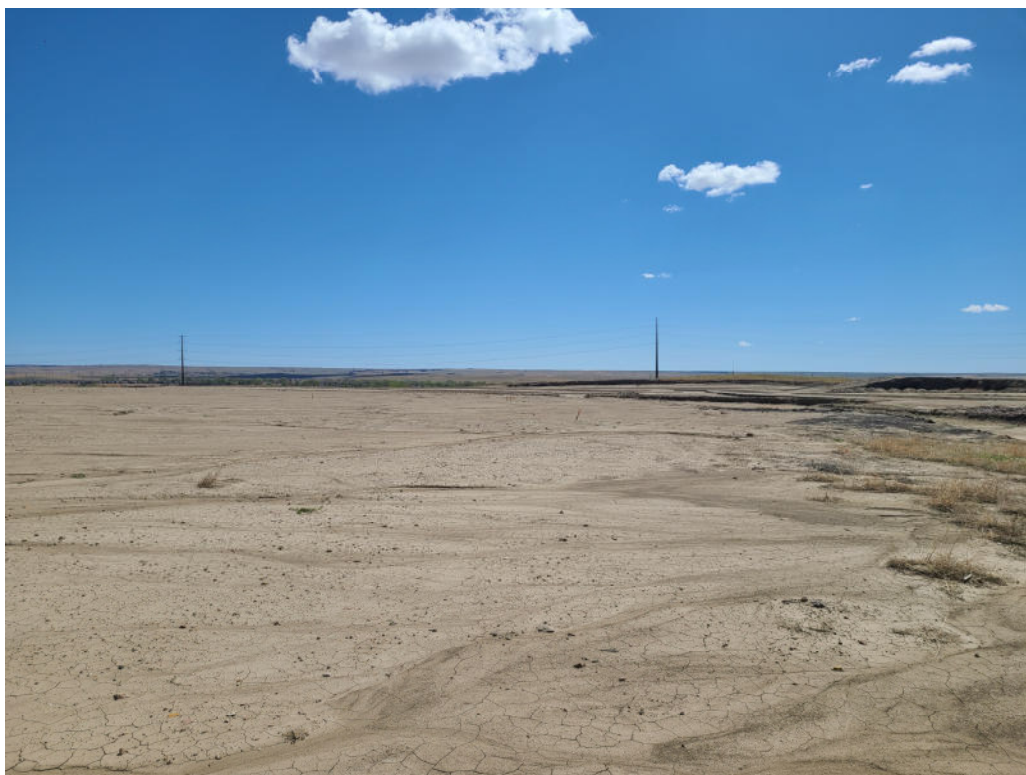
**Looking east from the  
southwest side of the  
site.**

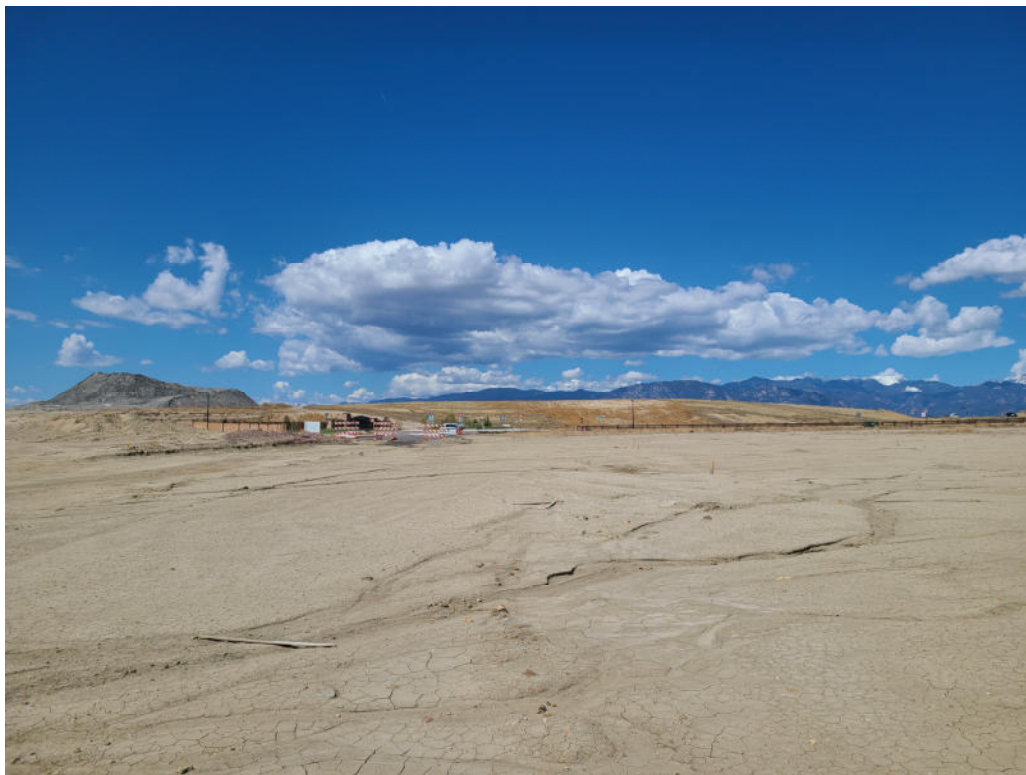
**Looking west from the  
southeast side of the  
site.**

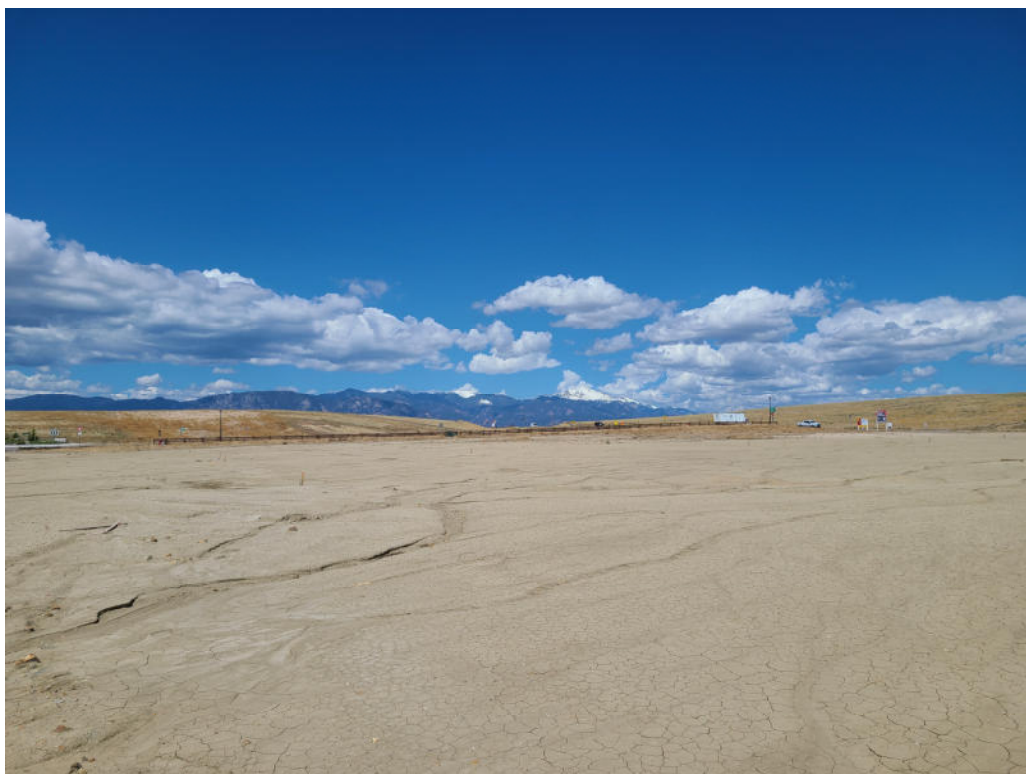
**Looking northwest  
from the southeast  
side of the site.**
