GEOLOGIC HAZARD EVALUATION AND PRELIMINARY GEOTECHNICAL INVESTIGATION

PETERSON ROAD SUBDIVISION
PETERSON ROAD AND HIGHWAY 24
COLORADO SPRINGS, COLORADO

Project No. CS19836-115

August 6, 2024

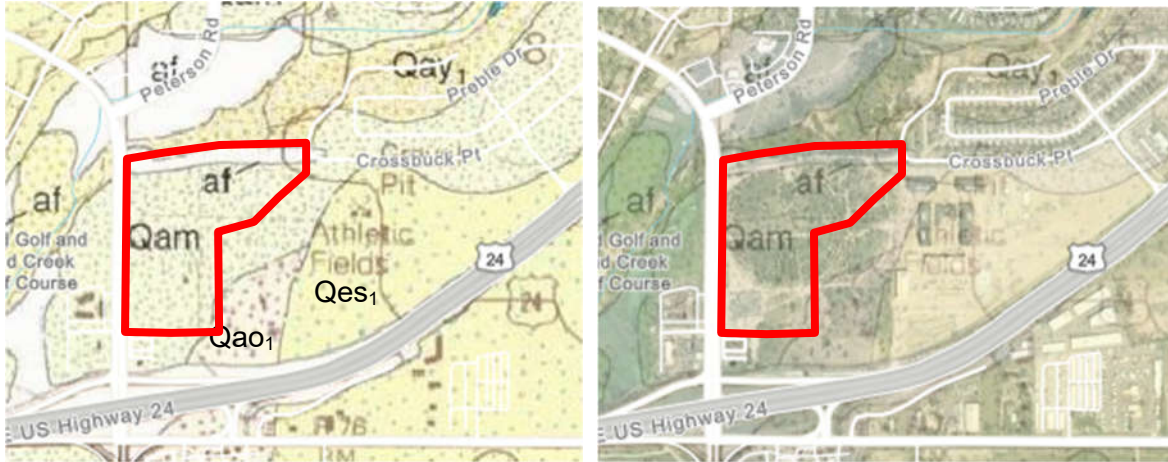
Excerpt from the Elsmere Quadrangle with the approximate project area shown in red

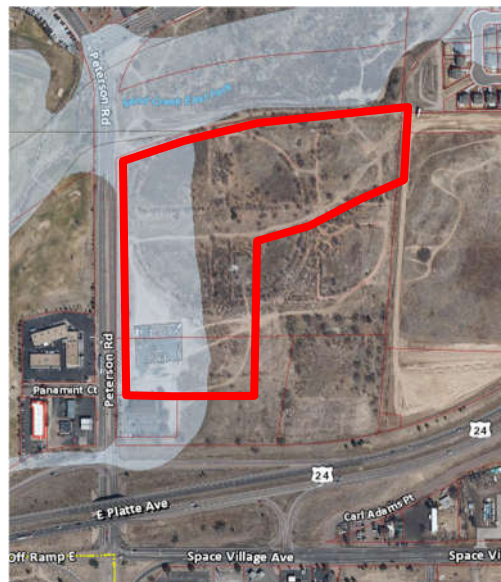
northern edge of the property. The project Civil Engineer should determine the extents of the flood mapping for the site, the flood potential, and design surface drainage.

Clip from online City of Colorado SpringsView mapping, 100-year floodplain in grey, approximate project area outlined in red

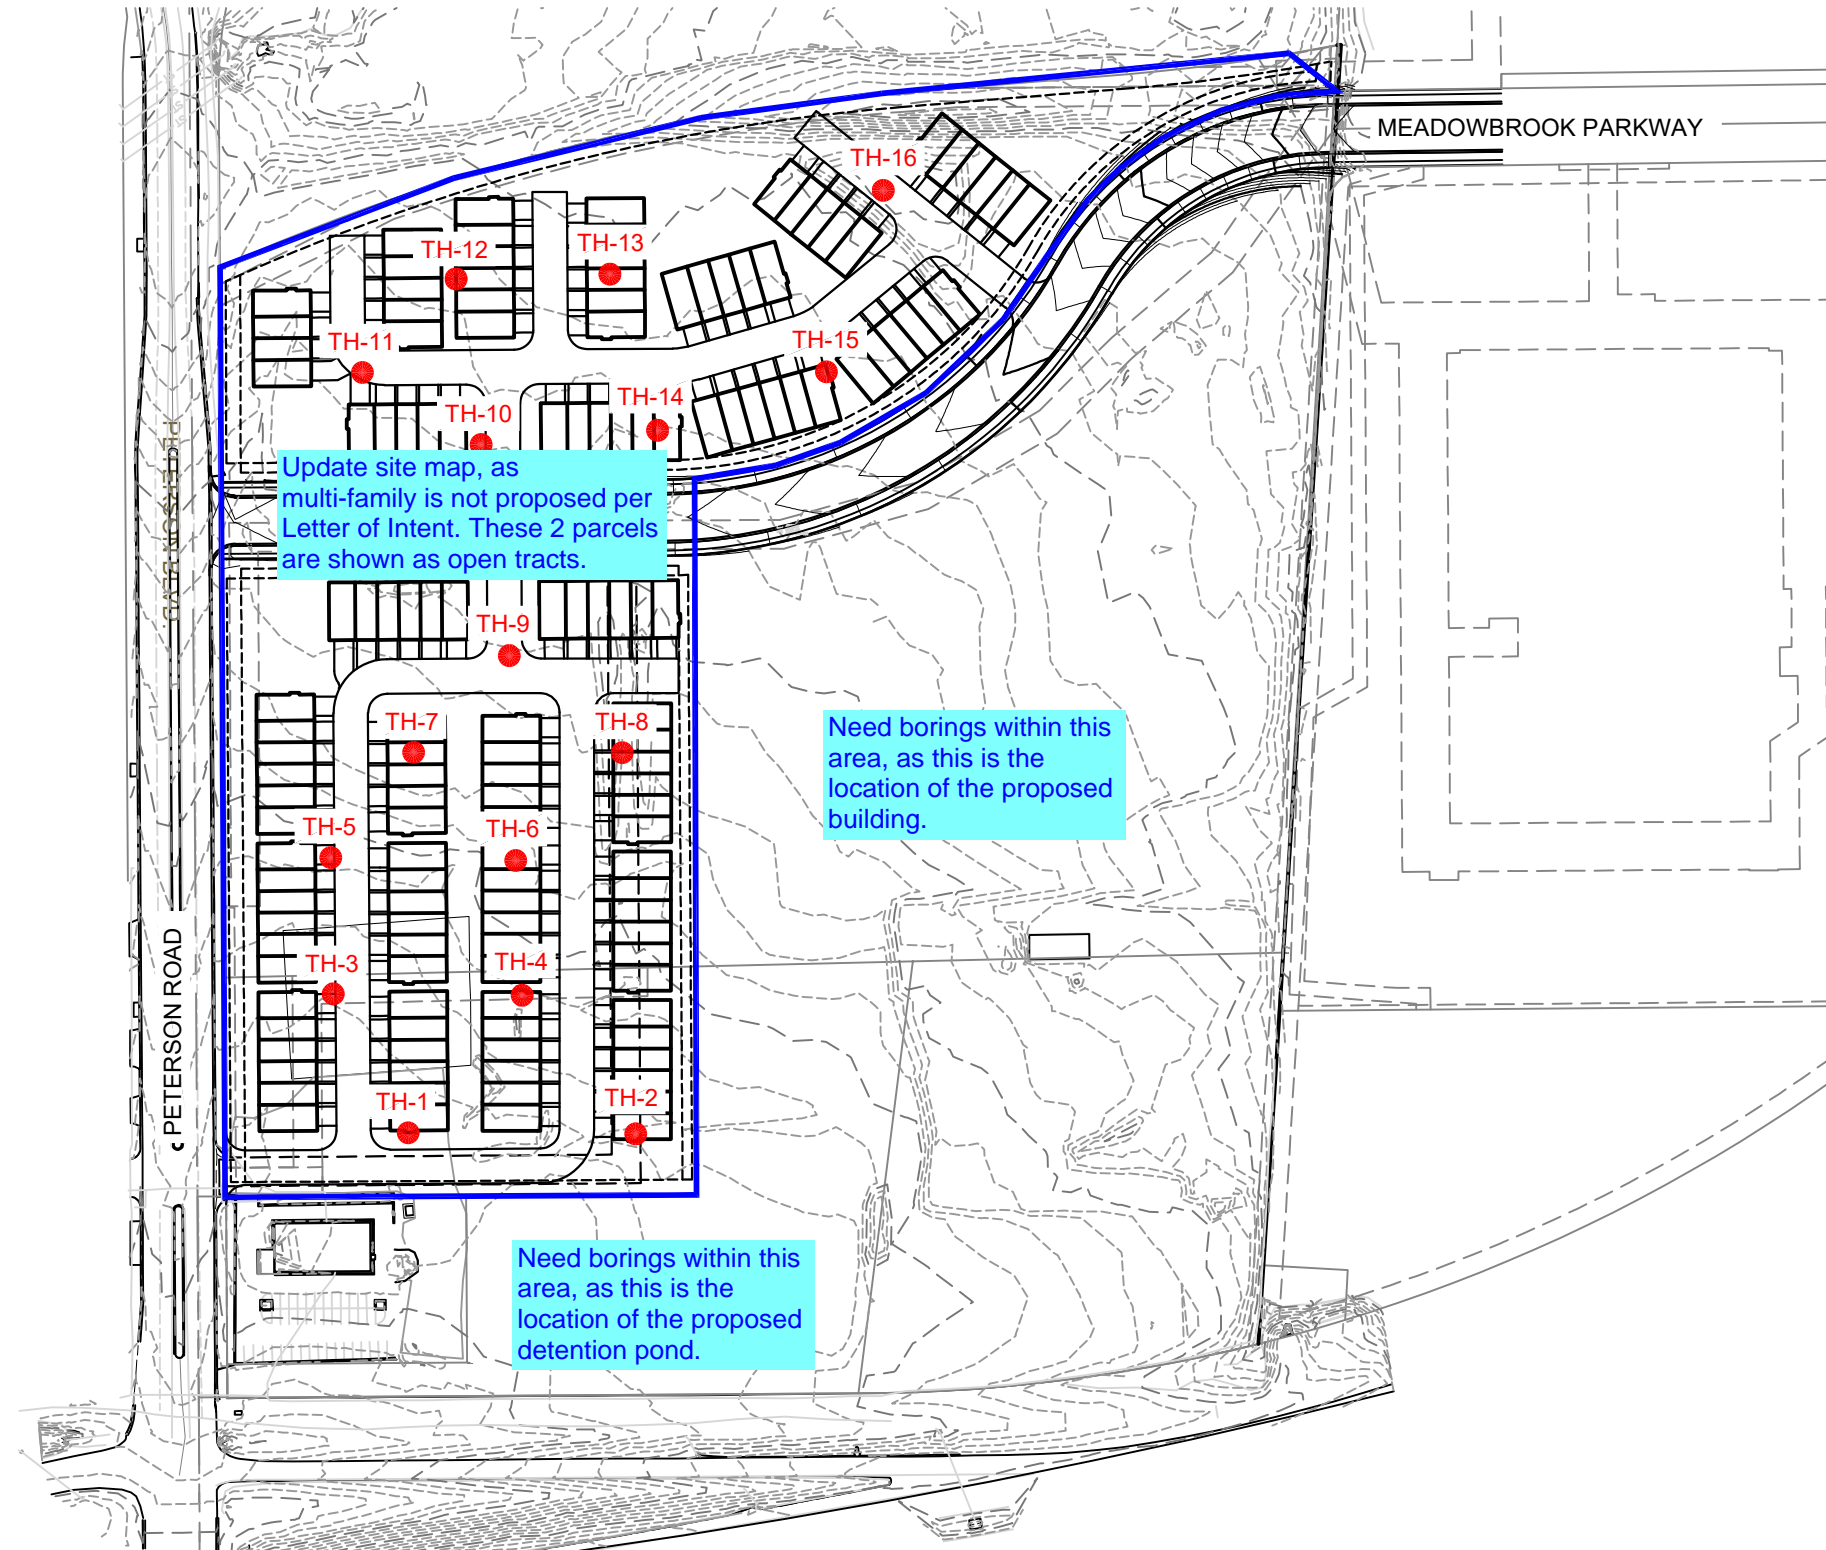
FIG. 1 – LOCATIONS OF EXPLORATORY BORINGS

borings were only done in one area of the property and more borings will need to be done through out the property in order for an accurate report

Subsurface conditions at the site were investigated by drilling sixteen, widely spaced, exploratory borings to depths between 25 and 35 feet. The approximate locations of the borings are shown in Fig. 1. Our representative observed the drilling operations, logged the subsurface conditions found in the borings, and obtained samples for laboratory testing. Graphical logs of the borings, including the results of field penetration resistance tests, and some laboratory test
