**ENTECH**  
ENGINEERING, INC.

**SOIL, GEOLOGY, GEOLOGIC HAZARD,  
AND WASTEWATER STUDY,  
SADDLEHORN RANCH SUBDIVISION  
EL PASO COUNTY, COLORADO**

April 29, 2019

Entech Job No. 181823  
AAprojects/2018/181823 countysoil/geo/ww

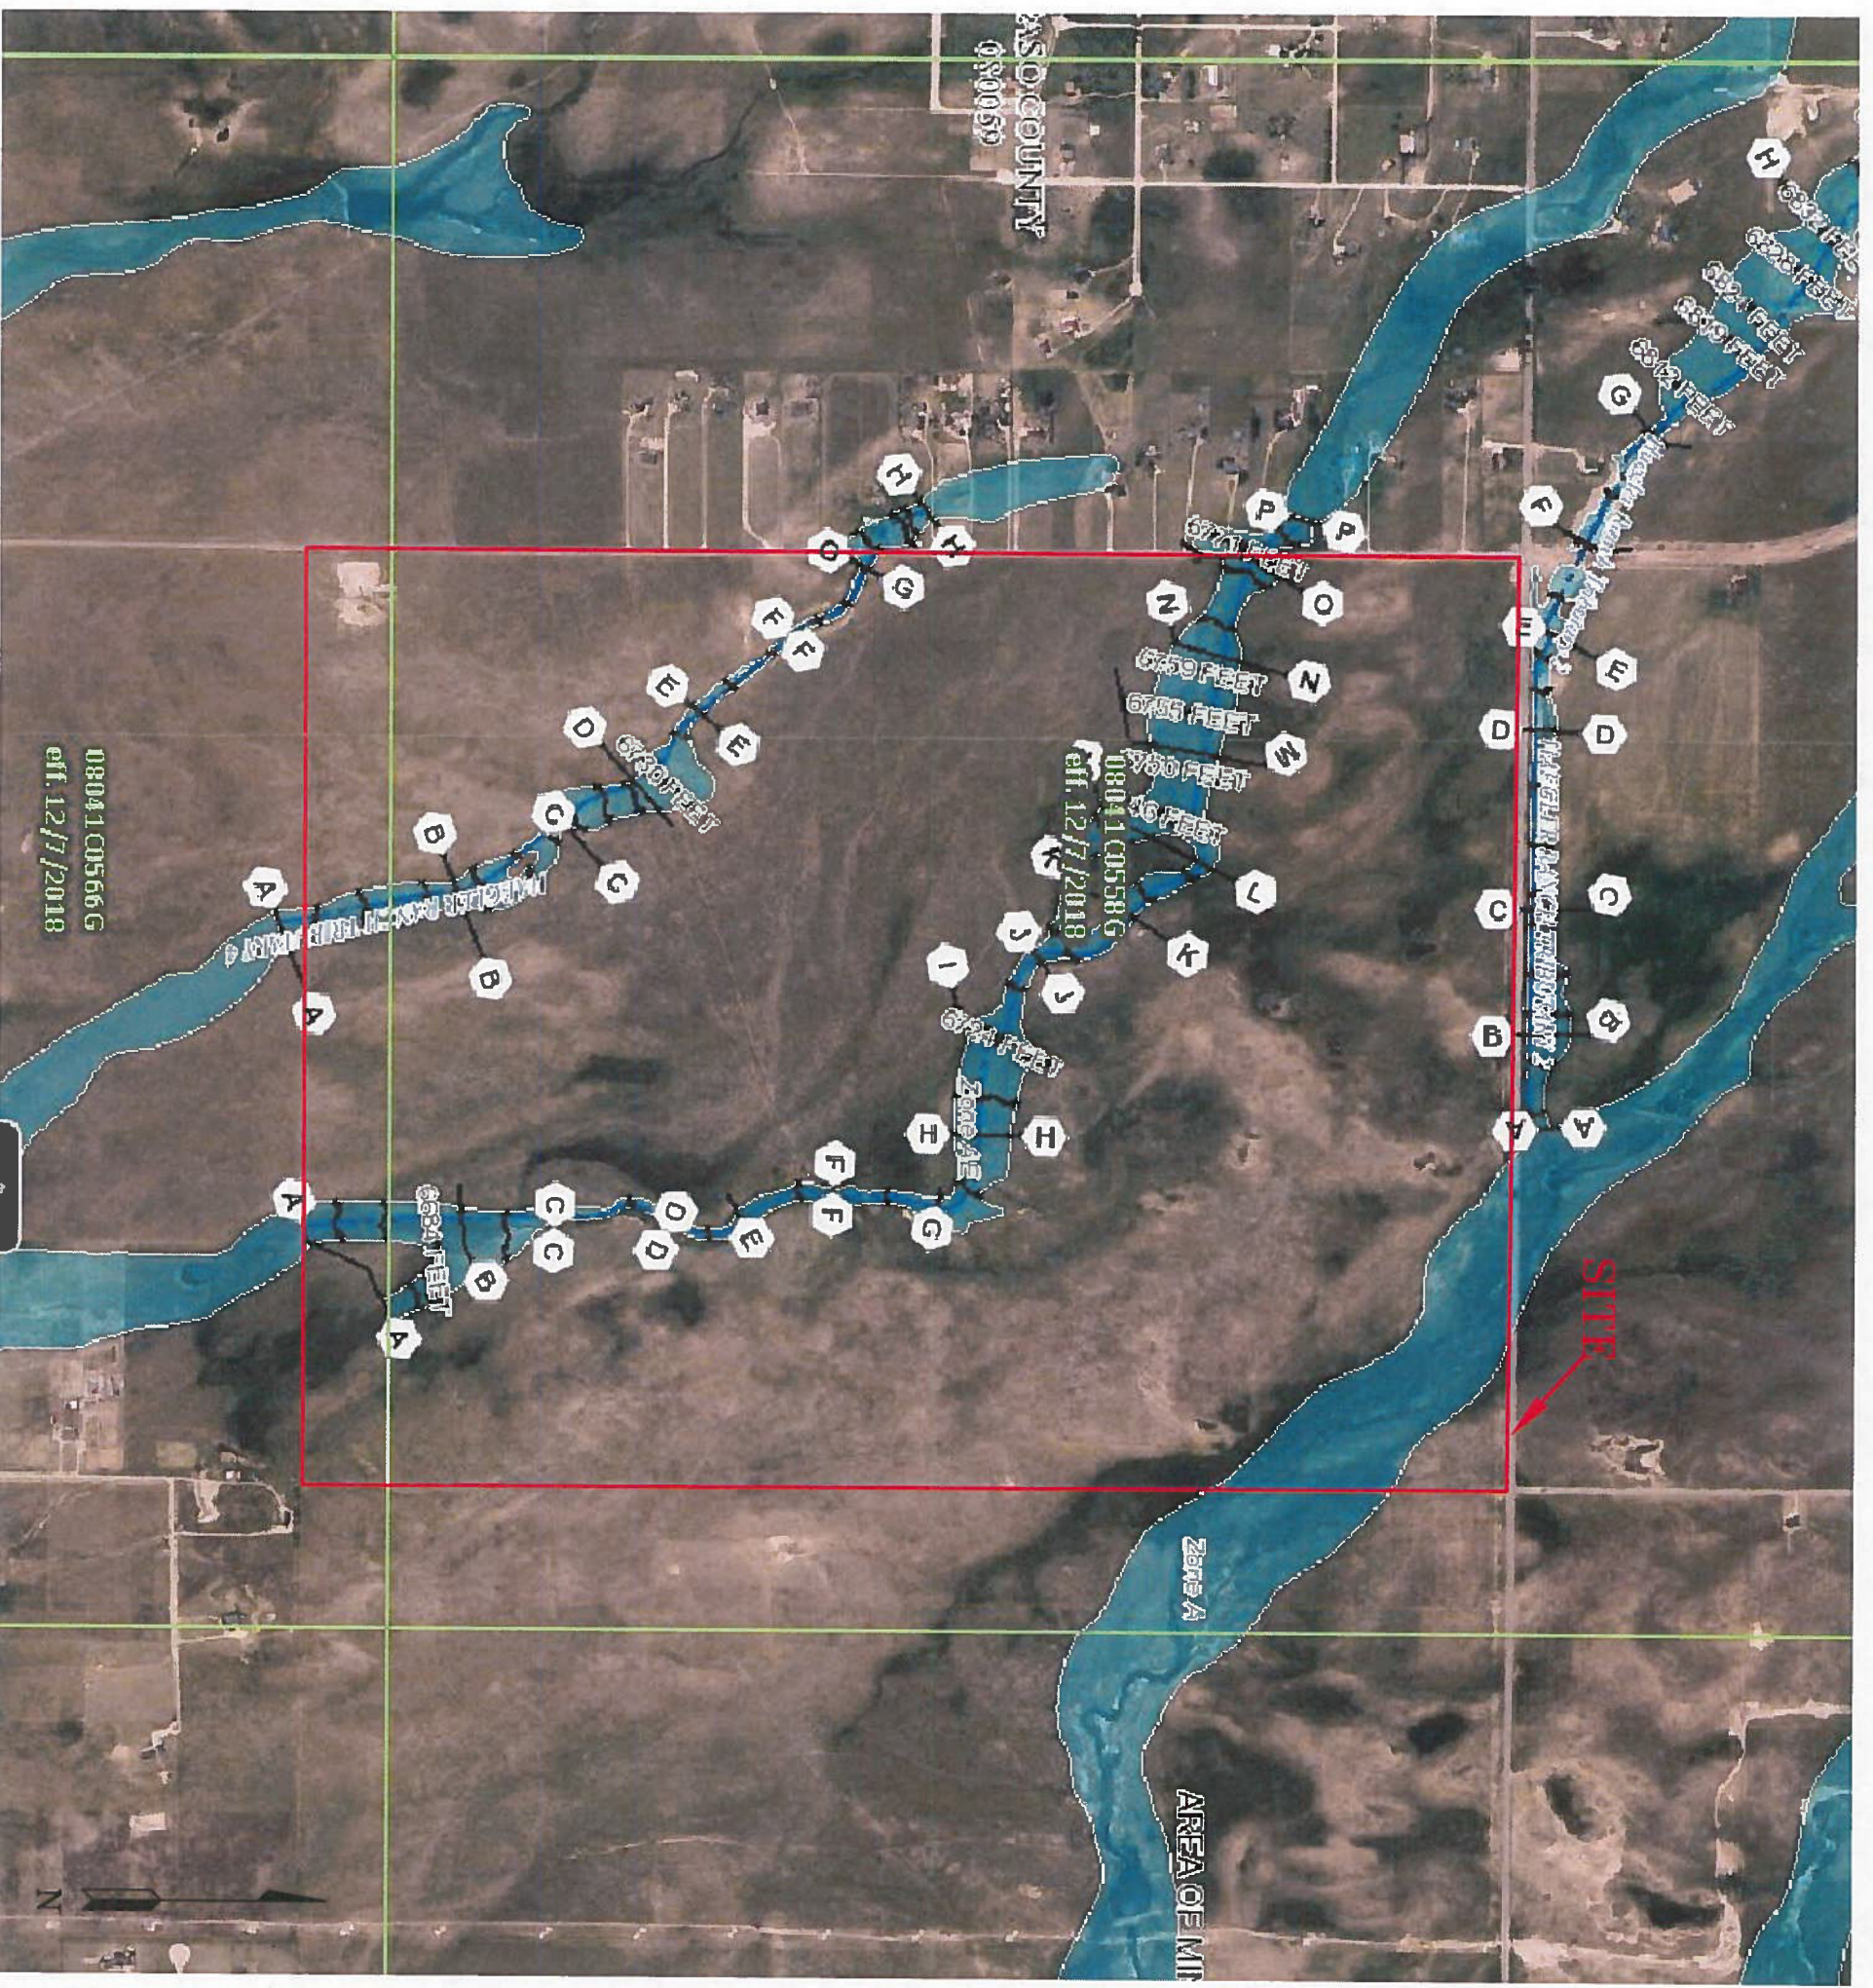
As mentioned previously, detailed mapping has been performed on this site to produce an Geology/Engineering Geology Map (Figure 6). This map shows the location of various geologic conditions of which the developers should be cognizant during the planning, design and construction stages of the project. These hazards and the recommended mitigation techniques are as follows:

*sw, psw – Seasonal and Potentially Seasonal shallow groundwater areas:* In these areas, we would anticipate the potential for periodically high subsurface moisture conditions, frost heave potential, and highly organic soils. Areas where perched water conditions are encountered should also follow these recommendations. Construction proposed in or adjacent to these areas, should follow these precautions:

Mitigation: In these locations, foundations are subject to severe frost heave and should penetrate to a sufficient depths so as to prevent the formation of ice lenses beneath foundations. At this location and elevation, a foundation depth for frost protection of 30-inches is recommended. In areas where high subsurface moisture conditions are anticipated periodically, a subsurface perimeter drain will be necessary to help prevent the seepage of water into areas below grade. A typical perimeter drain detail is presented in Figure 8. Any grading in these areas should be done in a manner that directs surface flow around construction to avoid areas of ponded water. Areas of organic material will require removal prior to any fill placement. Unstable soil conditions should be expected in areas of shallow groundwater. Where foundations approach the groundwater level, stabilization of the excavations utilizing shot rock may be necessary. Underslab drains or capillary breaks, and interceptor drains may be necessary to prevent intrusion of water into areas below grade. Typical drain details are presented in Figures 9 and 10.

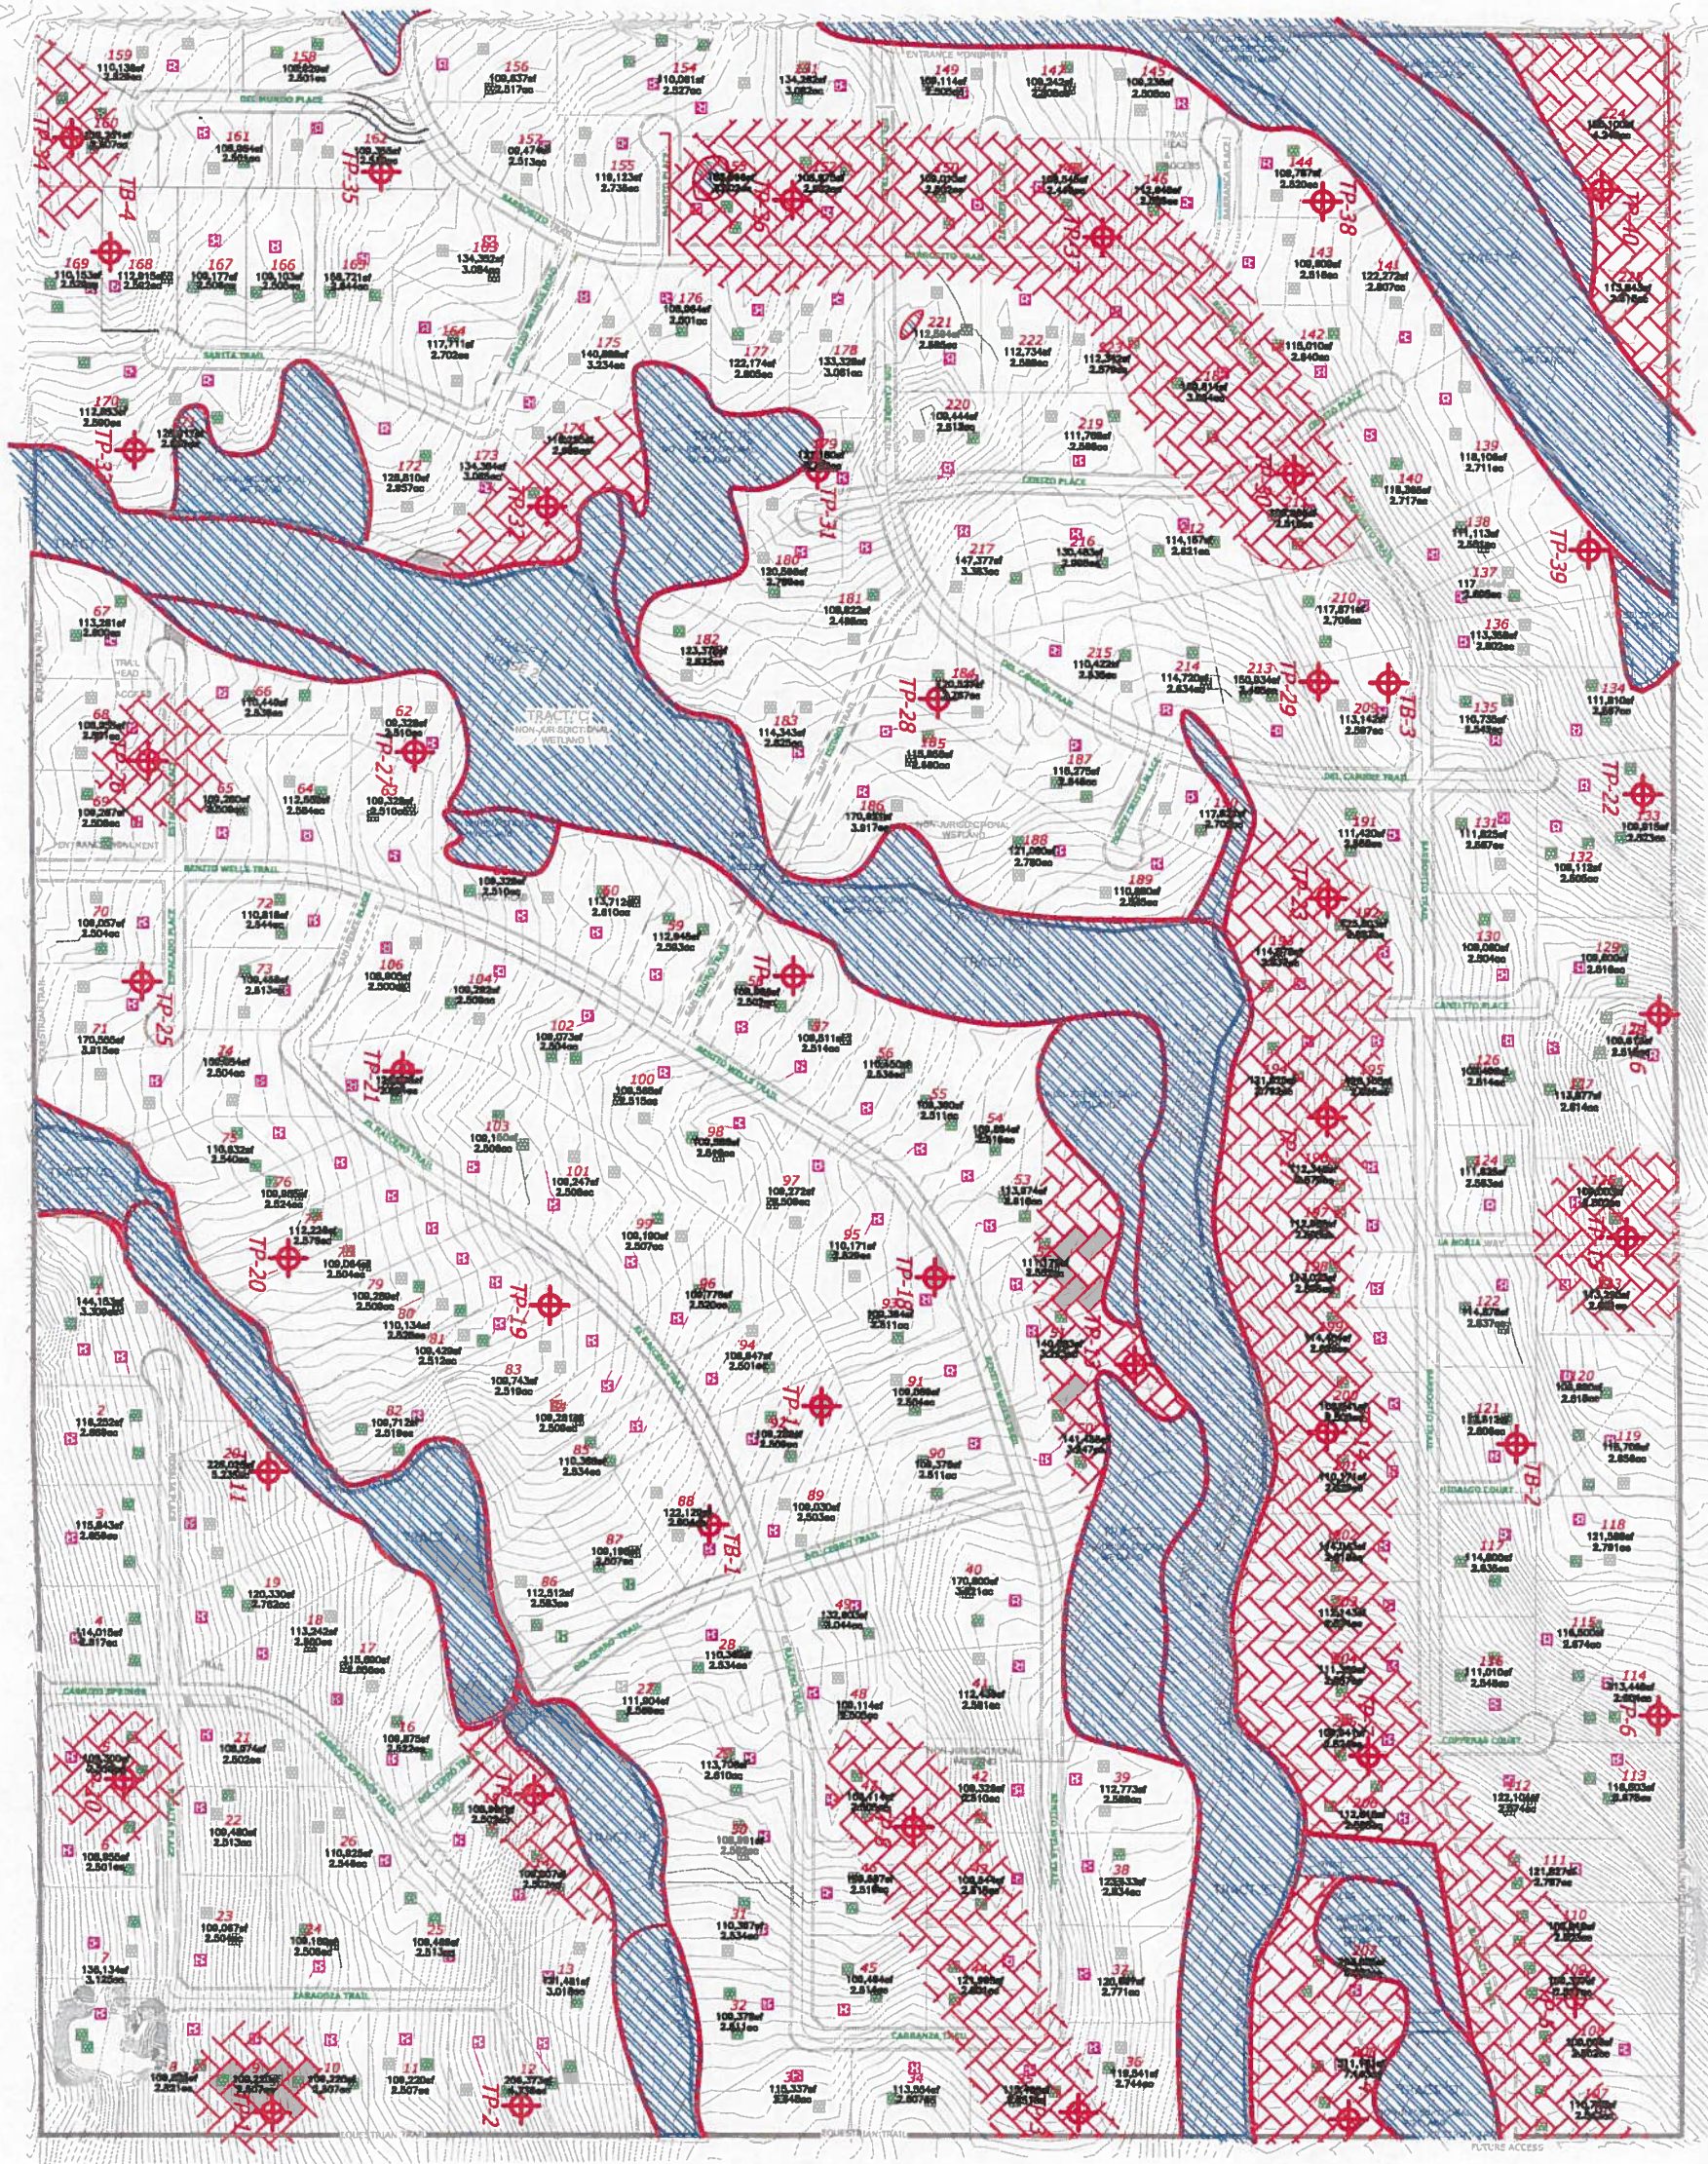
DATE	4/29/19
SCALE	AS SHOWN
JOB NO.	181023
ISSUE NO.	11

- APPROXIMATE LOCATION OF PERCOLATION TEST
- AREAS WHERE DESIGNED SYSTEMS ARE RECOMMENDED DUE TO UNSUITABLE SOILS, SHALLOW BEDROCK OR SHALLOW GROUNDWATER
- AREAS WHERE SEPTIC SYSTEMS ARE NOT RECOMMENDED UNLESS SHALLOW BEDROCK, SHALLOW GROUNDWATER OR UNSUITABLE SOILS ARE ENCOUNTERED REQUIRING DESIGNED SYSTEMS
- POSSIBLE HOUSE LOCATION
- TWO POSSIBLE OWTS (ON SITE WASTEWATER TREATMENT SITES)
- APPROXIMATE TEST BORING LOCATIONS
- APPROXIMATE TEST PIT LOCATIONS
