**SOILS AND GEOLOGY STUDY
STERLING RANCH EAST – SKETCH PLAN
PARCEL NOS. 52270-00-005 AND 52270-00-006
COLORADO SPRINGS, COLORADO**

Prepared for:
Classic SRJ
2138 Flying Horse Club Drive
Colorado Springs, CO 80921

August 25, 2023

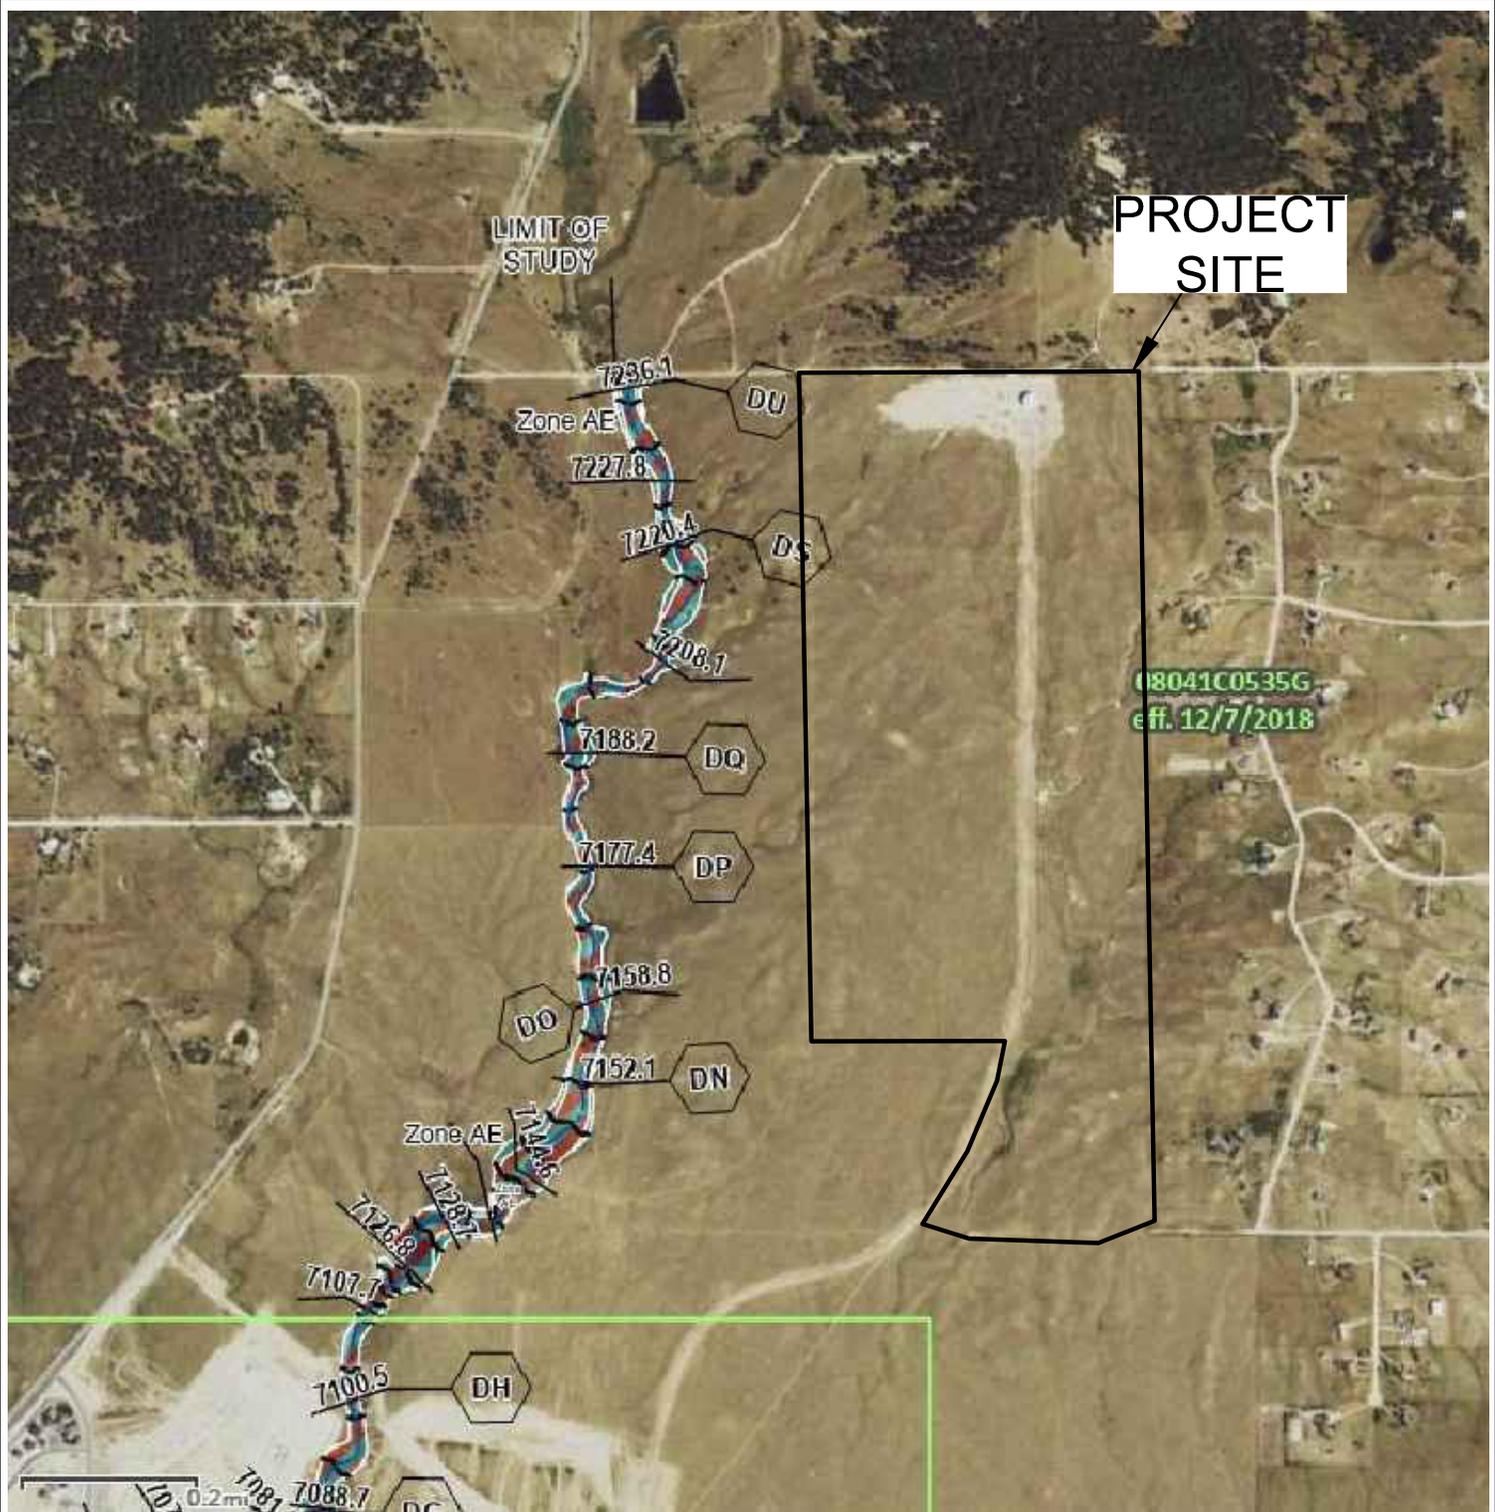
FIG. 8

The site is not mapped within floodplain zones according to the FEMA Map No. 08041CO535G, Figure 8 (Reference 8). However, water was observed flowing in the drainages in the central and southeastern portions of the site. These areas are discussed as follows:

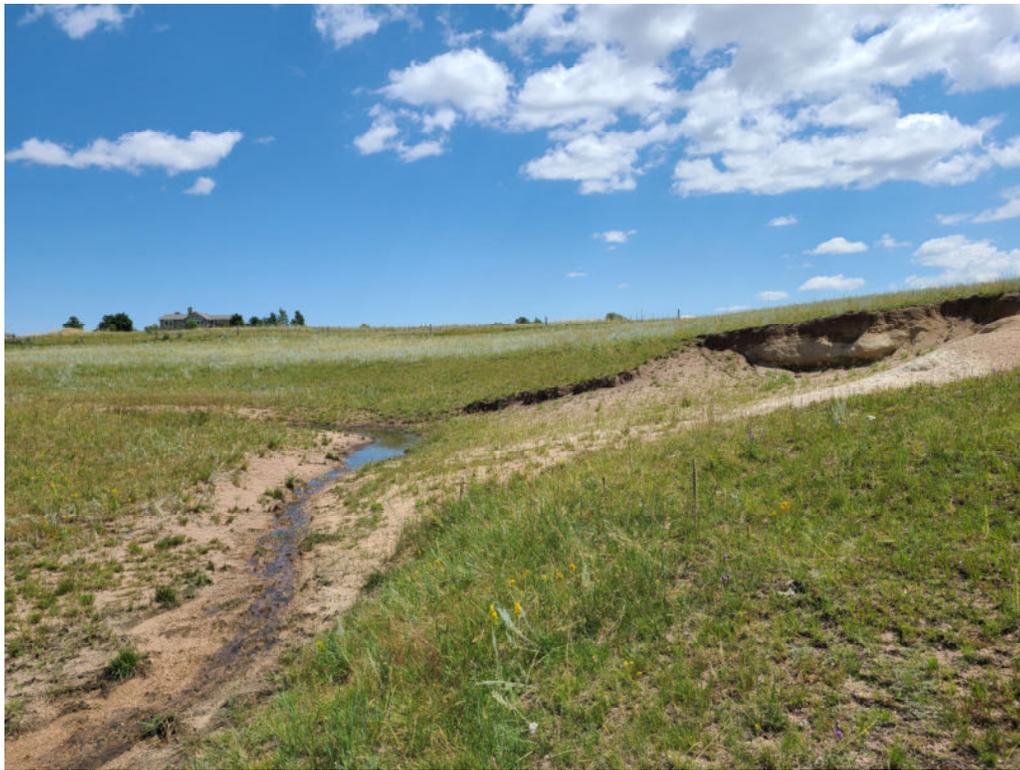
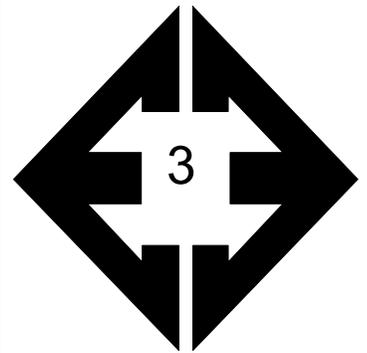
Looking east towards erosion feature eastern side of site.

Areas of erosion and gullying may require the construction of check dams and revegetation of the site soils after construction. General recommendations for erosion control are discussed under Section 8.0 "Erosion Control".

Cut and fill slope areas will be subjected primarily to sheetwash and rill erosion. Unchecked rill erosion can eventually lead to concentrated flows of water and gully erosion. The best means to combat this type of erosion is, where possible, the adequate re-vegetation of cut and fill slopes. Cut and fill slopes having gradients more than three (3) horizontal to one (1) vertical become increasingly more difficult to revegetate successfully. Therefore, recommendations pertaining to the vegetation of the cut and fill slopes may require input from a qualified landscape architect and/or the Soil Conservation Service.
