**GEOLOGIC HAZARD INVESTIGATION  
VILLAGES AT WATERVIEW NORTH  
SOUTH POWERS BOULEVARD AND BRADLEY ROAD  
EL PASO COUNTY, COLORADO**

May 15, 2020  
Revised: October 1, 2020  
Revised: July 15, 2022

Entech Job No. 200599  
A\projects\2020\200599 city geohaz-rev

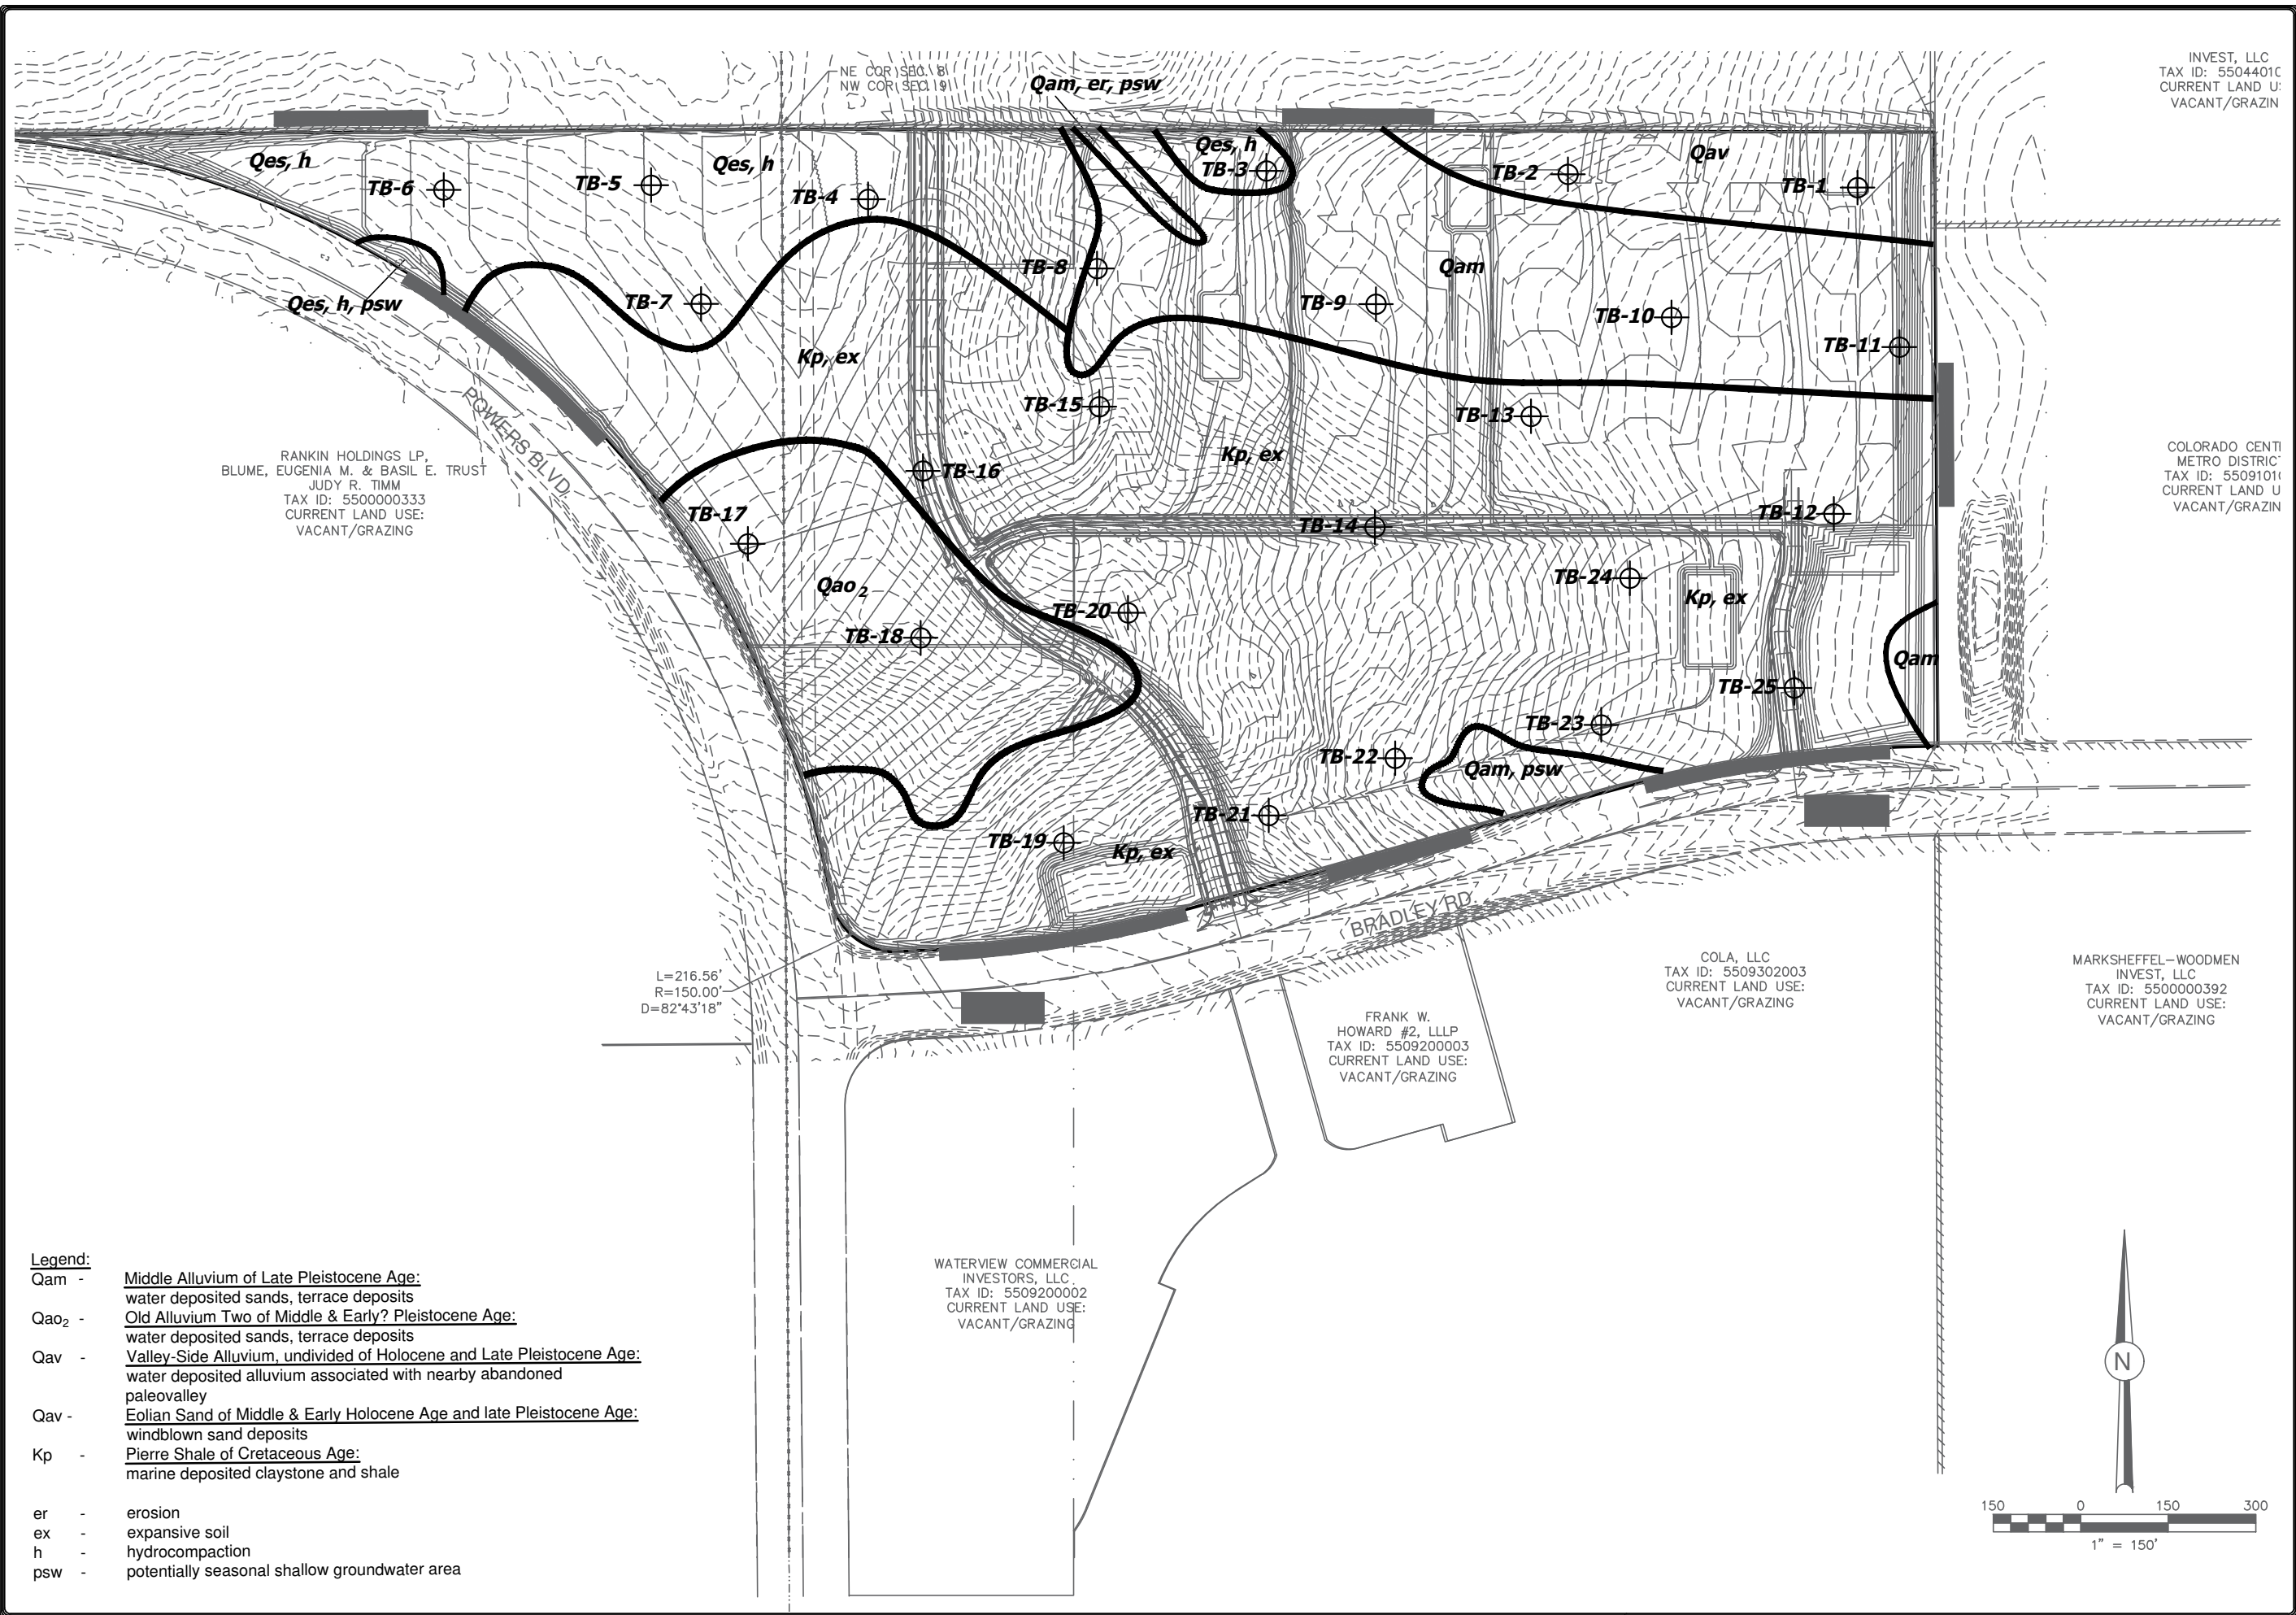
Detailed mapping has been performed on this site to produce an Engineering Geology Map Figure 7. This map shows the location of various geologic conditions of which the developers should be cognizant during the planning, design and construction stages of the project. Hazards include areas of collapsible soils/hydrocompaction, highly expansive soils, potential seasonal shallow groundwater, and shallow bedrock. Minor areas of erosion were also observed. These hazards and the recommended mitigation techniques are as follows:
