ENTECH
ENGINEERING, INC.

**SOILS AND GEOLOGY STUDY
OVERLOOK AT HOMESTEAD
ELBERT ROAD
EL PASO COUNTY, COLORADO**

August 2, 2023
Revised December 1, 2023

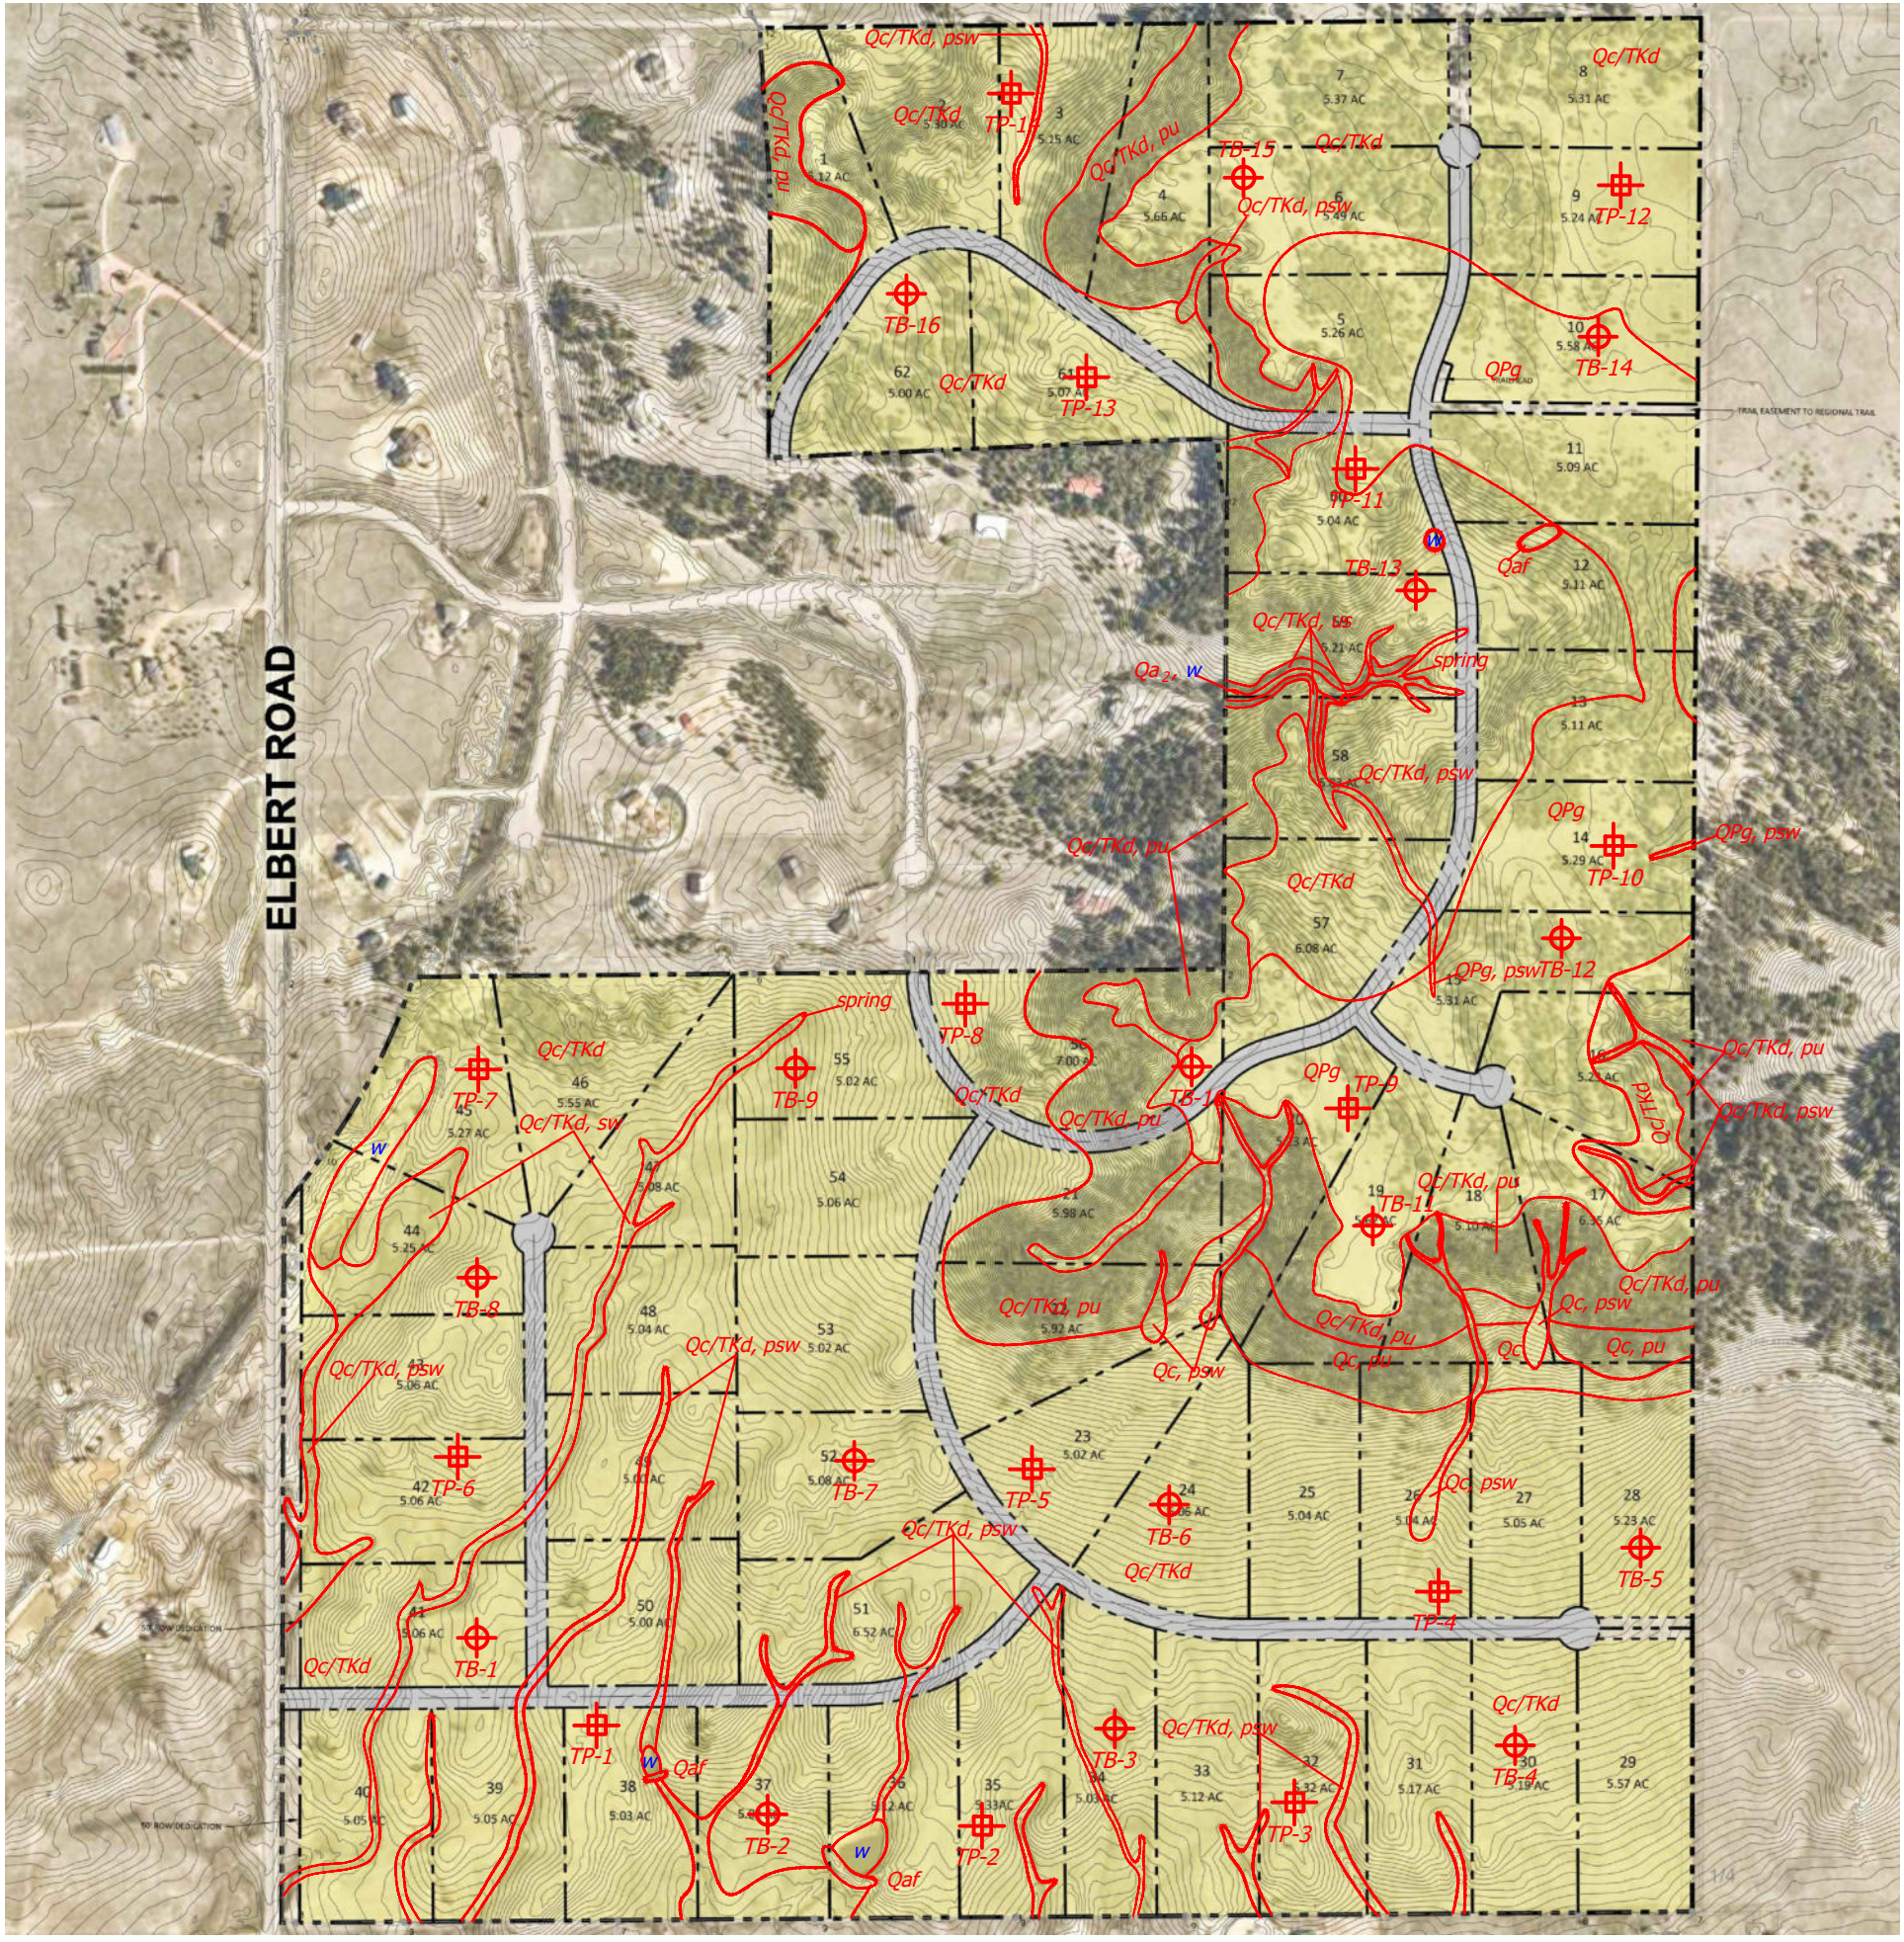
JOB NO.
230677
FIG. 6

Detailed mapping has been performed on this site to produce an Engineering Geology Map Figure 6. This map shows the location of various geologic conditions of which the developers should be cognizant during the planning, design and construction stages of the project. These hazards and the recommended mitigation techniques are as follows:

Debris Flow Susceptibility - (Figure 8) Lots affecting by this potential hazard include Lots 23 - 35

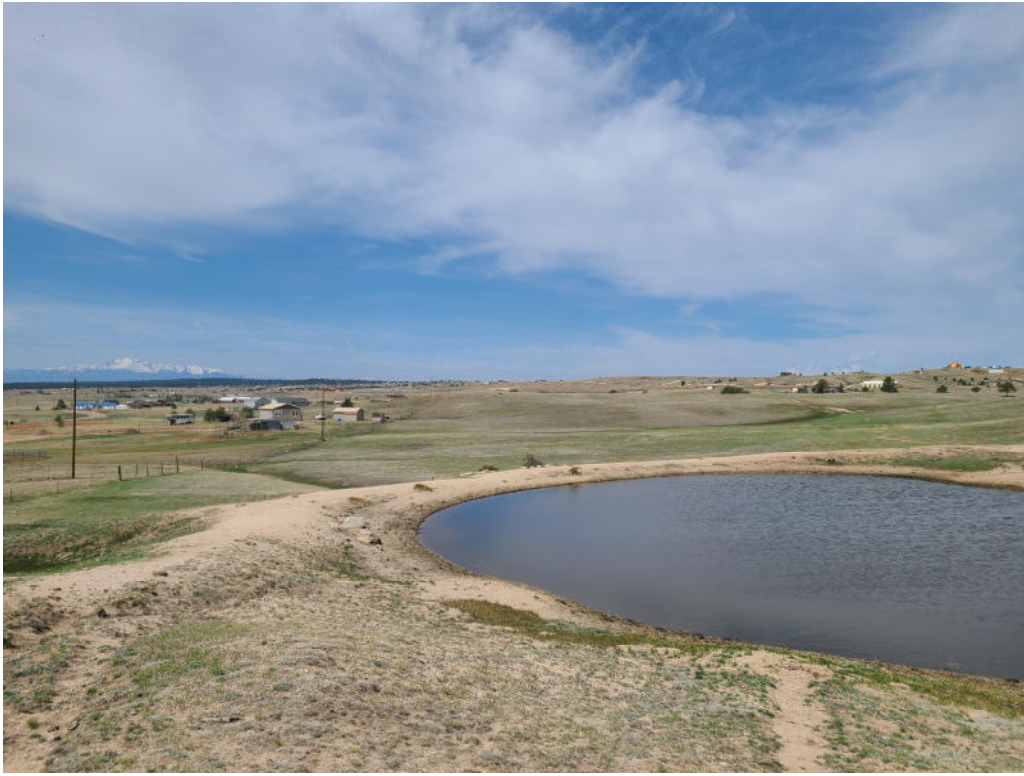
Looking west towards pond in the southern side of the site.

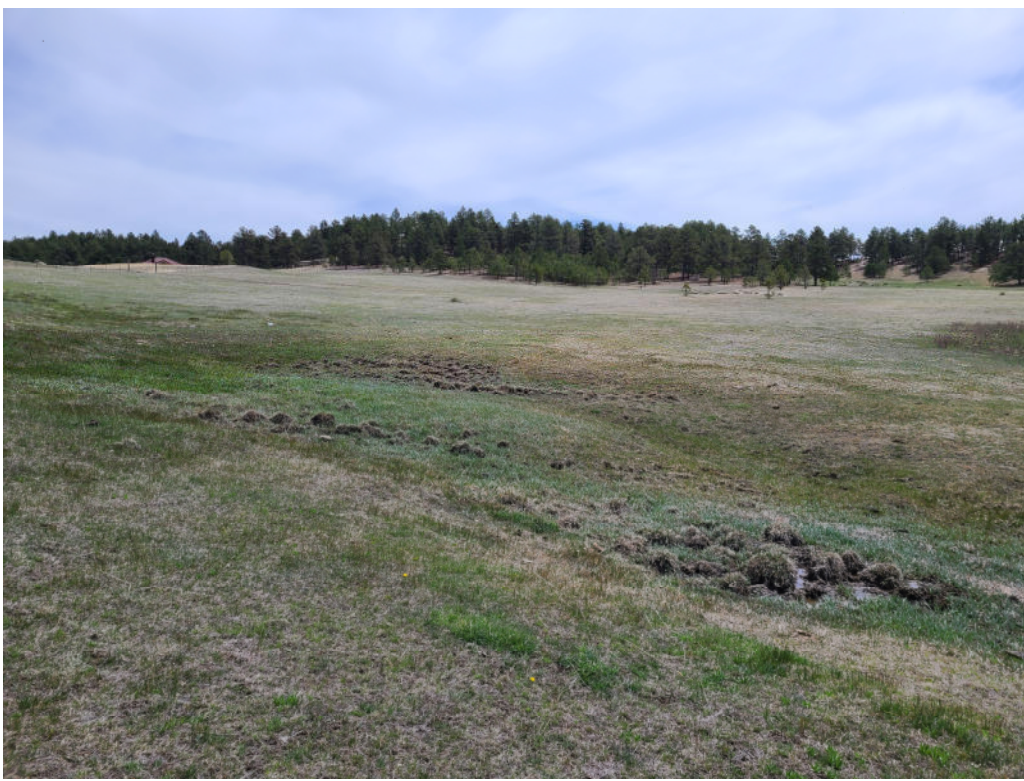
Two springs were observed in the west-central portion of the site. The springs should be avoided by development and will likely be located within drainage easements. Springs other than those indicated on Figure 6 may be present on the site.

Looking east towards spring in the area of Lots 47 and 55.

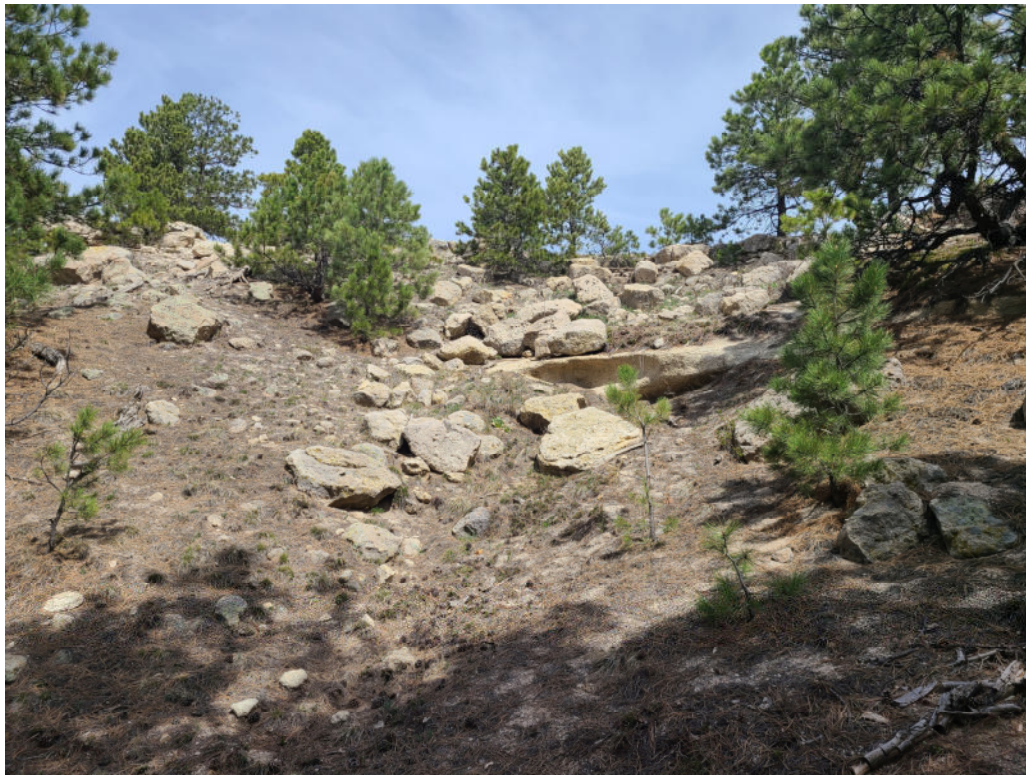
Based on our site observation, some of the rock outcrops along the mesa have the potential for minor rockfall hazards. These areas are associated with the cliff-forming portions of the Dawson Formation along the slopes of the mesa. These areas have been identified on the Geology/Engineering Geology Map, Figure 6.

**Looking towards cliff
in the southeastern
portion of the site.**

Mitigation: Due to the proposed lot sizes in these areas, there should be sufficient room on the lots to avoid the potential hazard with designated preservation/no-build easements. Additional investigation is recommended on a lot specific basis once building locations have been determined.

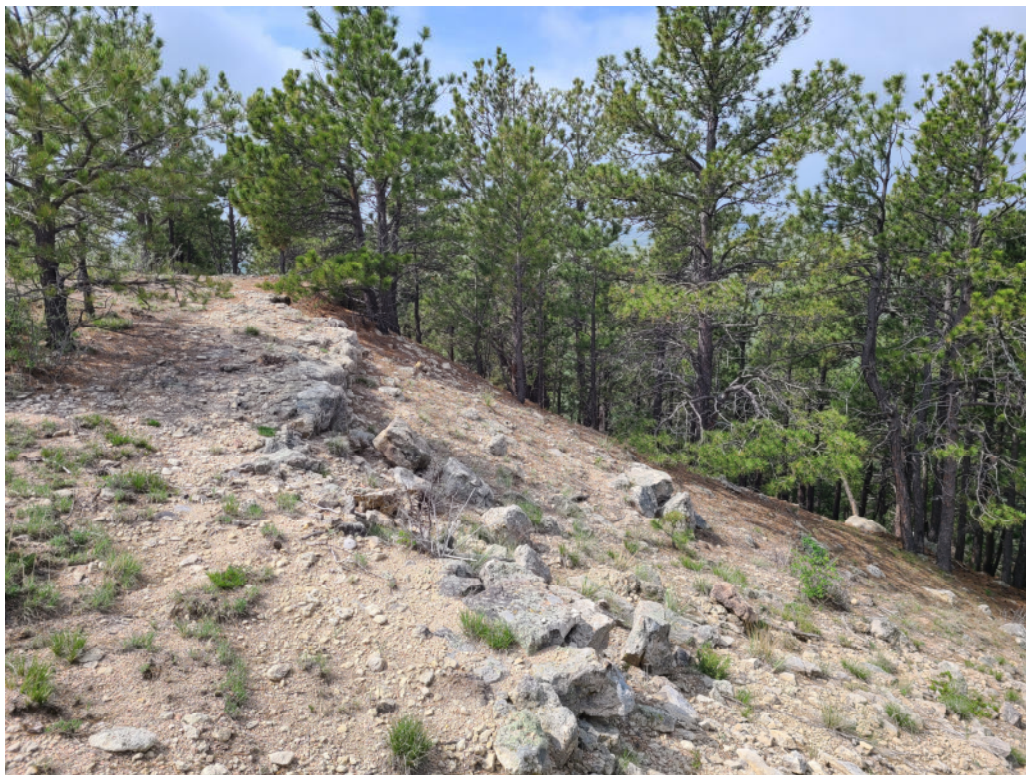
These slopes are considered stable in their present condition; however, care must be exercised in these areas not to create a condition which would tend to activate instability. The steeper slopes along mesa should be avoided by development. A minimum setback of 30 feet from the crest of the cliffs/steep slopes is recommended. Structures can also be placed at a sufficient distance from the potentially unstable slopes. Additional investigation may be warranted once building locations are determined on the lots with this constraint. Based on the size of the site and anticipated development these areas can likely be avoided or mitigated.

Looking south along steep slope in the area of Lot 20.

Mitigation: It is anticipated the majority of these areas can be avoided. Building should be avoided on the potentially unstable slopes unless they are stabilized. A minimum setback of 30 feet from the crest of these slopes is recommended. Stabilization could involve regrading to slope angles no steeper than 3:1 or the use of engineer-designed retaining walls, tiebacks, or buttresses. Where retaining walls are not used, erosion protection may be necessary to prevent undercutting by the creek during periods of high water.

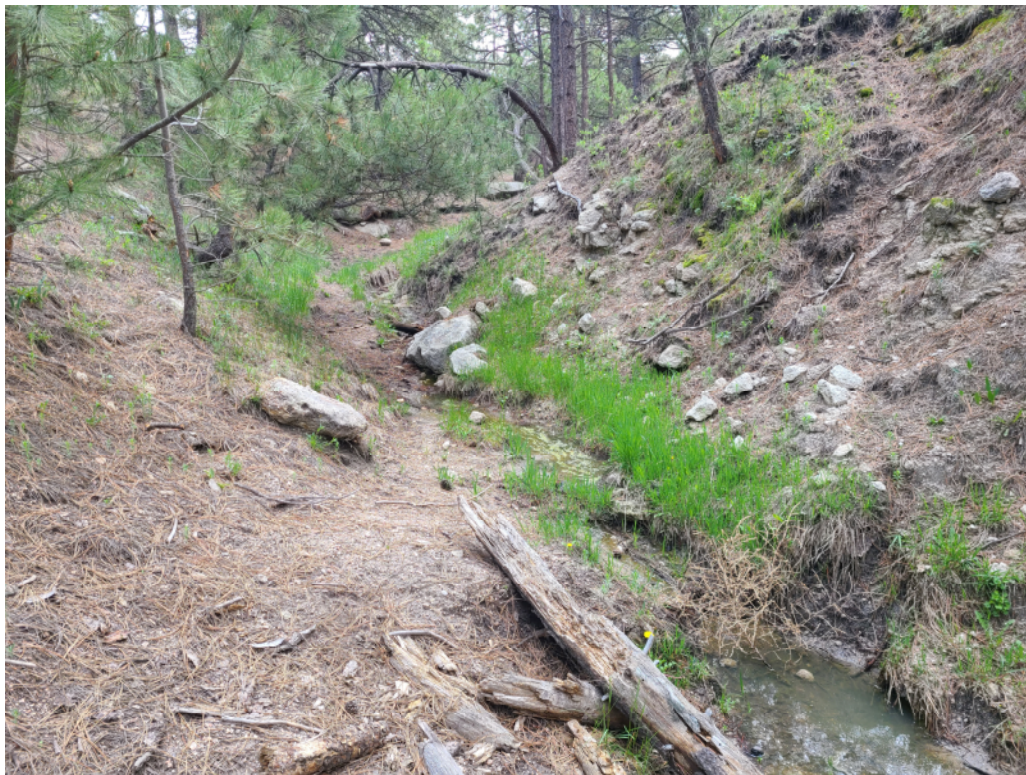
**Looking east along
drainage on Lot 59.**

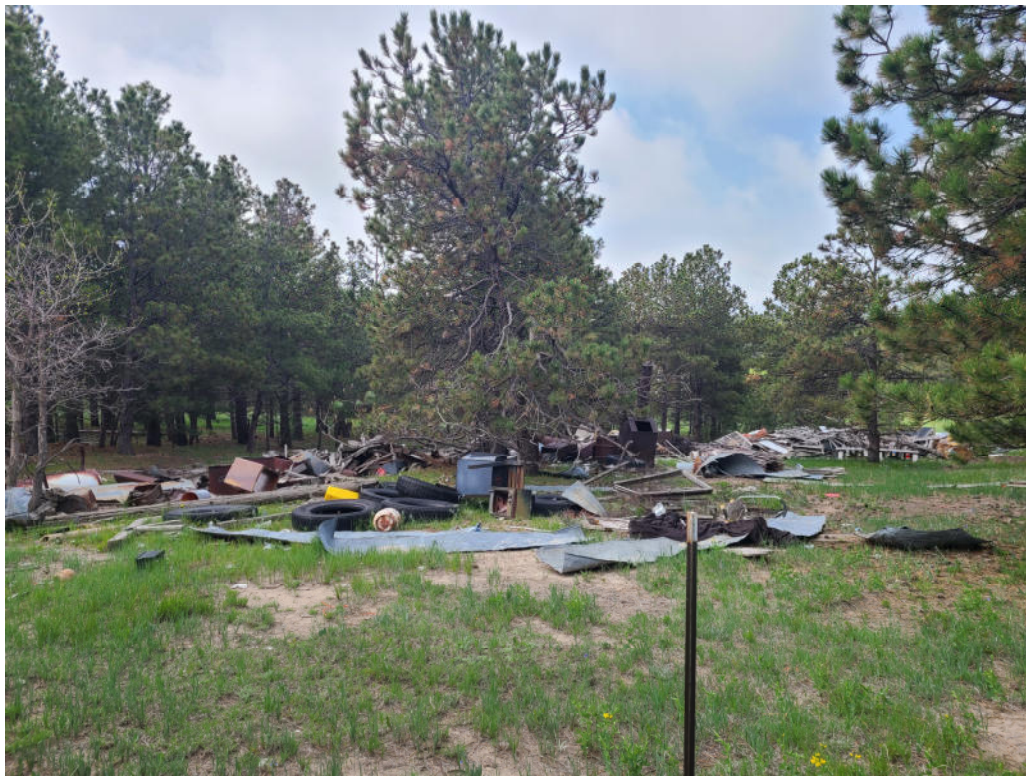
**Looking southwest
toward trash pile on
Lot 12.**

Mitigation: The fill on this site is considered uncontrolled for construction purposes. Any uncontrolled fill encountered beneath foundations will require removal and recompaction at a minimum of 95% of its maximum Modified Proctor Dry Density, ASTM D-1557.

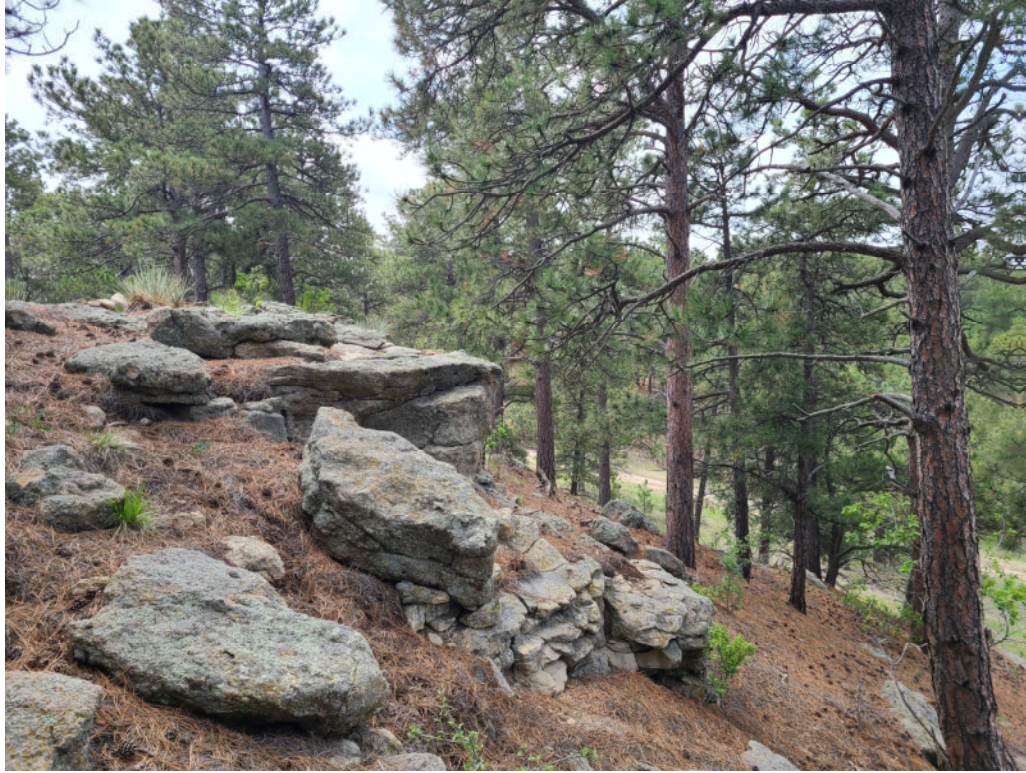
**Looking southwest
along cliff and slope
northern portion of the
site.**
